***Technical Memorandum for:***

**Compilation and Interpretation of Key Historic Studies  
Abandoned Mining Wastes - Torch Lake non-Superfund  
Site – C&H Tamarack City Operations Area  
(Site ID # 31000098)  
Houghton County, Michigan  
20177.001.001.0010**

**March 2015**

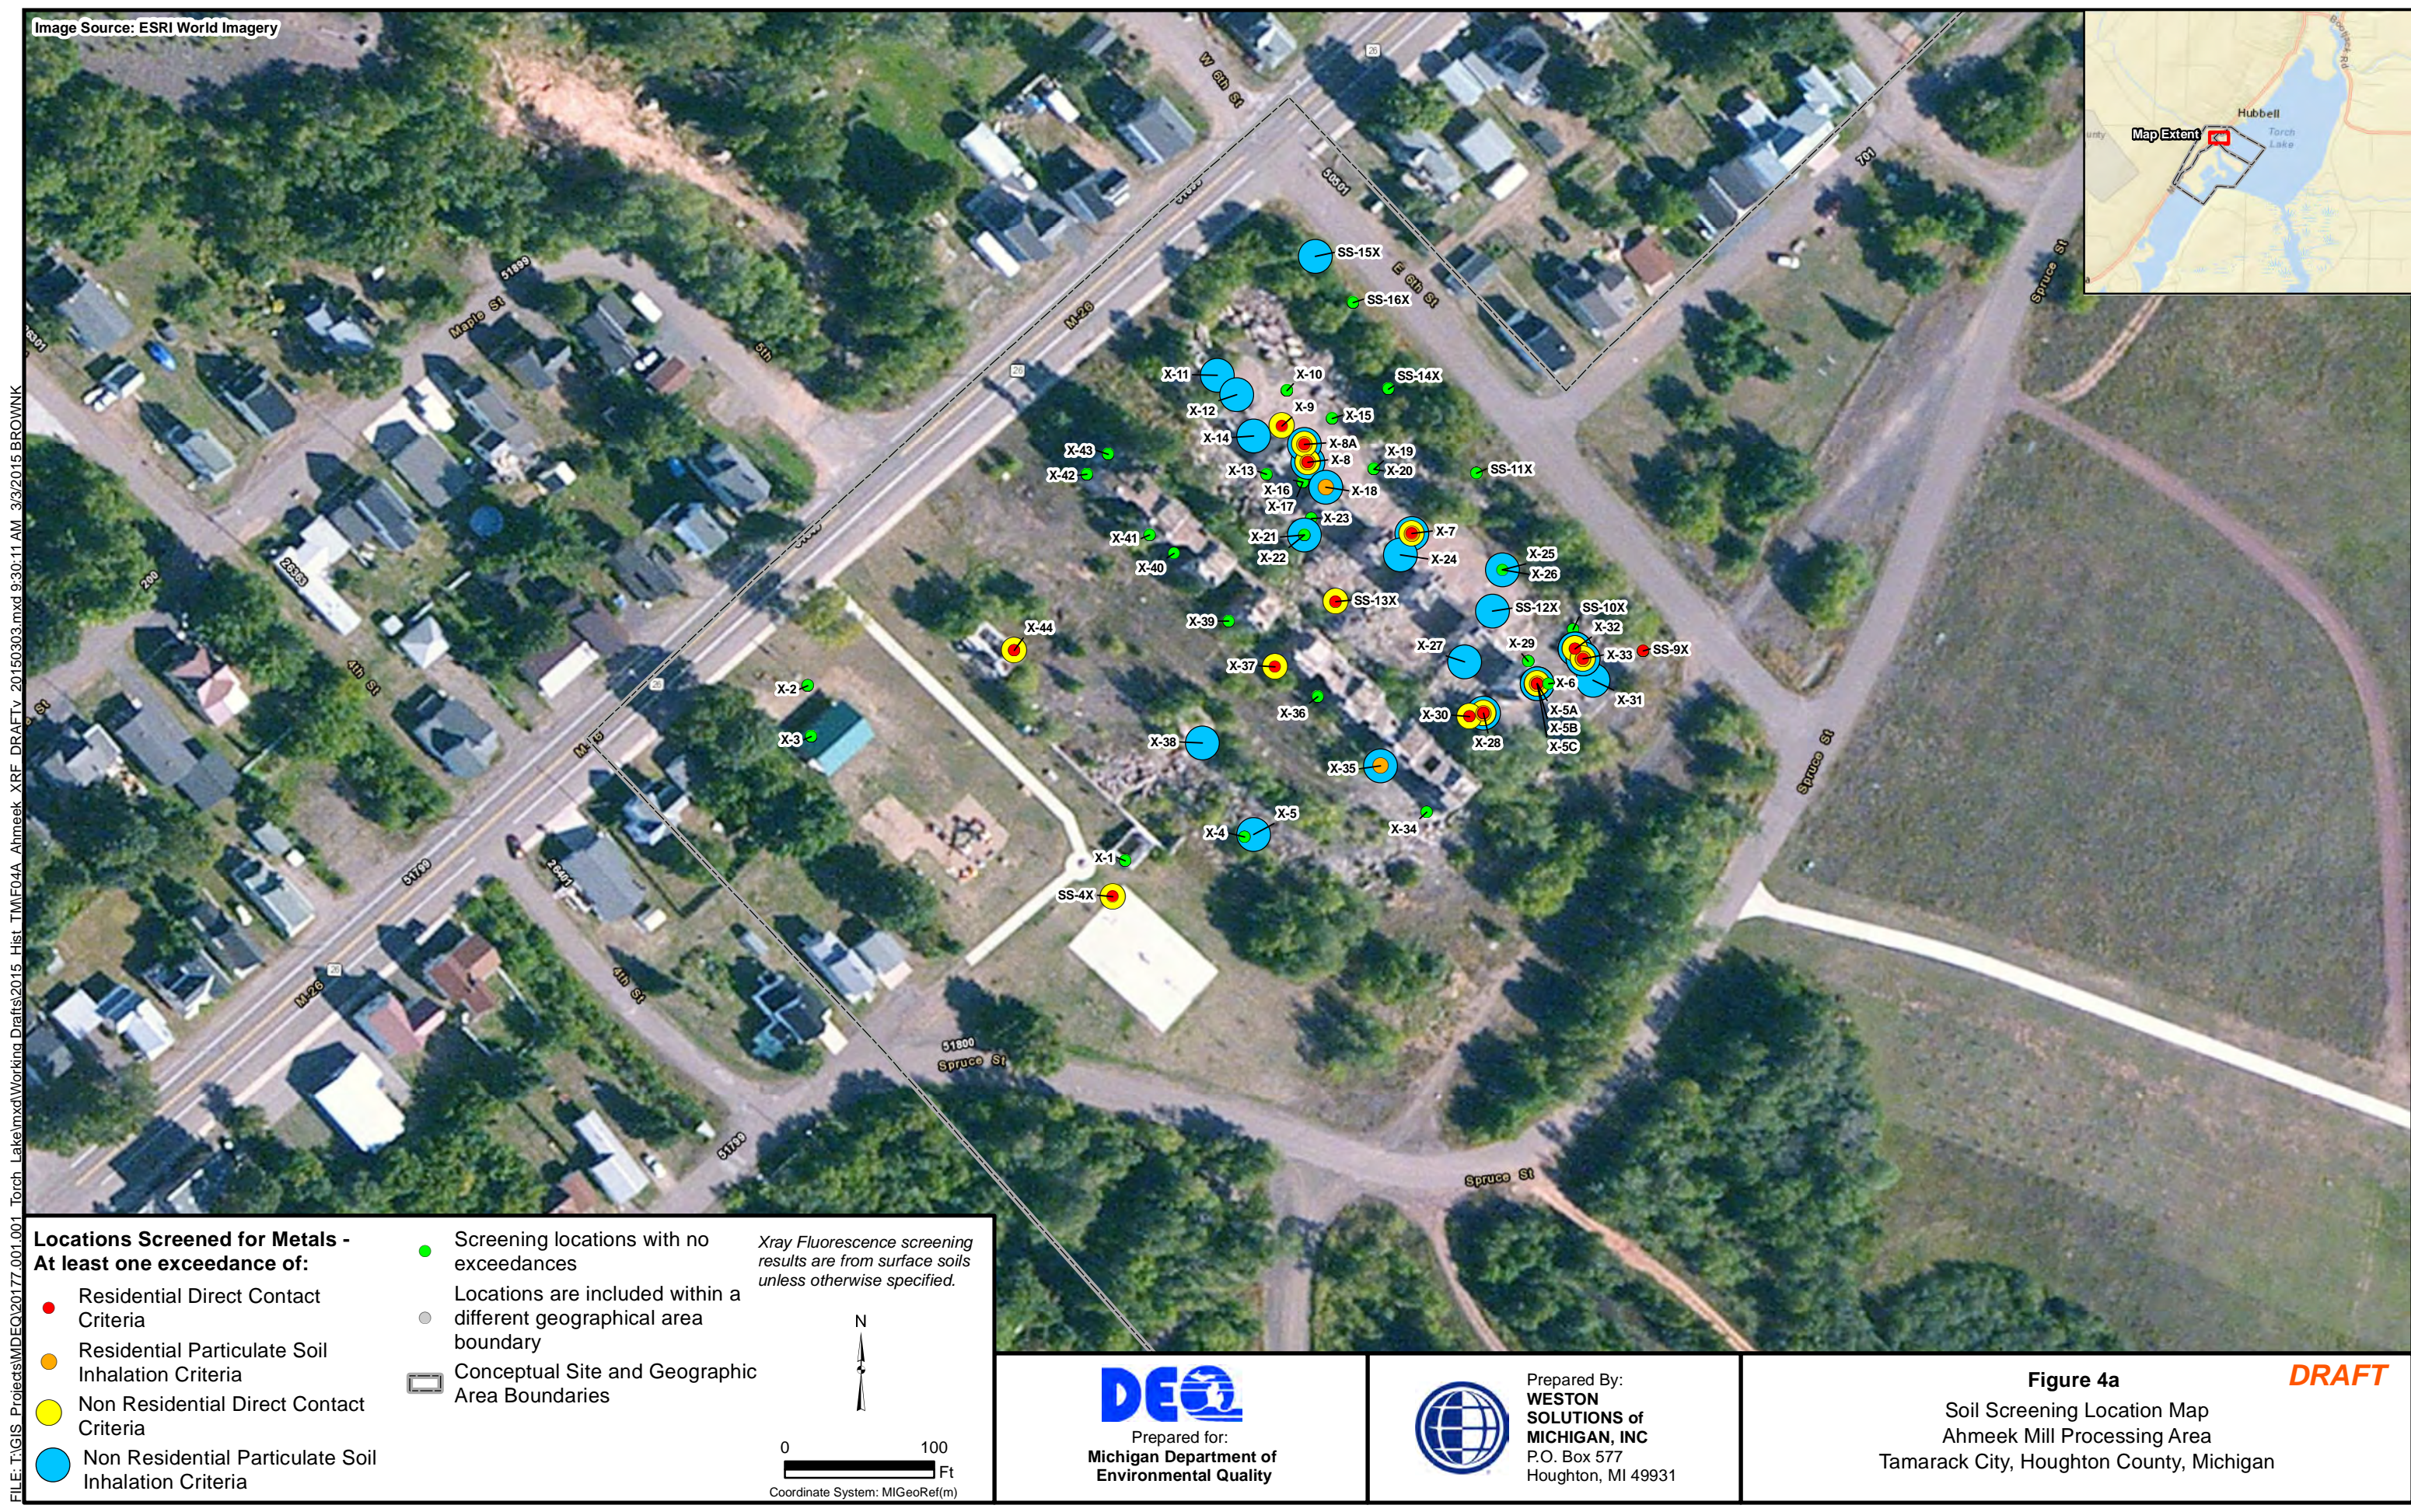
**Locations Screened for Metals -  
At least one exceedance of:**

- Residential Direct Contact Criteria
- Residential Particulate Soil Inhalation Criteria
- Non Residential Direct Contact Criteria
- Non Residential Particulate Soil Inhalation Criteria

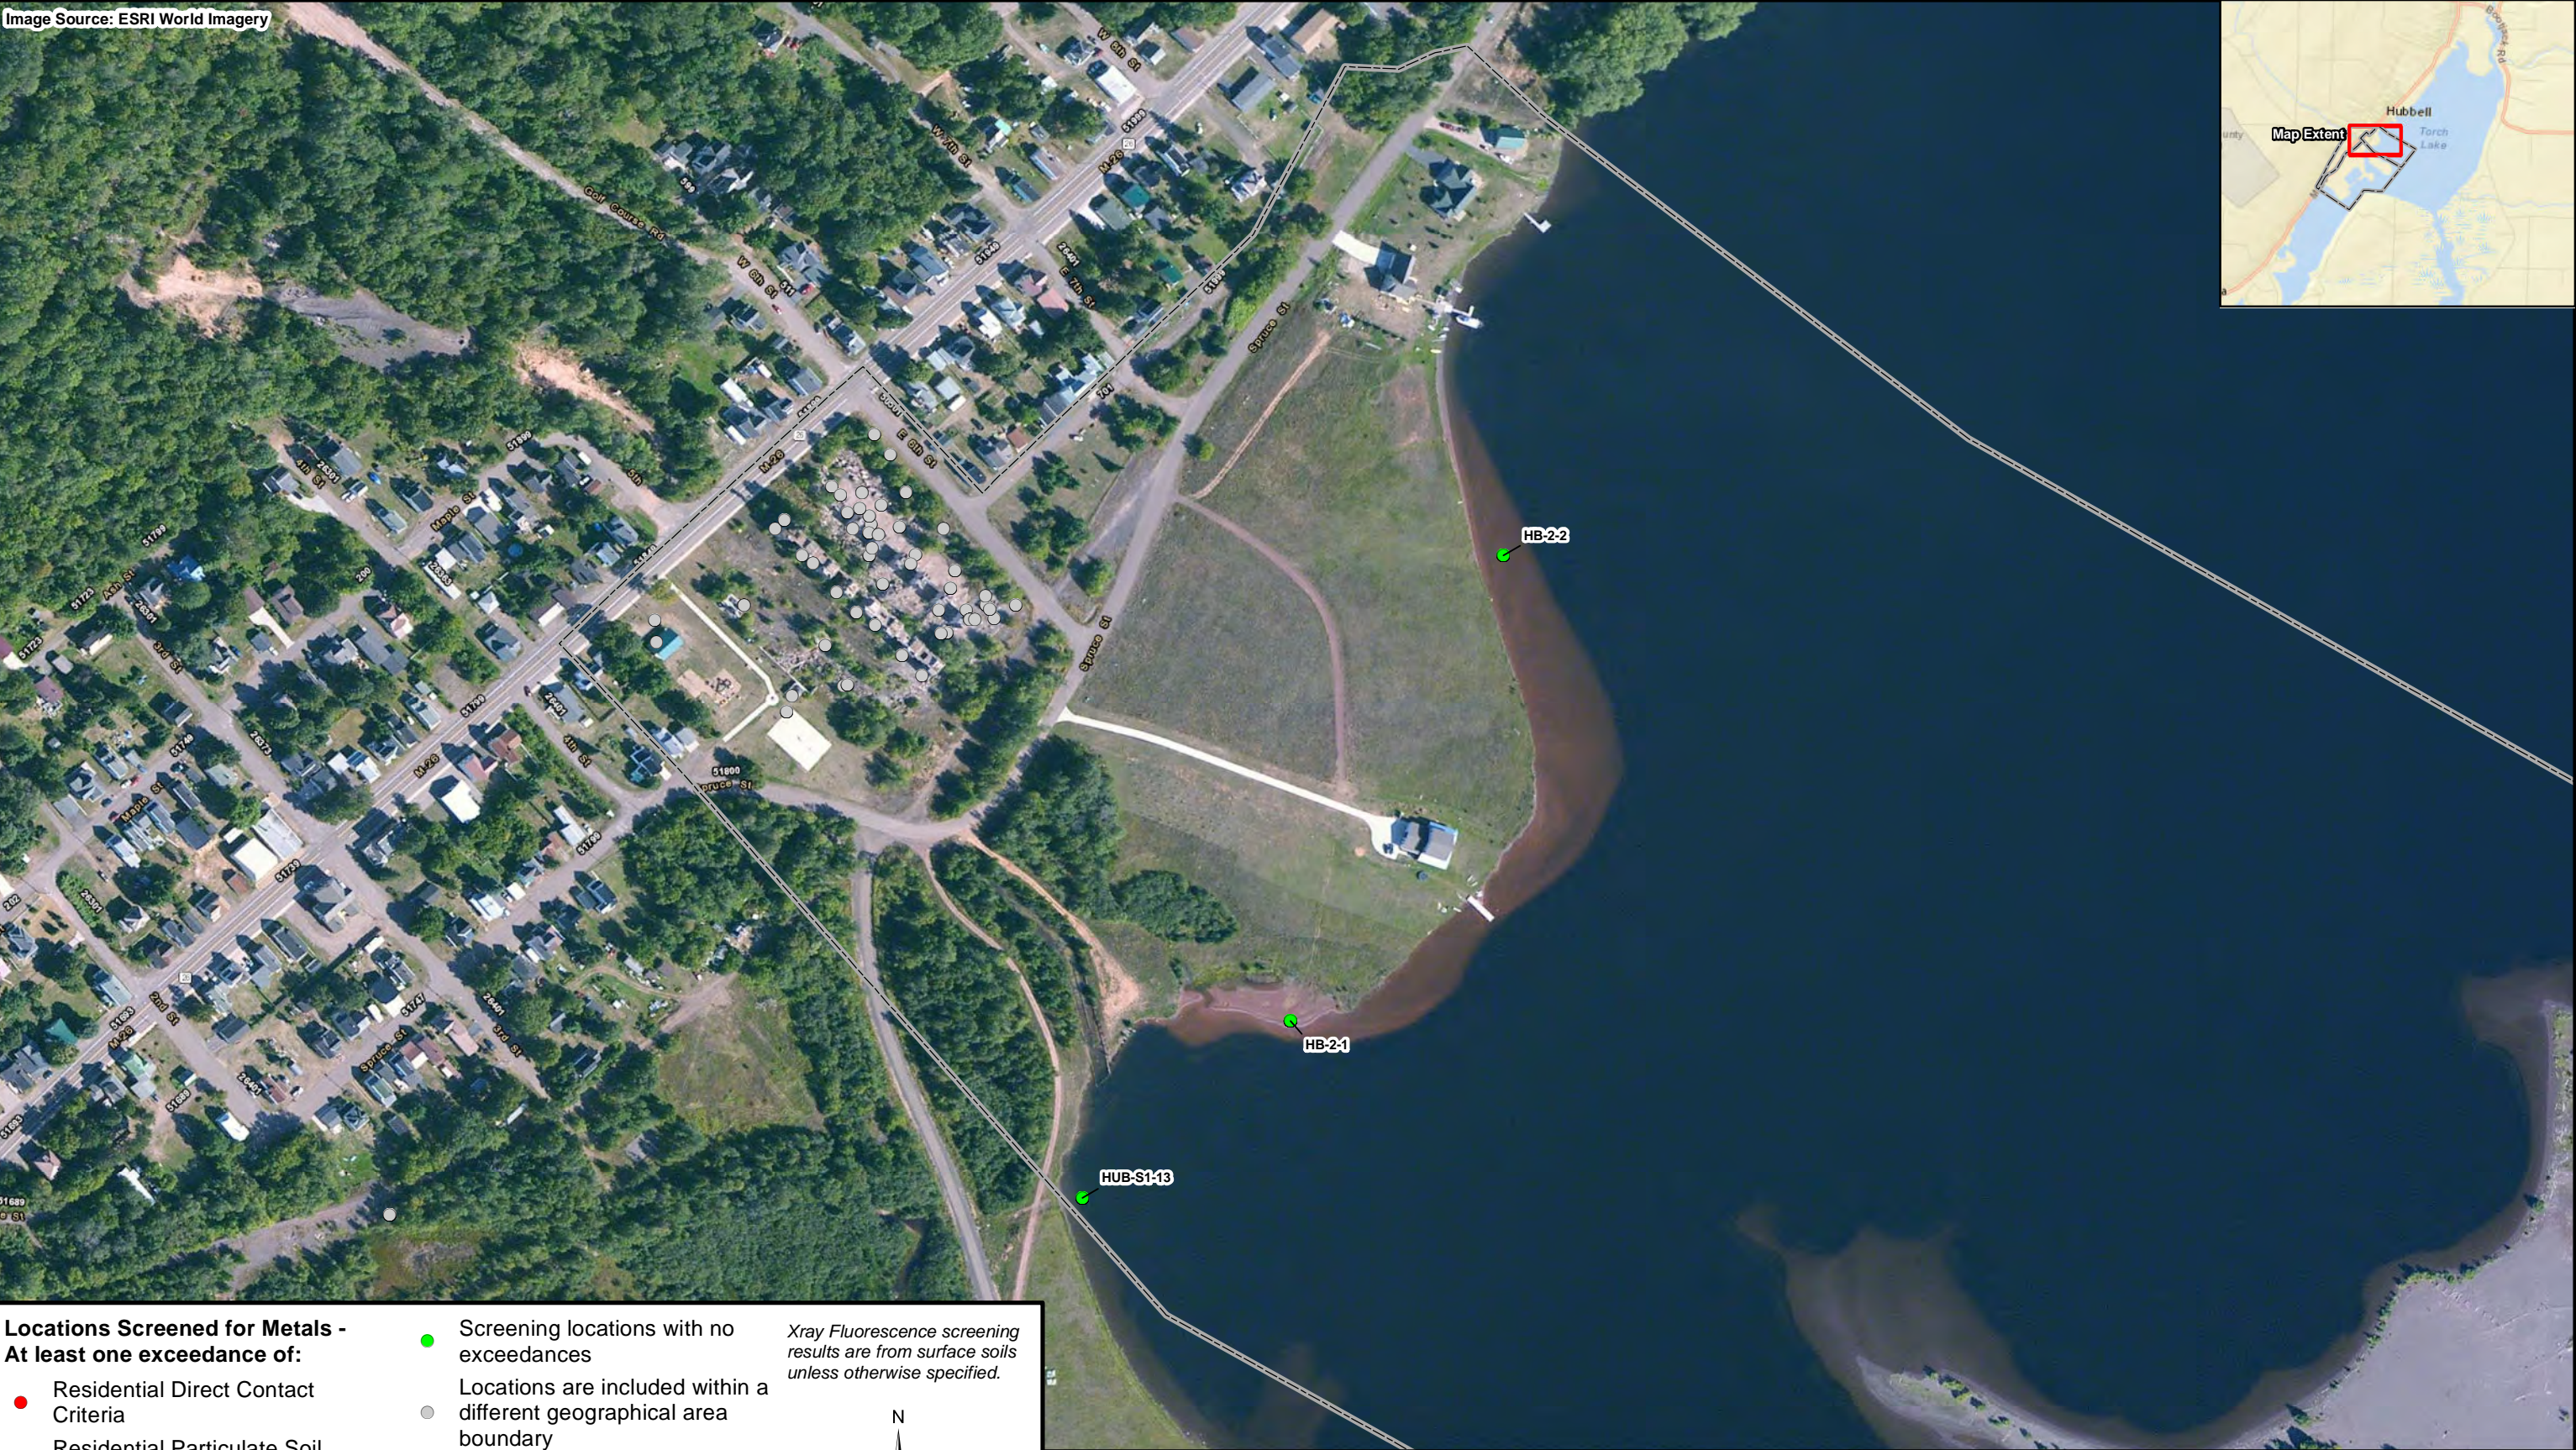
Soil Screening Location Map  
Ahmeek Mill Processing Area  
Tamarack City, Houghton County, Michigan

**Locations Screened for Metals -  
At least one exceedance of:**

- Residential Direct Contact Criteria
- Residential Particulate Soil Inhalation Criteria
- Non Residential Direct Contact Criteria
- Non Residential Particulate Soil Inhalation Criteria

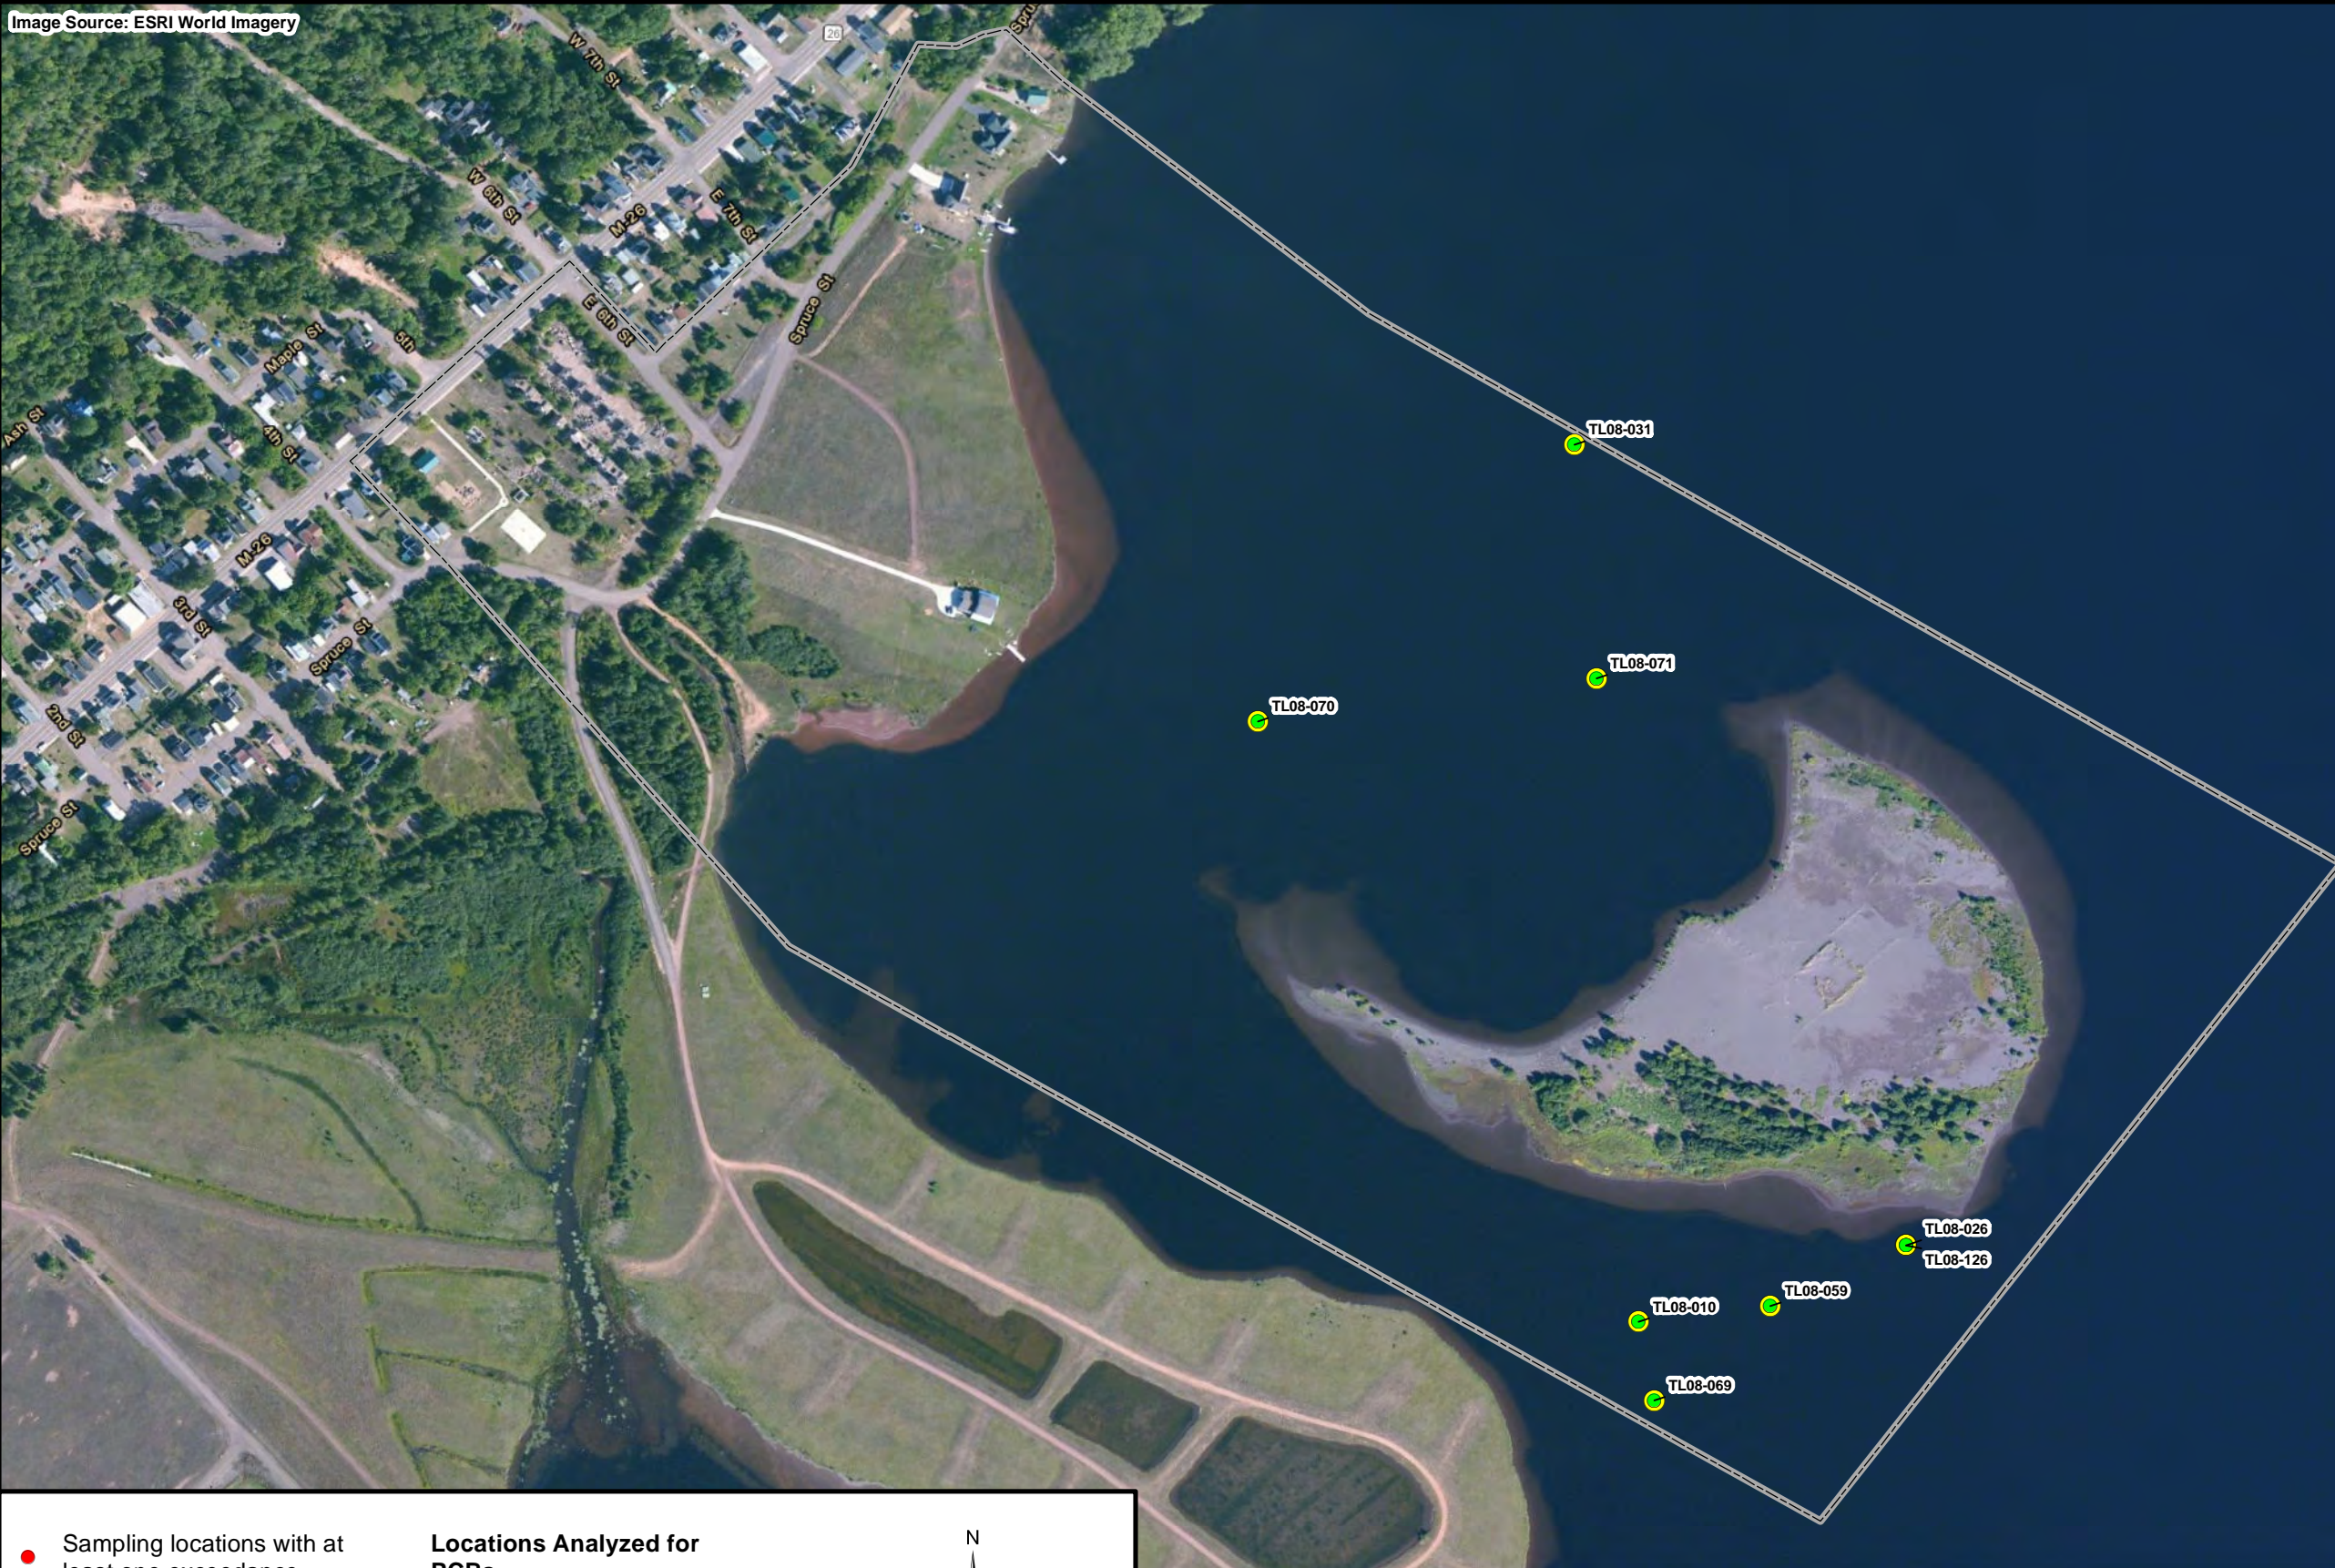
<p>Prepared By: <b>WESTON SOLUTIONS of MICHIGAN, INC</b> P.O. Box 577 Houghton, MI 49931</p>	<p><b>Figure 6</b></p> <p>Sediment Sample Location Map Ahmeek Mill Processing Area Tamarck City, Houghton County, Michigan</p> <p><b>DRAFT</b></p>
--	--	--

- Sampling locations with at least one exceedance
  - Sampling locations with no exceedances
  - Locations are included within a different geographical area boundary
- Locations Analyzed for PCBs**
- No Detections
  - At Least One Detection
  - Conceptual Site and Geographic Area Boundaries

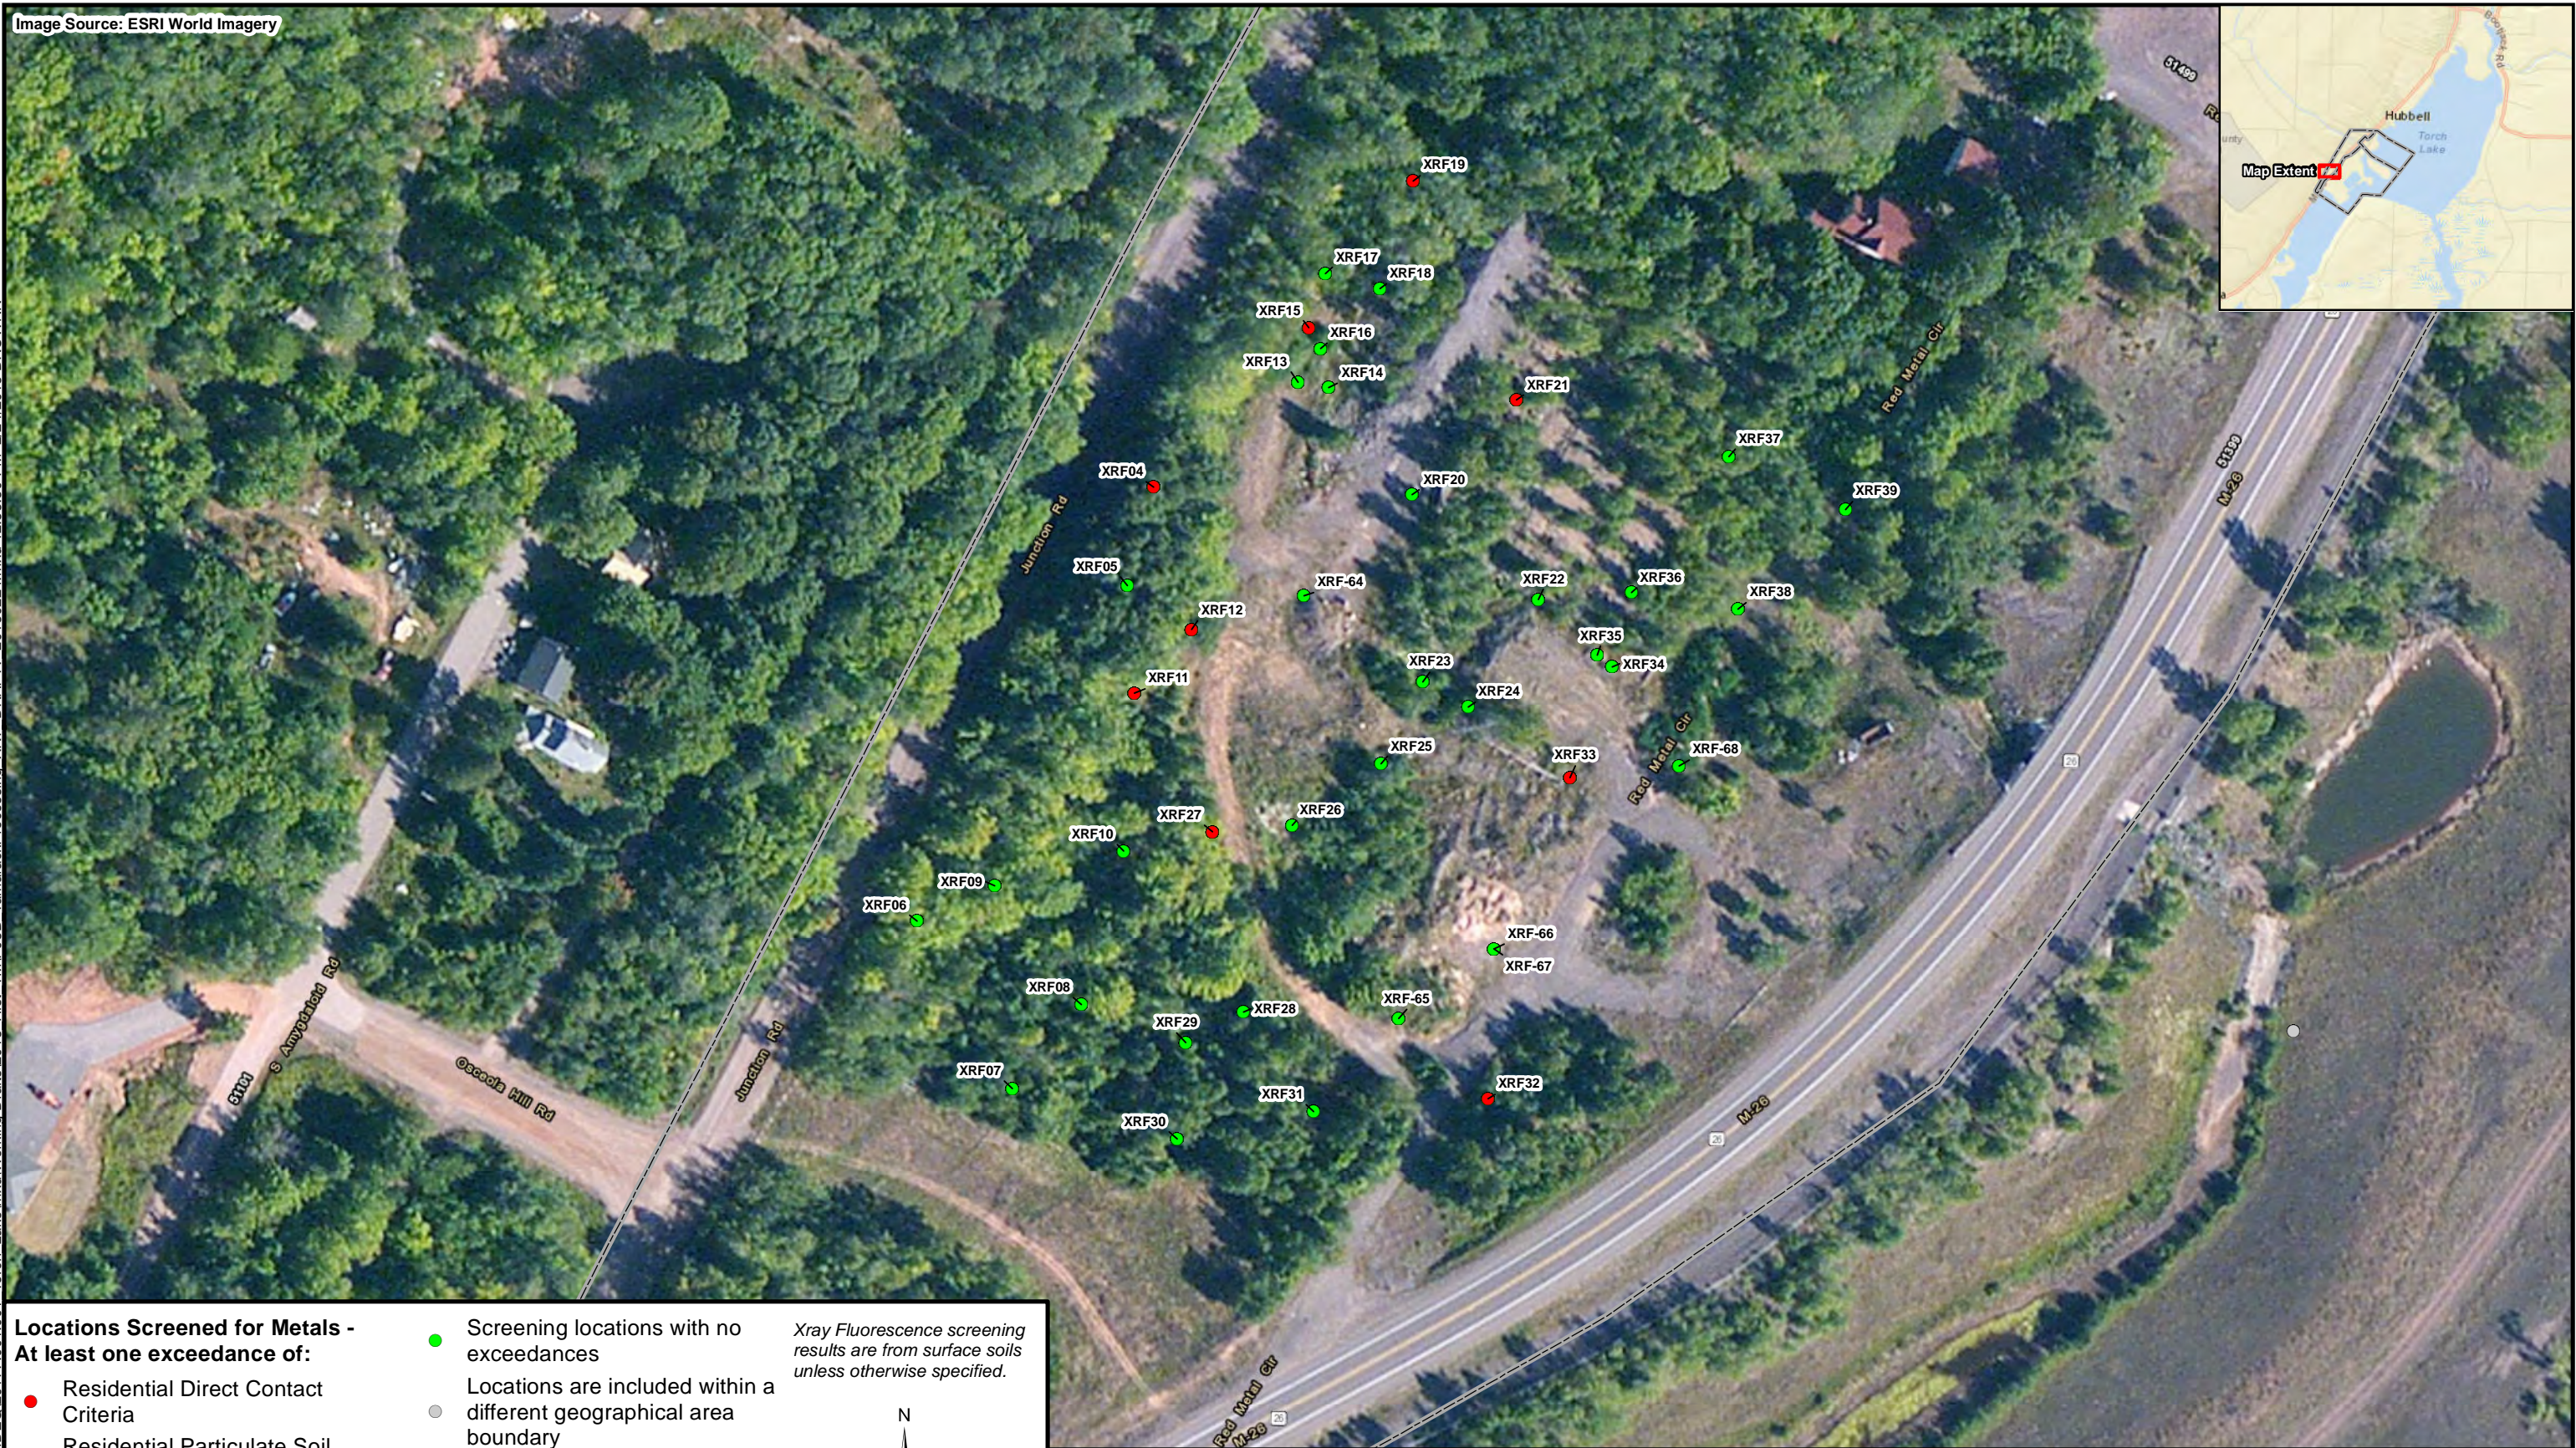
**Locations Screened for Metals -  
At least one exceedance of:**

- Residential Direct Contact Criteria
- Residential Particulate Soil Inhalation Criteria
- Non Residential Direct Contact Criteria
- Non Residential Particulate Soil Inhalation Criteria

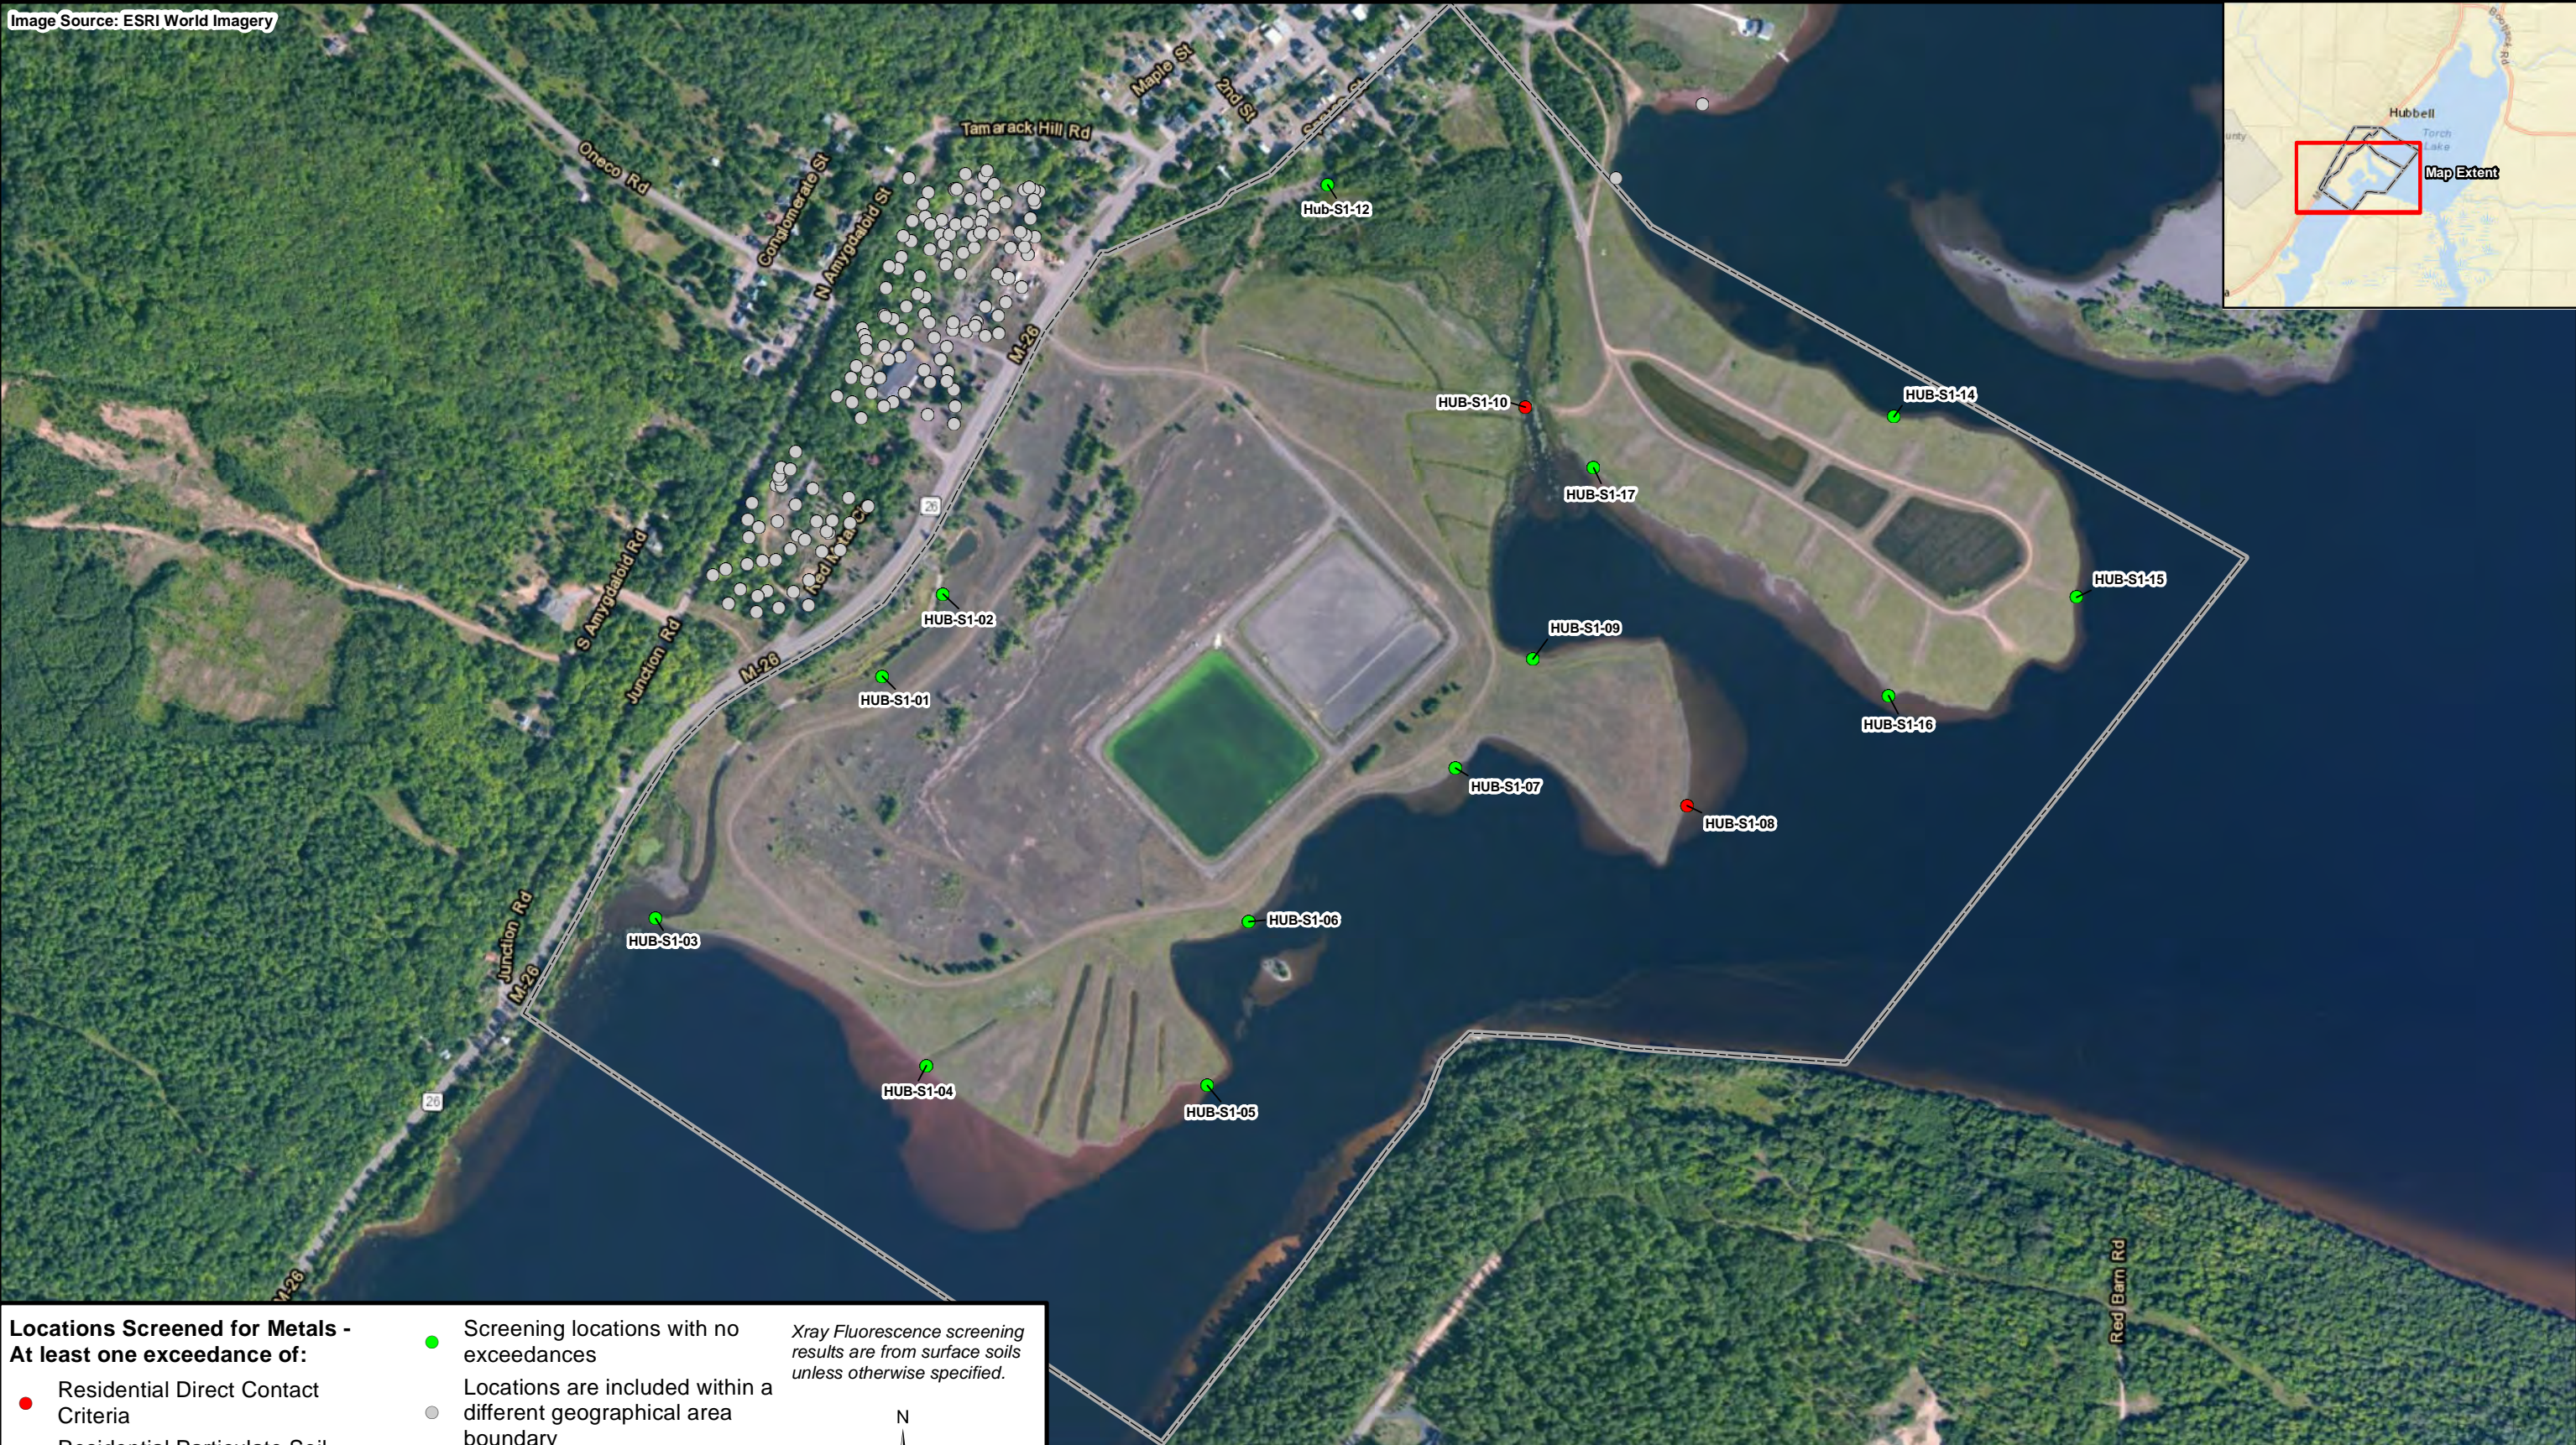
**Locations Screened for Metals -  
At least one exceedance of:**

- Residential Direct Contact Criteria
- Residential Particulate Soil Inhalation Criteria
- Non Residential Direct Contact Criteria
- Non Residential Particulate Soil Inhalation Criteria

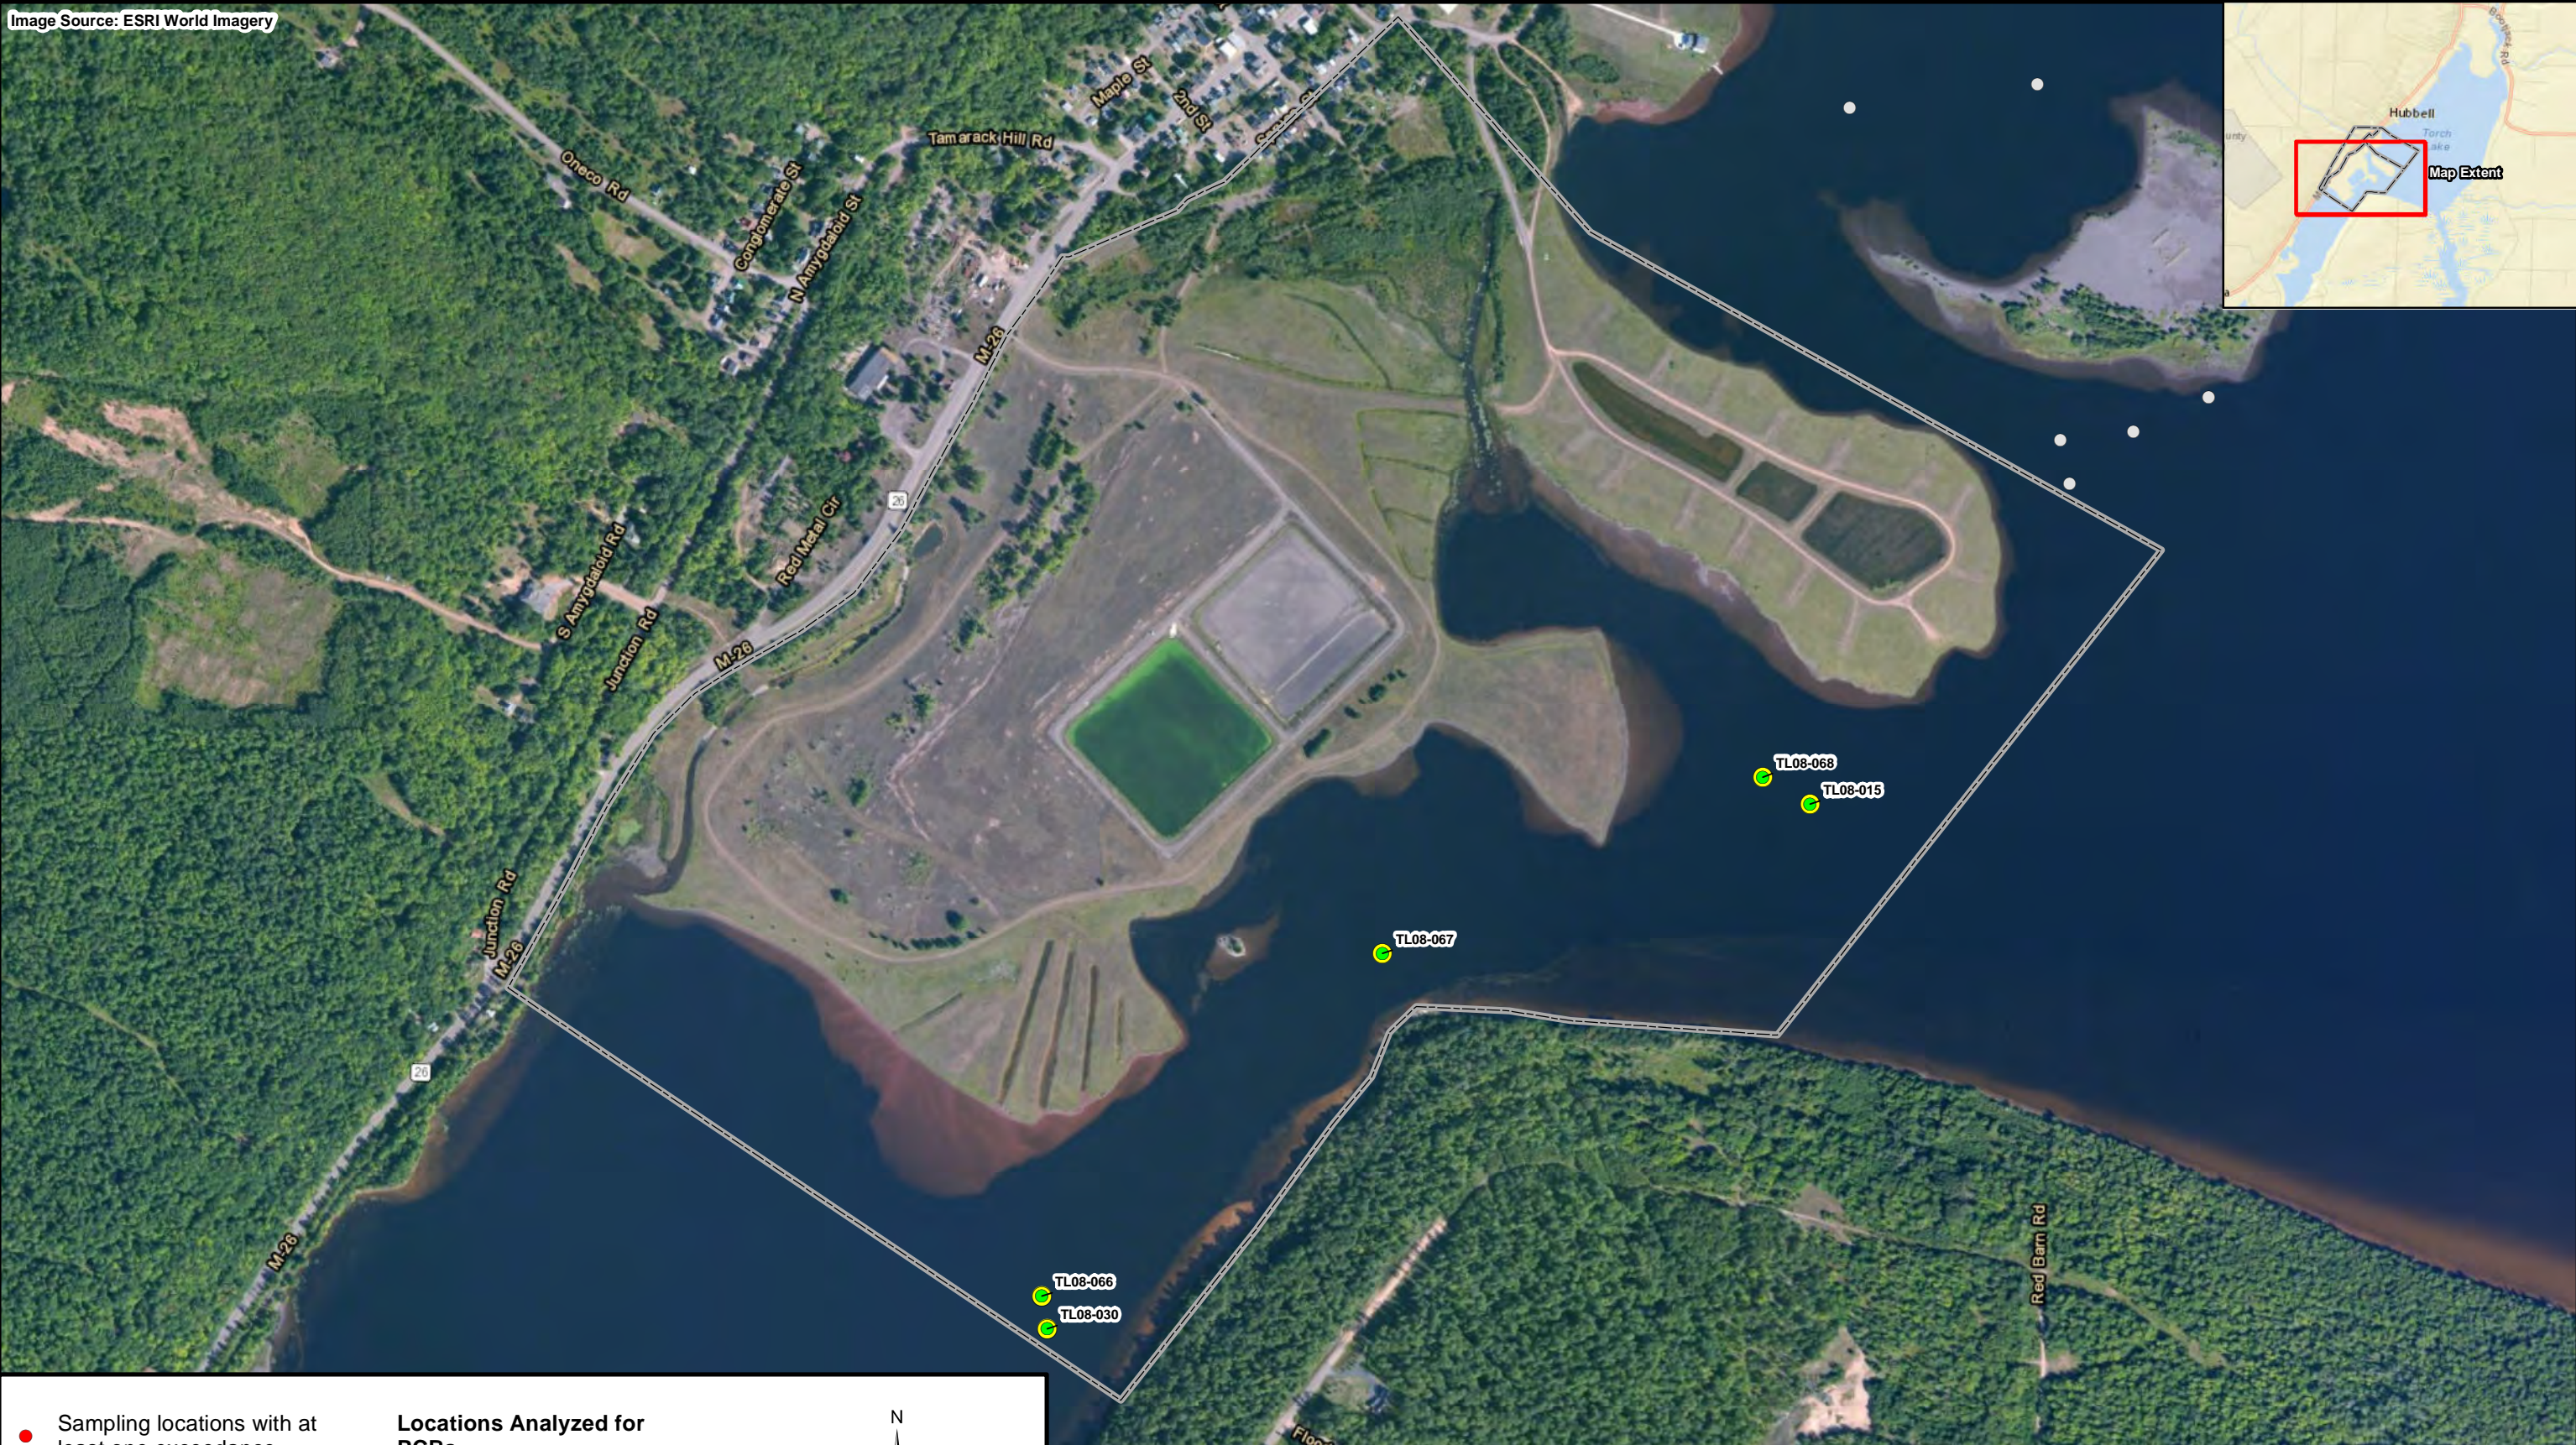
Sampling locations with at least one exceedance
