**LAKE LINDEN
CALUMET AND HECLA POWER PLANT SITE**

**POST-CONSTRUCTION REPORT
BUILDING DEMOLITION AND SOIL REMOVAL**

August 2015

Project 3293121489

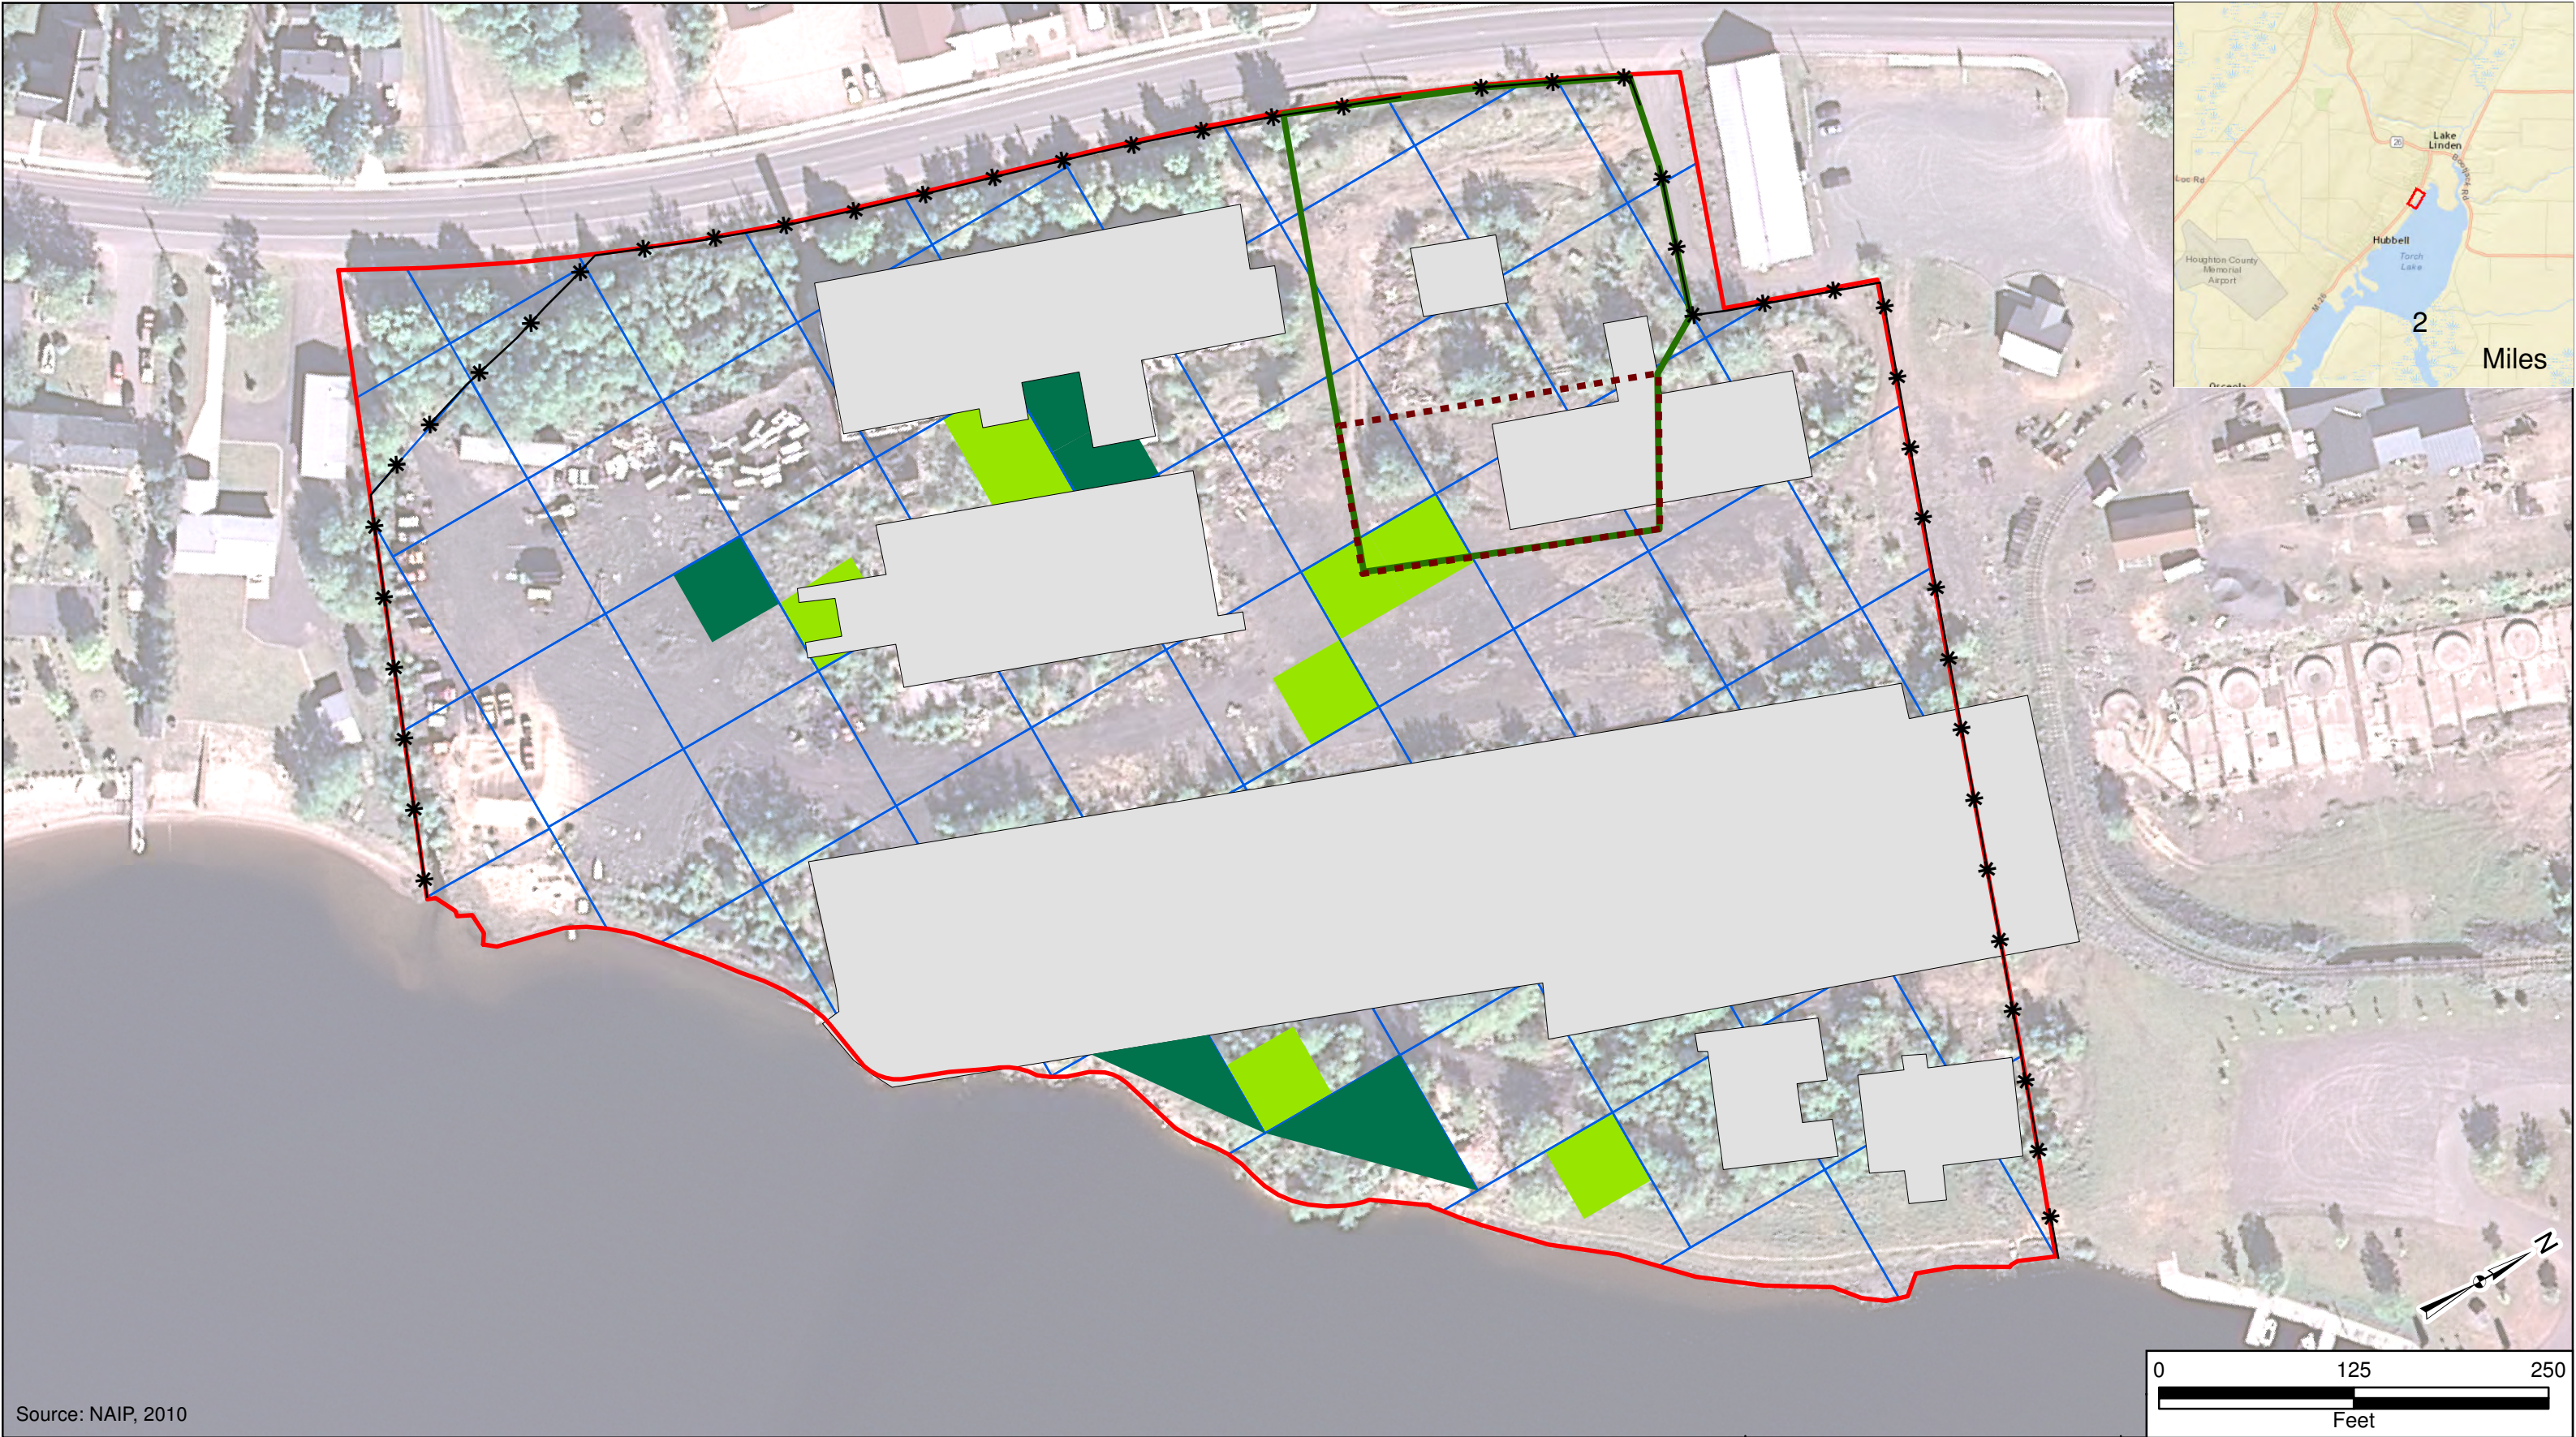
Figure 2.3
Soils Exceeding
1% Asbestos Concentration
Former C & H POWER PLANT SITE
LAKE LINDEN,
HOUGHTON COUNTY, MICHIGAN
Project 3293-11-1440
Privilege and Confidential

- Site Boundary
- Building Foundation
- 100 ft Grid Cell
- Soils exceeding 1% asbestos concentration in the 0-2' range
- Approximate Support Zone Area
- Extended Support Zone
- Fence

- State of Michigan Part 201/213 Non-Residential Direct Contact Cleanup Criteria (NRDCC) for arsenic and/or lead in the 0-0.5 foot and/or 0.5-2 foot range (Figure 2.2);
- 1 percent (%) asbestos concentration in the 0-0.5 foot and/or 0.5-2 foot range (Figure 2.3);
- The Site-specific Commercial Worker asbestos remediation goal of 0.00842 fibers per cubic centimeter (f/cc) (Figure 2.4).

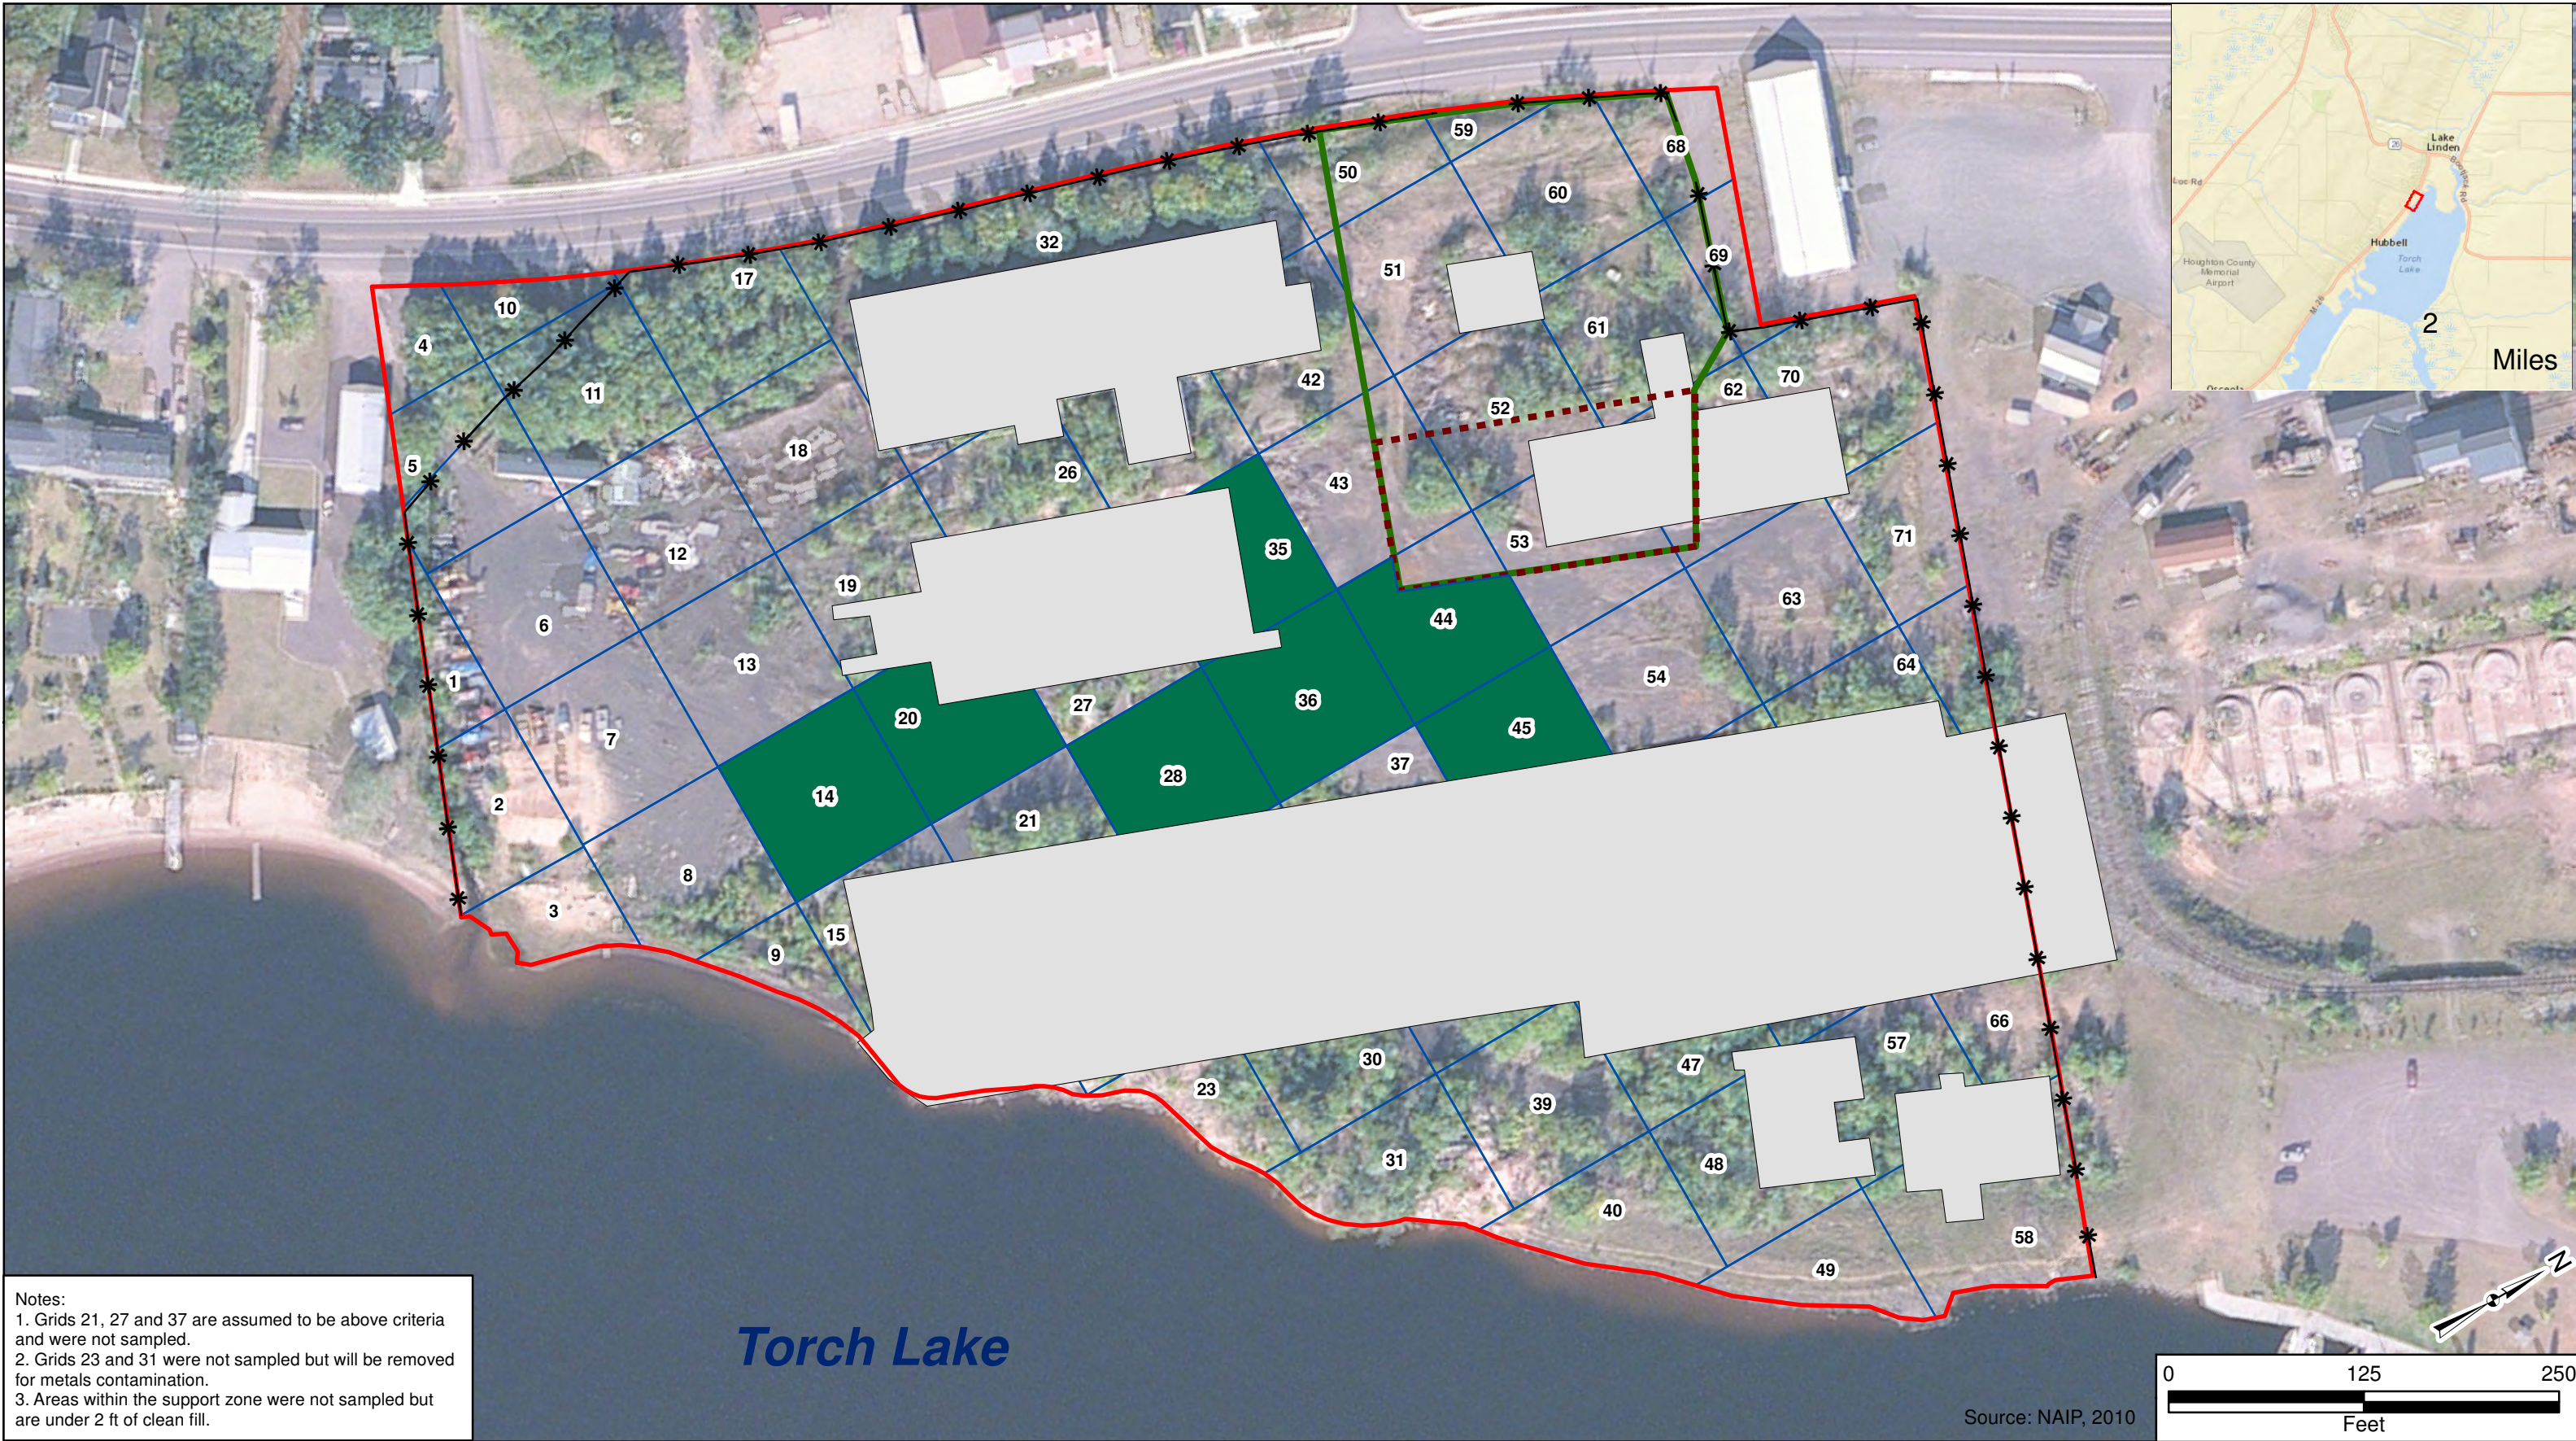
Figure 3.5
2014 Soil Sample Locations
Former C & H POWER PLANT SITE
TORCH LAKE TWP, MICHIGAN
Project 3293-11-1440

| Site Boundary | Building Foundation | Locations analyzed for lead and/or arsenic in the 0-2' range |

As discussed in the 2014 Work Plan, in May 2014, samples were collected from 28 cells that previously exceeded the RCRA “20 Times Rule” for lead and/or arsenic (Figure 3.5). These newly collected samples were analyzed for lead and/or arsenic. Results are presented in Table 3.7 and laboratory analytical is included in Appendix D. No samples exceeded the RCRA “20 Times Rule” for arsenic. Those samples with lead concentrations above the RCRA “20 Times Rule” were analyzed by toxicity characteristic leaching procedure (TCLP) analyses for disposal purposes (Figure 3.6). Laboratory results indicated that the top six inches of the southwest corner of Cell 45 (Cell 45SW) exceeded the TCLP criterion for lead (Figure 3.7). No other locations exceeded TCLP criteria. Results are presented in Table 3.8. See Appendix D for laboratory analytical. The bottom 18 inches of Cell 45SW did not exceed TCLP criteria and was disposed according to procedures described in Section 3.1.8.

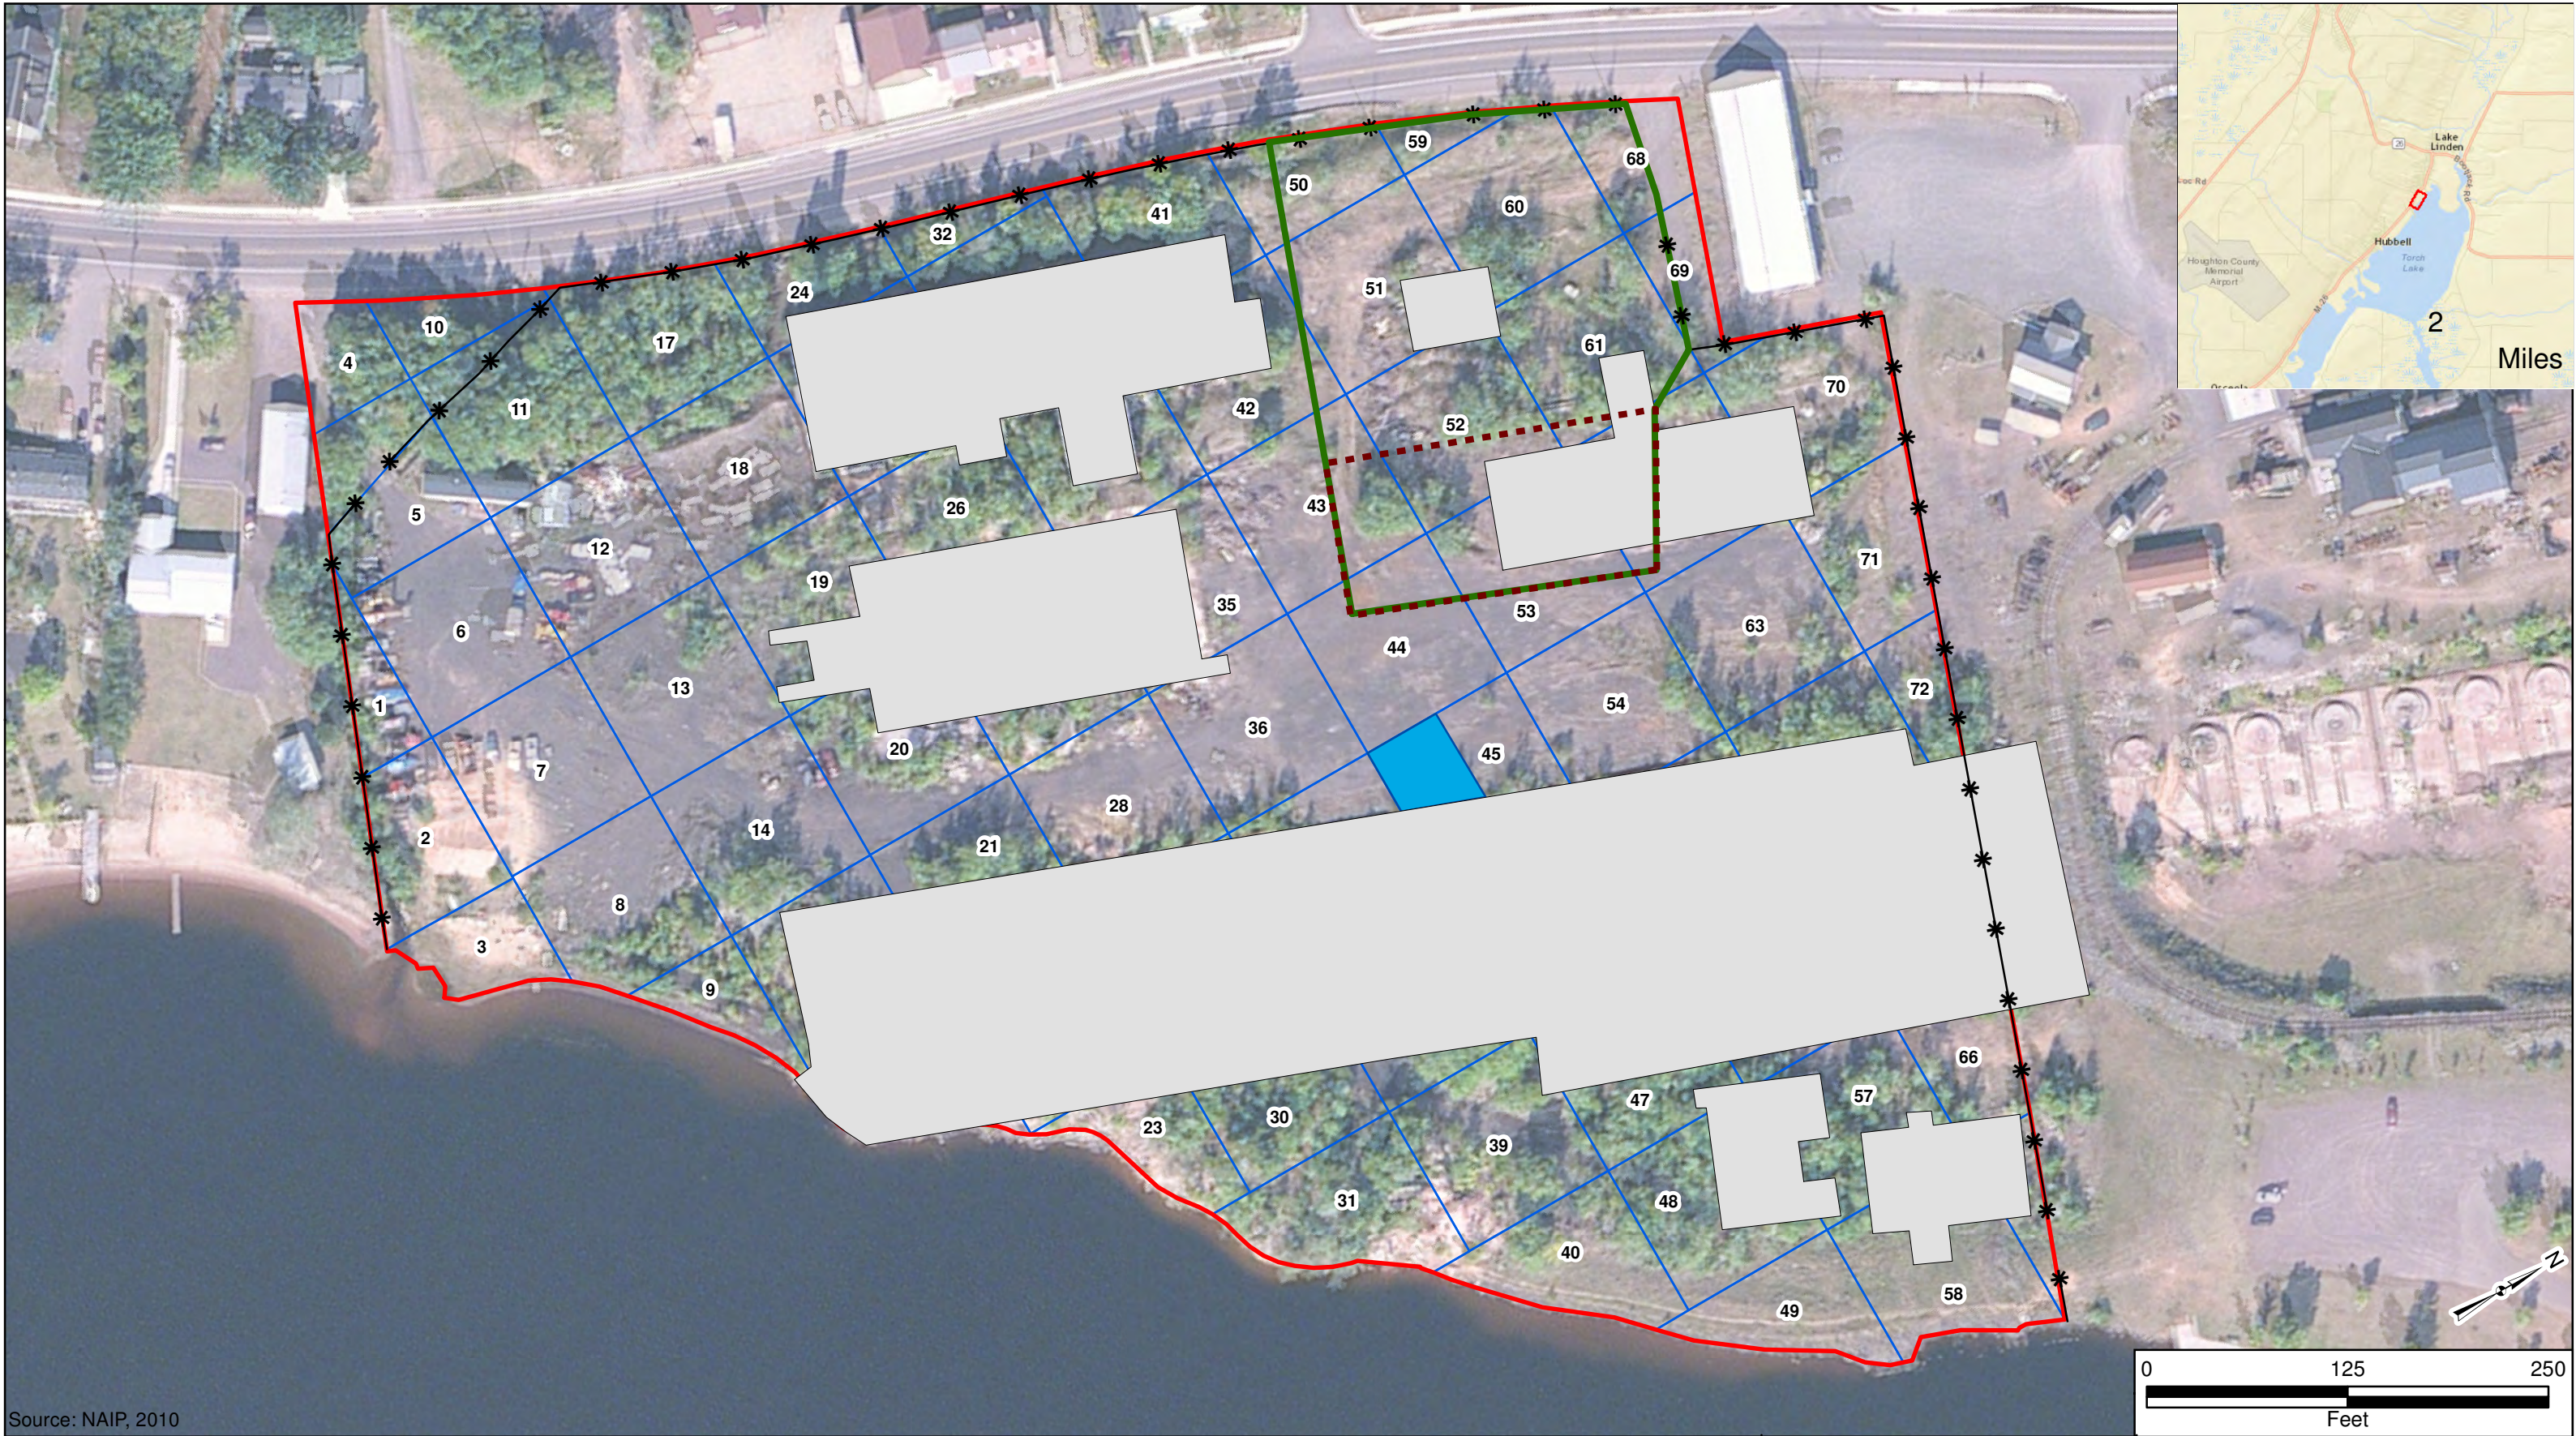
Figure 3.7
TCLP Exceedance Locations
Former C & H POWER PLANT SITE
TORCH LAKE TWP, MICHIGAN
Project 3293-11-1440

| Site Boundary | Building Foundation | TCLP Results Exceed 5.0 mg/L in the 0-6" Range |

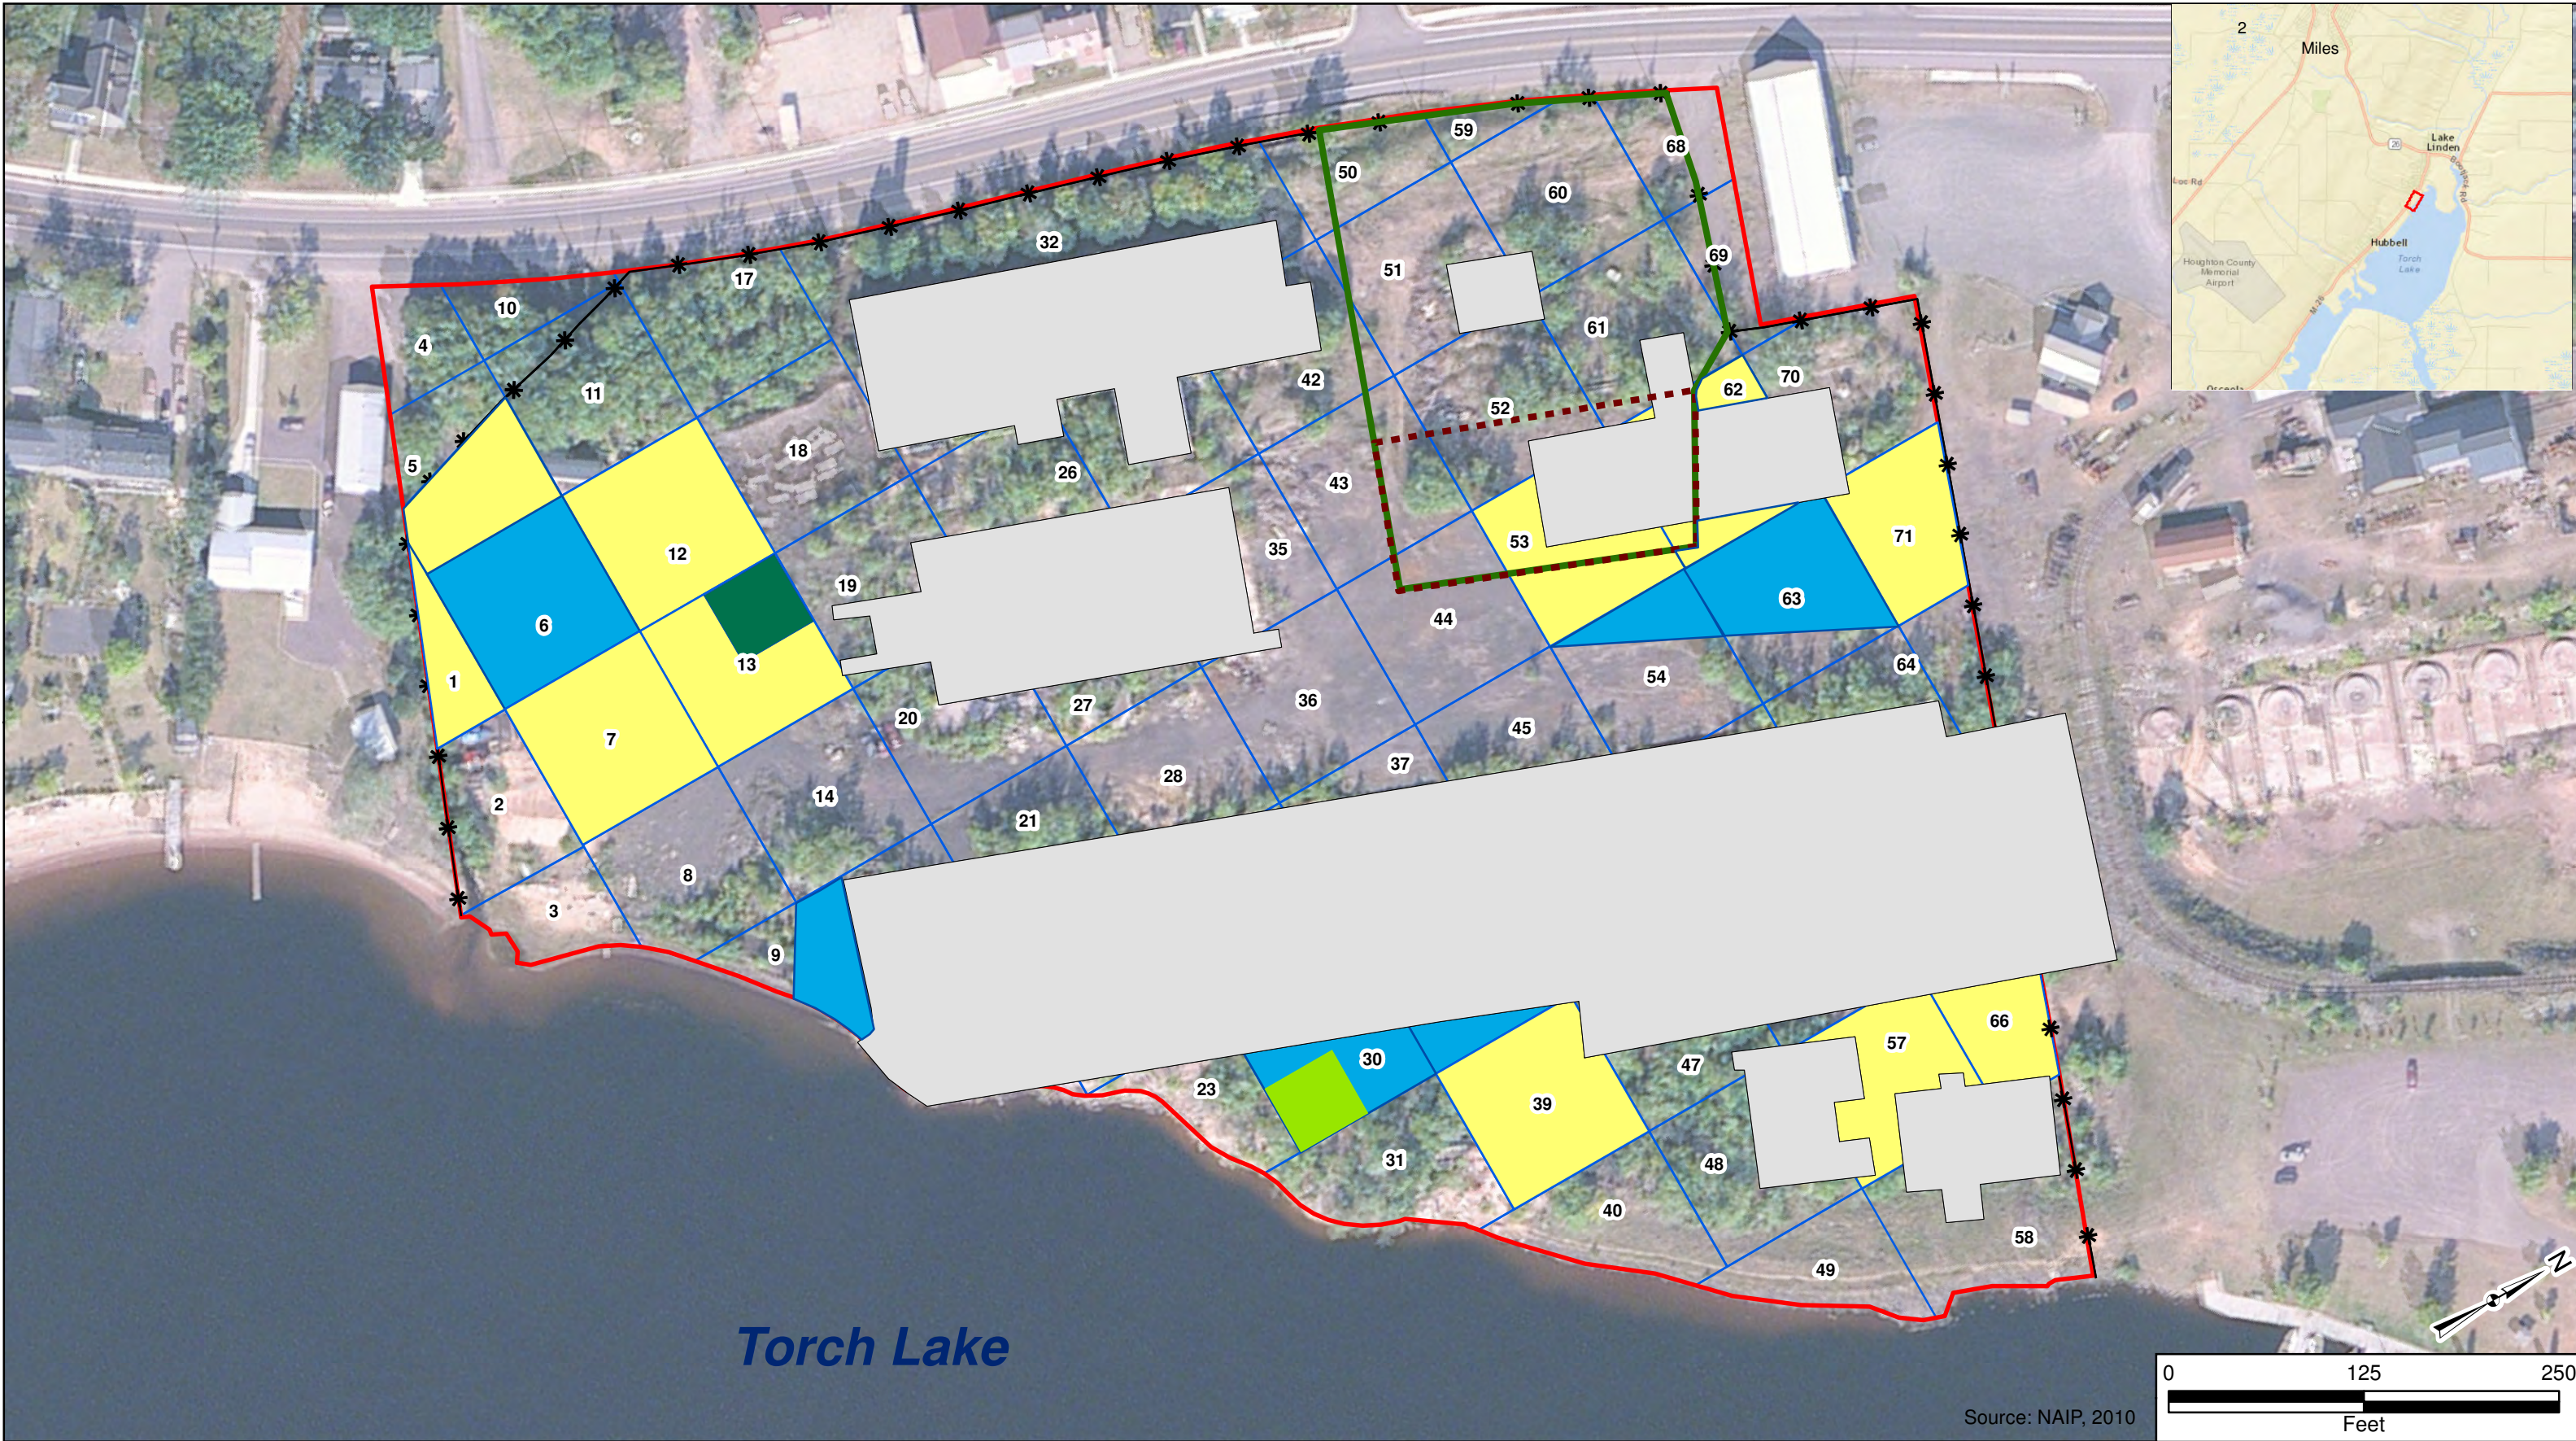
| Building Foundation | Approximate Support Zone Area | Excavated 6" Prior to Cover System Placement |

As shown of Figure 3.8, a two foot cover system was placed over soils adjacent to the former Still House foundation. The initial intent was to leave this foundation exposed; however, to prevent potential drainage issues, the foundation was cleaned and then covered with two feet of clean fill material, as depicted on the final topographic Site survey included in Appendix L.
