# HISTORICAL DATA REVIEW AND COMPILATION TECHNICAL MEMORANDUM

ABANDONED MINING WASTES – TORCH LAKE NON-SUPERFUND SITE  
QUINCY MINING COMPANY PORTAGE OPERATIONS AREA  
HOUGHTON COUNTY, MICHIGAN  
SITE ID# 31000098

AUGUST 2018

PREPARED FOR:  
MICHIGAN DEPARTMENT OF ENVIRONMENTAL QUALITY  
REMEDATION & REDEVELOPMENT DIVISION  
CALUMET FIELD OFFICE  
CALUMET, MICHIGAN

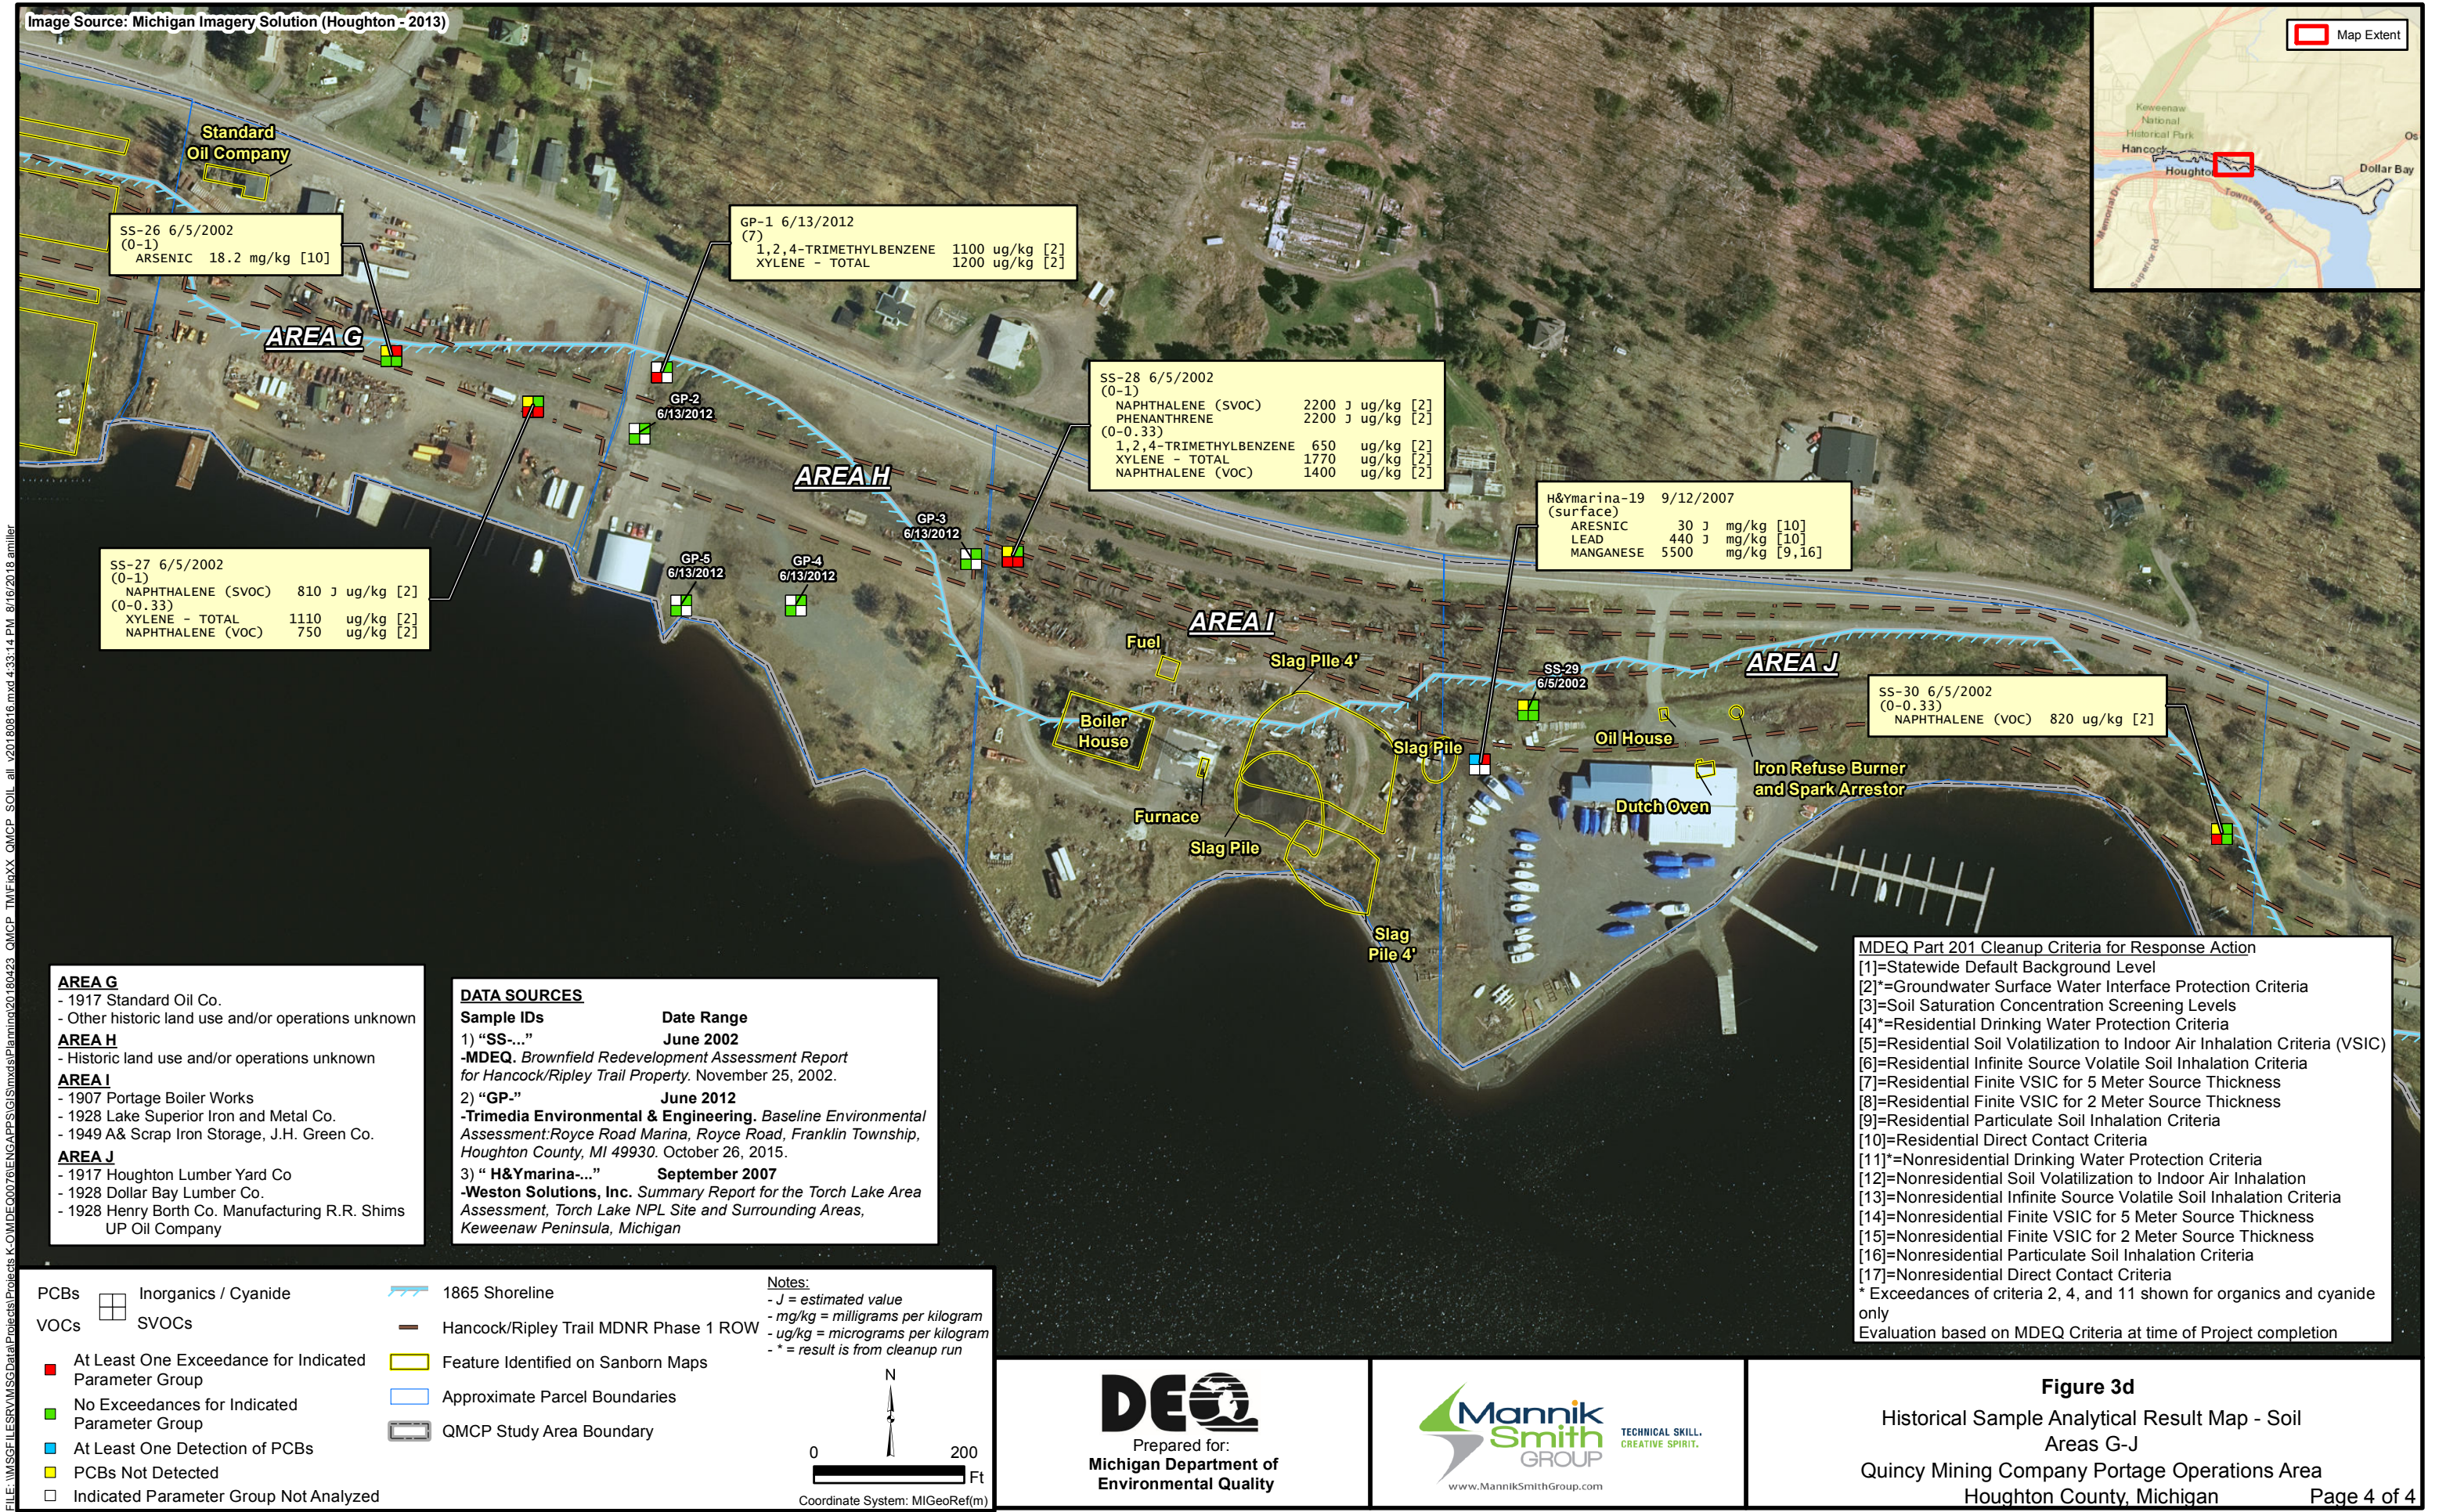
**Figure 3c**  
Historical Sample Analytical Result Map - Soil  
Areas C-F  
Quincy Mining Company Portage Operations Area  
Houghton County, Michigan

*Figure 3c, Historical Sample Analytical Results Map – Soil Areas C-F, and Figure 3d, Historical Sample Analytical Results Map – Soil Areas G-J.* The analytical data generated during the investigation will be used to evaluate the potential presence of mining-era and/or other impacts that would be represented by elevated levels of organic and inorganic contaminants.

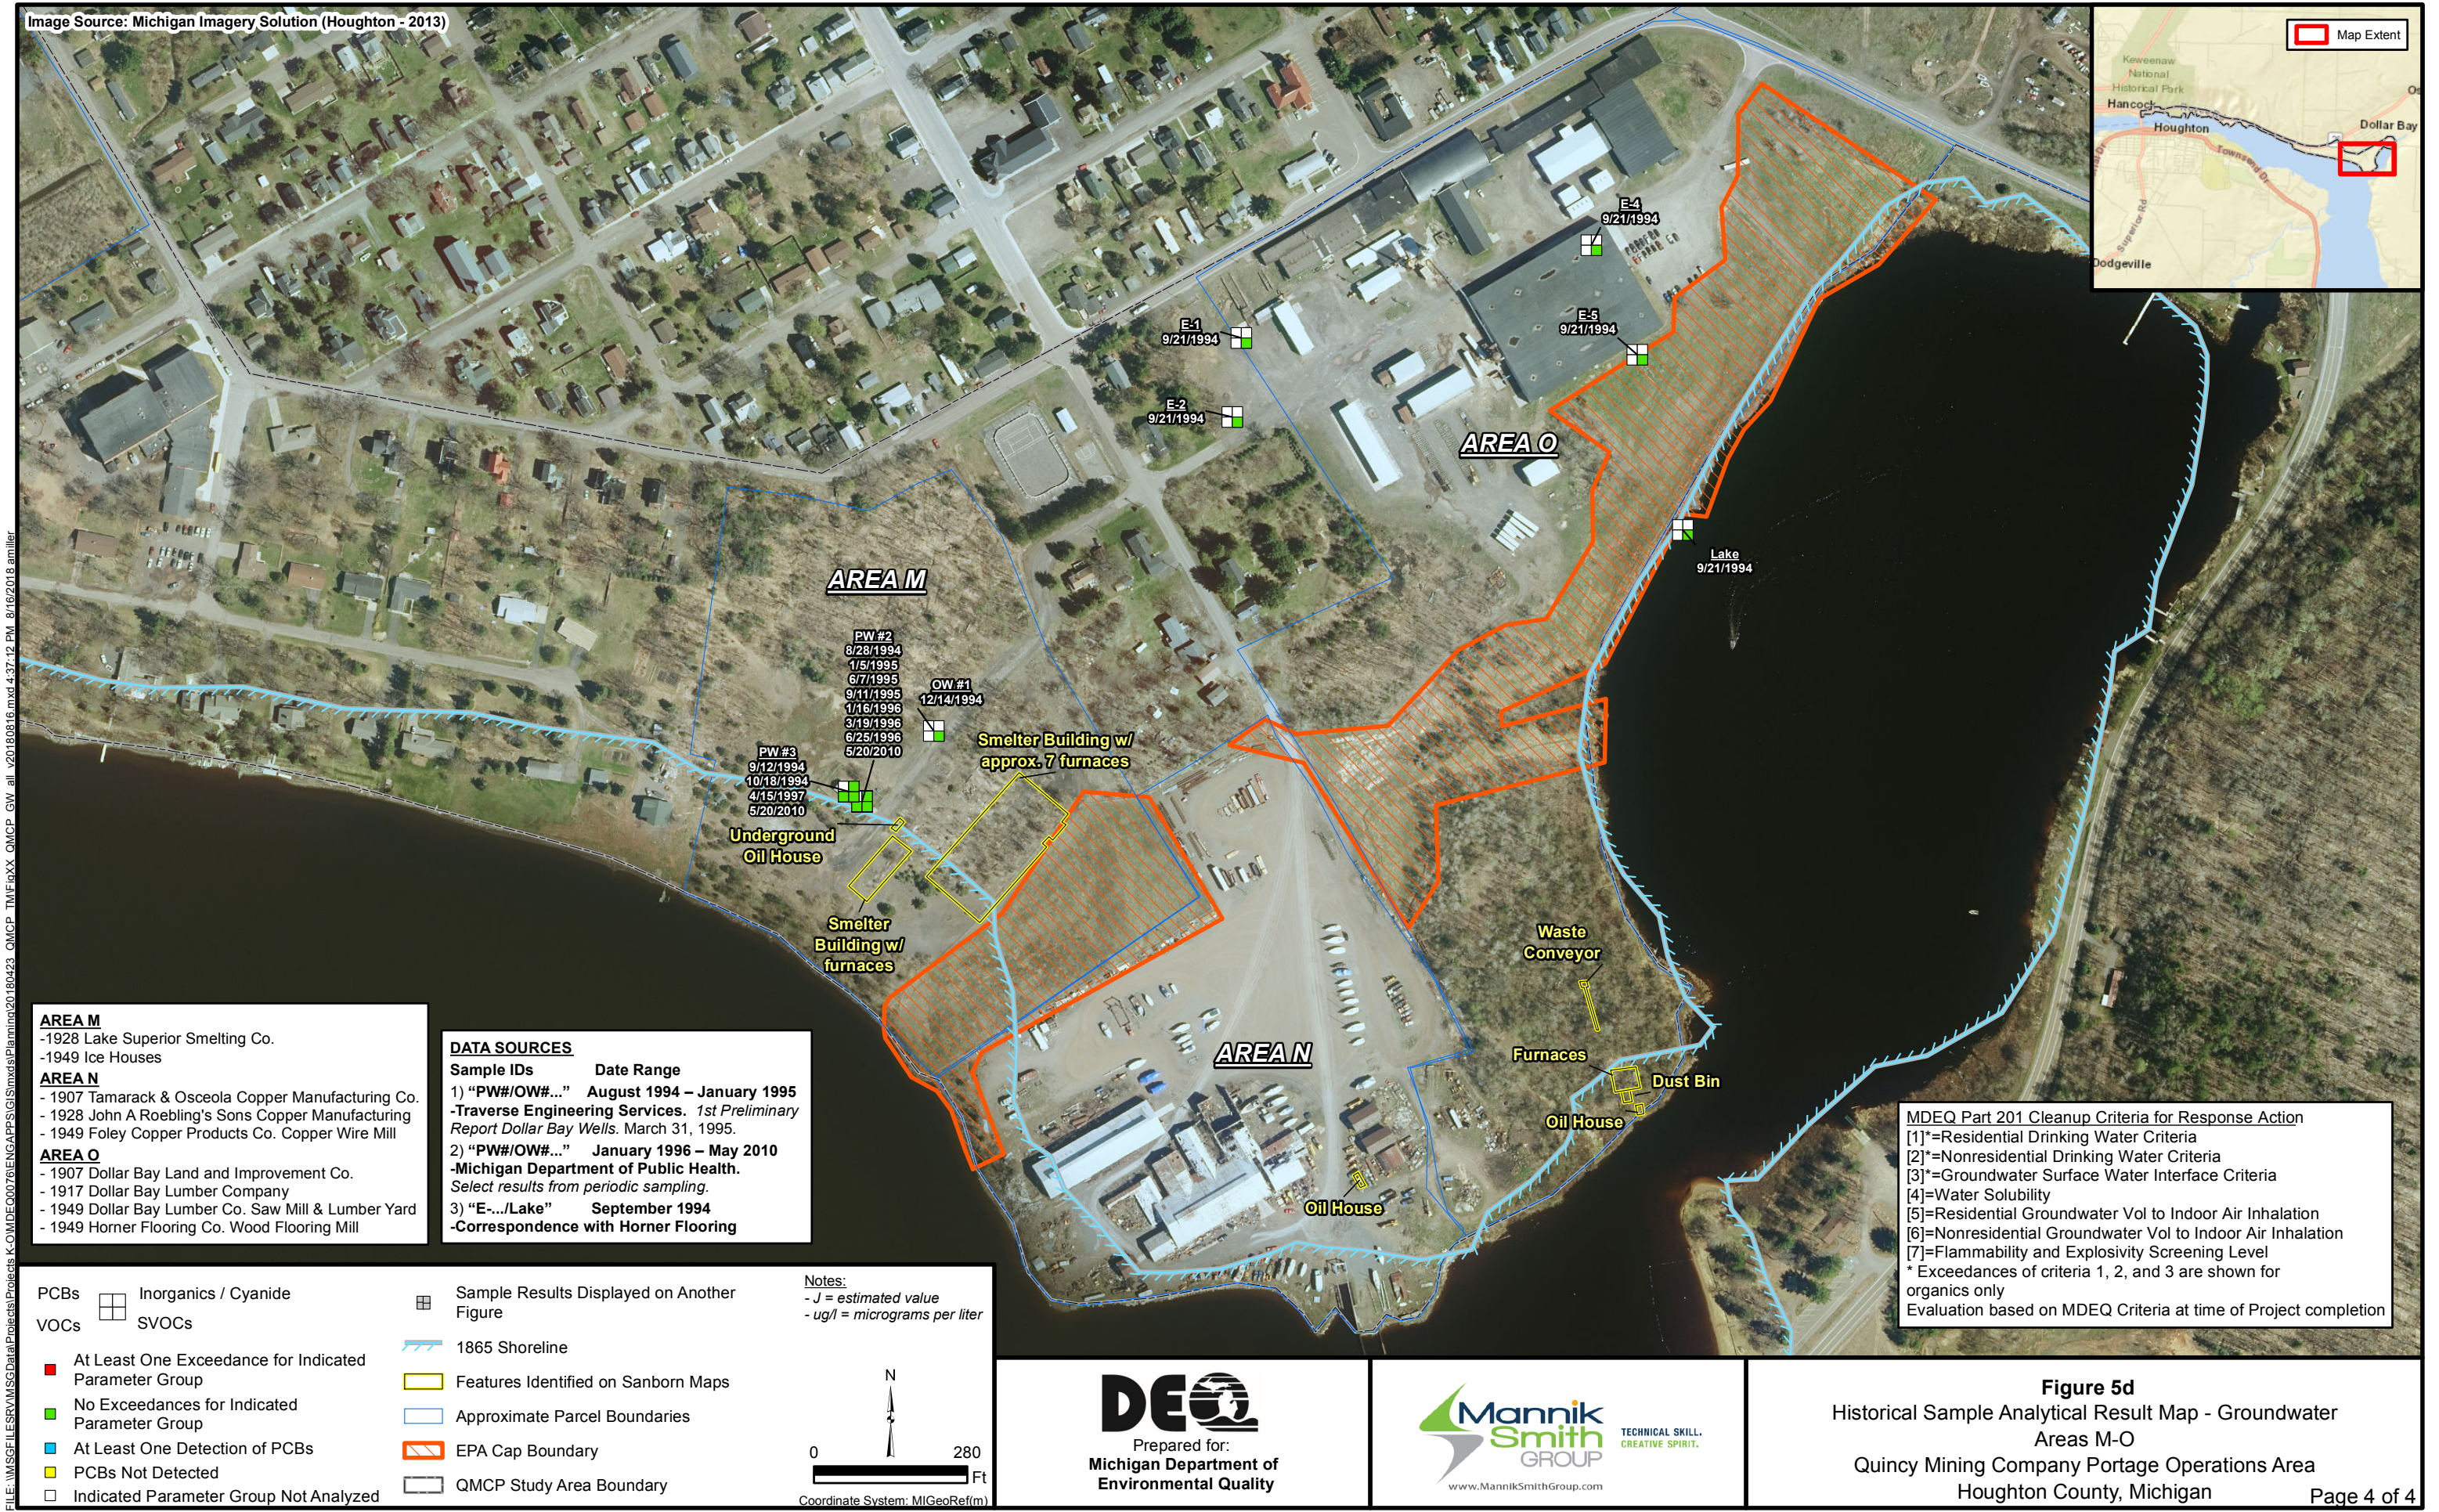
Locations of observed underwater reconnaissance targets are depicted on **Figure 6, Area Assessed by Side Scan Sonar and Underwater Reconnaissance Targets**.

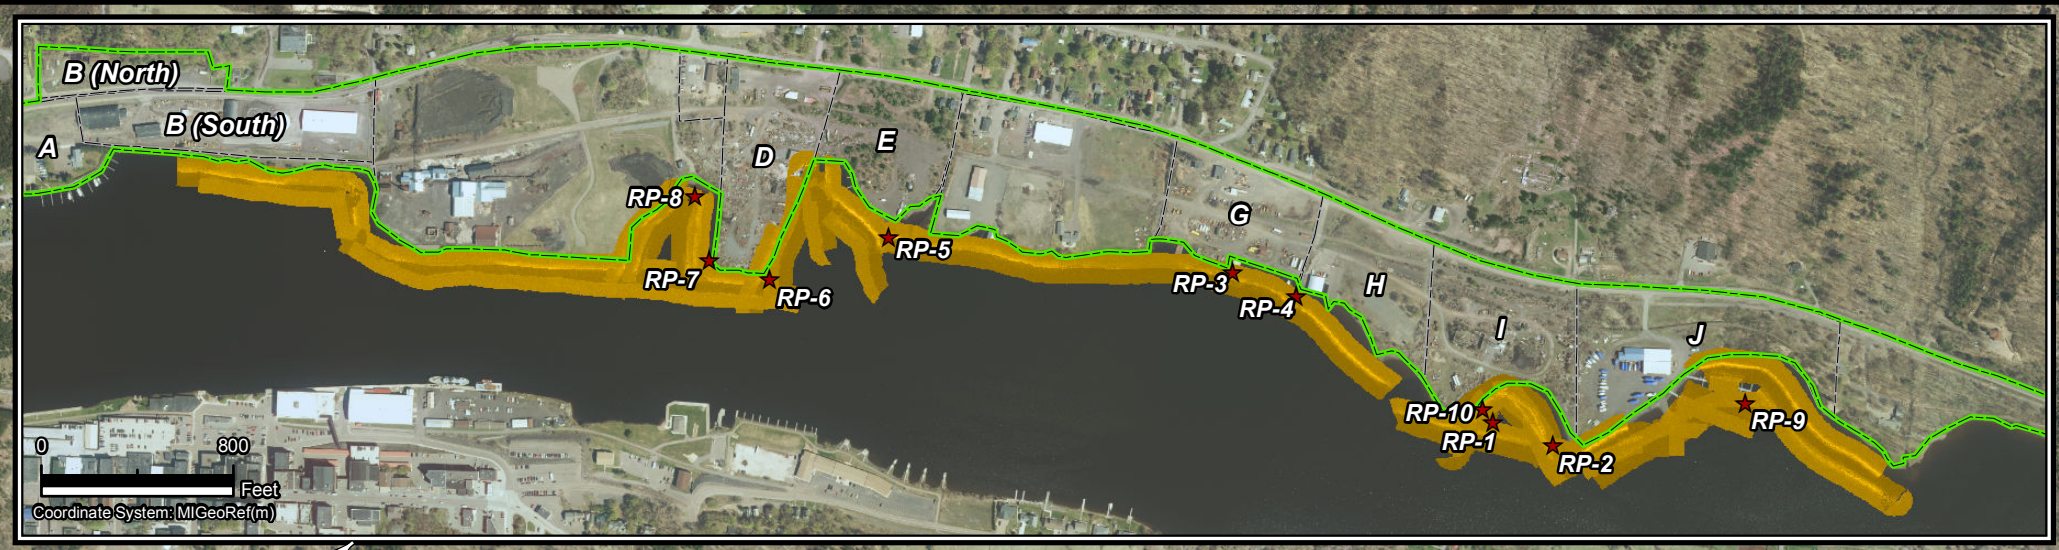
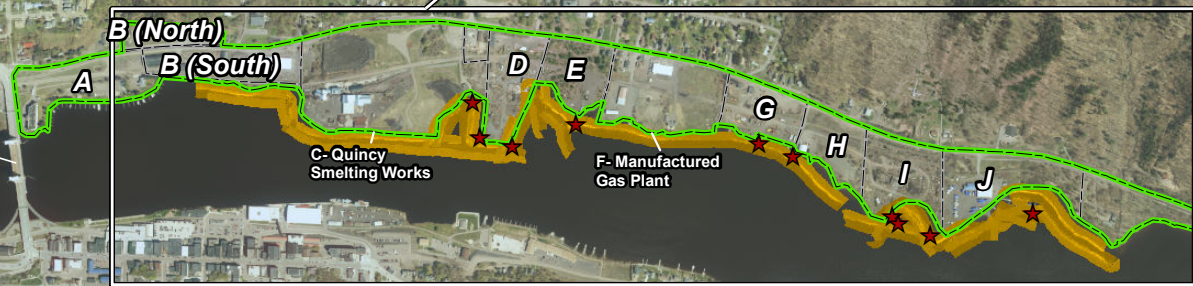
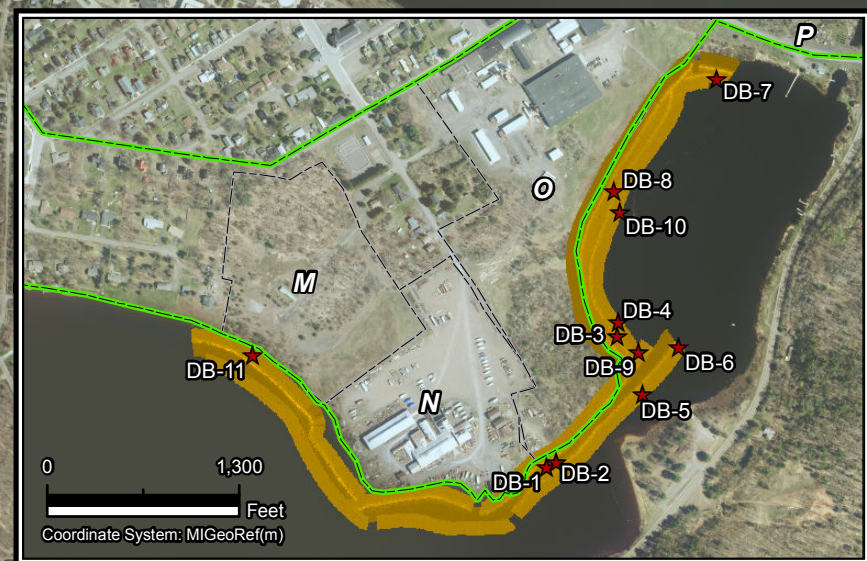
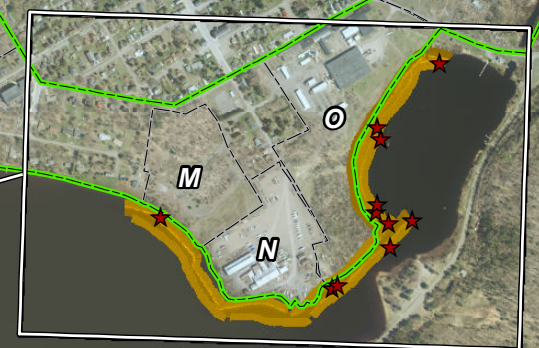
- ★ Underwater Reconnaissance Target
- MDEQ Sidescan Sonar Tracks
- QMCP Study Area Boundary
- Approximate Parcel Boundaries

Notes:  
- RP = Ripley  
- CD = Coal Dock  
- DB = Dollar Bay
