**PHASE I SUMMARY REPORT
FOR
DETROIT LEAD ASSESSMENT PROJECT
ACME METAL COMPANY – 1436 HOLBROOK STREET
DETROIT, WAYNE COUNTY, MICHIGAN**

March 2004

W. O. No. 20083.028.001

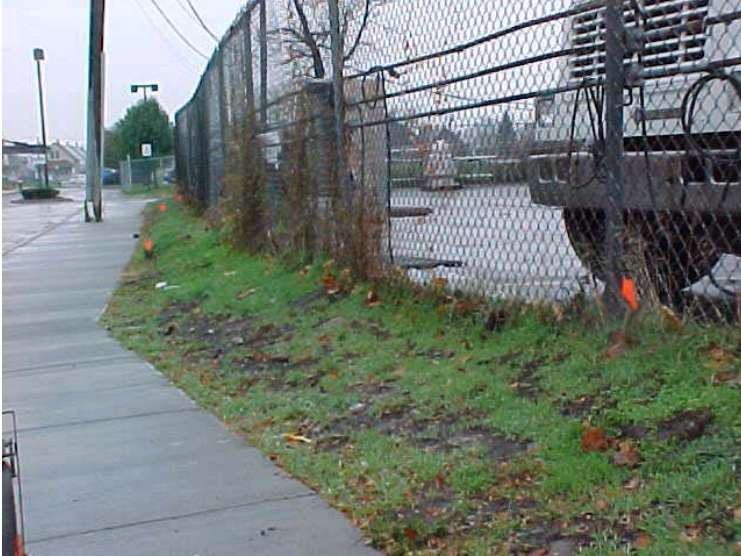
2620 Brombach – Greenway located on the southwest side of Brombach St across from the Hamtramck Senior Plaza and to the northeast of an enclosed parking lot.

Looking south along greenway at 5 discrete sample A locations.

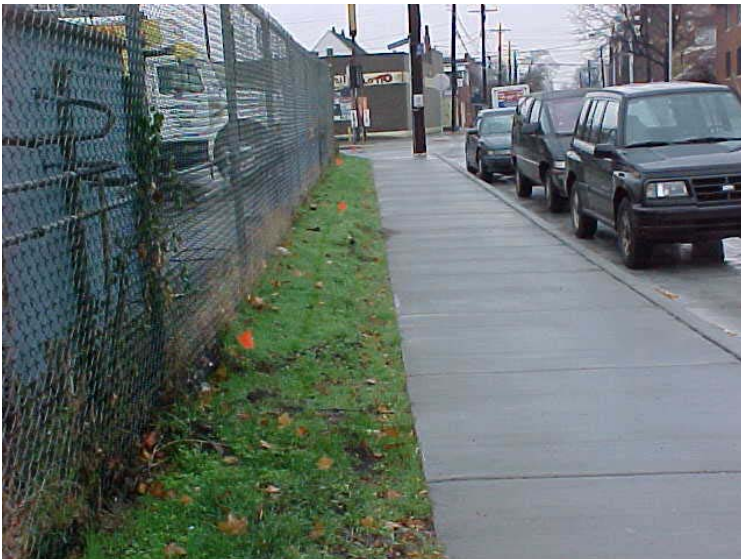
Looking northwest along greenway at 5 discrete sample B locations.

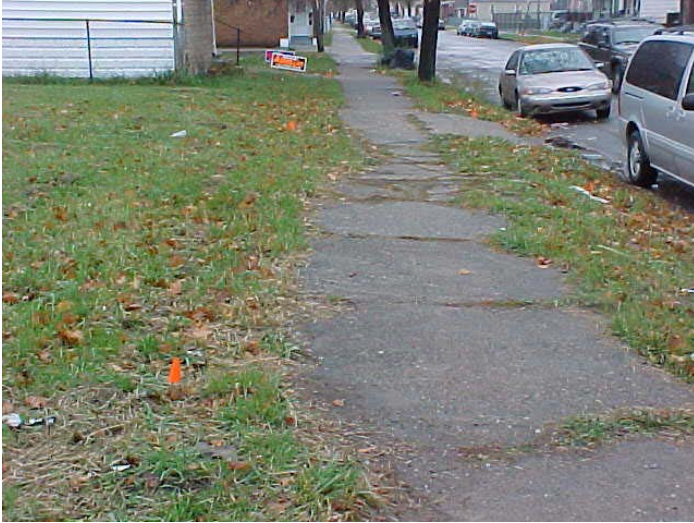
9010 Lumpkin – Greenway located on the east side of Lumpkin St and directly north of the house at 9010 Lumpkin. The greenway is on the corner of Lumpkin and Wyandotte St.

Looking south along greenway at 5 discrete sample A locations.

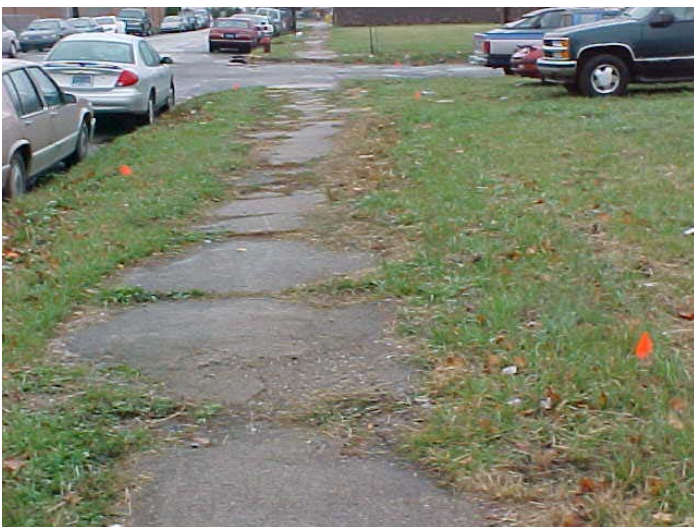
Looking north along greenway at 5 discrete sample B locations.

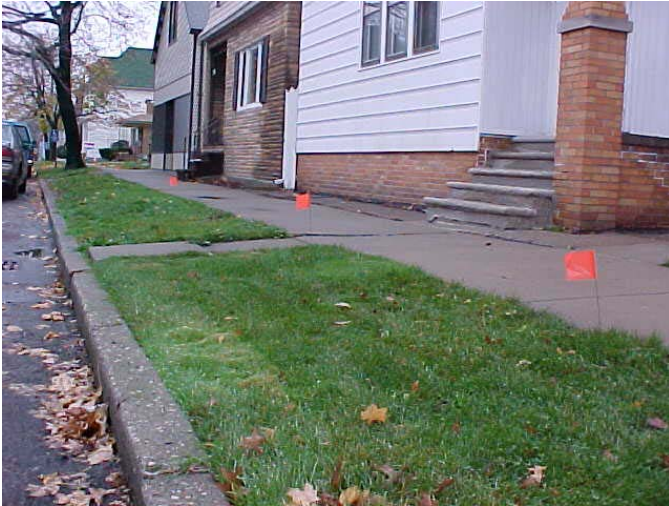
2406 Florian – Greenways located to the south of Florian St and in front of houses 2406, 2412, and 2420 Florian.

Looking east along greenway at 5 discrete sample A locations.

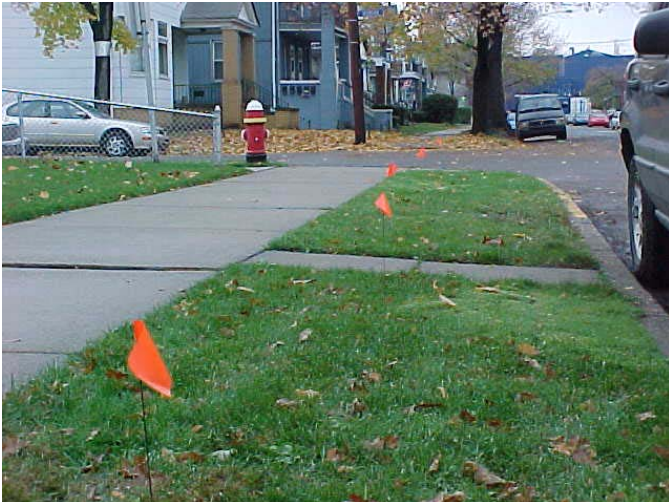
Looking west along greenway at 5 discrete sample B locations.

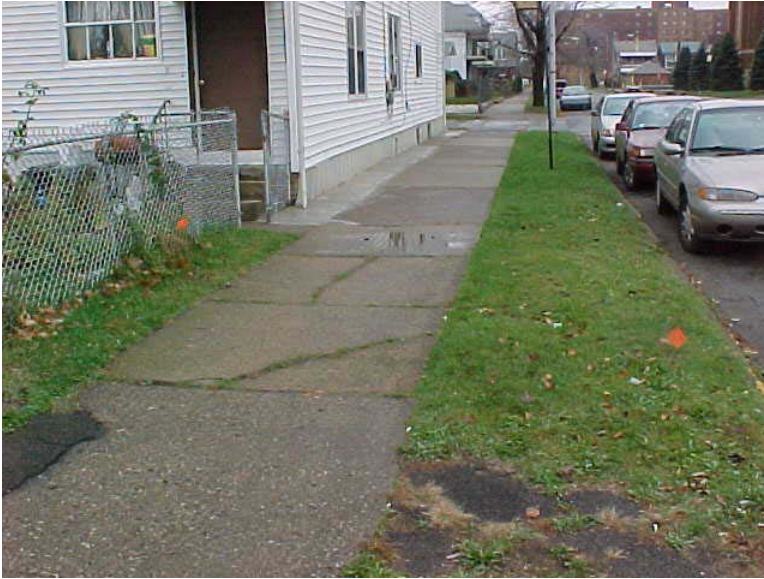
2703 Latham – Greenway located on the east side of Latham St in front of house at 2703 Latham and in front of enclosed yard at house to the north of 2703 Latham.

Looking south along greenway at 5 discrete sample A locations.

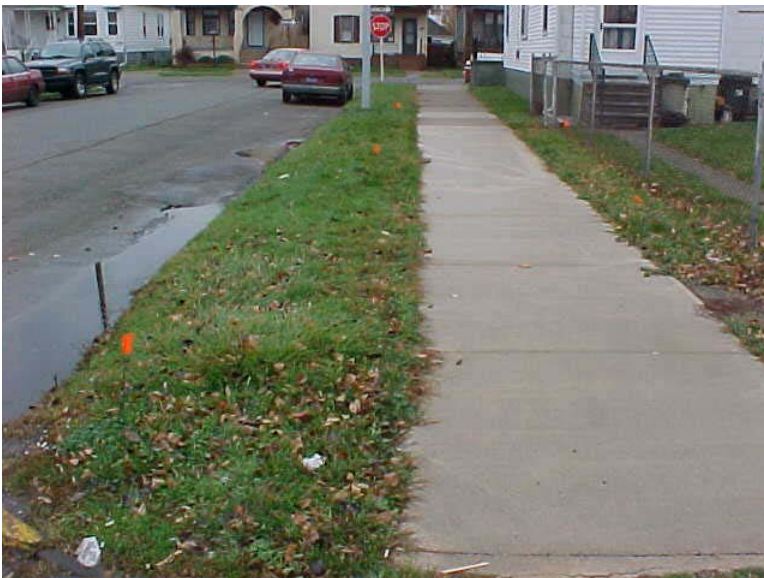
Looking north along greenway at 5 discrete sample B locations.

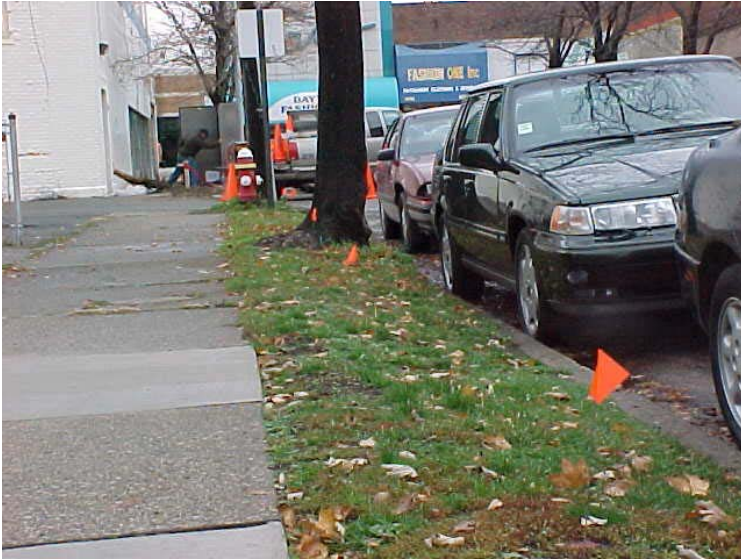
2761 Poland – Greenways located on the north side of Poland St and to the south of houses at 2761, 2755, 2747, and 2743 Poland.

Looking east along greenway at 5 discrete sample A locations.

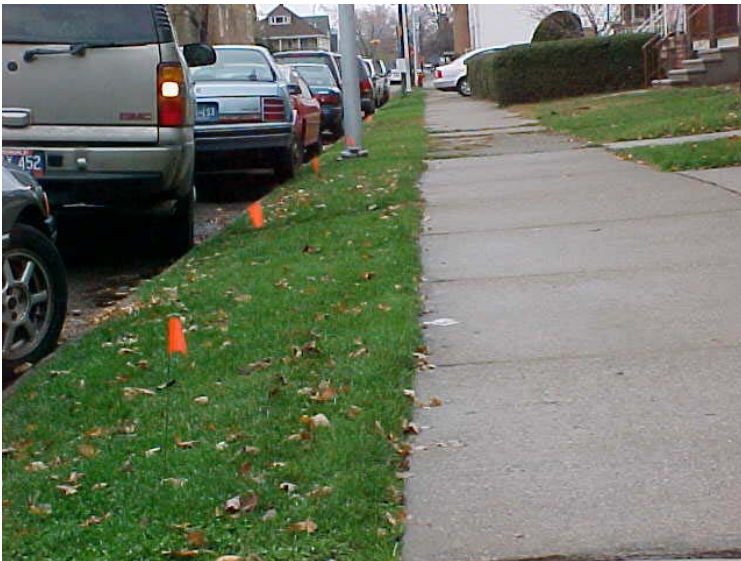
Looking west along greenway at 5 discrete sample B locations.

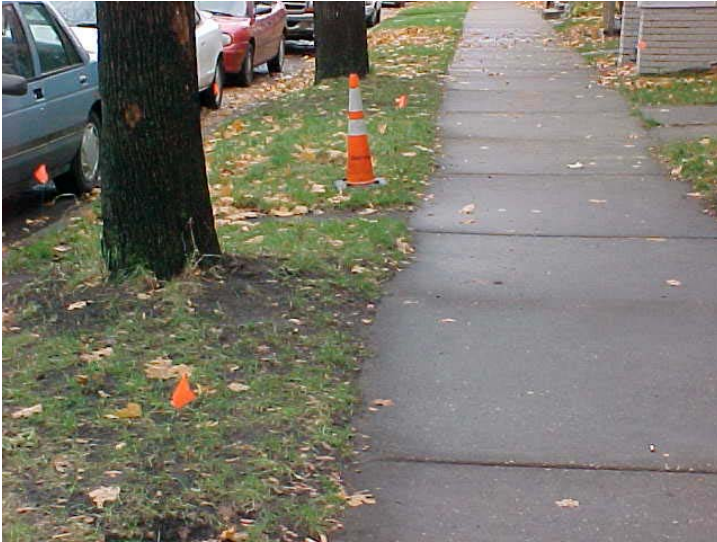
9537 Mitchell – Greenways located on the west side of Mitchell St and to the east of houses at 9537, 9521, 9519, and 9515 Mitchell.

Looking south along greenway at 5 discrete sample A locations.

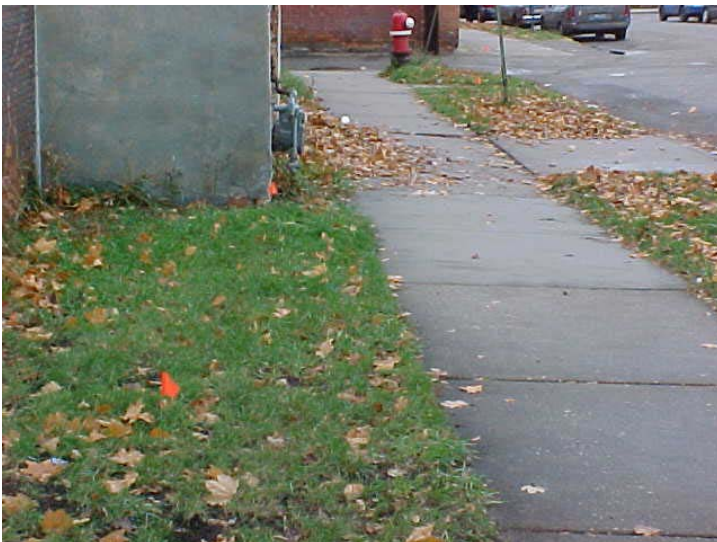
Looking north along greenway at 5 discrete sample B locations.

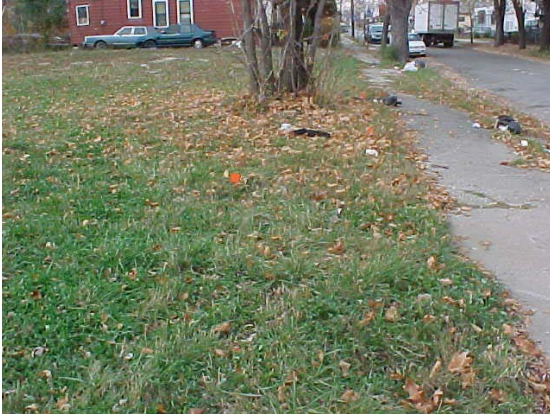
8941 Cameron – Vacant property on the west side of Cameron St and surrounded by vacant properties.

Looking north along vacant property at 3 of 5 discrete sample A locations.

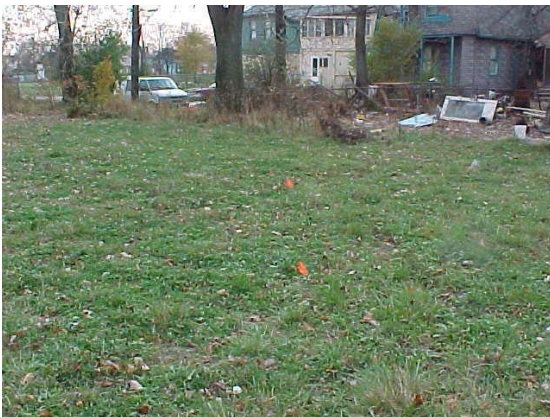
Looking southwest along vacant property at 2 of 5 discrete sample A locations.

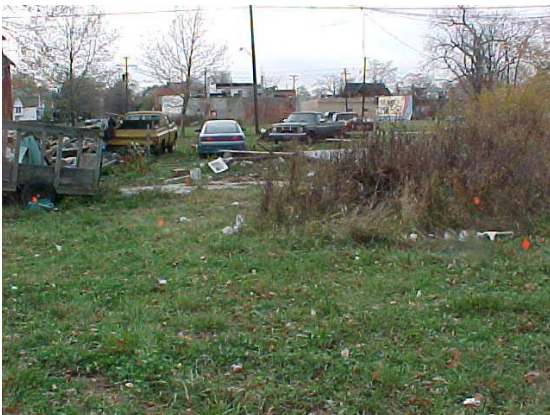
Looking west along vacant property at 5 discrete sample B locations.

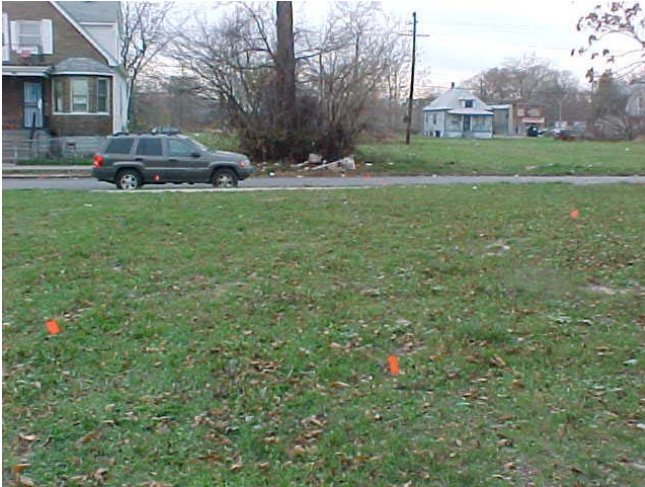
9200 Cameron – Vacant property located on the northeast side of Cameron St and surrounded by vacant properties.

Looking southwest along vacant property at 5 discrete sample A locations.

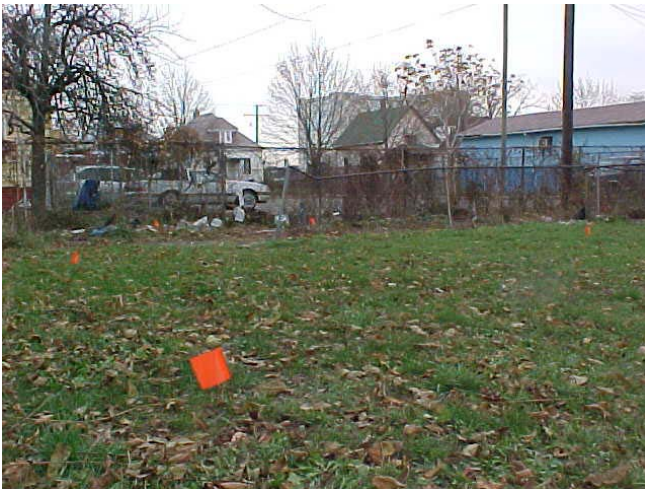
Looking east along vacant property at 5 discrete sample B locations.

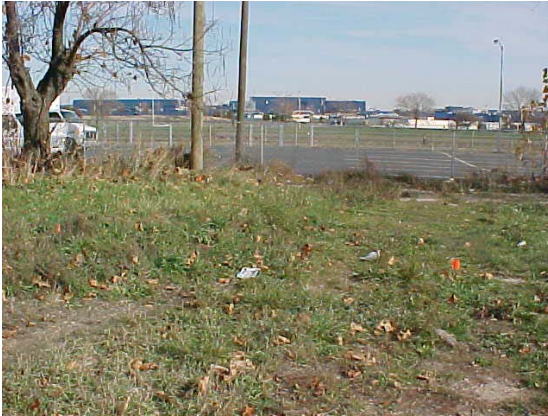
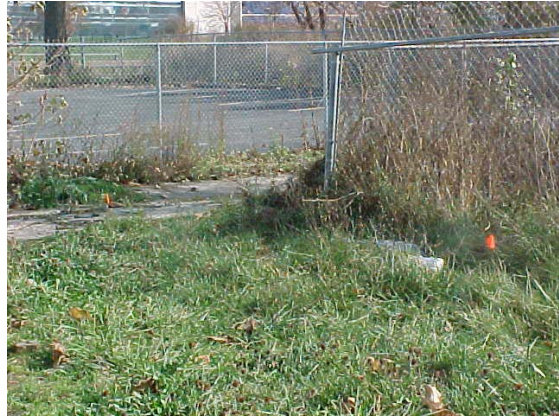
9148 Delmar – Vacant property located on the northeast of Delmar St and directly east of a vacant property at 9154 Delmar.

Looking southwest and southeast, respectively, along vacant property at 5 total discrete sample A locations.

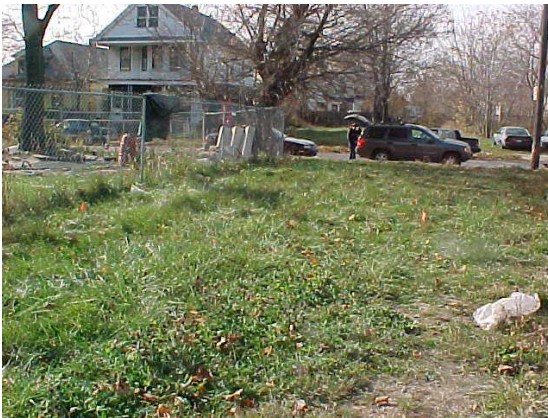
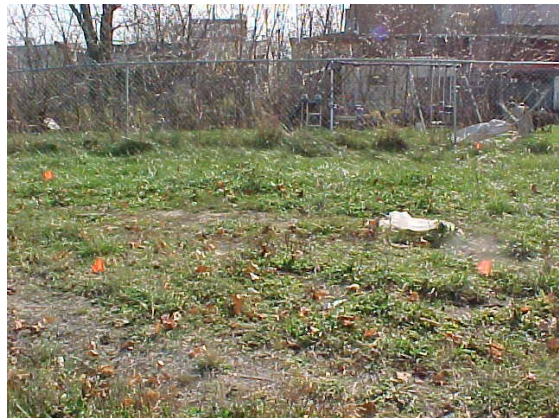
Looking north and east, respectively, along vacant property at 5 total sample B locations.

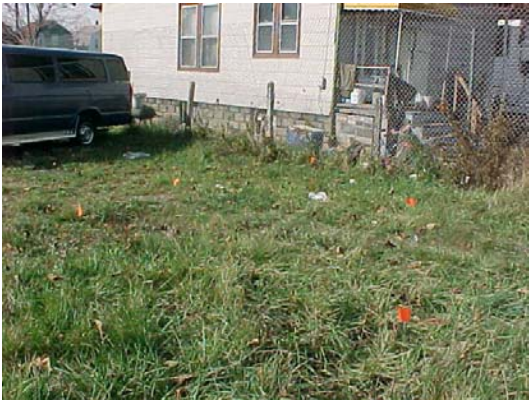
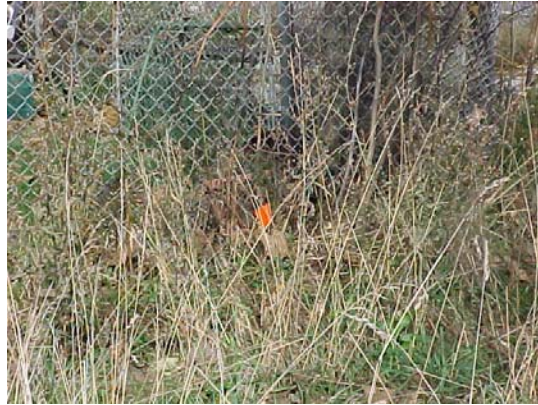
9154 Delmar – Vacant property located to the northeast of Delmar St and directly east of a house at 9160 Delmar.

Looking northwest along the vacant property at 3 of 5 discrete sample B locations and at 2 of 5 discrete sample A locations. Also looking north at 1 of 5 sample A locations.

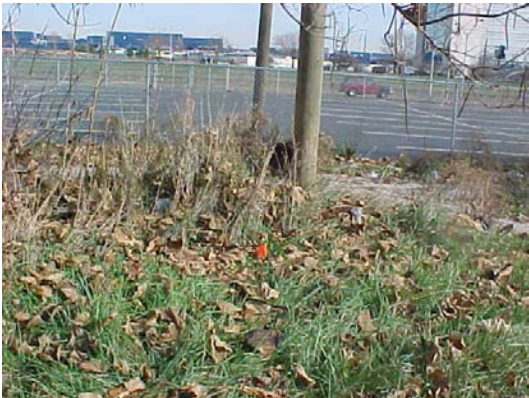
Looking northeast along the vacant property at 2 of 5 sample A locations.

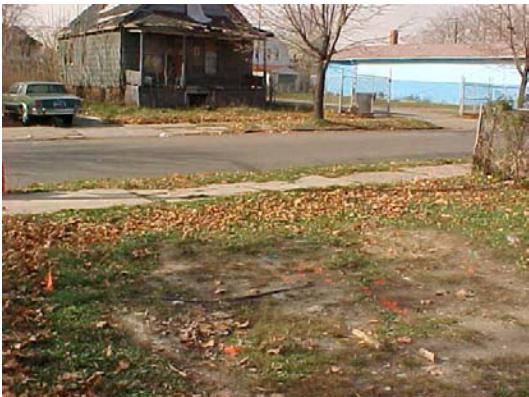
Looking southwest along vacant property at 2 of 5 discrete sample B locations.

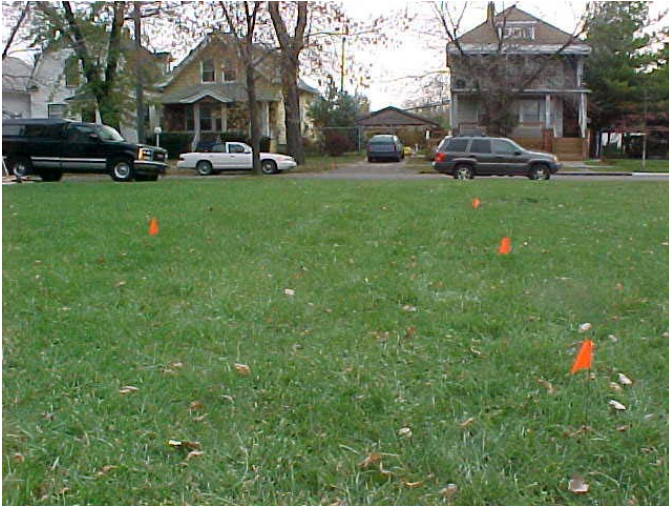
987 King – Vacant property located on the north side of King St and surrounded by vacant properties.

Looking south along the vacant property at 5 discrete sample A locations.

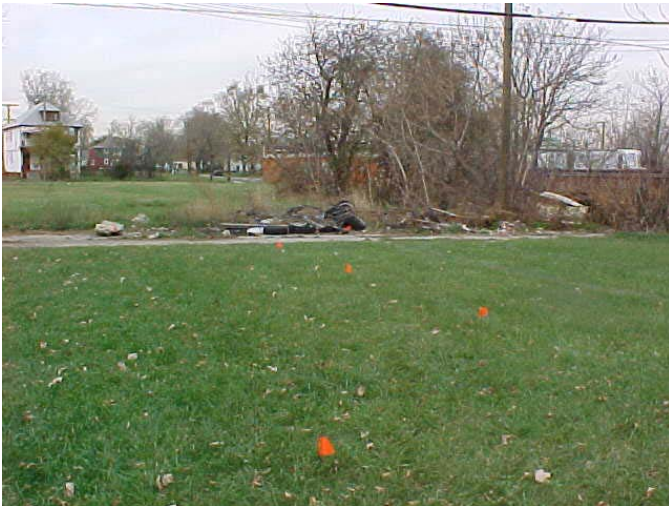
Looking north along the vacant property at 5 discrete sample B locations.

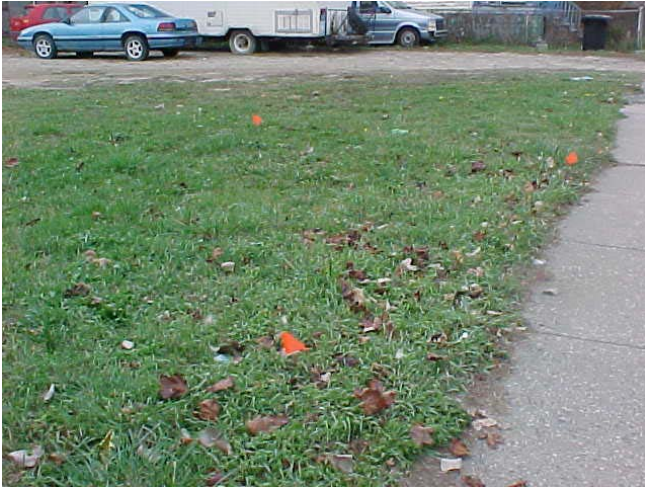
9185 Chrysler – Vacant property located on the west side of Chrysler Dr, to the north of a fenced parking lot, and to the south of a dirt parking area of a house at 9191 Chrysler.

Looking northwest along vacant property at 4 of 5 discrete sample A locations.

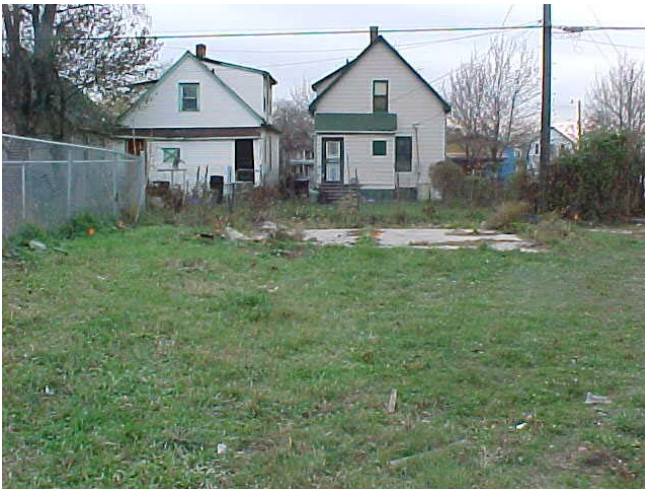
Looking west along the vacant property at 1 of 5 discrete sample A locations and 5 discrete sample B locations.
