**PHASE I SUMMARY REPORT
FOR
DETROIT LEAD ASSESSMENT PROJECT
GREAT LAKES SMELTING – 1640 EAST EUCLID STREET
DETROIT, WAYNE COUNTY, MICHIGAN**

**MICHIGAN DEPARTMENT OF ENVIRONMENTAL QUALITY
REMEDIATION AND REDEVELOPMENT DIVISION**
Detroit Field Office – Cadillac Place
Suite 2-300
3058 West Grand Boulevard
Detroit, Michigan 48202

WESTON SOLUTIONS OF MICHIGAN, INC.
2501 Jolly Road
Suite 100
Okemos, Michigan 48864

March 2004

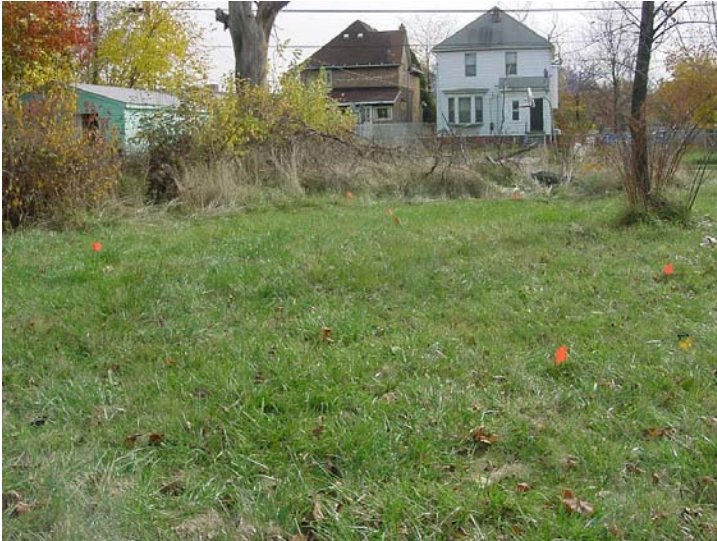
998 East Euclid – Vacant property located on the south side of East Euclid St.

Looking south along the vacant property at 5 discrete sample A locations.

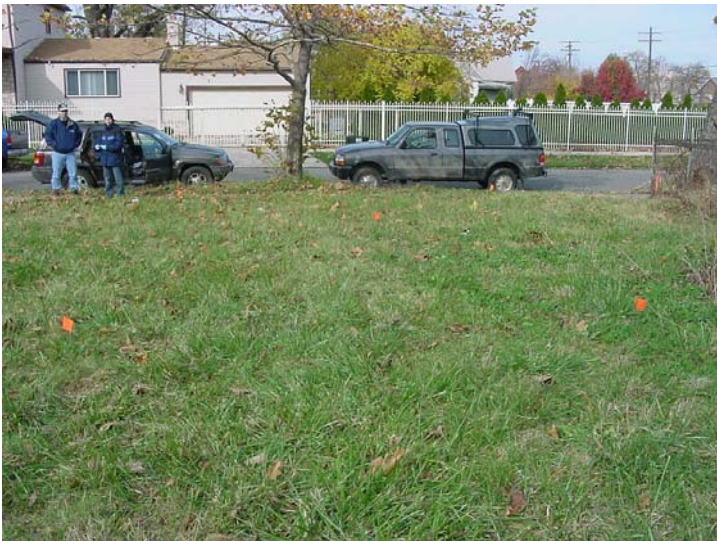
Looking north along the vacant property at 5 discrete sample B locations.

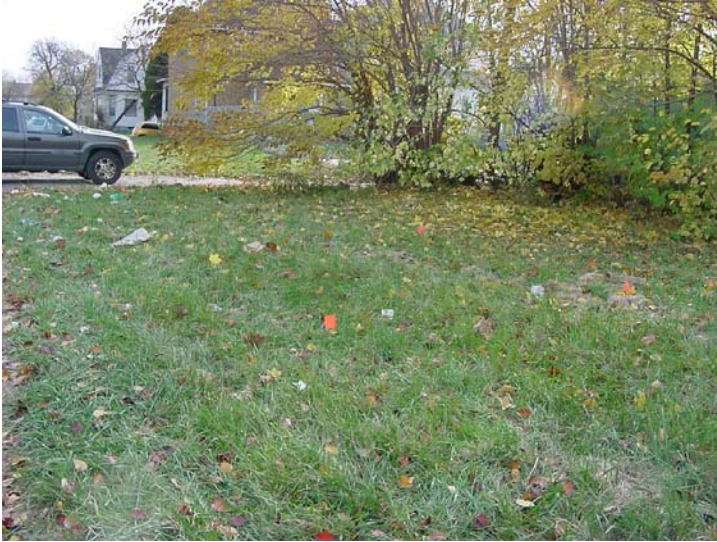
1014 East Euclid – Vacant property located on the south side of East Euclid St and at the corner of East Euclid and Cameron St.

Looking southwest along the vacant property at 5 discrete sample A locations.

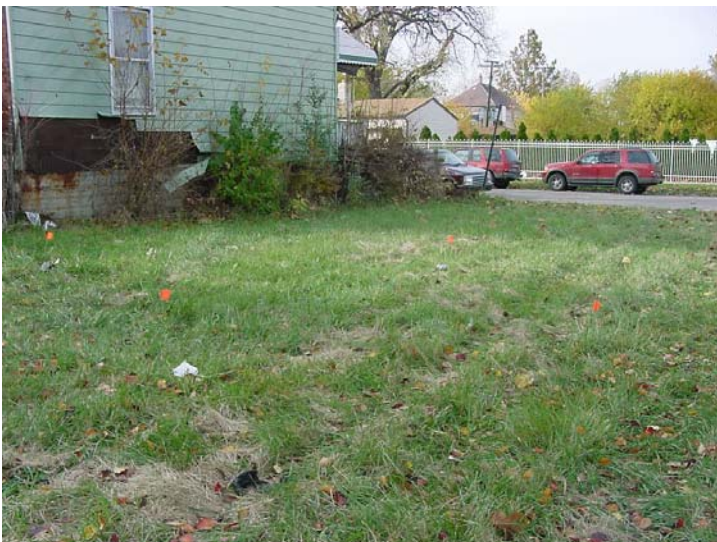
Looking northwest along the vacant property at 5 discrete sample B locations.

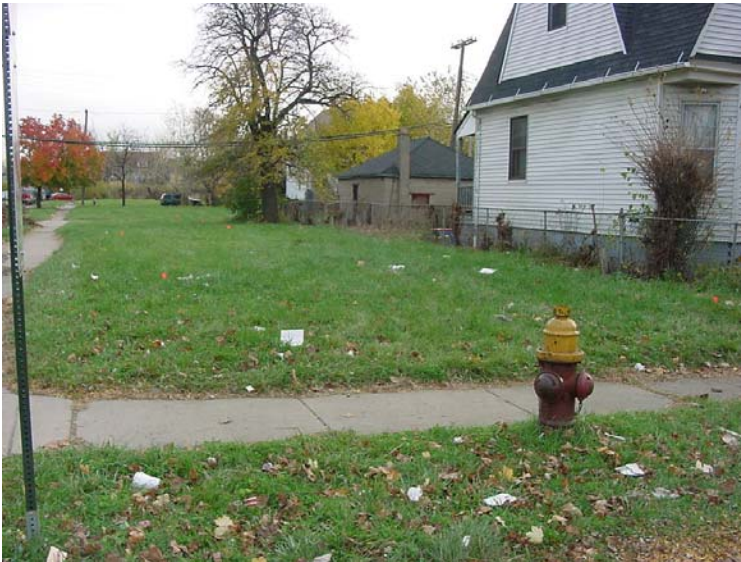
1016 Melbourne – Vacant property located on the south side of Melbourne St and at the corner of Melbourne and Cameron St.

Looking south along the vacant property at 10 total of discrete sample B and A locations, respectively.

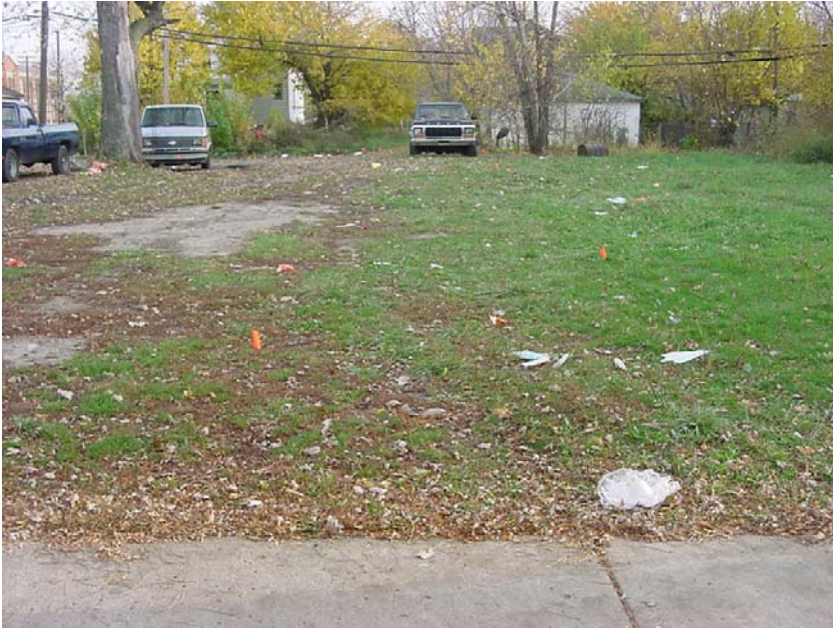
998 Melbourne – Vacant property located on the south side of Melbourne St and in between two other vacant lots.

Looking south along the vacant property at 10 total of discrete sample B and A locations, respectively.

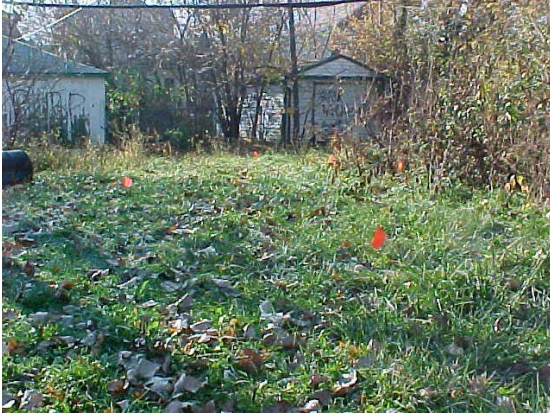
990 Melbourne – Vacant property located on the south side of Melbourne St and directly to the west of the vacant property at 998 Melbourne.

Looking south along the vacant property at 5 discrete sample A locations.

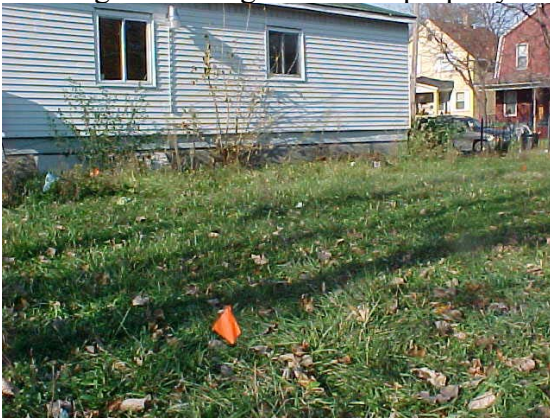
Looking west along the vacant property at 3 of the 5 discrete sample B locations.

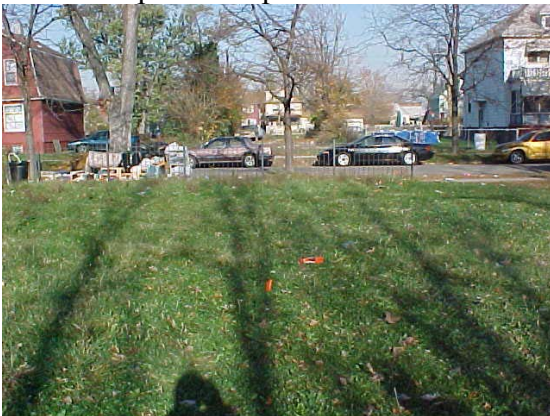
Looking north along the vacant property at 3 of the 5 discrete sample B locations. One location repeated in photo.

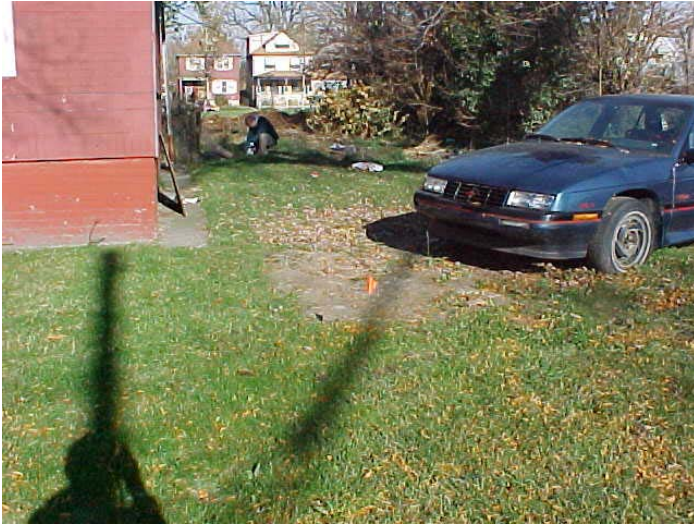
987 Melbourne – Vacant property located on the north side of Melbourne St and to the west of another vacant property.

Looking northeast along the vacant property at 5 discrete sample A locations. Sample B locations further to the north. 1 location is not seen in the photo because it is to the southeast of the car.

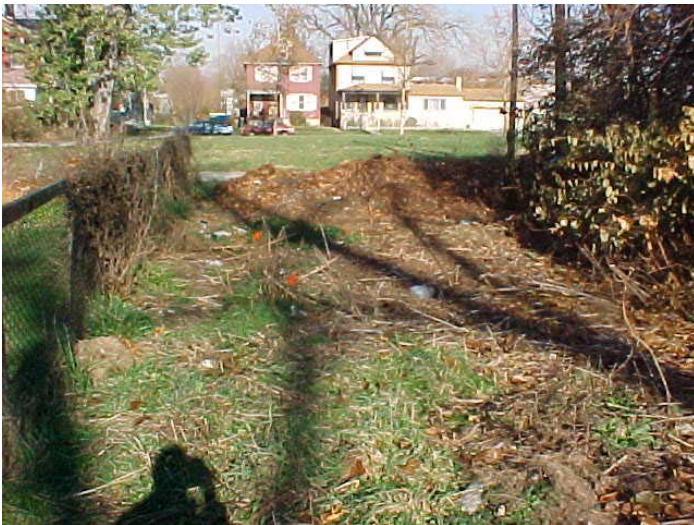
Looking north along the vacant property at 5 discrete sample B locations. 2 locations located behind the leaf/straw pile so they are not in seen in the photo.

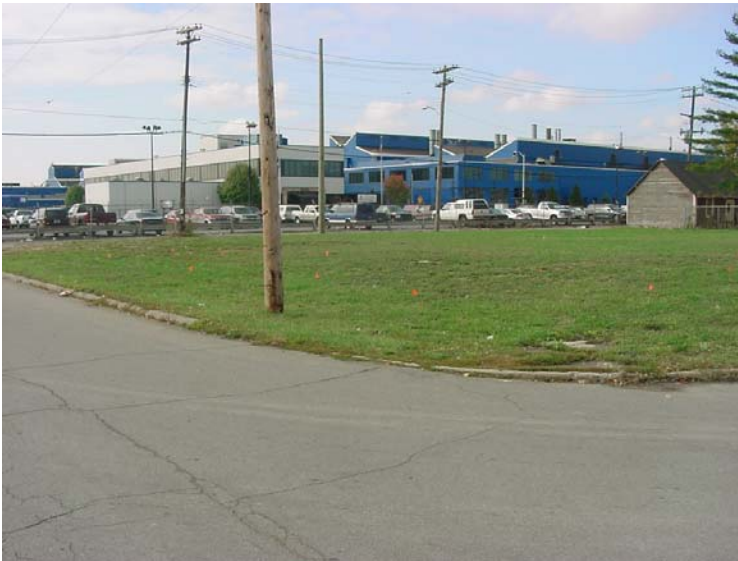
8435 St Aubin – Greenway of a vacant property on the corner of Denton St and St Aubin. It is located to the north of Denton St and across the street and to the east of the American Axle Facility at 8435 St Aubin. A separate greenway also sampled is located to the south of Denton St and also across the street and to the east of 8435 St Aubin.

Looking northwest along the vacant property at 10 total discrete sample A and B locations, respectively.

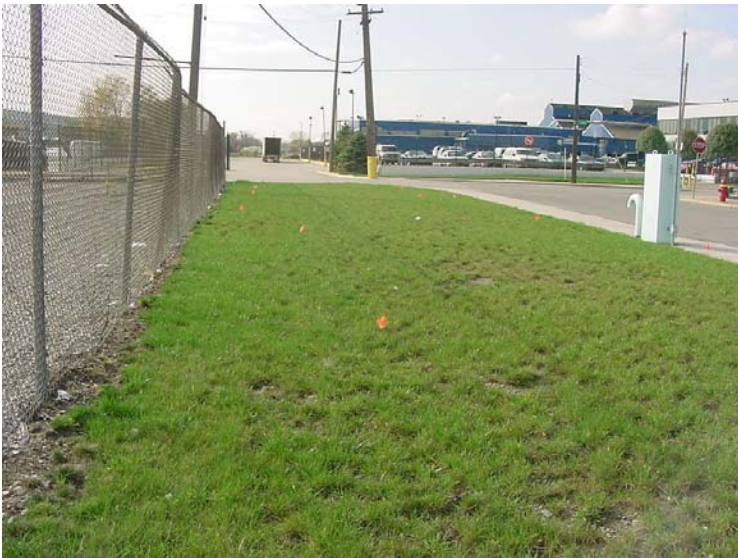
Looking northwest along the greenway at 10 total discrete sample C and D locations, respectively.

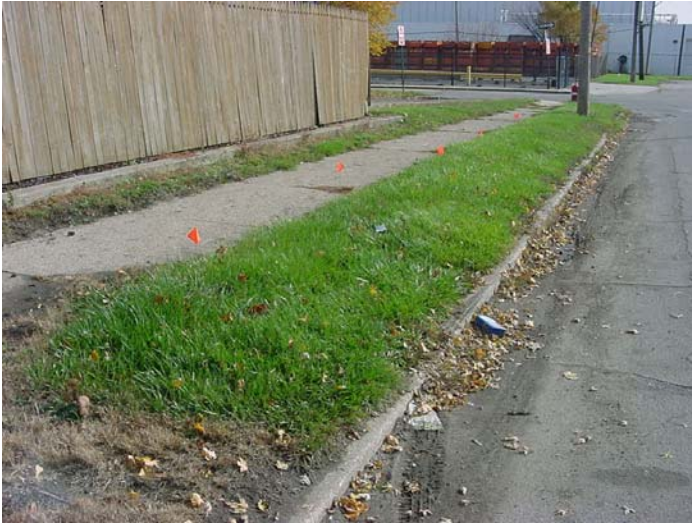
8434 Lumpkin – Greenway located to the east of Lumpkin St in front of a fenced in lot and to the south of the property at 8434 Lumpkin.

Looking south along the greenway at 5 discrete sample A locations.

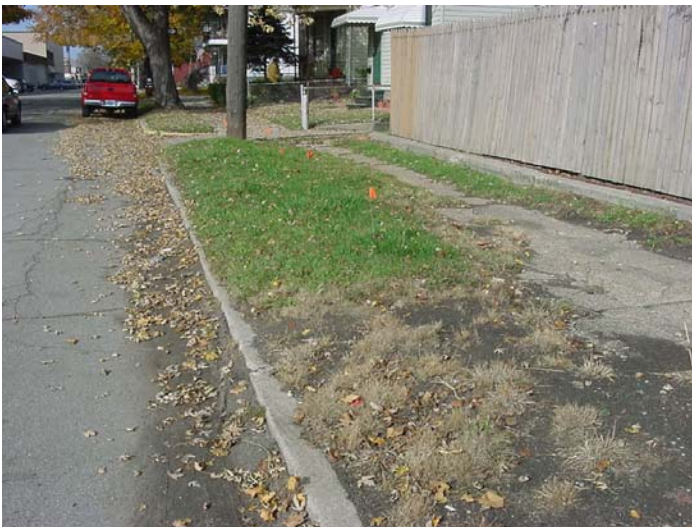
Looking north along the greenway at 5 discrete sample B locations.

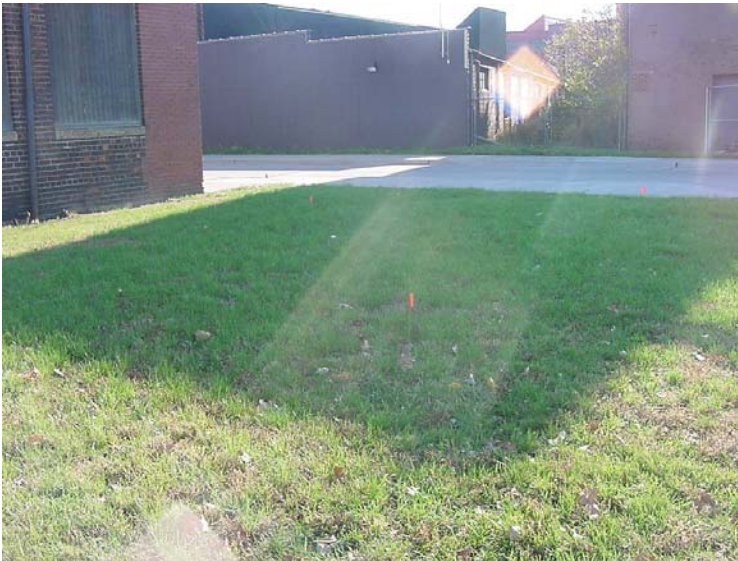
1901 Marston – Greenway located on the east side of Morrow St and on the corner of Morrow and Marston St. On the west side of the greenway is Wessel Co, an abandoned Factory. Another greenway located on the east side of Morrow St and across the street from an American Axle Plant gated drive.

Looking southeast along the greenway at 5 discrete sample A locations.

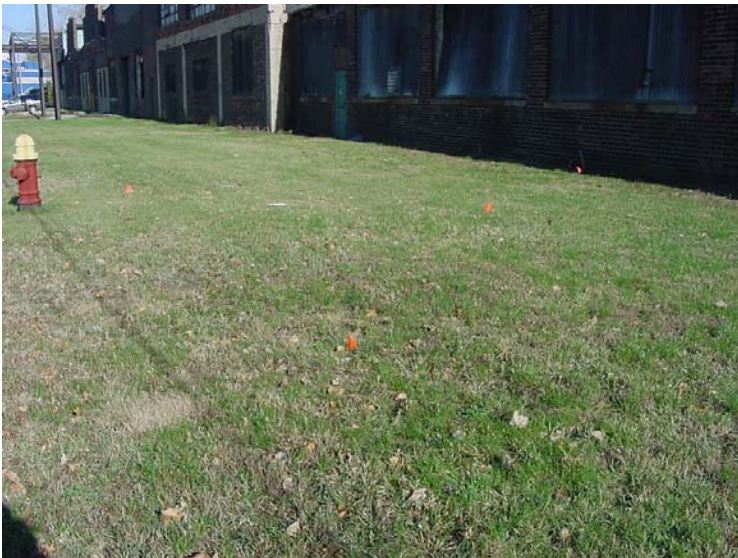
Looking northeast along the greenway at 5 discrete sample B locations.

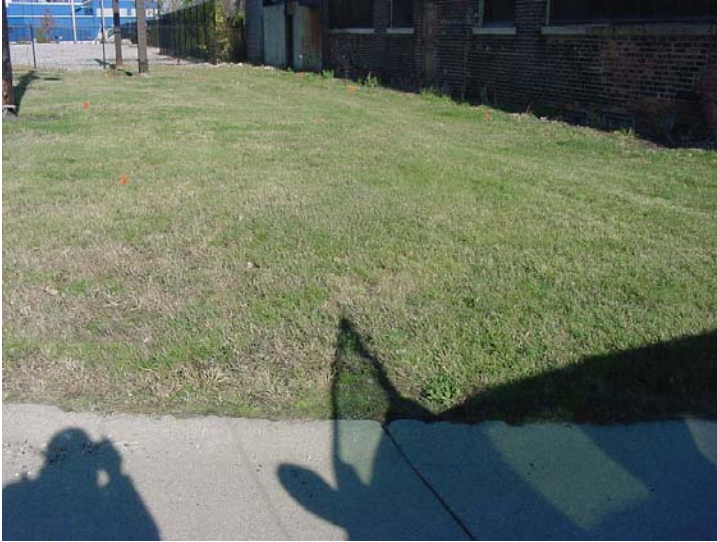
Looking northeast along the greenway at 10 total discrete sample C and D locations, respectively.

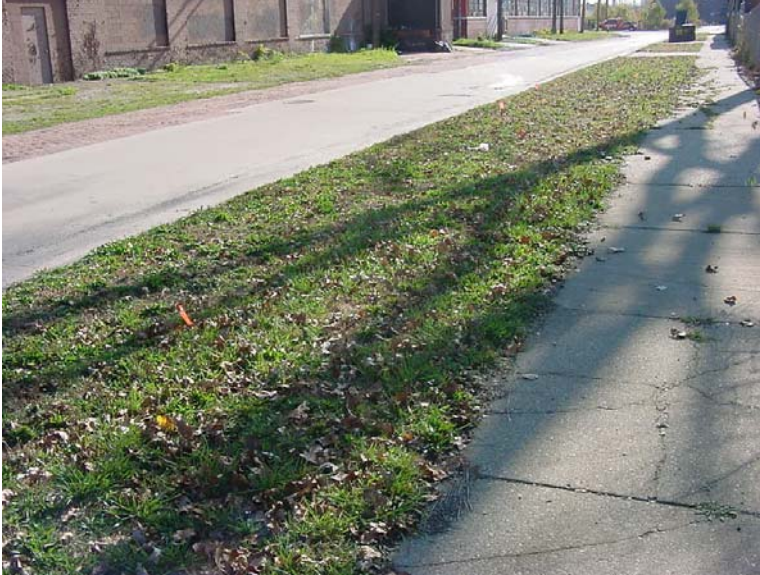
1831 Clay – Greenway located on the west side of Morrow St and to the east of an enclosed property at 1831 Clay, located on the corner of Clay and Morrow St.

Looking southeast along the greenway at 10 total discrete sample B and A locations respectively.

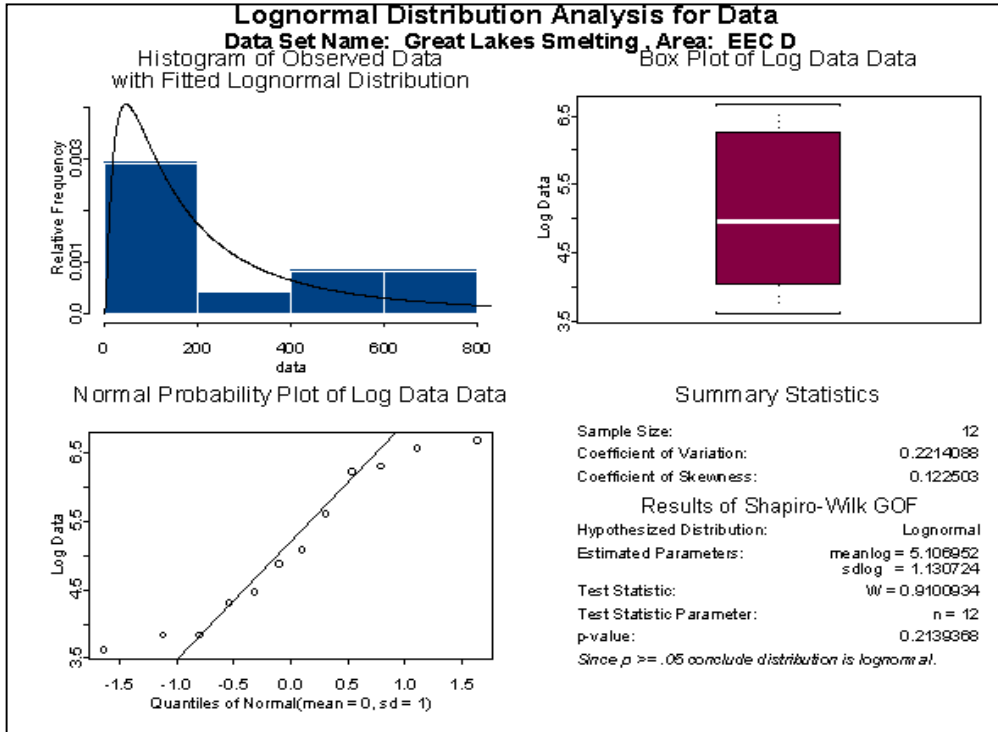
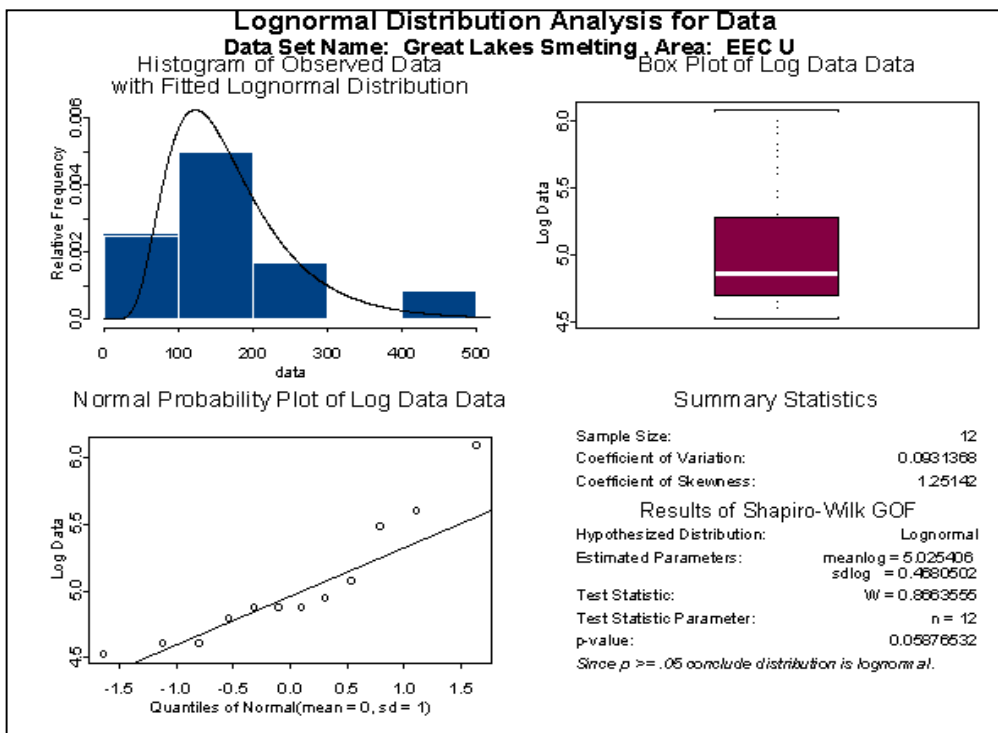
ATTACHMENT F
STATISTICAL DISTRIBUTION

GREAT LAKES SMELTING STATISTICAL DISTRIBUTION

concentrations are similar. Comparison of the relative frequency histogram (**Attachment F**) for the downwind and upwind data indicates, a higher frequency of occurrence for both data sets between 0 and 200 mg/kg and a greatly decreasing frequency above 300 mg/kg also indicating the data are similar. Comparison of the upwind and downwind data sets indicates the lead concentrations are similar to each other both in mean concentration and distribution to conclude that the data represent the same conditions.
