PHASE I SUMMARY REPORT FOR DETROIT LEAD ASSESSMENT PROJECT INDUSTRIAL SMELTING – 19430 MT ELLIOTT STREET DETROIT, WAYNE COUNTY, MICHIGAN

MICHIGAN DEPARTMENT OF ENVIRONMENTAL QUALITY REMEDIATION AND REDEVELOPMENT DIVISION

WESTON SOLUTIONS OF MICHIGAN, INC. 2501 Jolly Road Suite 100 Okemos, MI 48864 March 2004

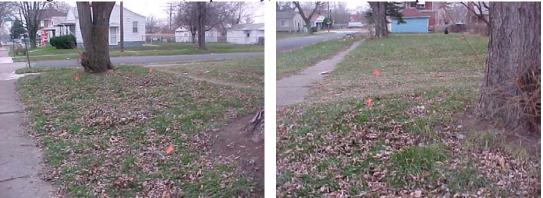
19303 St Louis – Vacant property located at the corner of Emery and St Louis St and on the south side of the house at 19309 St Louis.

Looking southwest and west, respectively, at 5 total discrete sample A locations.

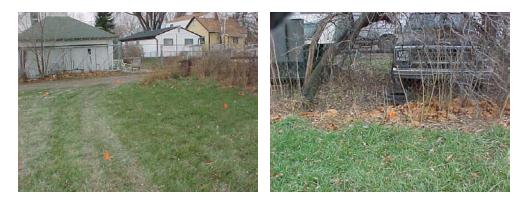
19145 Albany – Vacant property on the west side of Albany St and directly south of a fenced in lot.

Looking northwest and north, respectively, at 5 total discrete sample B locations.

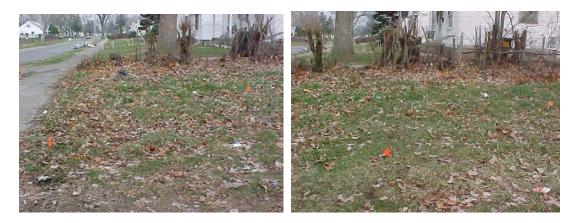
19186 Syracuse – Vacant property located on the east side of Syracuse St and on the south side of a house at 19194 Syracuse.

Looking north along the vacant property at 5 total sample B locations.

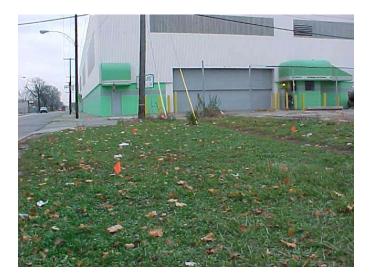
3900 E Outer Dr – Greenway located at the corner of Sherwood and Lantz St, on the east side of the parking lot of the old Kmart, and directly north of Industrial building at 19451 Sherwood.

Looking south along greenway at 5 discrete sample A locations.

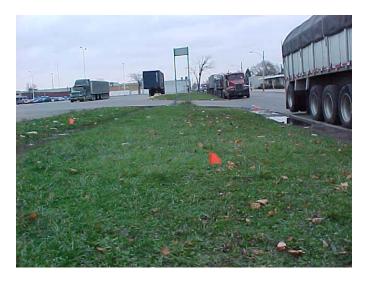
Looking north along greenway at 5 discrete sample B locations.

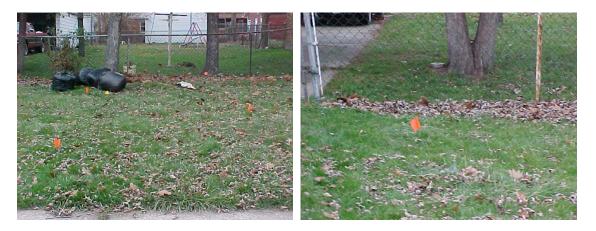
19448 Concord – Vacant property located on the west side of Concord St and directly south of a house at 19456 Concord. Front of property and greenway used due to fence.

Looking east along property at 5 total discrete sample A locations.

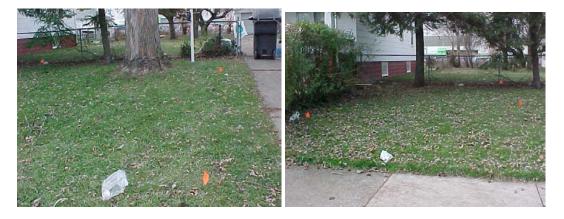
19459 Concord – Vacant property located on the west side of Concord St and directly south of a house at 19465 Concord. The front of the property and greenway were used due to a fence.

Looking west along the property at 5 total discrete sampling B locations.

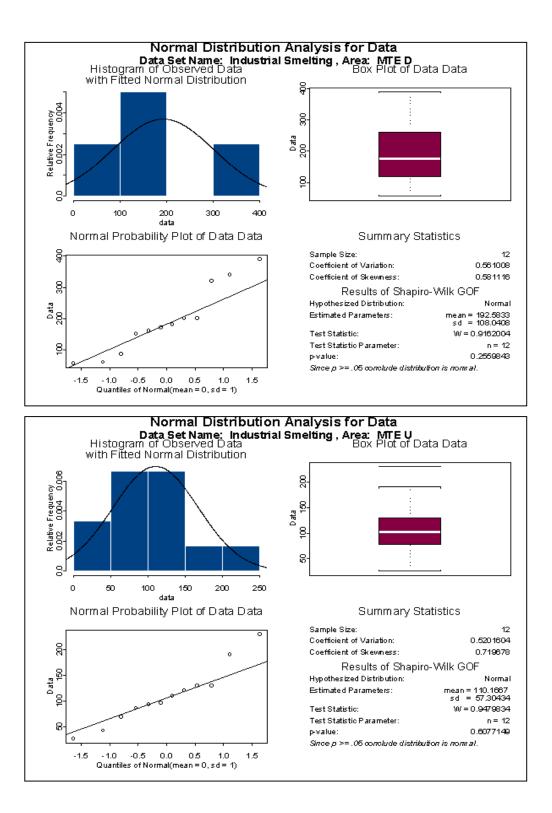
INDUSTRIAL SMELTING STATISTICAL DISTRIBUTION

Analytical data was entered into a spreadsheet file and differentiated as downwind and upwind samples, then processed using the MDEQ online statistical interface for Part 201 evaluations. As shown on the distribution analysis figures included in **Attachment F** the downwind mean is 192 mg/kg and the upwind mean is 110 mg/kg indicating the downwind concentrations are greater than the upwind concentrations. In addition the relative frequency histogram (**Attachment F**) for the downwind data is an uneven distribution across a wide range of concentrations while the upwind results exhibit a more even distribution over a smaller range of concentrations. Comparison of the upwind and downwind data sets indicates the lead concentrations are sufficiently different from each other both in mean concentration and distribution to conclude that the data potentially represent separate conditions.
