**PHASE I SUMMARY REPORT
FOR
DETROIT LEAD ASSESSMENT PROJECT
MICHIGAN SMELTING – 7885 JOSEPH CAMPAU STREET
HAMTRAMCK, WAYNE COUNTY, MICHIGAN**

**MICHIGAN DEPARTMENT OF ENVIRONMENTAL QUALITY
REMEDIATION AND REDEVELOPMENT DIVISION**

WESTON SOLUTIONS OF MICHIGAN, INC.

March 2004

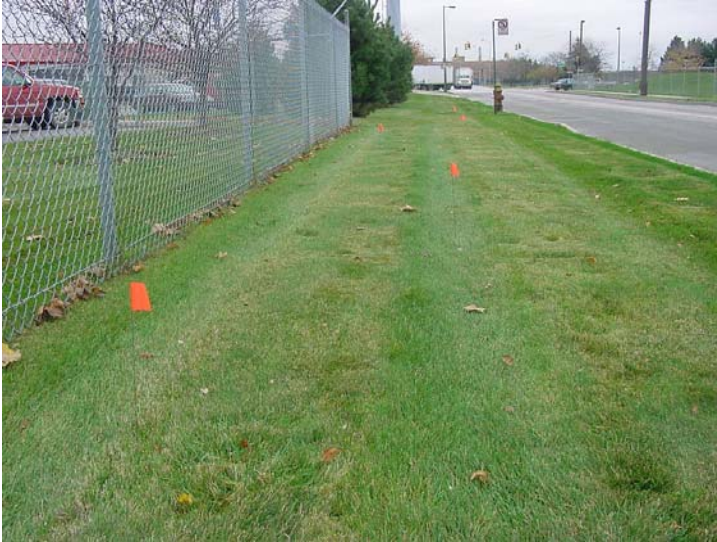
2525 E Grand Blvd – Greenway at the corner of E Grand Blvd and Milwaukee St. It is located on the north side of Milwaukee St and to the south side of a fence surrounding the Midwest Steel building located at 2525 E Grand Blvd.

Looking east along greenway at 5 discrete sample A locations.

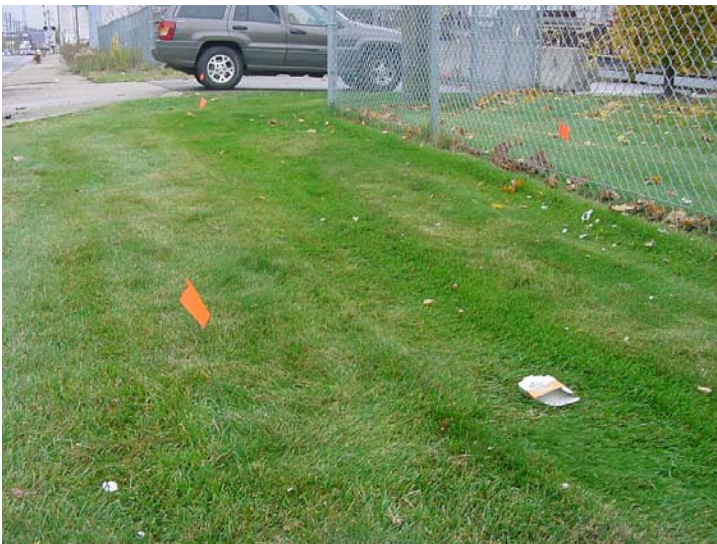
Looking west along greenway at 5 discrete sample B locations.

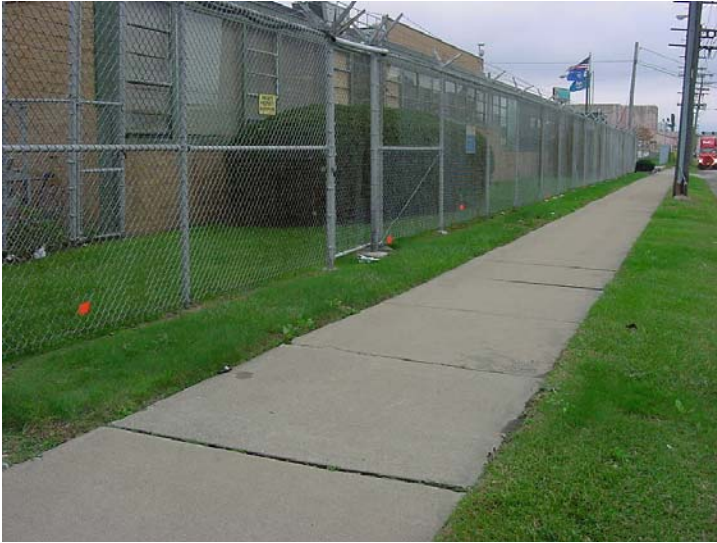
1530 Trombly – Greenway located on the south side of Trombly St and to the north of a fence surrounding the DTE Energy building located at 1530 Trombly.

Looking northeast along greenway at 5 discrete sample A locations.

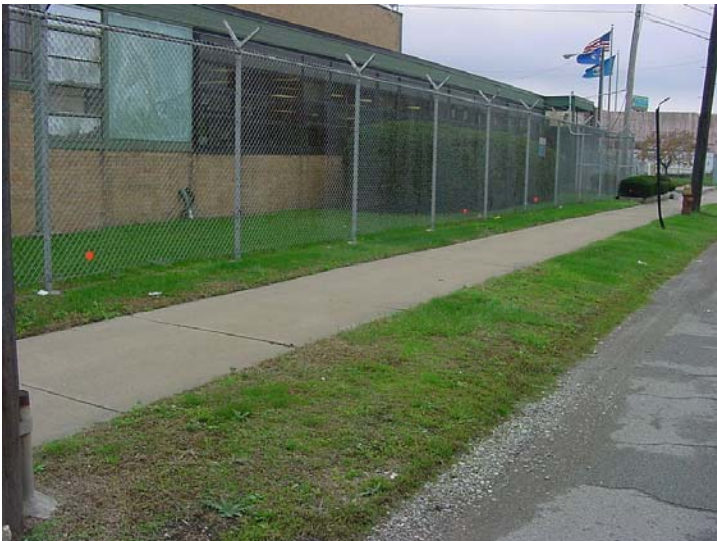
Looking northeast along greenway at 5 discrete sample B locations.

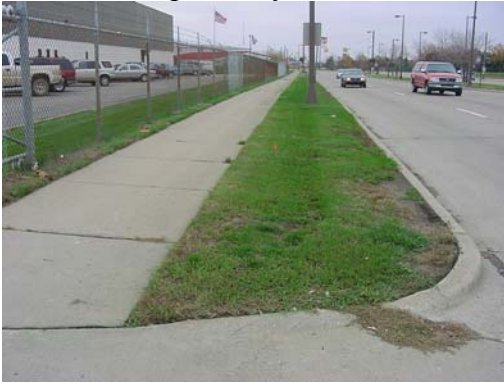
2445 E Grand Blvd – Greenways located in front and to the east of a fence surrounding the Simon and Leeman Fruits & Vegetables Distributor building located at 2445 E Grand Blvd. Samples A and B were sampled on greenway on the west side of southbound E Grand Blvd and samples C, D, E, F, G, and H were samples on greenway between the north and south bound lanes of E Grand Blvd.

Looking north along greenway west of southbound E Grand Blvd at sample A and B locations, respectively.

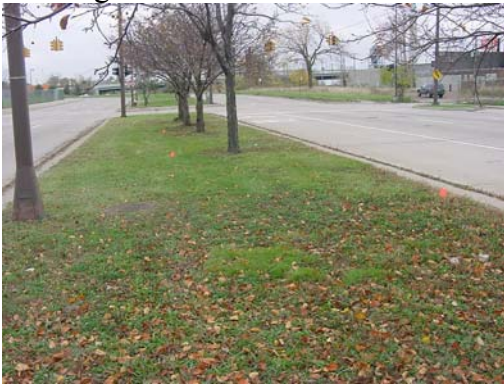
Looking south between north and southbound E Grand Blvd at sample C locations.

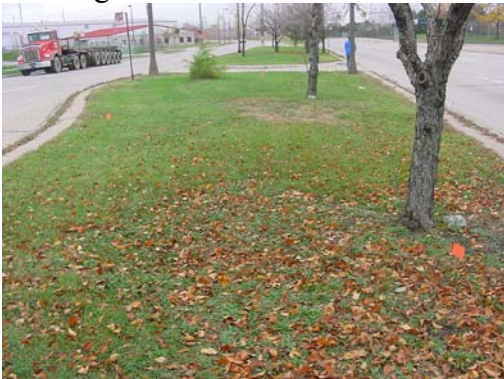
Looking north between north and southbound E Grand Blvd at sample D locations.

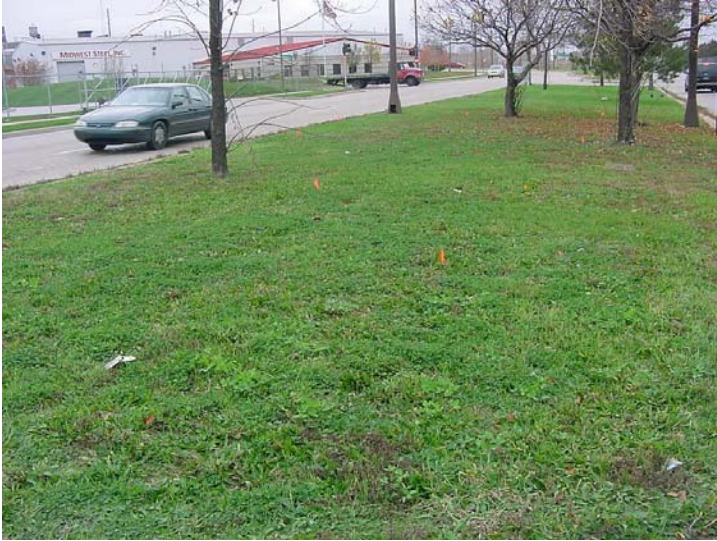
Looking north between north and southbound E Grand Blvd at sample E and F locations, respectively.

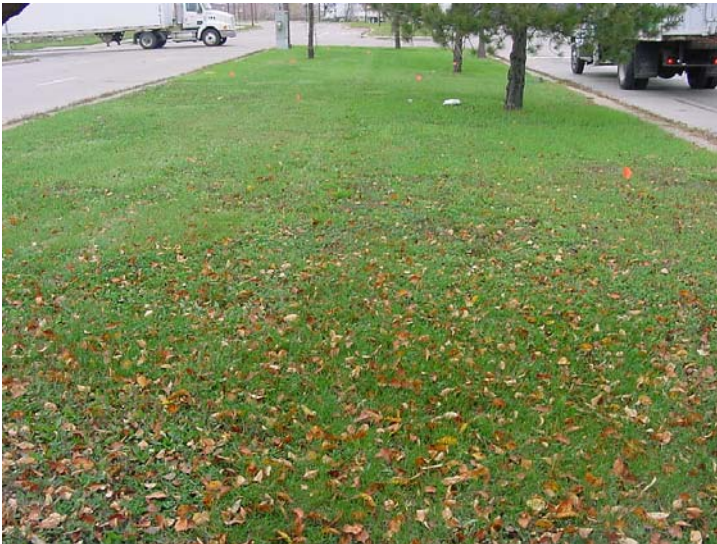
Looking north between north and southbound E Grand Blvd at sample G and H locations, respectively.

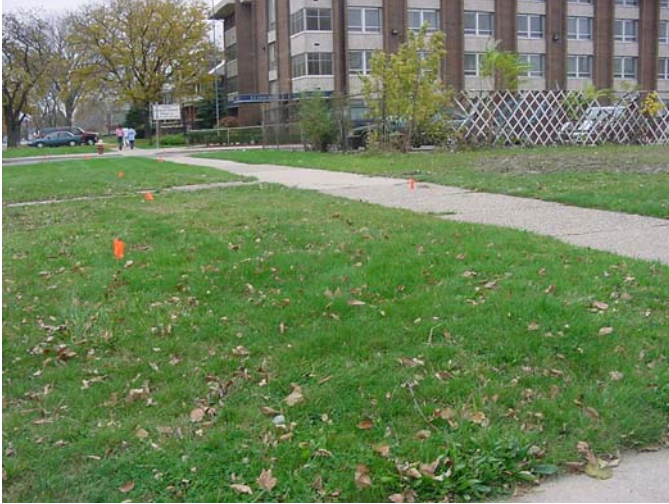
1904 E Grand Blvd – Greenway located on the south side of E Grand Blvd in between an empty lot, a house at 1904 E Grand Blvd, and a parking lot on the corner of Elmwood and E Grand Blvd.

Looking northeast along greenway at 5 discrete sample A locations.

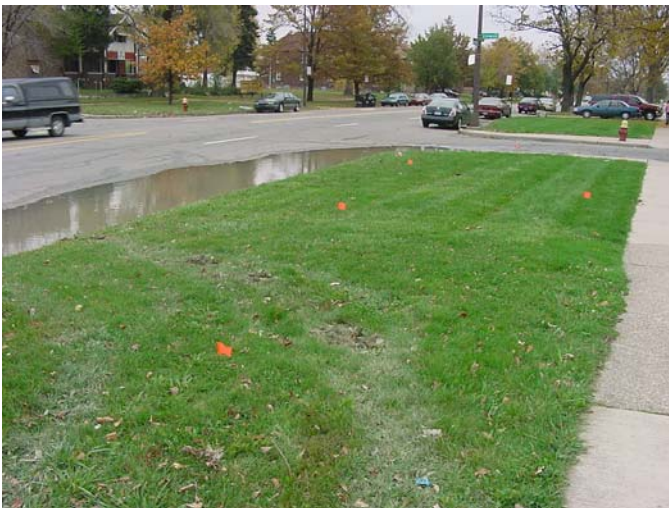
Looking southeast along greenway at 5 discrete sample B locations.

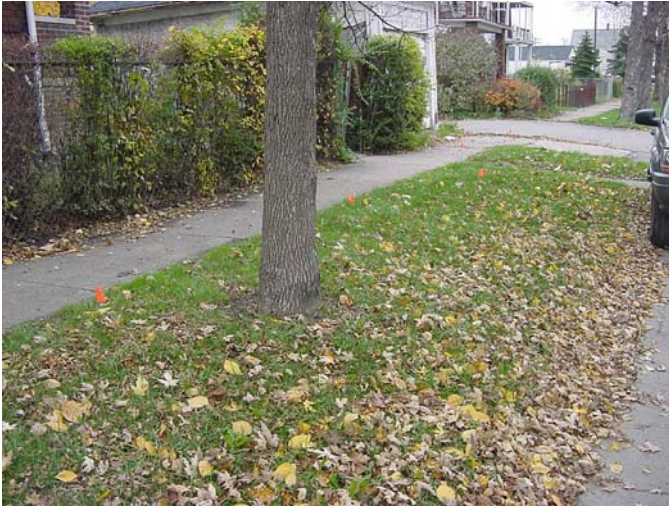
1998 E Grand Blvd – Greenway on the corner of Medbury St and E Grand Blvd. It is located on the north side of Medbury St and to the south side of the house at 1998 E Grand Blvd.

Looking northeast along greenway at 5 discrete sample A locations.

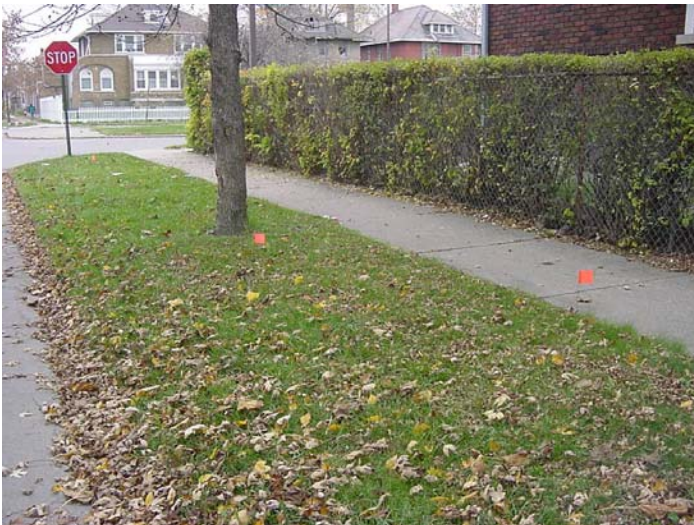
Looking northwest along greenway at 5 discrete sample B locations.

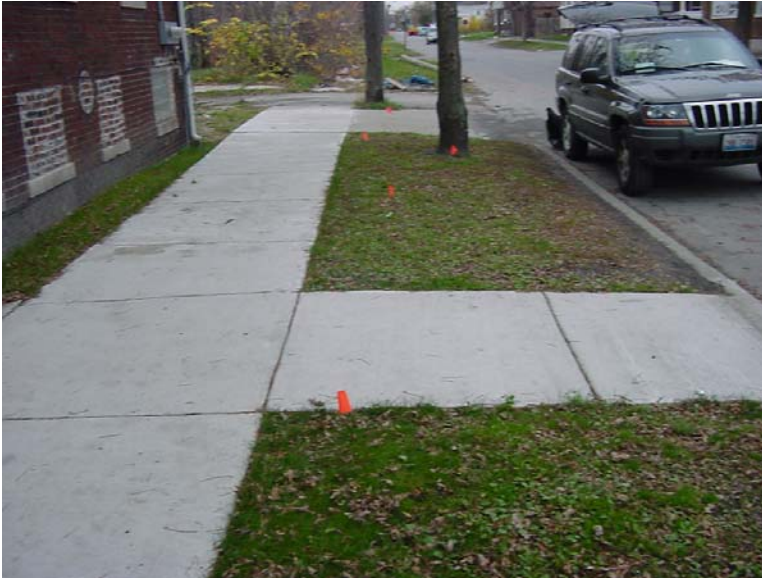
3030 Medbury – Greenway located on the south side of Medbury St and to the south side of the house at 3030 Medbury.

Looking west along greenway at 5 discrete sample A locations.

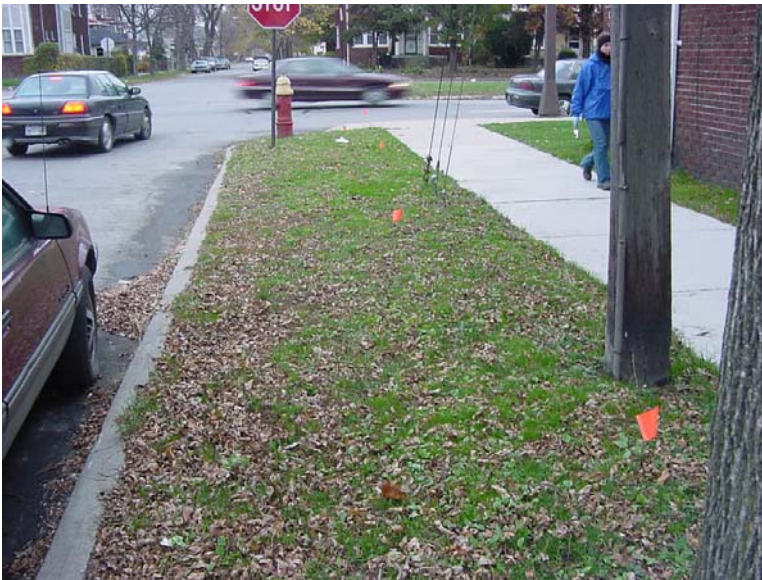
Looking east along greenway at 5 discrete sample B locations.

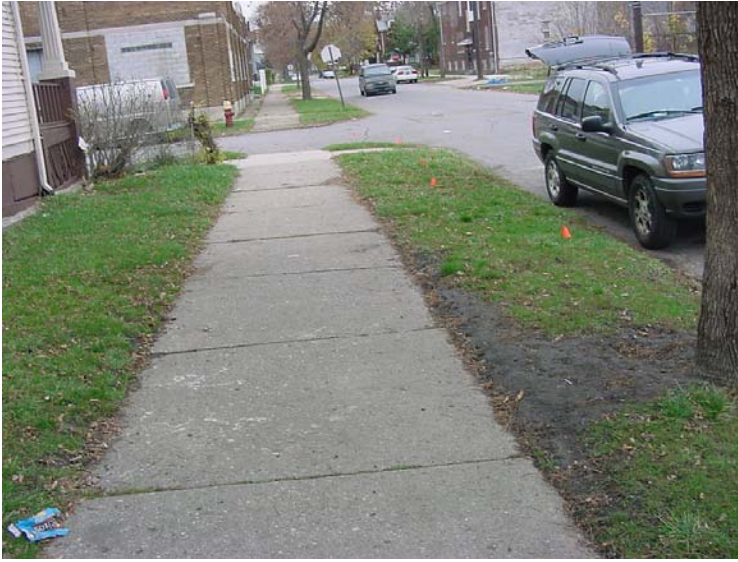
5901 Mitchell – Greenway on the corner of Mitchell St and Medbury St. It is located on the north side of Medbury St and to the south side of the house at 5901 Mitchell.

Looking east along greenway at 5 discrete sample A locations.

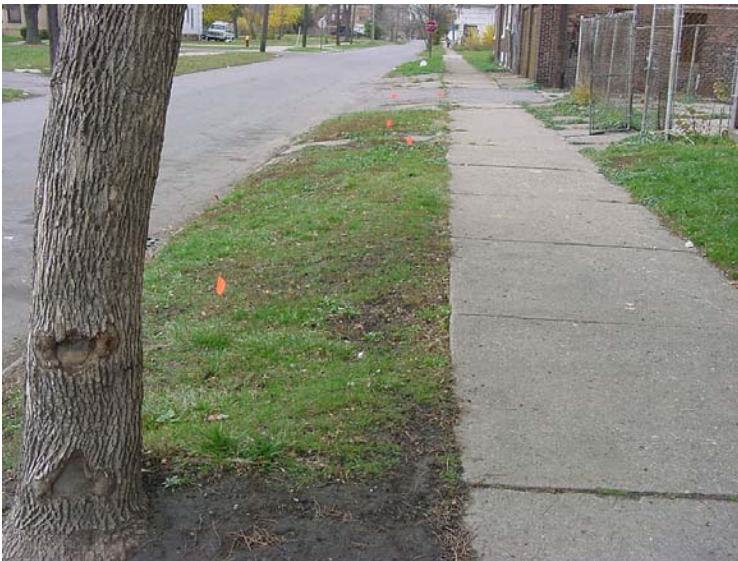
Looking west along greenway at 5 discrete sample B locations.

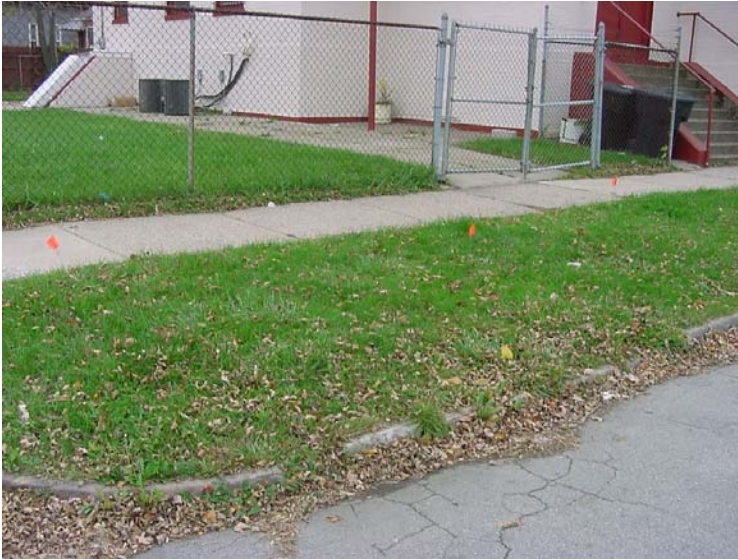
2918 Hendrie – Greenway on the corner of Hendrie St and Joseph Campau St. It is located on the south side of Hendrie St and to the north side of a church at 2918 Hendrie.

Looking southwest along greenway at 5 discrete sample A locations.

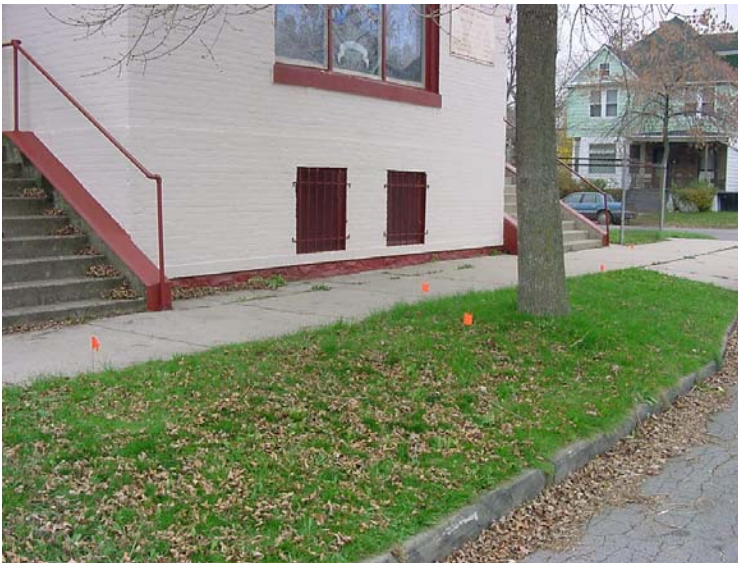
Looking southwest along greenway at 5 discrete sample B locations.

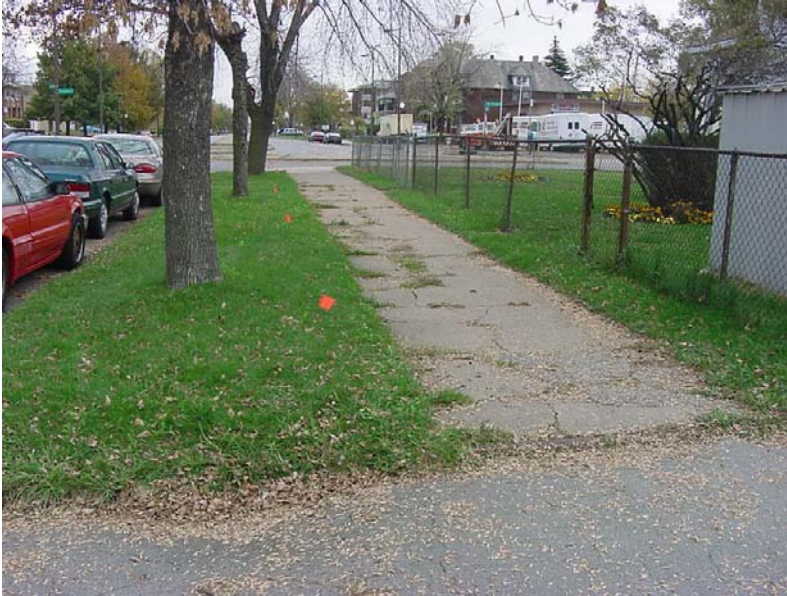
1945 E Grand Blvd – Greenway on the corner of Hendrie St and E Grand Blvd. It is located on the south side of Hendrie St and to the north side of a house at 1945 E Grand Blvd and an empty lot (lot directly west of house; house and lot are separated by an alley).

Looking west along greenway at 5 discrete sample A locations.

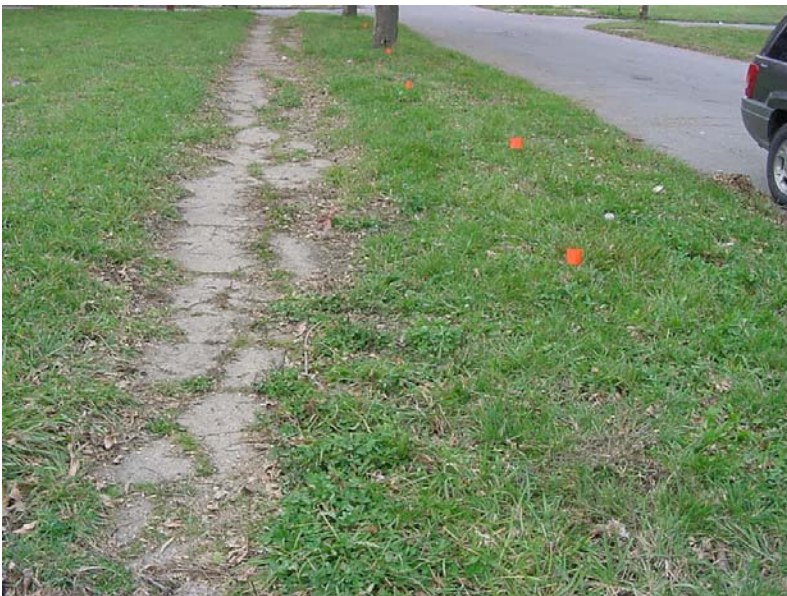
Looking east along greenway at 5 discrete sample B locations.

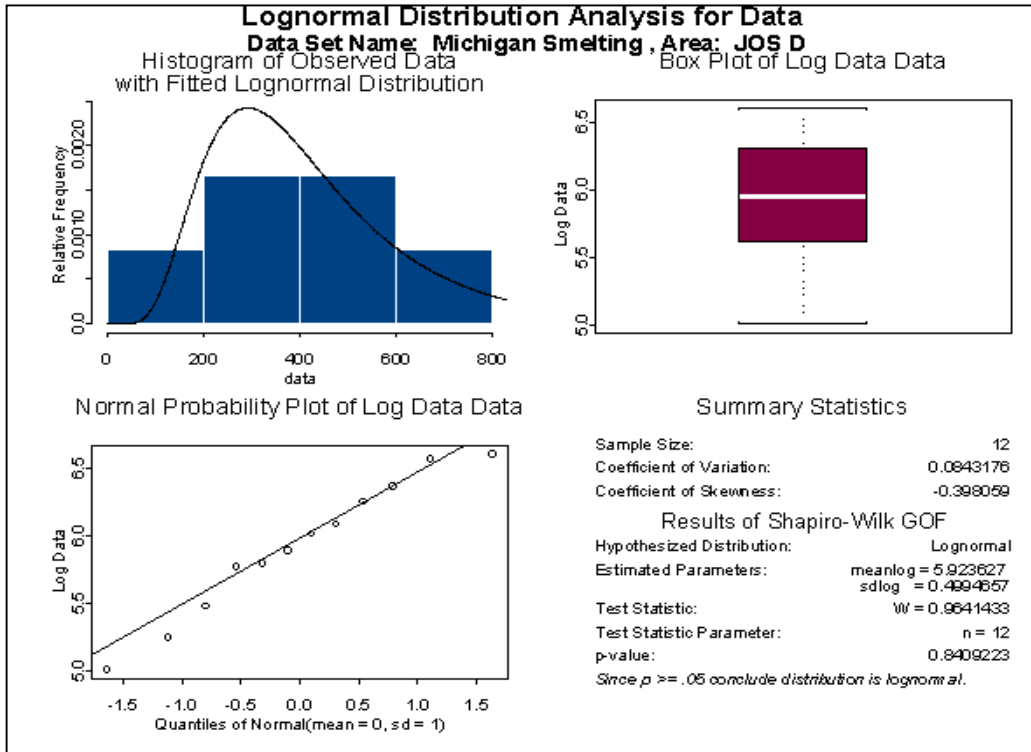
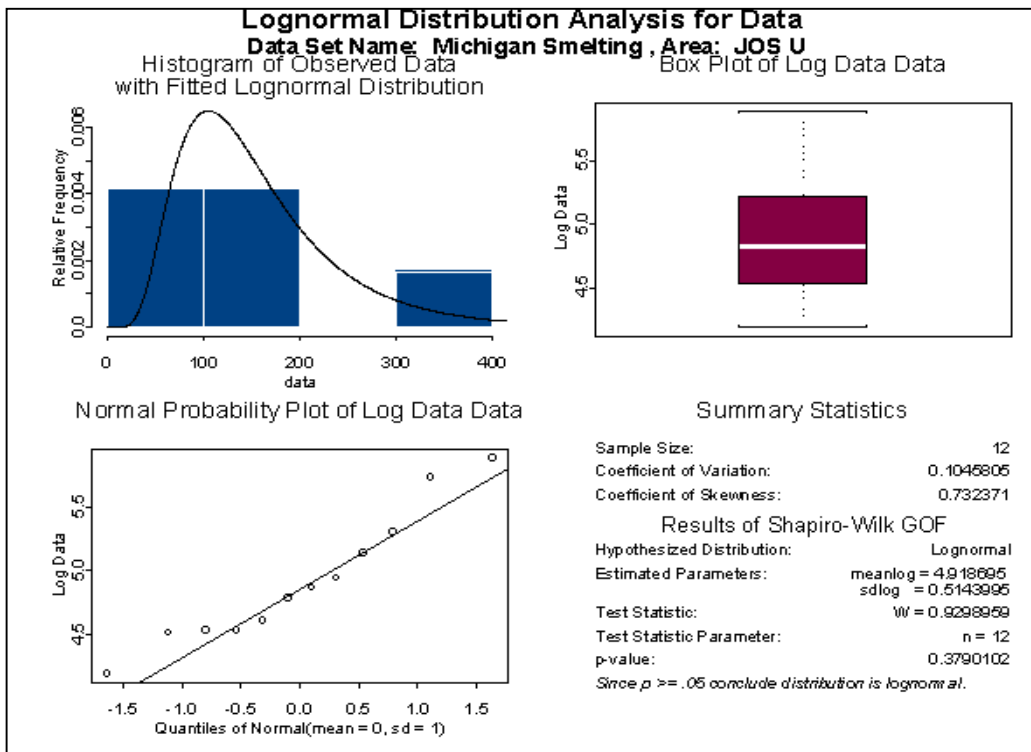
MICHIGAN SMELTING STATISTICAL DISTRIBUTION

Analytical data was entered into a spreadsheet file and differentiated as downwind and upwind samples, then processed using the MDEQ online statistical interface for Part 201 evaluations. As shown on the distribution analysis figures included in **Attachment F** the downwind logmean is 5.9 mg/kg and the upwind logmean is 4.9 mg/kg indicating the downwind concentrations are greater than the upwind concentration. In addition the relative frequency histogram (**Attachment F**) for the downwind data shows a larger variation across the sample set than the upwind which contains a more even distribution relative to the lognormal curve. Comparison of the upwind and downwind data sets indicates the lead concentrations are sufficiently different from each other both in mean concentration and distribution to conclude that the data represent separate conditions.
