**Clean Michigan Initiative  
Non-Point Source Grant**  
Tracking Code 2000-0137

## Carrier Creek Restoration – CMI I

July 27, 2001 thru December 31, 2004

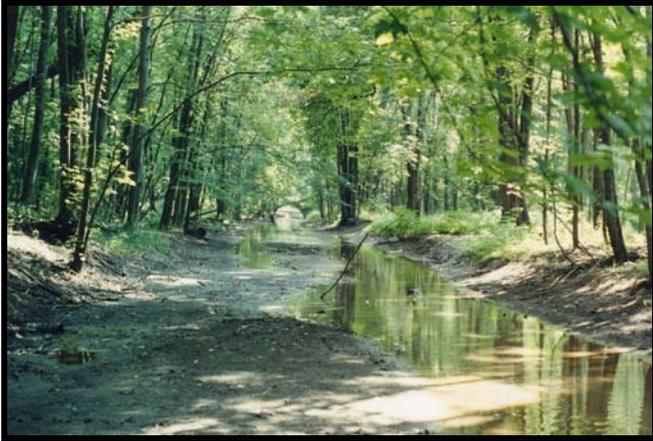
**Before:** The stream channel was significantly over dredged and inefficient at transporting sediment. Water was stagnant and there was no defined low-flow channel.

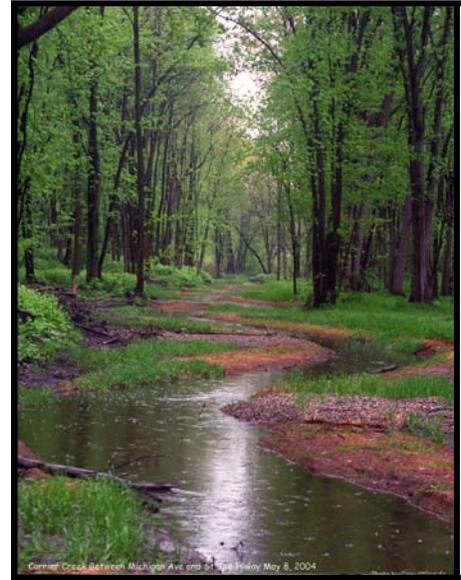
**After:** The new channel has appropriate width to depth ratio for transport of water and sediment. Meanders help dissipate energy. The floodplain is accessible and dissipates erosion energy at high flow.

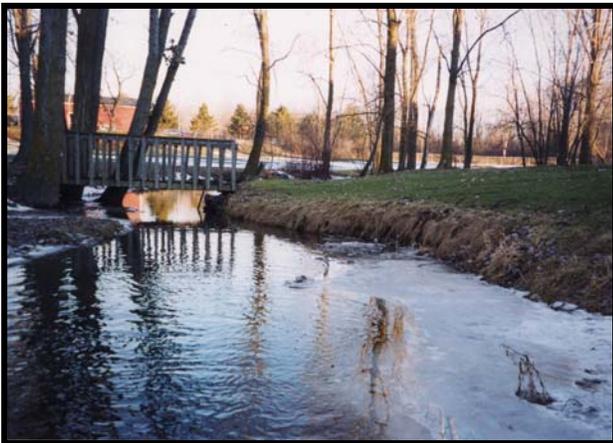
**Before:** The channel was too wide, with sediment deposition in center. Bank erosion was a problem.

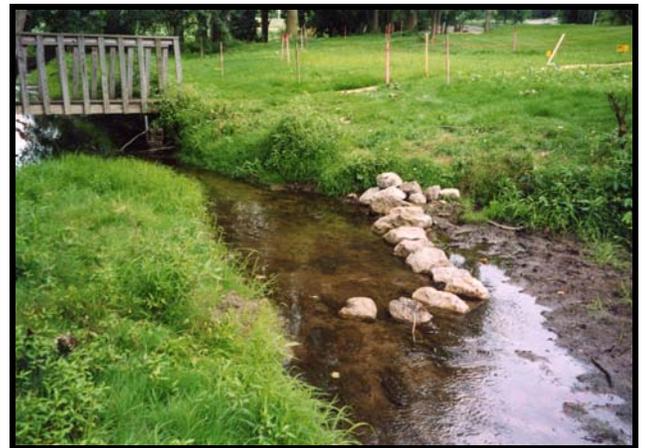
**After:** A J-hook directs flow away from streambank toward the center of the channel. Sediment is deposited behind the structure, stabilizing the bank and narrowing the stream.
