**Clean Michigan Initiative
Nonpoint Source Grant**
1999-0040

Cedar River Road Crossings Project

August 31, 2000 through December 31, 2001

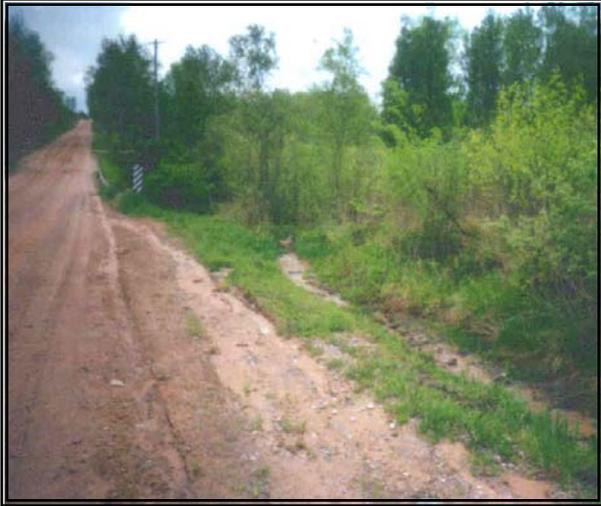
Site 2 Before:

Runoff from the dirt road and the road sides was washing into the river at the stream crossing. The crossing is located at the low point on the road, which increased the flow of the runoff.

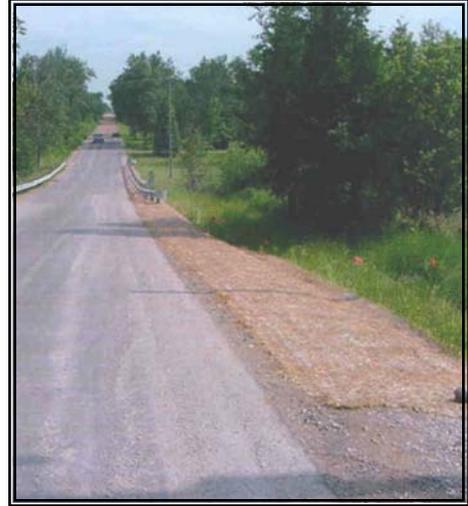
Site 2 After:

Runoff was decreased by raising the level of the road, paving 925 feet of road along the crossing, and installing a 500-foot spillway to direct water off the road. Plantings and check dams were also installed.

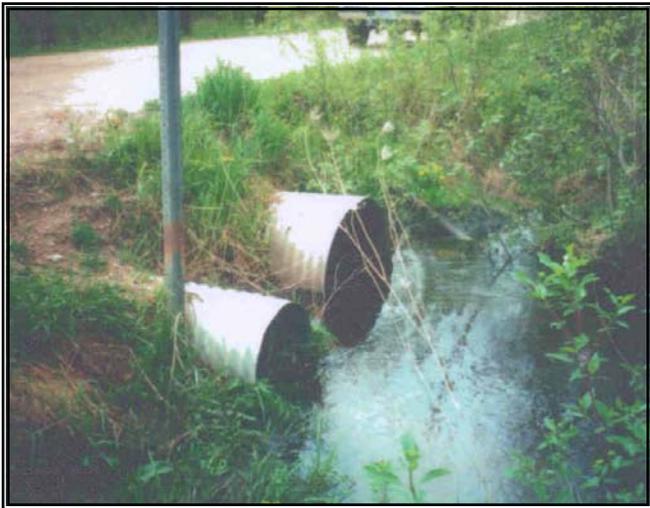
Site 5 Before:

Similar to Site 2 above, this crossing was experiencing excessive sedimentation into the river. This site was also located at a low point on the road.

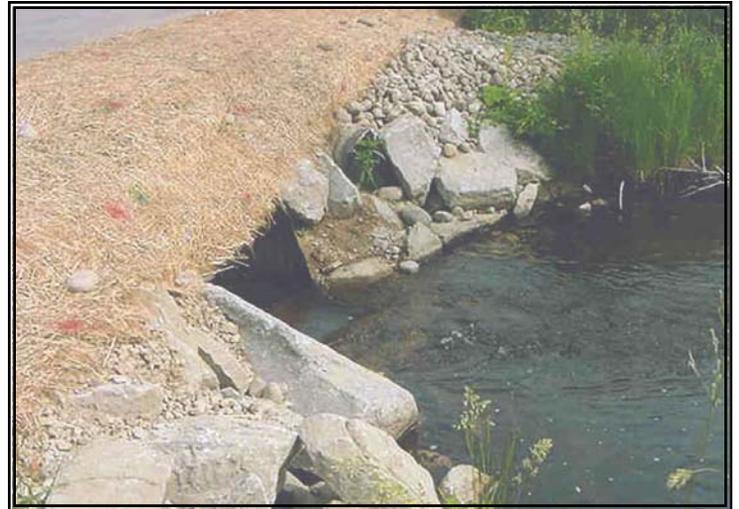
Site 5 After:

Runoff was decreased by raising the level of the road, paving 400 feet of road along the crossing, and installing a 100-foot spillway. Plantings and check dams were also installed.
