**Clean Michigan Initiative  
Nonpoint Source Grant**  
2000-0200

## Iron River Watershed Project

July 10, 2001-October 31, 2004

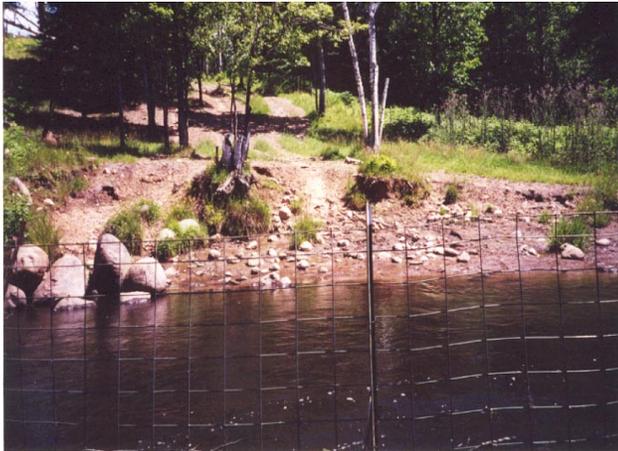
**Olsen Before:**

Erosion from livestock access had caused stream bank erosion.

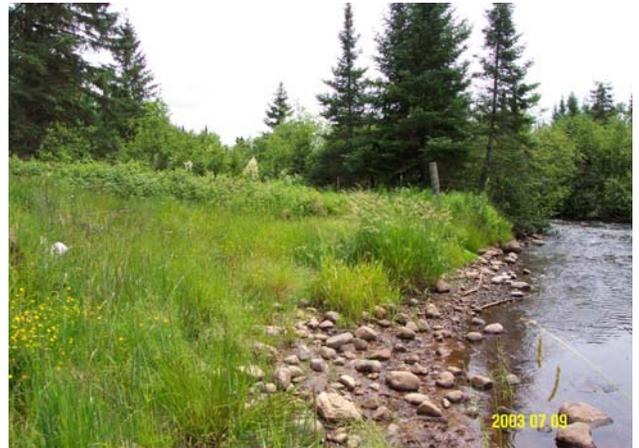
**Olsen After:**

80 linear feet of stream bank was revegetated using soft engineering and restored to a more natural state. A 19,200 square foot riparian buffer was established to filter pollutants and keep them from reaching the river.

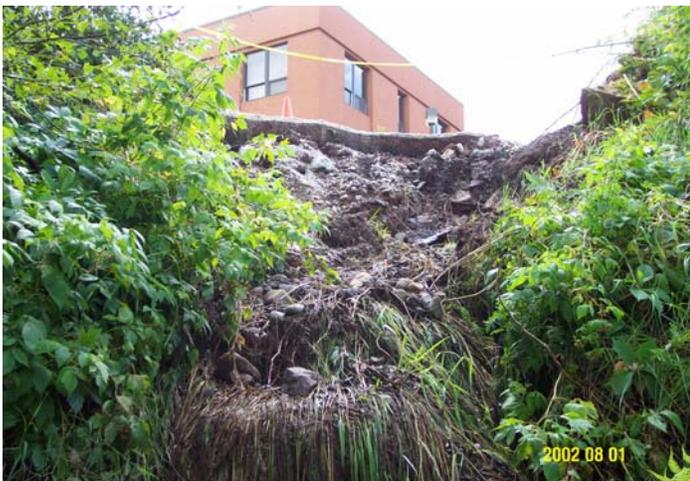
**ORV ACE Trail Washout Before:**

The ORV ACE trail experienced a massive washout in which more than half of the trail was swept away down this hill toward the river.

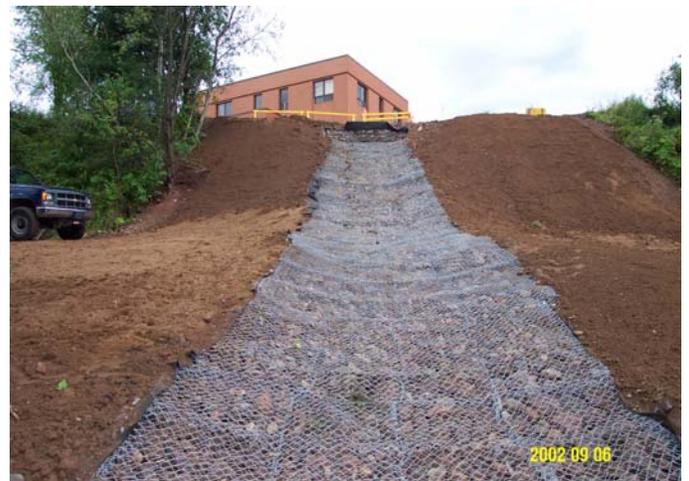
**ORV ACE Trail Washout After:**

An 84 linear foot storm water conveyance channel was installed to reduce erosion. A curb system was installed to direct flow into the storm water conveyance channel.
