**Federal Clean Water
Section 319 Grant**
2002-0060

Sebewaing River Watershed Tillage & Cover Crop I&E Project

September 15, 2002 through June 30, 2005

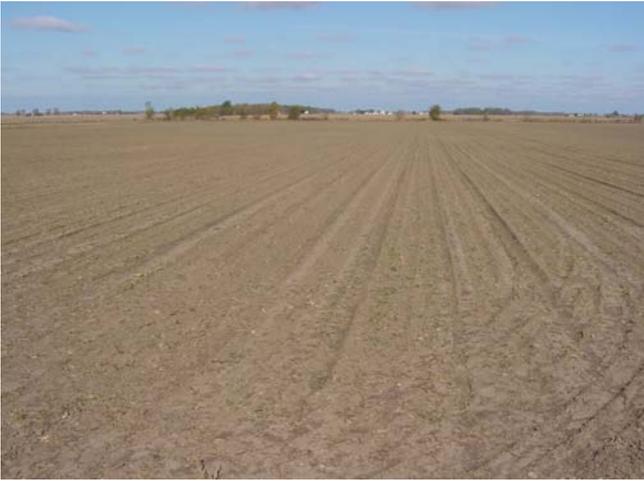
McNeil Tillage Demonstration Site Before:

A typical sugar beet field after harvest in the Sebewaing River Watershed is left with no residue to protect the soil from wind and water erosion over the winter months. This site has drains on three sides.

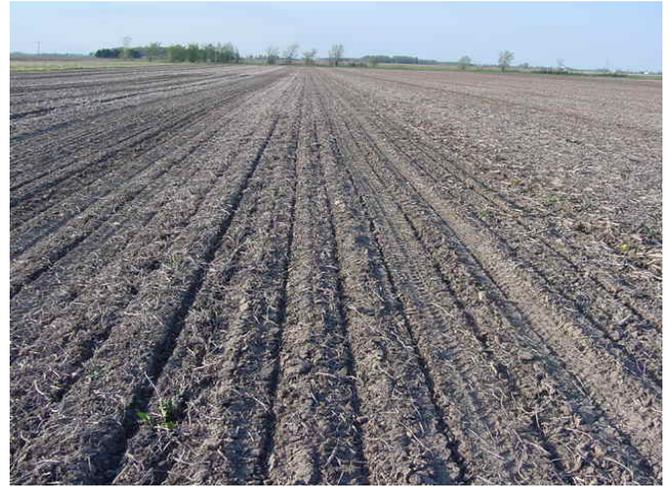
McNeil Tillage Demonstration Site After:

Randomized and Replicated Strips have been established on this site to compare conventional and zone tillage. The photo shows corn stalk residue left over winter to provide protection. The zone-built strips have been installed and in the spring planting will be done directly over these slots without additional tillage.

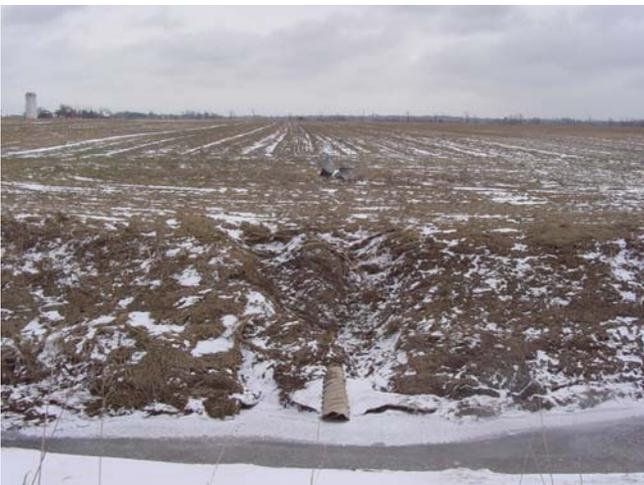
A typical fall plowed field in the watershed. This field is prone to wind and water erosion. The proximity to the drain leads to sediment and nutrient loading.

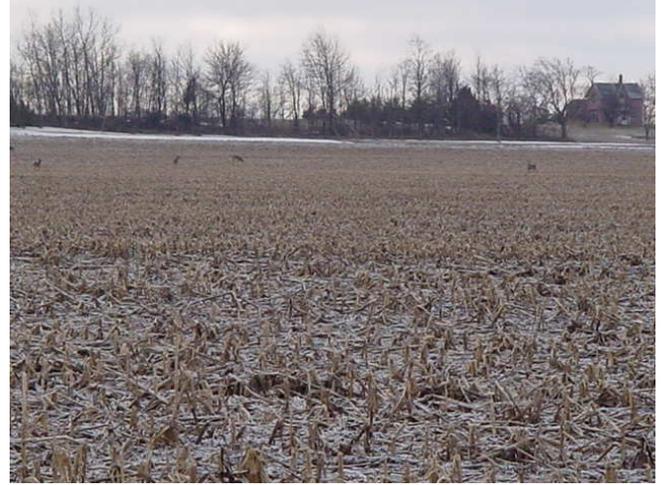
Corn stalk residue left in place over winter reduces wind and water erosion and sediment and nutrient deposition. Corn stalks also provide wildlife cover and a winter food source.
