Title: Cass River and Saginaw Bay Watershed Livestock Exclusion

Title: Iron River Livestock Exclusion Project

Title: Carrier Creek Restoration Project

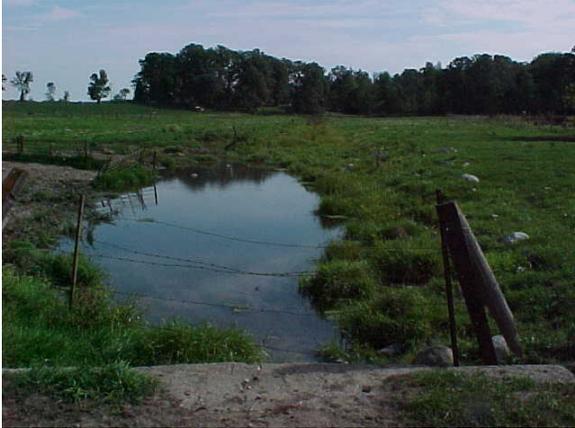
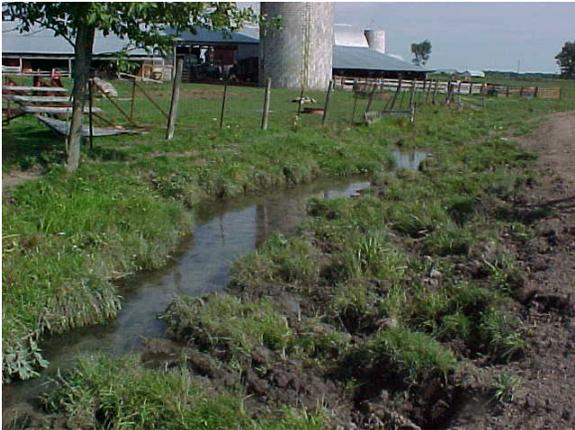
Before BMP installation

Problem: Carrow Creek is a tributary to the Cass River, in Sanilac County. Much of the Cass River watershed is rural, and in 1996 MDEQ surveys identified 44 eroding livestock access sites throughout the watershed, including 29 sites that were considered to be severely degraded. Excessive sedimentation negatively impacted instream habitat and the resident fish and macroinvertebrate populations.

One of the 29 severely degraded sites was on the Schunk dairy farm, on Carrow Creek. The CMI-NPS grant spent \$26,870 to install one alternate water source for cattle and three livestock crossings on the farm. This work was completed in June of 2002. Pre-BMP monitoring was performed in September 2001, and post-BMP monitoring was performed in September 2004. All monitoring was supported by Section 319 funds.

Results: Pre- and post-BMP photographs suggested that the BMPs described above improved riparian and instream habitat conditions in this reach of Carrow Creek (photographs, below), and biological monitoring conducted before and after the BMPs were installed confirmed their effectiveness (Tables 1, 2 and 3). Aquatic and riparian habitat features related to bank erosion and sedimentation improved substantially after BMP installation, and this improved habitat was

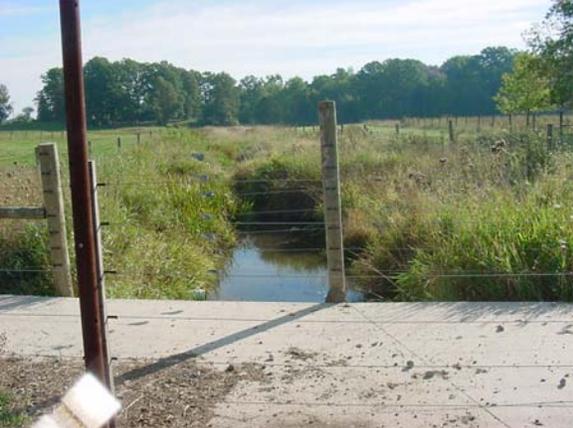
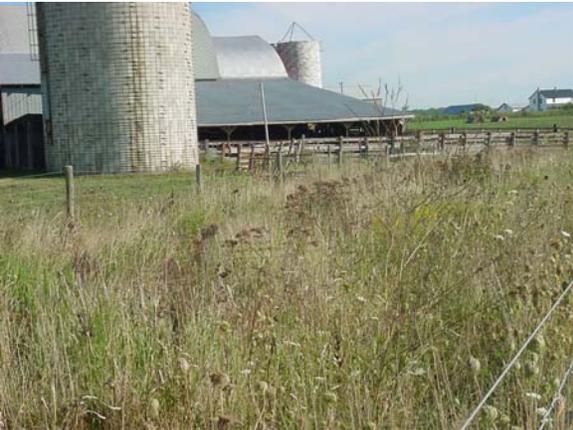
After BMP installation

reflected in the biological data. While the total number of fish and the number of fish species in the sampled reach of this very small stream did not increase substantially, the dominant fish changed from a species tolerant of turbid water, silty sediments and low dissolved oxygen concentrations (central mudminnow) to two species that prefer clear water, stable stream bottoms and higher dissolved oxygen concentrations (creek chub and brook stickleback). Similarly, the total number of macroinvertebrate taxa did not change with BMP installation, but the composition shifted from taxa tolerant of poor water quality to more sensitive taxa (mayflies, caddisflies, and stoneflies).

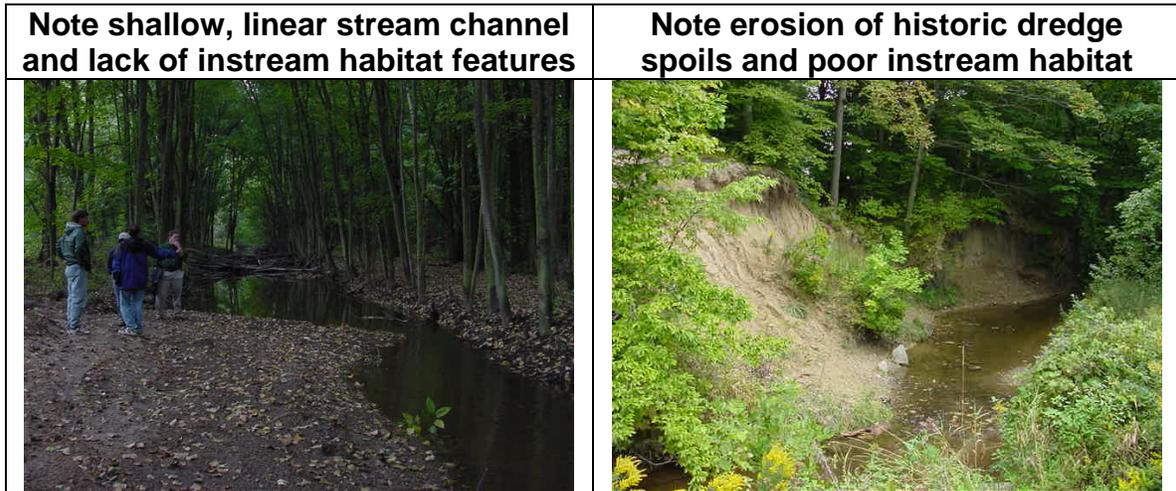
Figure 1. Pre-BMP Pictures of Carrier Creek.

Carrier Creek is a designated drain in a rapidly developing area near Lansing, Michigan. Historic channelization and more recent urban runoff resulted in eroding stream banks, high sedimentation rates, and degraded aquatic habitat and fish and macroinvertebrate communities. Extensive stream restoration and storm water retention activities were initiated in 2001, and the latter are still underway today. Consequently, this is an interim report on the performance of this still-developing project.

Carrier Creek, in Eaton County, Michigan, is a tributary to the Grand River. Four miles of the creek are on Michigan's 303(d) list due to degraded macroinvertebrate communities, caused by urban runoff, poor instream habitat and excessive sedimentation.

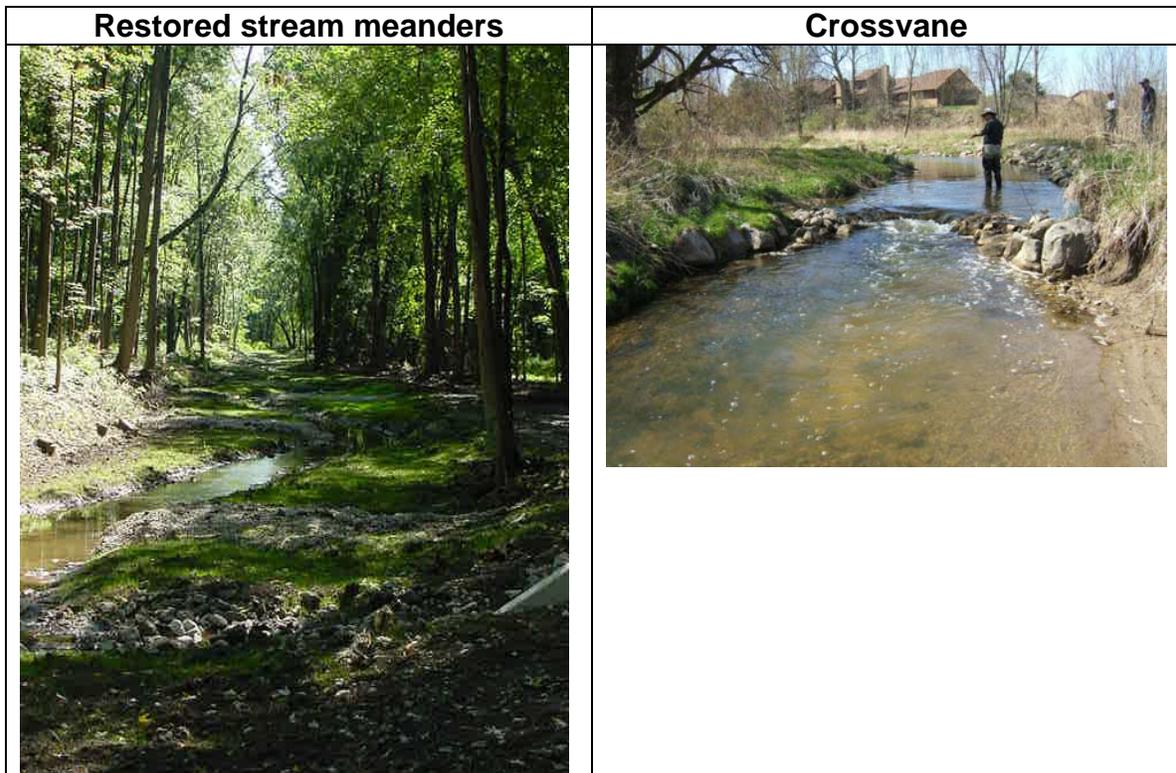
Figure 2a. Post-BMP Pictures of Carrier Creek.

Several types of stream stabilization BMPs were installed. At the upstream end the channel was narrowed and stream "pattern" was reestablished with meander structures, which are semicircles of stone placed up to the bankfull elevation and alternating from one side of the bank to the other. Throughout most of the rest of the restored reach various structures were installed to stabilize the channel, including crossvanes, J-hooks, lunkers, log revetments and riprap. At points where historical dredge spoils on the bank were separating the stream from the natural floodplain, parts of the dredge spoils were removed. Finally, a segment of the lower reach of the creek was totally reconstructed to provide a stable pattern, cross section and slope.

Also, a single slippershell mussel (*Alasmodonta viridis*) was found during an informal inspection of the restored reach in 2007 (Figure 2). The slippershell is listed as a Species of Special Concern by the Michigan Natural Features Inventory.

The restoration activities conducted to date, both those funded by the MDEQ and those executed independently by the Drain Commissioner, are believed to have stabilized the stream channel and its hydrology, reduced stream bank erosion, and improved aquatic habitat. Fish and macroinvertebrate communities are beginning to respond, and future monitoring will hopefully show further improvements in the biota.
