MICHIGAN DEPARTMENT OF ENVIRONMENTAL QUALITY
WATER RESOURCES DIVISION
APRIL 2013

STAFF REPORT

A BIOLOGICAL SURVEY OF THE PERE MARQUETTE RIVER
AND LINCOLN RIVER WATERSHEDS
NEWAYGO, LAKE, OCEANA, AND MASON COUNTIES, MICHIGAN
JULY, AUGUST, AND SEPTEMBER 2010

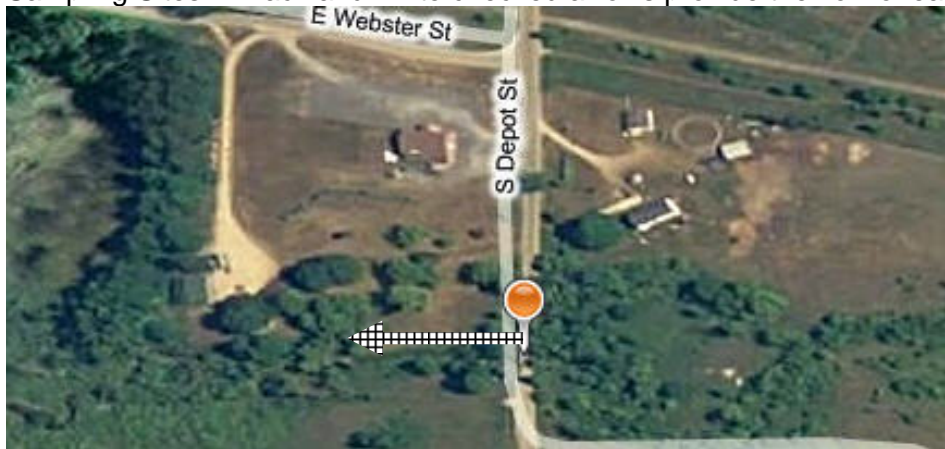
Middle Branch Pere Marquette River at Depot Street (Station 1).

Habitat: Good; Macroinvertebrates: Acceptable

Visual Assessment: Open water is not visible due to canopy cover or low flow/water levels while channel sinuosity is apparent further west.

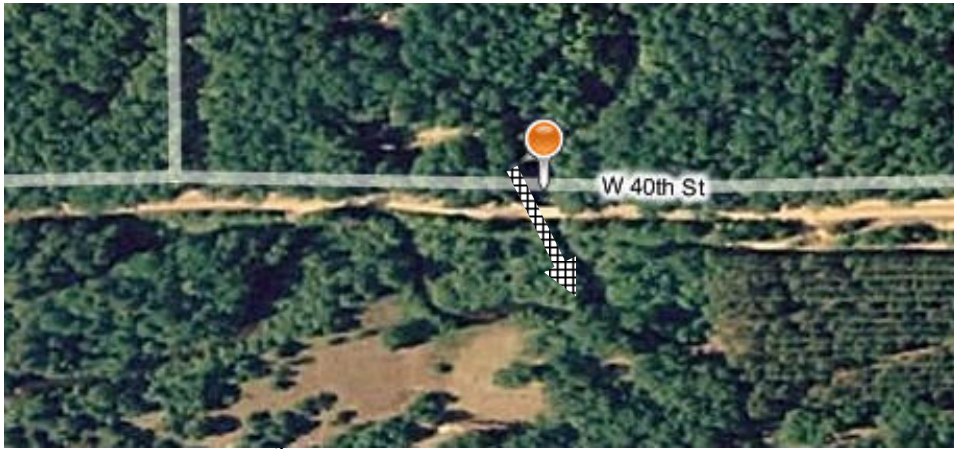
Baldwin River at 40th Street (Station 4).

Habitat: Good; Macroinvertebrates: Excellent

Visual Assessment: This portion of the river has good channel sinuosity with forested cover surrounding the water body, which provides a thick canopy and shades the water body. In effect the temperature of the water cools and the dissolved oxygen increases in the water.

In addition, the Baldwin River and Sanborn Creek should be assessed downstream from the culverts that were removed in 2011 to monitor potential improvement. Culverts tend to back up water bodies above a culvert thereby creating an impoundment, decreasing dissolved oxygen, increasing the temperature, and creating a more stagnant system. Below a culvert, the flow tends to be higher due to the constriction of the culvert speeding up the velocity and creating deep pools below the culvert due to erosion. Improvements in habitat and macroinvertebrate scores would be anticipated in these two streams. Some additional areas to sample in future surveys include Lichte Creek and India Creek due to dense agriculture as well as water bodies surrounding Scottville due to high intensity development.

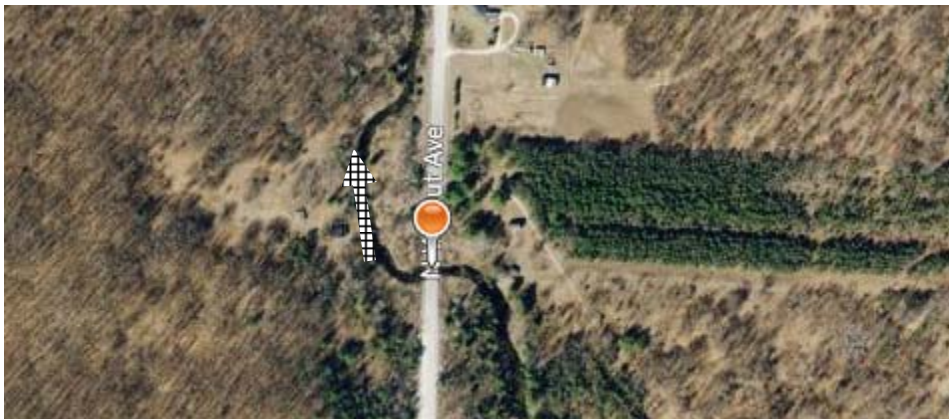
Little South Branch Pere Marquette River at Walnut Avenue (Station 5).

Habitat: Excellent; Macroinvertebrates: Excellent

Visual Assessment: Excellent, natural channel sinuosity is present with good forest habitat surrounding it. There is not any apparent channelization providing natural flows of water and sediment in the system.

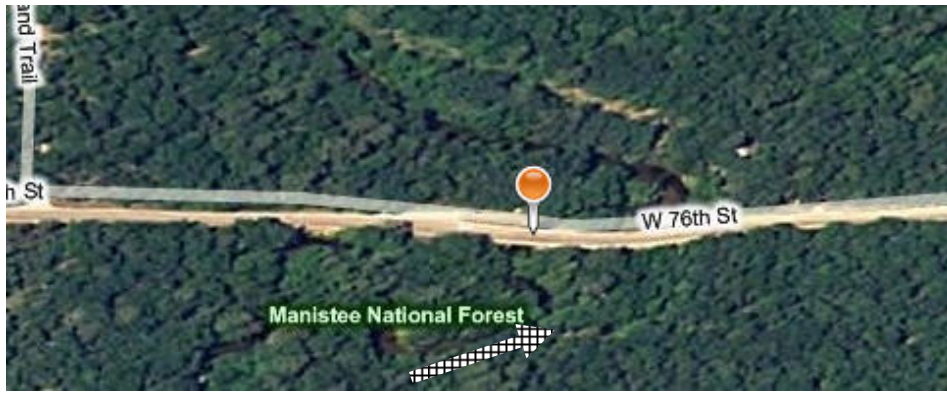
Little South Branch Pere Marquette River at 76th Street (Station 7).

Habitat: Excellent; Macroinvertebrates: Excellent

Visual Assessment: This portion of the river flows through the Manistee National Forest area providing a thick canopy leading to shaded/cooler water. The forested area provides fallen trees in the river over time leading to additional habitat.

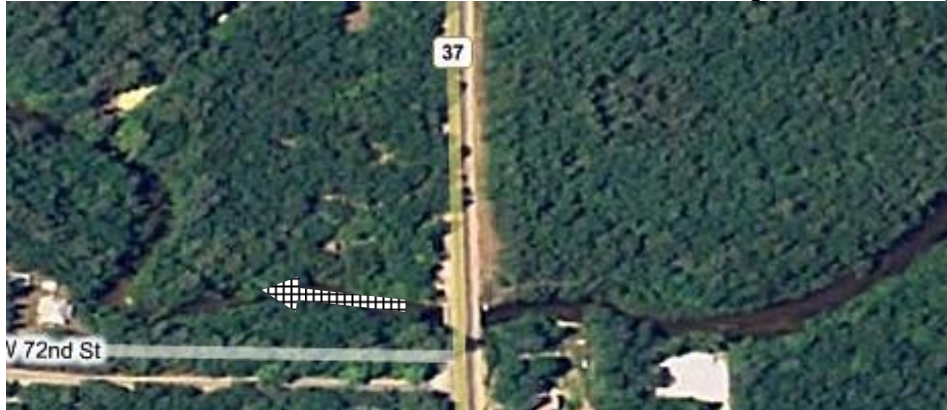
Pere Marquette River at M-37 (Station 9).

Habitat: Excellent; Macroinvertebrates: Excellent

Visual Assessment: This portion of the river has very high canopy coverage. The shade from the trees provides cooler water temperatures and provides habitat from fallen trees in the channel. There is apparent channel sinuosity and no obvious signs of impairment to the stream aside from the road crossing.

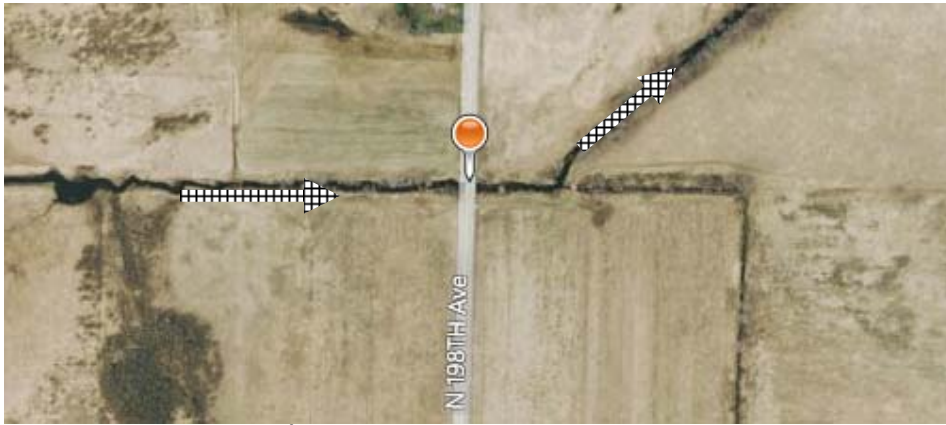
Beaver Creek at 198th Avenue (Station 10).

Habitat: Good; Macroinvertebrates: Acceptable

Visual Assessment: This portion of the creek is extremely channelized. The water body flows through an agricultural area with no apparent buffer strips to trap flowing sediments from the agriculture fields. The system appears to have been manipulated and possibly moved over the years to provide square agricultural fields.

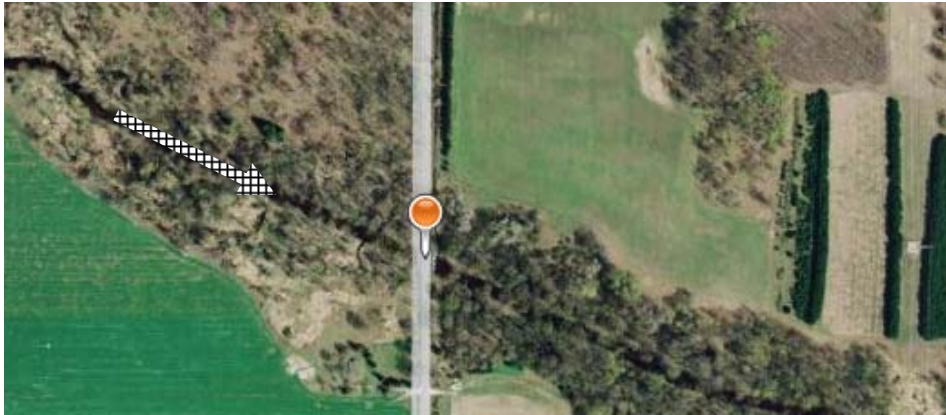
Beaver Creek at Comstock Avenue (Station 11).

Habitat: Marginal; Macroinvertebrates: Acceptable

Visual Assessment: This portion of the creek is channelized through an agricultural area and is not the natural channel. The channel has been manipulated and straightened removing sinuosity; however, the channel does have buffer strips on either side to help with sedimentation into the creek.

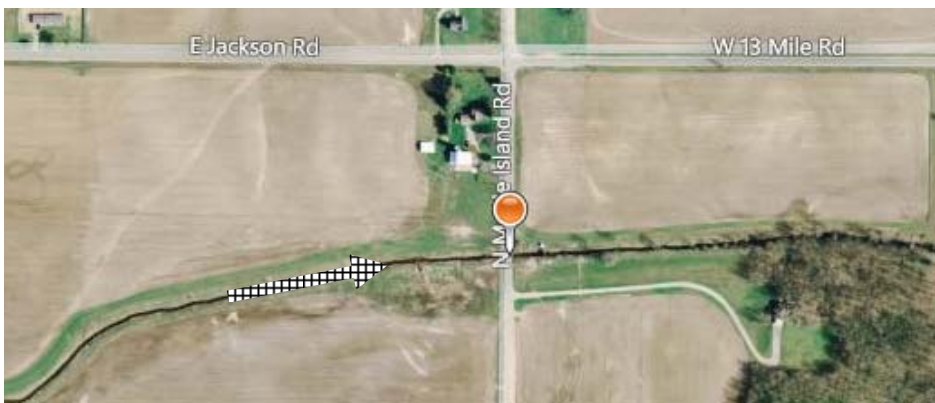
Freeman Creek at Maple Island Avenue (Station 12).

Habitat: Marginal; Macroinvertebrates: Acceptable

Visual Assessment: The creek is channelized through an agricultural area creating an unnatural channel, decreasing sinuosity, and changing the flow of the creek. There are minimal buffer strips on either side of the channel to aid in trapping loose sediments.

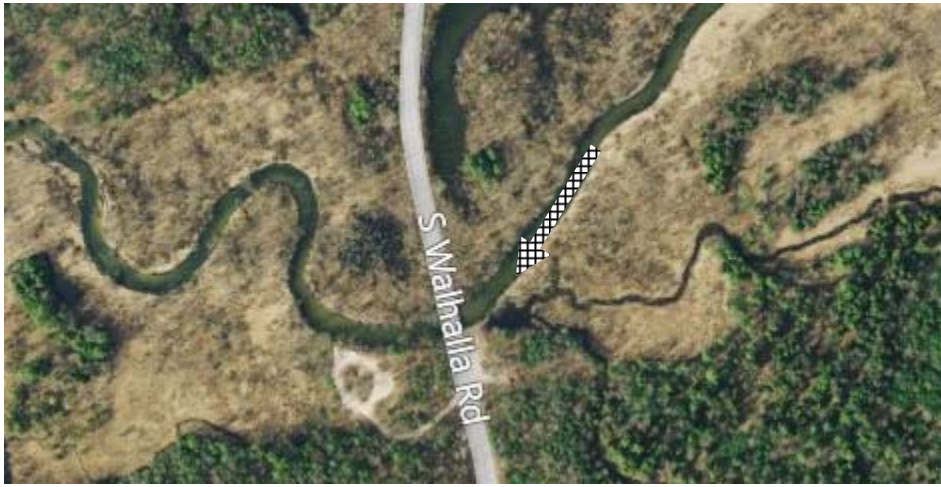
Pere Marquette River at Walhalla Road (Station 13).

Habitat: Excellent; Macroinvertebrates: Excellent

Visual Assessment: This portion of the river has excellent habitat heterogeneity. There is natural channel sinuosity providing for natural flow in the system along with vegetation along the channel. In addition, there is a feeder stream bringing an input of dissolved oxygen into the system and increasing the system for habitat and macroinvertebrate communities.

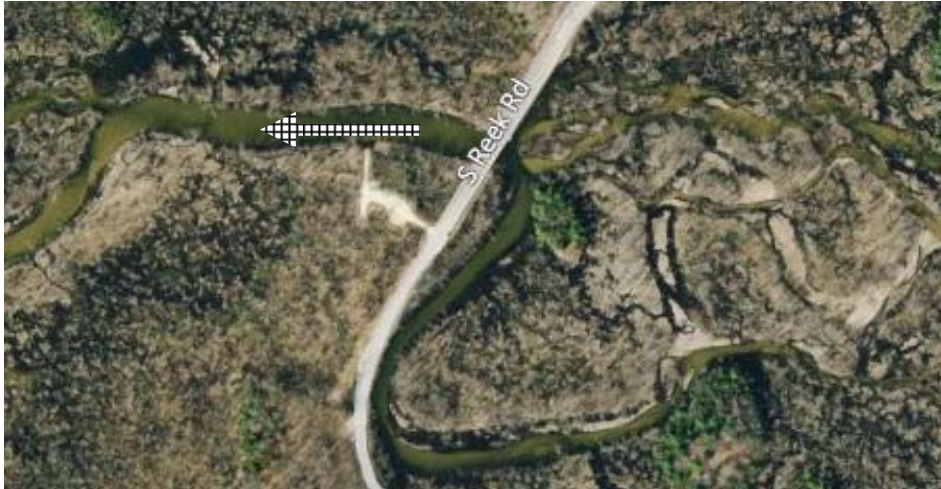
Pere Marquette River at Reek Road (Station 14).

Habitat: Good; Macroinvertebrates: Excellent

Visual Assessment: This portion of the stream has excellent habitat heterogeneity for macroinvertebrates due to forested cover, wetland vegetation, and shoreline vegetation to prevent sedimentation. The channel has natural sinuosity and various different habitats to support various types of wildlife.

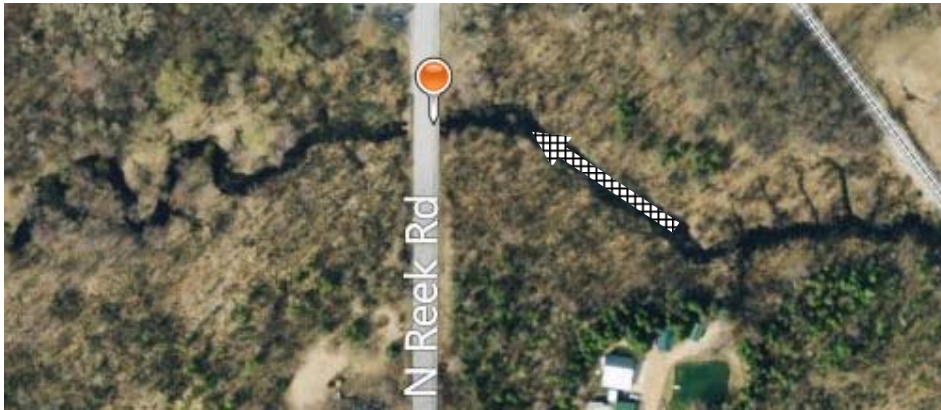
North Branch Lincoln River at Reek Road (Station 15).

Habitat: Good; Macroinvertebrates: Excellent

Visual Assessment: This stream has excellent habitat heterogeneity for macroinvertebrates between forested areas, wetland areas, and shoreline vegetation. There is channel sinuosity throughout this stretch of river allowing natural flows of water and sediment through the area.

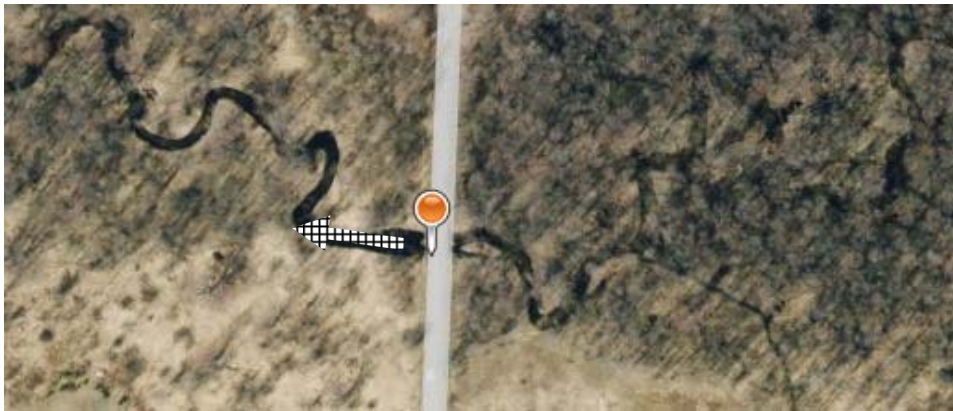
North Branch Lincoln River at Custer Road (Station 16).

Habitat: Good; Macroinvertebrates: Acceptable

Visual Assessment: This portion of the river has natural channel sinuosity and open water, but not much of a variety of habitats. There is some vegetation along the shoreline to prevent sedimentation.

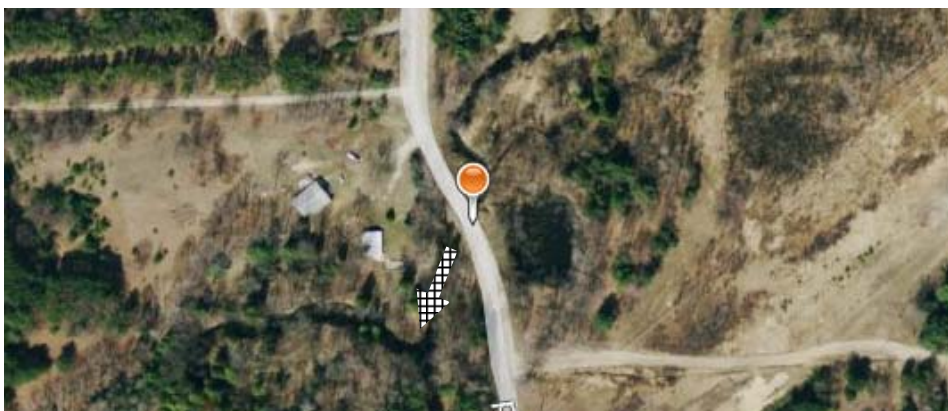
South Branch Lincoln River at Victory Road (Station 17).

Habitat: Good; Macroinvertebrates: Acceptable

Visual Assessment: This stretch of river shows impacts to the shoreline with clearing of vegetation therefore reducing habitat. There is natural channel sinuosity, but not much vegetation along the shoreline to provide habitat complexity.

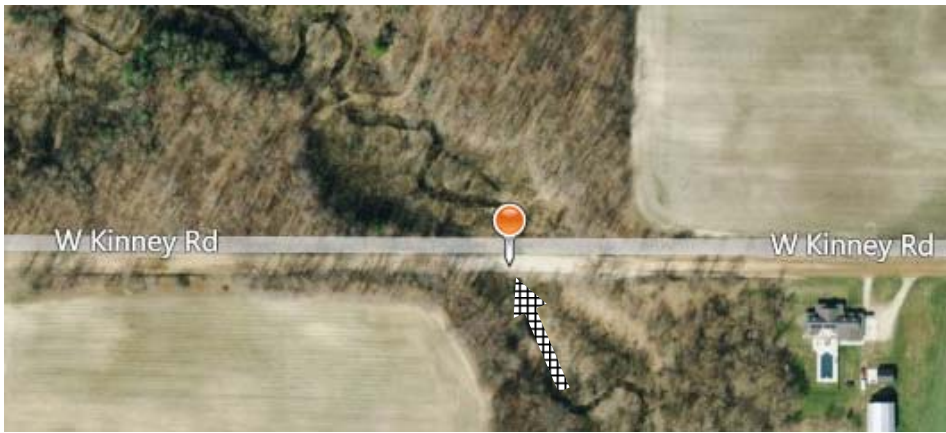
Swan Creek at Kinney Road (Station 18).

Habitat: Good; Macroinvertebrates: Acceptable

Visual Assessment: This stretch of the creek is near an agricultural field, which provides runoff of sediments and high nutrients in the system. There is natural channel sinuosity within this stretch; however, the accumulation of sediments from the agriculture fields could lead to reduced macroinvertebrate habitat.
