MICHIGAN DEPARTMENT OF ENVIRONMENTAL QUALITY
WATER RESOURCES DIVISION
APRIL 2012

STAFF REPORT

BIOLOGICAL SURVEY OF THE KEWEENAW WATERSHED GROUP
IN BARAGA, HOUGHTON, KEWEENAW, MARQUETTE AND ONTONAGON COUNTIES
JUNE AND AUGUST, 2011

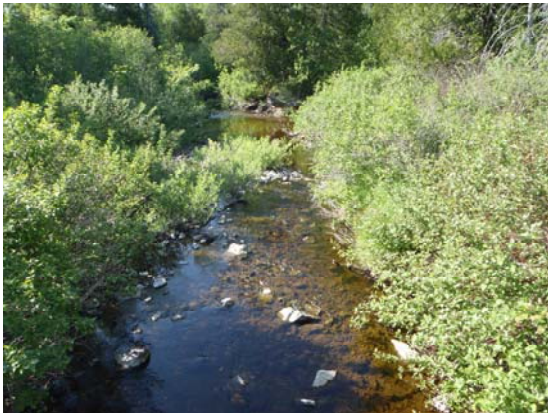
Figure 2. Trap Rock River below Lincoln School Road.

In 2011, the Trap Rock River was surveyed at Lincoln School Road (Station 2, Figure 2). Habitat quality rated excellent with all individual metrics ranking between good and excellent except channel flow status-flashiness which rated poor. This flashiness has obviously been a problem at this location since there was recent bank stabilization activity at the road crossing. Undercut banks, large woody debris and aquatic macrophytes were sparse with the absence of root wads within this reach. However there was a moderate amount of overhanging vegetation which was available for macroinvertebrate colonization which rated excellent at this location. There were 29 macroinvertebrate taxa identified of which

53 percent of the total individuals were made up of the taxa EPT.

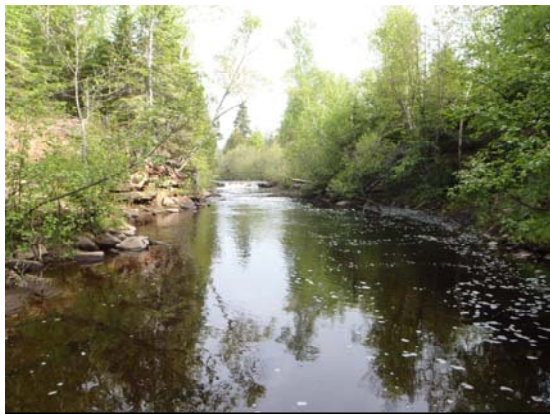
Figure 3. Tobacco River at Gay/Lac La Belle Road.

The Tobacco River was surveyed at Gay/Lac La Belle Road (Station 5, Figure 3) and was found to have excellent habitat assessment. All habitat parameters rated between excellent and good except for flashiness which rated poor due to bank scouring and lack of channel retention devices in the river. Overhanging vegetation and aquatic macrophytes were sparse within this reach with no undercut banks, large woody debris or rootwads to aid in macroinvertebrate colonization. The substrate at this location was dominated by bedrock with roughly 25 percent of the remaining substrates composed of boulder, cobble, gravel and sand. Macroinvertebrate communities were rated acceptable with 25 total taxa identified with the dominate orders composed of mayflies and

caddisflies consisting of over 63 percent of the total individuals in the sample.

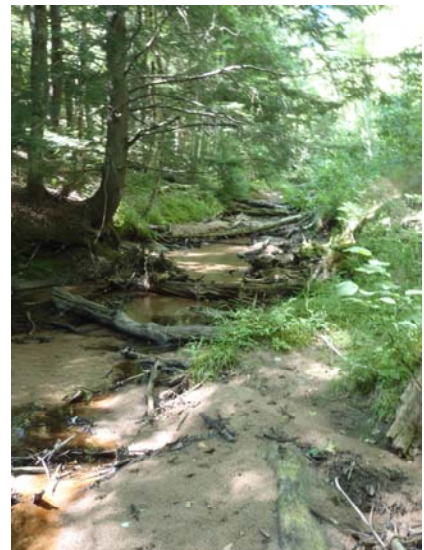
Figure 4. Lost Creek at County Road 510.

The habitat quality of Lost Creek at County Road 510 (Station 6, Figure 4) rated good even though a majority (6 of 11) of the metrics rated marginal and poor. Sediments were dominated by sand which was significantly increasing the formation of sand bars and substantially filling in all pools within this reach. During low water periods, the stream does not fill the available channel due to the heavy deposition of sediments. However, during high water events, the bank is moderately unstable presenting areas of high erosion potential and bedload transport downstream. In spite of these limitations and the sparse availability of undercut banks, aquatic macrophytes and absence of overhanging vegetation and rootwads, the macroinvertebrate community rated excellent. Excellent bank protection and depth regimes aided in the presence of 31 total taxa along with the extensive availability of large woody debris. Orders of EPT comprise 47 percent of the total individuals identified.

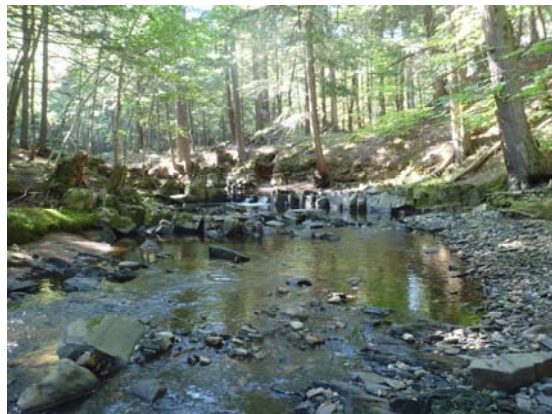
Figure 5. West Branch Huron River at Black Road.

The 2011 survey on the West Branch Huron River was conducted at Black Creek Road (Station 7, Figure 5) where the habitat quality rated excellent with all habitat parameters ranking in the excellent range. Large woody debris and aquatic macrophytes were sparse within this section with no undercut banks, overhanging vegetation or rootwads to add additional structure for macroinvertebrate colonization. The

macroinvertebrate community was also rated excellent at this site with 35 total taxa identified, including 5 mayfly, 8 caddisfly and 1 stonefly taxa.

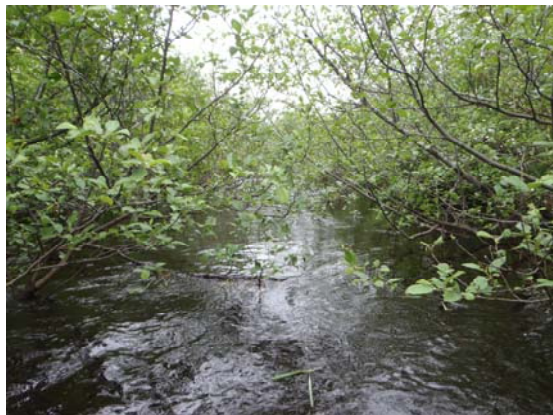
Figure 6. Yellow Dog River at Burma Trail #5/AAA Road.

The second site located at Burma Trail #5/AAA Road (Station 9, Figure 6) is several miles upstream from Station 6 and within the Kennecott Mine road construction area that was taking place throughout the summer. Habitat quality at this site rated good as metrics for epifaunal substrate/cover, pool substrate characterization, flashiness and channel sinuosity scored marginal. The reach was shaded mainly by alders along the riparian zone and the sediments were composed of sand and silt. Macroinvertebrate communities rated acceptable with no stoneflies identified at this location. However, over 52 percent of the total individuals were composed of caddisflies and mayflies.

Twenty-three total taxa were found inhabiting the extensive overhanging vegetation, moderate undercut banks and sparse availability of large woody debris and aquatic macrophytes.

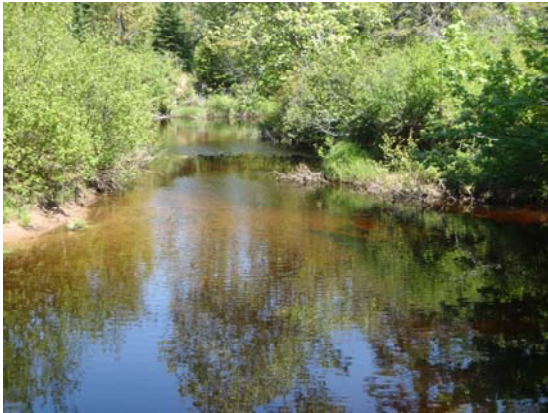
Figure 7. Montreal River off Mandan Road.

The Montreal River was surveyed off Mandan Road (Station A, Figure 7). The habitat rated excellent with only one parameter rating marginal, the remaining parameters ranged from excellent to good. Habitat availability was less than desirable with frequently disturbed substrates, additional structures which were available for colonization included moderate amounts of large woody debris; sparse undercut banks, overhanging vegetation and aquatic macrophytes with no rootwads present. Macroinvertebrate communities within this reach were rated acceptable with 25 total taxa identified at this location and dominated by EPT orders and chironomids, which made up 36 percent and

32 percent each of the total organisms identified, respectively.

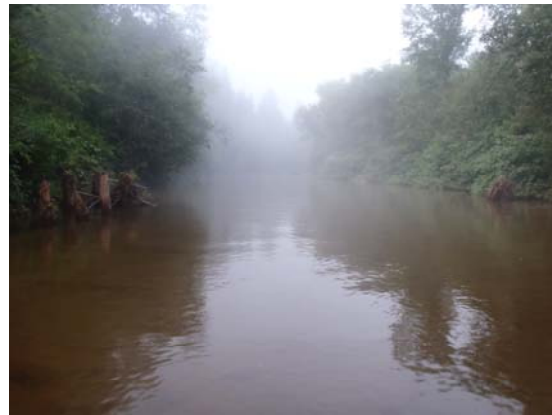
Figure 8. Otter Creek at Johnson & Cabbage Roads.

The Otter River at Johnson and Cabbage Roads (Station F, Figure 8) habitat assessment rated good. Four out of eleven parameters rated marginal or poor. Substrates were composed of sand and silt with sediment deposition assessed as the major problem at this location. Sparse to absent habitat availability and heavy deposits of fine material which have increased bar development has led to an acceptable macroinvertebrate community. Thirty-one macroinvertebrate taxa were collected of which 43 percent were composed of Brachycentrids.

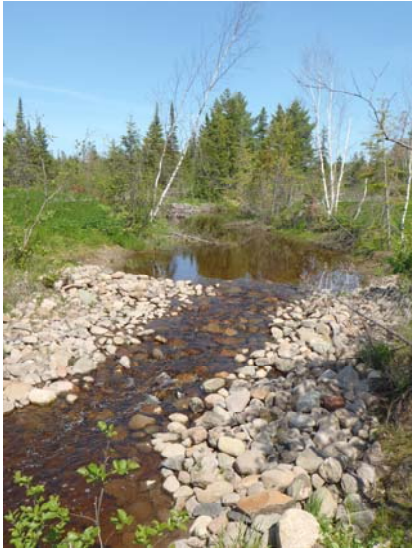
Figure 9. East Branch Eagle River at Gratiot Lake Road.

The first location was at Gratiot Lake Road (Station NPS1, Figure 9) where obvious stream modifications were observed including canopy removal, bank stabilization and areas of habitat improvement were observed, attributing to the habitat assessment which rated good. Seven out of eleven habitat metric rated excellent to good with the remaining metrics; velocity/depth regime, channel alteration, vegetative protection and riparian zone width, rating marginal. Sediments were primarily composed of gravel and sand but all substrate types were present at this location. Aquatic macrophytes were moderately abundant with large woody debris, undercut banks and overhanging vegetation sparse. No rootwads were present within this reach. The macroinvertebrate communities rated acceptable with 16 total taxa identified. One mayfly, four caddisfly and one stonefly taxa were identified within this reach but was dominated by Chironomids which composed 28 percent of the 75 individuals collected in this survey. These reduced overall numbers still suggest this location is being negatively impacted by leachate from copper stamp sands.

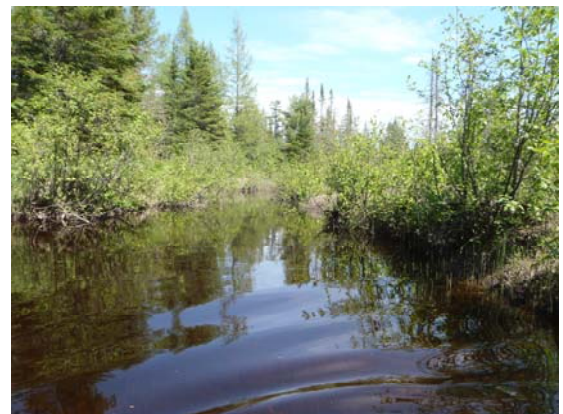
Figure 10. East Branch Eagle River off of US-41, downstream of Central Mine 3.

The second location on the East Branch Eagle River was surveyed off of US-41 (downstream of Central Mine 3) at the confluence of Central Creek (Station NPS2, Figure 10). This location displayed canopy removed from the left bank where large expanses of stamp sand material had been deposited. The upper portion of this reach was deep and slow and impounded by a beaver dam. The habitat quality rated good but marginal bank stability and vegetative protection along the left bank displayed areas of high erosion potential during high water events areas of bare soil/sand with very little vegetation to stabilize it. The riparian vegetative zone width was also impacted with less than 10 feet of riparian zone on the left bank and between 10-75 feet on the right bank due to US-41 skirting the stream at this location. Sediments were composed mainly of sand and silt with moderate overhanging vegetation and large woody debris within the stream for macroinvertebrate colonization. Undercut banks, aquatic macrophytes and rootwads were present, but sparse, resulting in a macroinvertebrate community rating of acceptable. The total number of taxa was identified at ten including one stonefly taxa, one mayfly taxa and four caddisfly taxa comprising 80 percent of the sample.

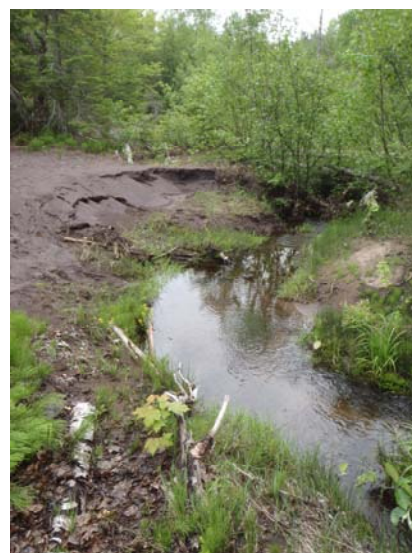
Figure 11. Kearsarge Creek upstream of the Slaughterhouse Creek confluence.

Kearsarge Creek was surveyed upstream of the confluence with Slaughterhouse Creek (Station NPS7, Figure 11). The habitat rated marginal with only two out of eleven metric rating good or better. Sediment deposition within this reach was moderate as most of the sediments were composed of silt and sand with

20 percent to 30 percent of the reach composed of CPOM and FPOM. The stream within this section was classified as flashy and unstable with many eroded “raw” areas along the straight sections with obvious bank sloughing near bends. Macroinvertebrate colonization structures were moderate to sparse throughout this reach with the absence of aquatic macrophytes and rootwad structures. Macroinvertebrate communities were still rated acceptable even with the marginal habitat within this reach. A total of 12 taxa were collected at this location including one mayfly, three caddisflies and one stonefly. However, Chironomids dominated this reach with 57 percent of the individuals identified.

Kearsarge Creek at confluence with Slaughterhouse Creek (Station NPS7)

- Bank stability – both banks need help, left bank is unstable with many eroded “raw” areas with bank sloughing. Right bank is moderately unstable with high erosion potential during high water events.
- Flashiness – bank scour along stream channel was noticed at greater than 20” with little woody debris in the active channel.
- Epifaunal substrate/available cover – very little stable habitat present within this stream with sediments composed of sand and silt that are frequently disturbed.

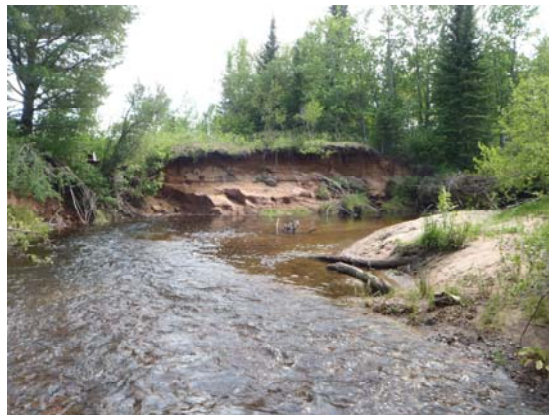
Figure 12. Trap Rock River off of Rimfetti Road.

The habitat assessment for the Trap Rock River off of Rimfetti Road (Station NPS8, Figure 12) was rated good with 9 out of 11 parameters rating good or excellent. Bank scour and stability of both banks was poor contributing to the many unstable, eroded areas throughout the reach. Substrates were primarily composed of gravel, cobble and boulder with small areas of sand and silt. Large woody debris, undercut banks and overhanging vegetation was moderately available at this location with sparse aquatic macrophytes and rootwads. The macroinvertebrate assessment was rated excellent with a total of 30 taxa collected. Four mayfly taxa, nine caddisfly taxa and one stonefly taxa were identified making up approximately 61 percent of the total individuals.

Trap Rock River off Rimfetti Road (Station NPS8)

- Bank stability – both banks rated poor exposing “raw” unstable areas with bank sloughing.
- Flashiness – Bank scour along stream channel was noticed at greater than 20” with little woody debris in the active channel.

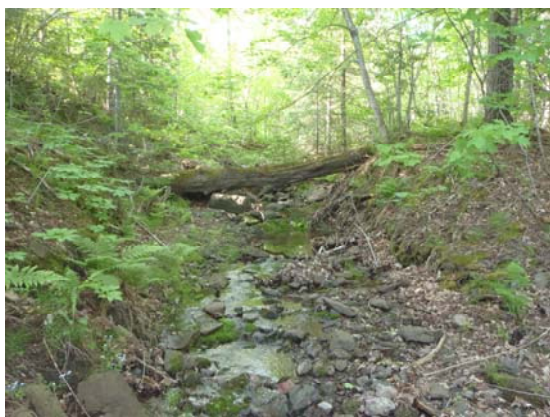
Figure 13. Owl Creek at Loop Road.

The habitat assessment at Owl Creek at Loop Road (Station NPS9, Figure 13) was rated as excellent. Habitat parameters were rated excellent to good for 10 out of the 11 total parameters measurable. The velocity/depth regime metric rated marginal with only two of the four habitat regimes (shallow fast and slow) present at this reach. Structures available for macroinvertebrate colonization within this reach are limited with a moderate amount of large woody debris but all other structures (undercut banks, overhanging vegetation, aquatic macrophytes and rootwads) absent. Macroinvertebrate communities were found to be acceptable which may be correlated to the lack of habitat throughout this reach. Sixteen taxa were collected, made up of 5 caddisfly taxa and 1 stonefly taxa. The dominant taxa consisted of Chironomidae and Simuliidae which consisted of over 75 percent of the total individuals collectively.

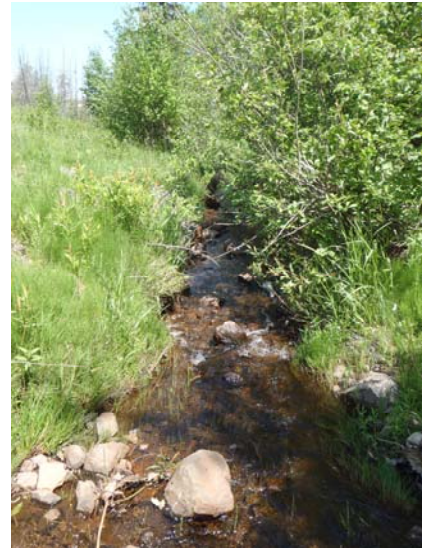
Figure 14. Billy Butcher Creek running parallel to Division Street/CR-553.

Habitat assessment was rated good at Billy Butcher Creek at Division Street/CR-553 (Station NPS12, Figure 14). Four habitat parameters rated from marginal to poor with the remaining metrics ranging from good to excellent. Sediments were soft, composed of sand and silt covering gravel and cobble with 30 percent to 60 percent of the reach composed of FPOM and CPOM. The stream was consistently 4 feet wide and shallow with the occasional riffle or bend, deep water regimes were absent along this entire reach. Colonization structures, including undercut banks and large woody debris, were extensive along with a moderate amount of overhanging vegetation. However, aquatic macrophytes and rootwads were sparse. The macroinvertebrate community rated acceptable with a total of 20 taxa collected. One mayfly taxa, four caddisfly taxa and one stonefly taxa were identified making up approximately 26 percent of the total individuals. However, Chironomidae were the dominant taxa composing 37 percent of the total individuals collected.
