MICHIGAN DEPARTMENT OF ENVIRONMENTAL QUALITY
WATER RESOURCES DIVISION
MARCH 2012

STAFF REPORT

BIOLOGICAL SURVEYS OF SELECTED STATIONS IN THE
PAW PAW RIVER WATERSHED
VAN BUREN AND BERRIEN COUNTIES, MICHIGAN
JULY, AUGUST, AND SEPTEMBER 2011

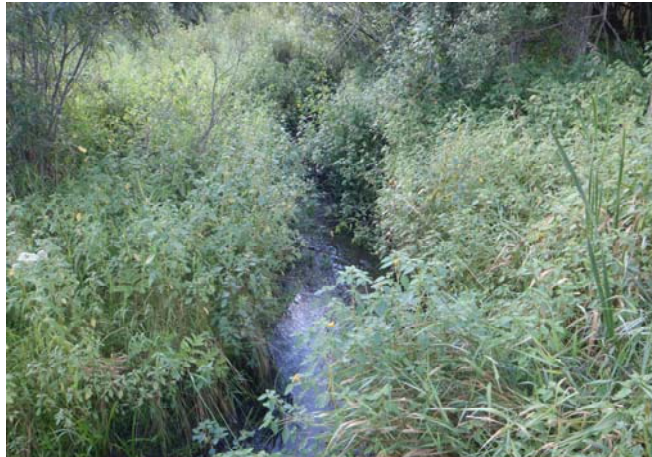
Figure 4: Hayden Creek upstream of County Road 652

Hayden Creek was sampled at County Road 652 (Station 1). It is designated as a coldwater stream. The glide/pool habitat was rated as good (148; Table 2a). This site is at the upper portion of the Hayden Creek watershed; therefore, the stream was fairly small with an average width of 3 feet. The riparian zone consisted of a wetland area with few trees and an abundance of shrubs and herbaceous vegetation. There was little large woody debris in the stream, so rootwads and overhanging vegetation provided the epifaunal substrate. Sand and silt deposition was evident making shallow pools much more prevalent than deep pools. The macroinvertebrate community scored excellent (5; Tables 2b, c) although no stonefly taxa and only two mayfly taxa were found. These taxa are less tolerant of environmental stress.

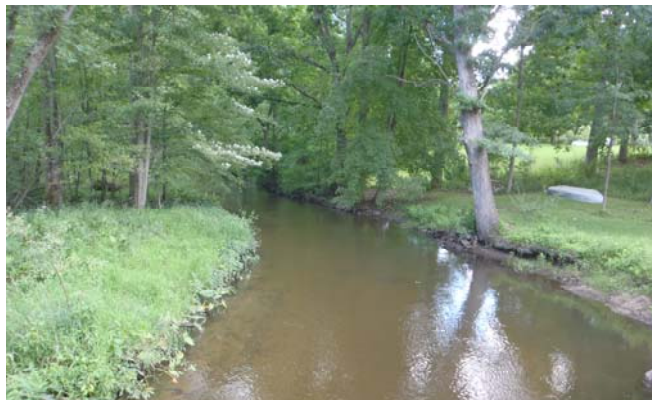
Figure 3: North Branch Paw Paw River upstream of 32nd Street.

The North Branch was sampled at 32nd Street (Station 2), and is designated as a coldwater stream. The glide/pool habitat was rated as good (115; Table 2a). The riparian zone on the left side of the stream consisted of a yard that was mowed nearly to the edge, but large trees had been left. The right bank consisted of a natural wooded floodplain. The substrate consisted of clay and shifting sand. Rip rap had been placed against the left bank for stabilization. Woody debris and leaf packs provided a majority of the epifaunal substrate. The stream was lacking sinuosity, possibly due to historic channelization. The macroinvertebrate community scored at acceptable (-1; Tables 2b, c). Amphipods made up more than 40% of the total individuals collected. A community dominated by one or two taxa can indicate an environmental stress (MDEQ, 1990).

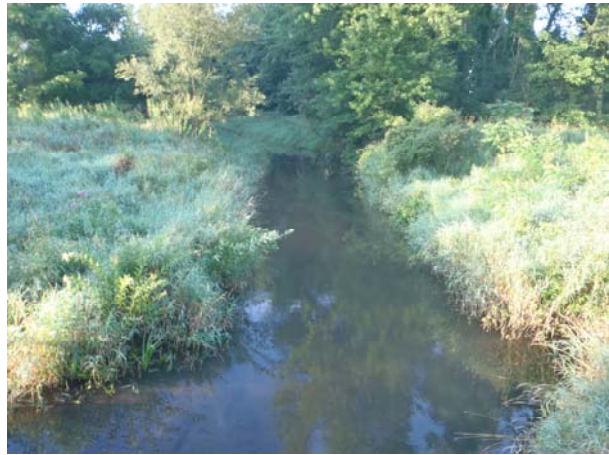
Figure 4: South Branch Paw Paw River, upstream of 72nd Avenue.

Lawton Drain confluence and Lawton Drain are currently listed on the 305b list as having insufficient information for the other indigenous aquatic life and wildlife (OIALW) designated use. In 2001, the macroinvertebrate community was sampled in Lawton Drain at County Road 665 and scored acceptable. For the 2011 survey, the habitat at Station 3 was rated at the high end of marginal (103; Table 2a). The South Branch is actively maintained as a drain in this portion of the river. The channel has been straightened and dredged in the past. The riparian area was missing smaller shrubs but the riparian zone was approximately 100 feet on each side. Large woody debris was sparse, but where some was present a pool had formed just downstream of it. Undercuts banks and overhanging vegetation were extensive. Silt covered the large woody debris that was present and the substrate was dominated by shifting sand. Siltation and sedimentation was evident with the silt exceeding three feet in depth in some areas. The macroinvertebrate community scored acceptable (3; Tables 2b, c). Diversity was good at this station with 6 Ephemeroptera, Plecoptera, and Trichoptera (Mayflies, Stoneflies, and Caddisflies) families found. These families are typically less tolerant of environmental stress; however, the density of individuals was very low.

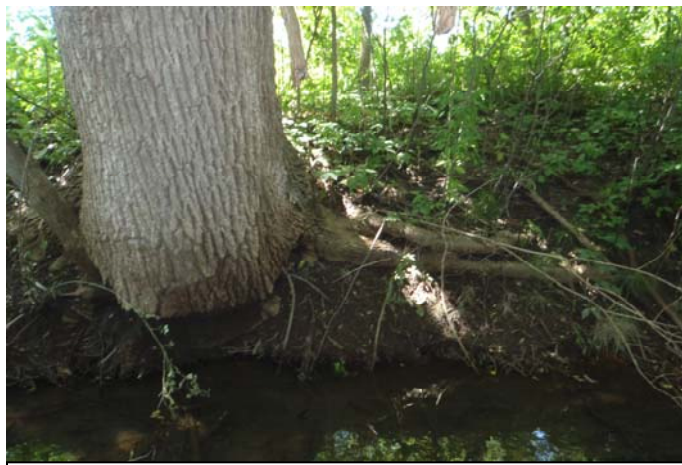
Eagle Lake Drain is a tributary to the South Branch Paw Paw River upstream of the Maple Lake impoundment. It is designated as a warmwater stream. The drain was sampled at 42nd Street (Station 4). The glide/pool habitat was rated at the low end of marginal (64; Table 2a). Very little substrate was available for colonization at this station. Large woody debris was present in the stream channel; however, it was deeply embedded and covered with silt. Aquatic vegetation was the only other available epifaunal substrate. The stream channel had obviously been dredged and straightened in the past, and there was very little channel sinuosity or pool variability. Unstable silt and sand were as deep as 2 feet in places. The stream appeared very flashy with raw banks being held to some degree by roots from riparian trees and vegetation. The macroinvertebrate community scored at the low end of acceptable (-4; Tables 2b, c). No stonefly or mayfly taxa were found. The low score for macroinvertebrates can most likely be attributed to past and possibly current maintenance activities within the drain.

Figure 5: Eagle Lake Drain upstream of 42nd Street. Erosion under tree likely to due to flashy flows.

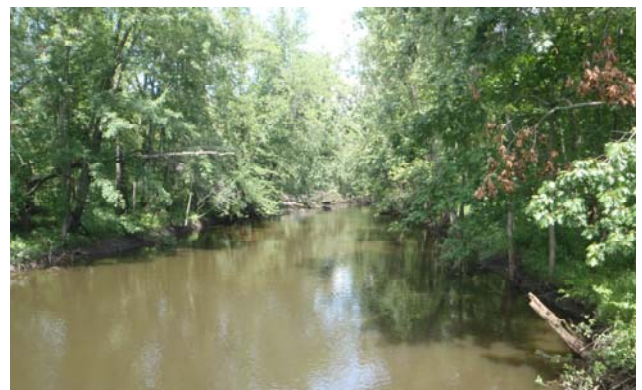
Figure 6: Paw Paw River upstream of 48th Avenue.

deep areas (> 6 feet) along outside bends and in the mid channel and thus sampling was somewhat restricted to river margins or areas where sediment was deposited and large woody debris had settled and collected leaf packs. Sand dominated the substrate at each station and pools and run areas were equally available.

The most upstream station sampled on the Paw Paw River was at 48th Street northeast of the village of Lawrence (Station 7). The glide/pool habitat was rated at the higher end of good (141; Table 3a). The water levels were high in 2011, and therefore there was a limited amount of area that could be safely sampled. Rootwads and undercut banks were extensive but could not be sampled due to the depth of the pools along the streambanks formed by lateral scour. Woody debris and leaf packs were the primary epifaunal substrate. There was no cobble, gravel, or aquatic vegetation present. The stream channel had a large amount of shifting sand substrate. The riparian zone was an extensive, wooded floodplain area. The macroinvertebrate community scored acceptable (4; Tables 3b, c).

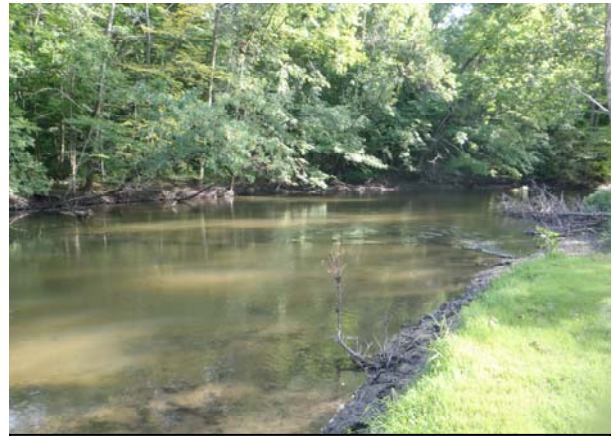
Figure 7: Paw Paw River off of M-140.

Station 10 was located further downstream on the Paw Paw River off of M-140. This station was located on the property of a campground behind the Ma and Pa Restaurant. The glide/pool habitat was rated as good (118; Table 4a). The dominant habitat available for macroinvertebrate colonization was woody debris and leaf packs. This site was on a bend and the outside portion of the bend is very deep and could not be sampled. The riparian area at this station was much different than most stations sampled on the Paw Paw. The right bank was mowed to the stream edge due to the campground, leaving only large trees in place. The left bank was an extremely high (> 20 feet) bluff and was left intact. The macroinvertebrate community scored acceptable (2; Tables 4b, c). This station is a trend station and was sampled in 2006. It will be sampled in future surveys to look at long term trends in water quality.

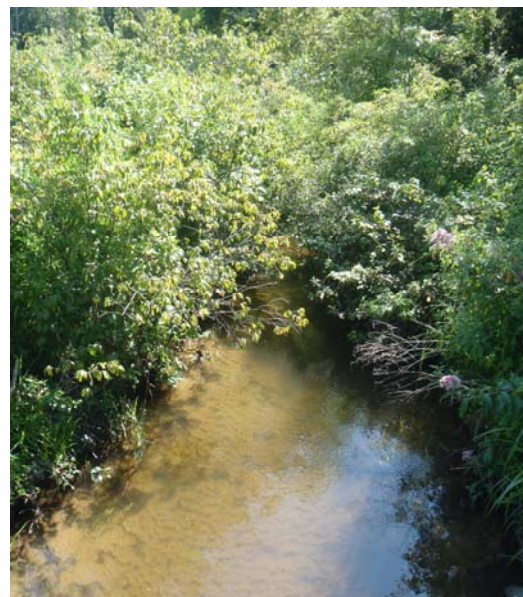
The headwaters of Brush Creek begin south of the village of Lawrence. The Creek flows north to the confluence with the Paw Paw River, in the village of Lawrence. Brush Creek is designated as a coldwater stream and was sampled at 72nd Avenue (Station 8). The glide/pool habitat was rated good (143; Table 3a). Large woody debris, undercut banks, leaf packs, and rootwad made up the available epifaunal substrate. There was a good amount of pool variability, but the substrate was entirely shifting sand. The riparian zone was an intact wetland with overhanging alders. The macroinvertebrate community scored acceptable (2; Tables 3b, c).

Figure 8: Brush Creek upstream of 72nd Avenue. Sand sedimentation evident.

Fisheries Division has concerns about impacts of sedimentation in Brush Creek. A sand trap was installed upstream of 72nd Avenue, but they would have to empty it monthly to keep it operational. Bank erosion to a wetland area adjacent to Brush Creek was reported to MDEQ in 2010 and was responded to by MDEQ district office personnel. The habitat and macroinvertebrate community was surveyed at one station (Station 8) upstream of 72nd Avenue (Table 1, Figure 1). The substrate was dominated by sand and the habitat was rated as good. The macroinvertebrate community scored acceptable (2; Tables 3a, b,c). Shifting sand did dominated the stream substrate as is shown Figure 8 and habitat parameters metrics are detailed in Table 3a.

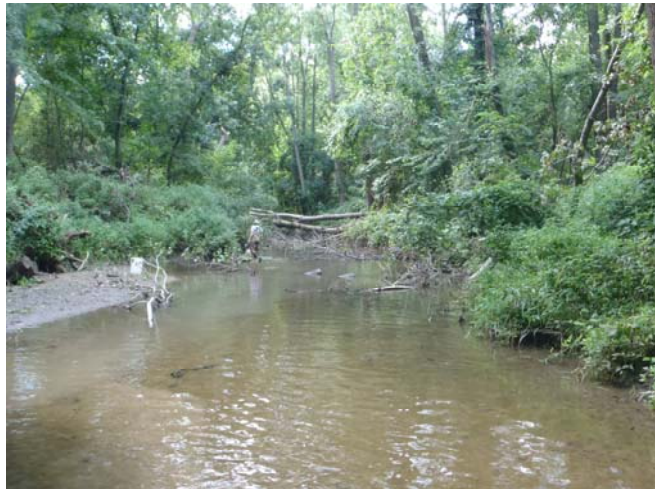
Figure 9: Pine Creek upstream of Red Arrow Highway.

Pine Creek is a tributary that flows from the south to its confluence with the Paw Paw River, just west of Hartford. Pine Creek is designated as a coldwater stream and was sampled at Red Arrow Highway (Station 9). The glide/pool habitat at Station 9 was rated as marginal (79; Table 4a). The stream channel at this station is very wide and straight and had a very shallow uniform depth (.5 feet). The substrate consisted of entirely sand with little pool variability. Large woody debris was present extensively throughout the site; however, it was deeply embedded in sand and covered in silt so that it could not be considered stable epifaunal

substrate. The stream also appeared very flashy with deeply incised raw banks 5 feet above the surface of the water. The riparian area was fairly intact and the roots from the trees and vegetation helped stabilize the banks to prevent sloughing. Although it does not appear that channelization has occurred recently in the stream, it appears that the stream has not been able to recover from previous channelization and regain any significant amount of channel diversity. The macroinvertebrate community scored at the low end of acceptable (-4; Tables 4b, c). No stonefly taxa were found. Amphipods made up 44% of the total individuals found indicating that there is an environmental stress at this station. The low score for macroinvertebrates can most likely be attributed to past and possibly current maintenance activities within the drain.

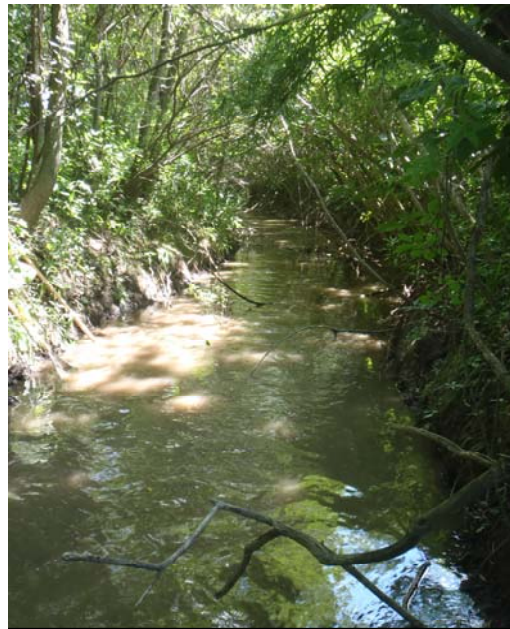
Figure 10: Mill Creek upstream County Line Road.

Mill Creek flows from the south to the confluence with the Paw Paw River in the village of Watervliet. It is designated as a coldwater stream, and was sampled at two stations. The most upstream station was sampled at County Line Road (Station 11). This station had riffle/run habitat, which is somewhat unique in the Paw Paw River watershed, and was rated as marginal (88; Table 4a). The epifaunal substrate included a small amount of cobble which was approximately 40% embedded and some woody debris that was covered with fine sand and silt. The channel was straight with a uniform channel width and depth, indicating that it has historically been a maintained channel. Large trees were missing from the riparian area. The stream seemed very flashy with erosion evident up to 5 feet above the surface of the water. The macroinvertebrate community scored at the lower end of acceptable (-2; Tables 4b, c). No stonefly taxa and only one mayfly taxa were found and amphipods consisted of 57% of the total individuals found, indicating that there is an environmental stress at this station.

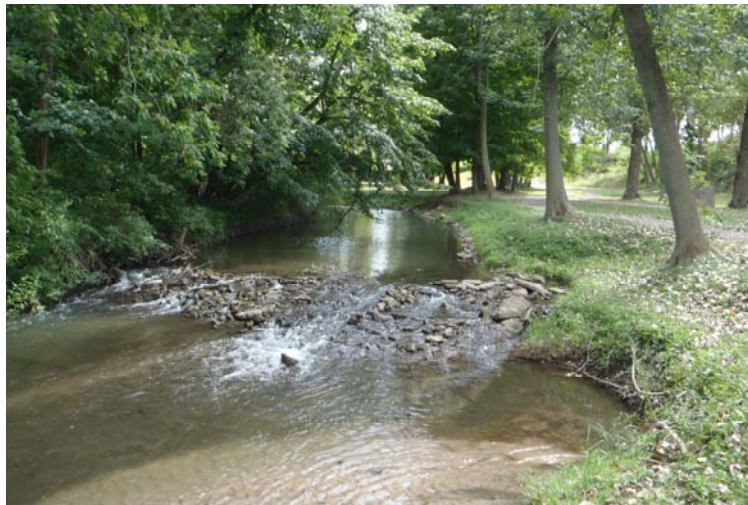
Figure 11: Mill Creek upstream at Butternut Road.

The second station on Mill Creek (Station 12) was sampled upstream of Butternut Road, less than 0.1 miles upstream from the confluence with the Paw Paw River. This station was located at a park. The glide/pool habitat was rated as marginal (95; Table 4a). A built up area of cobble is most likely the remnants of an old mill dam. Upstream of the old dam is a shallow run with gravel substrate and then a deeper pool area. The gravel was mixed with silt and sand and is approximately 70% embedded. Downstream of the old dam is a mixture of gravel, cobble, and sand. Some woody debris was caught in the riffle area or could be found pushed against the sides of the stream. The stream appeared fairly flashy and a local person indicated that the stream is often cloudy. The riparian area was impacted greatly by the park on the one side and was mowed to the edge of the stream for quite a distance. The macroinvertebrate community scored acceptable (0; Tables 4b, c). No stonefly taxa were found and amphipods consisted of 47% of the total individuals found, indicating that there is an environmental stress at this station.

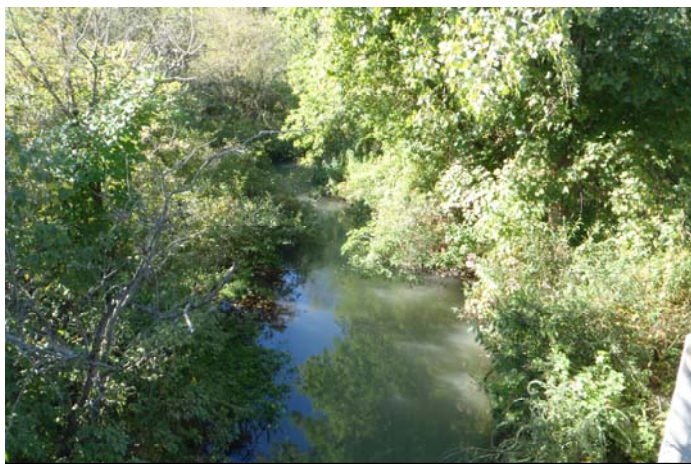
Figure 12: Blue Creek upstream of Territorial Road.

The next station sampled in the Blue Creek watershed (Station 15) was Blue Creek at its most downstream Territorial Road crossing. The glide/pool habitat at Station 15 was rated as good (135; Table 5a). The water was very cold (49 degrees Fahrenheit) and turbid at this station. The water was also somewhat high. These same conditions were observed earlier in the year. According to MDEQ district staff, the turbidity is somewhat common in the area and is the result of clay particle suspension in the water column. Large woody debris and leaf packs were the primary epifaunal substrate.

Watercress was available on areas where sandbars had developed. Sand and silt were the dominant substrate types along with clay areas. The riparian area was impacted by the road on the left side, but was intact on the right side with wetland shrub vegetation. The macroinvertebrate community scored acceptable (1; Tables 5b, c).

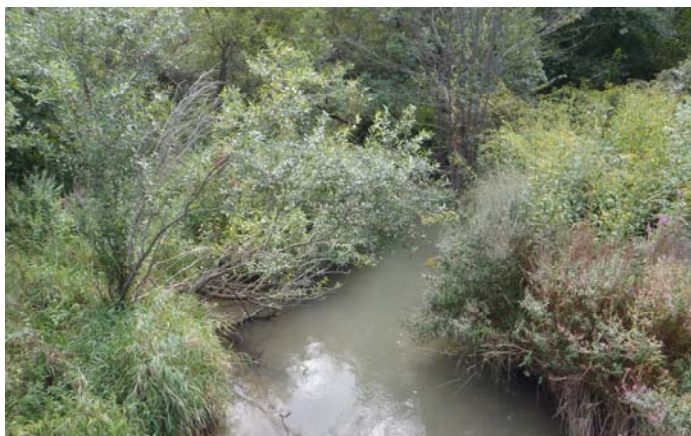
The most downstream station sampled in the Blue Creek watershed (Station 16) was sampled at Red Arrow Highway. The glide/pool habitat at Station 16 was rated as good (114; Table 5a). The water was still turbid at this downstream station, but clearer than Station 15. The substrate was dominated by shifting sand, but there was a lot of woody debris and leaf packs available as epifaunal substrate. The riparian area was intact on both sides of the stream with a small mown path on the left side. The stream appeared somewhat flashy with more than 2 feet of erosion in areas along the left bank. The stream was fairly straight and may have been channelized in the past. The macroinvertebrate community scored acceptable (1; Tables 5b, c).

Figure 13: Blue Creek upstream of Red Arrow Highway. Turbidity due to clay particles is evident.
