MICHIGAN DEPARTMENT OF ENVIRONMENTAL QUALITY  
WATER RESOURCES DIVISION  
MARCH 2013

STAFF REPORT

BIOLOGICAL AND WATER CHEMISTRY SURVEYS OF SELECTED STATIONS IN THE  
LOOKING GLASS RIVER WATERSHED  
SHIAWASSEE AND CLINTON COUNTIES, MICHIGAN  
JULY AND SEPTEMBER 2012

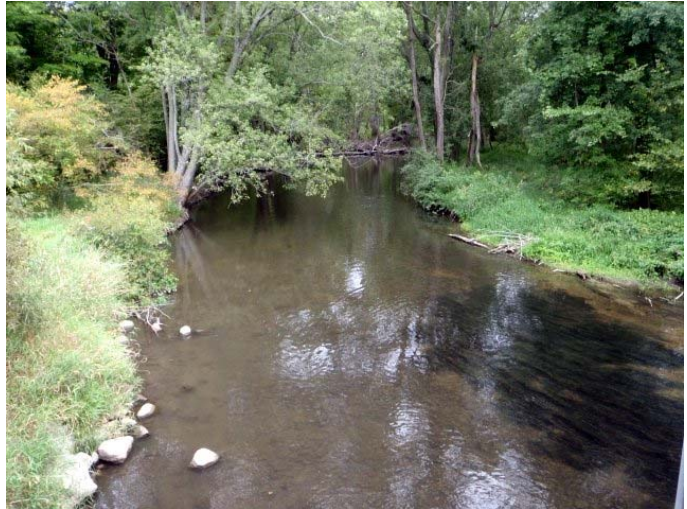
Station 4, upstream of Lowell Road (Figure B), was located 2.4 stream miles downstream of Station 3. The glide/pool habitat at Station 4 was rated as good (138; slightly impaired; Table 4a). There was an extensive and intact riparian area and floodplain at this station. The canopy was very dense and provided a large amount of shade to the river. Epifaunal substrate included large woody debris, cobble, gravel, and some leaf pack. A fine layer of silt was on a large amount of the substrate. Silt deposits with large amounts of fine particulate organic matter could be found in some areas. There was no aquatic vegetation and the water level looked very low. Many tree roots were exposed along the bank. The macroinvertebrate community scored excellent (6; Tables 4b and 4c).

Figure B. Looking Glass River upstream of Lowell Road.

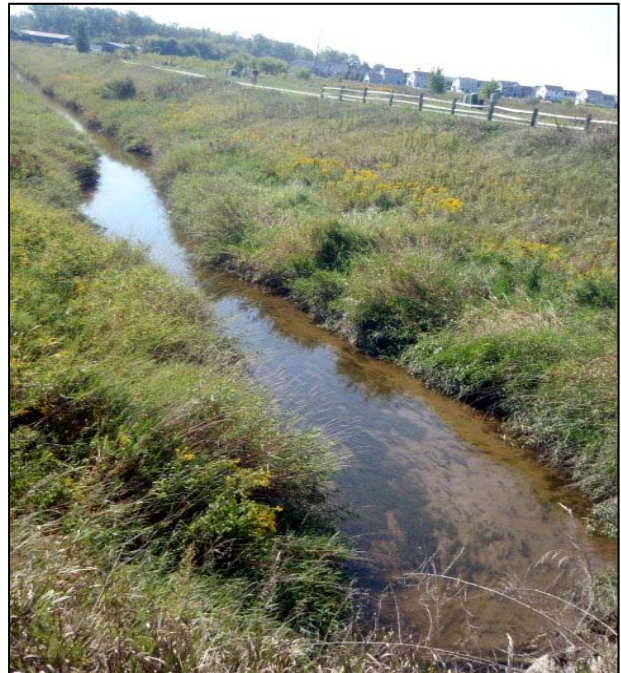
Station 6 (Figure C) was sampled at State Road and was the most upstream station in the Remy-Chandler Drain watershed. The glide/pool habitat was rated at the low end of marginal (63; moderately impaired; Table 5a). The station had very steep banks where the channel has been incised more than 30 feet. The riparian area consisted of closely cropped grass and then taller grass along the steep banks. There was a moderate amount of flow in the channel, which

Figure C: Remy-Chandler Drain upstream of State Road.

was significantly different than the flow observed the day before. A large rain event occurred two days prior, and the water was at least nine inches higher and very turbid at 4:00 p.m. one day prior to sampling. The substrate was dominated by sand and silt. Sand deposition was evident in the form of sand bars at the road culvert. Epifaunal substrate was absent except for the large amount of aquatic vegetation. Pools were absent due to the large amount of sedimentation. The macroinvertebrate community scored poor (-5; Tables 5b and 5c). In 2007, the habitat was rated as poor (43; severely impaired) and the macroinvertebrate community scored at the low end of acceptable (-3) (Lipsey, 2008). Only two of the more sensitive Ephemeroptera (mayfly), Plecoptera (stonefly), and Trichoptera (caddisfly) (EPT) families were found (compared to three in 2007), and the percent air breathers and dominant taxa both increased from 2007 to 2012 while the percent Ephemeroptera composition decreased. These factors indicate that environmental stress is impacting the macroinvertebrate community. Possible stressors include storm water impacts, sedimentation, and habitat and flow alterations.

In 2012, the glide/pool habitat at Station 6 was rated at the low end of marginal (63; moderately impaired; Table 5a) and the macroinvertebrate community scored poor (-5; Tables 5b and 5c). In 2007, the habitat was rated as poor (43; severely impaired) and the macroinvertebrate community scored at the low end of acceptable (-3; Lipsey, 2008). Only two of the more sensitive EPT taxa were found in 2012 (compared to three in 2007), and the percent air breathers and dominant taxa both increased while the percent mayfly composition decreased. Both of these metrics may indicate that environmental stressors (such as storm water impacts, sedimentation, and habitat alterations) have either increased or are having chronic effects on

the macroinvertebrate community. The Remy-Chandler Drain watershed received a large amount of rain 2 days prior to the sampling of this stream. The stream was observed approximately 8 hours prior to this survey and at that time it was found to still be very turbid and at least 9 inches higher than when it was sampled. The flashy flows and turbidity after a rain event combined with the poor macroinvertebrate community score suggest that storm water flow and associated stressors of this maintained drain may be impacting the macroinvertebrate community and causing nonattainment of the other indigenous aquatic life and wildlife designated use.

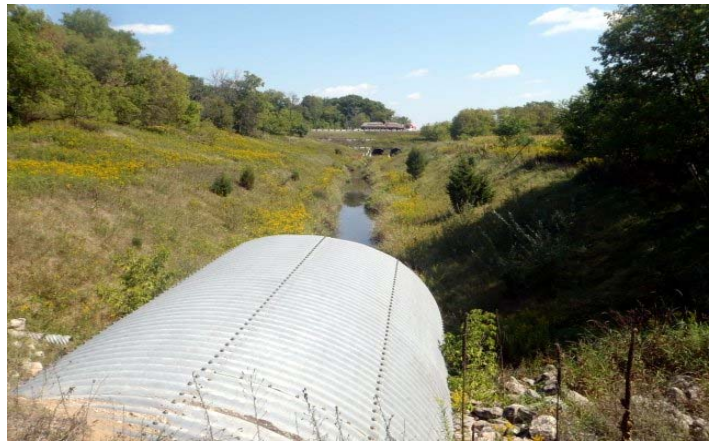
Station 7 was sampled at Wood Road. The glide/pool habitat was rated as marginal (73; moderately impaired; Table 5a). This score is similar to the habitat score found in 2007 (65; moderately impaired; Lipsey, 2008). The stream channel is straight at this station and flows through a channel that is incised more than 50 feet. The riparian area consisted of grass and some small shrubs to the top of the steep banks where there are trees on one side of the stream and an agriculture field on the other. The stream flows under I-69 just upstream of this station via 2 culverts, although flow was only coming from a third adjacent culvert. The Wood Road culvert is 20 feet in diameter due to the deep ravine (Figure D). The substrate at Station 7 was dominated by shifting silt and sand that was ankle deep in some places. Epifaunal substrate was absent except for submergent vegetation and some overhanging grass. A few deeply embedded large woody debris pieces and deeply embedded gravel were found. The macroinvertebrate community scored acceptable (-1; Tables 5b and 5c). This score was slightly lower than the score of 0 found in 2007 at this station (Lipsey, 2008). Four families found in 2007 were not found in 2012 decreasing the overall total number of taxa metric score by 1.

Figure D: Remy-Chandler Drain upstream of Wood Road.

In 2012, the glide/pool habitat at Station 7 (Wood Road) was rated as marginal (73; moderately impaired; Table 5a) and the macroinvertebrate community scored acceptable (-1; Tables 5b and 5c). In 2007, the habitat was rated as marginal (65; moderately impaired) and the macroinvertebrate community scored acceptable (0, Lipsey, 2008). Four families found in 2007 were not found in 2012, decreasing the overall total number of taxa metric score by 1. The number and % of EPT taxa increased slightly in 2012 when compared to 2007, but did not change the metric score.

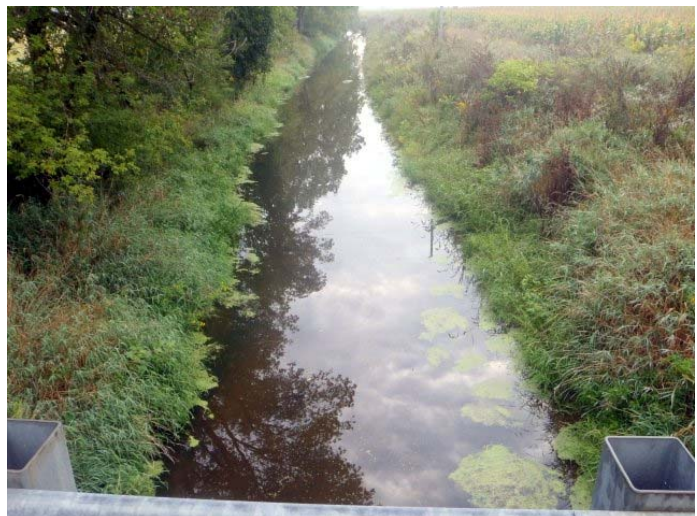
Figure E. Vermillion Creek upstream of Beardslee Road.

Vermillion Creek was sampled at two stations. The upstream station (Station 8) was located at Beardslee Road (Figure E) in the upper portion of the Vermillion Creek watershed. The glide/pool habitat was rated at the lower end of marginal (73; moderately impaired; Table 6a). The only epifaunal substrate available for colonization included a small amount of overhanging vegetation. Large woody debris was sparse and was mostly buried. Cladophora and an unknown alga covered the entire bottom of the stream. Some of the Cladophora was at least 10 inches long, although a majority of the algae was shorter. Deposits of fine sediment were as deep as 2 feet. Firmer sand could only be observed along the edges of the stream. The stream had an estimated surface velocity of 0.4 feet per second. The stream channel was very straight, and it was evident that it is a maintained drain, but it had not been recently dredged. There was a very narrow riparian area adjacent to corn fields on both sides of the stream and little canopy available to shade the stream. Two local residents indicated that they had never seen the water level so low in the stream. The macroinvertebrate community scored at the low end of acceptable (-4; Tables 6b and 6c) and was dominated by Oligochaetes (37%). When one taxon dominates a macroinvertebrate community, it is indicative of environmental stress. Visual observations of the landscape upstream of this station indicated that bean and corn row crops dominated the land use. The stream also flows through a golf course approximately two miles upstream of this station. Fertilizers used for the golf course and row crops are both possible sources of nutrients to the stream and could be contributing to the large amount of algae found in the stream.

Although the macroinvertebrate community in Vermillion Creek at Beardslee Road was meeting the “other indigenous aquatic life and wildlife” designated use, it was only one point away from a poor score and had nuisance vegetation conditions. Therefore, it should be further monitored before determining if WQS are being met. This particular year had extremely low water levels, and increased algae and macrophyte densities would be expected with lower flows. The creek is a maintained drain at this point in the watershed and although it has not been recently dredged, causes of the low score could include anthropogenic flow regime and substrate alterations due to historic drain maintenance activities.

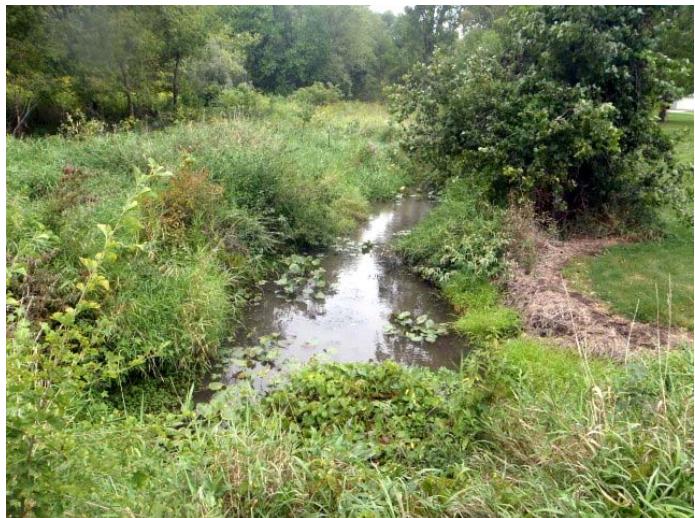
Station 10 was sampled on Osborn Creek downstream of Shaftsbury Road (Figure F). It is a small tributary to the Looking Glass River. Its confluence is upstream of the city of Laingsburg. Station 10 was sampled downstream of the road because the stream was not

Figure F. Osborn Creek downstream of Shaftsbury Road.

accessible for any discernible reach upstream of the road due to overhanging alders and shifting fine sediment that made wading nearly impossible. A small pond is located less than 0.7 miles upstream of the road crossing and influences this reach of stream. The glide/pool habitat at Station 10 was rated as marginal (99; moderately impaired; Table 6a). Aquatic vegetation was the primary epifaunal substrate present for colonization. No cobble and very little gravel or other firm substrate were available. Clay and some marl substrate were also present. The riparian area was intact on the left bank but on the right side the riparian area was mowed to the edge and an herbicide appeared to have been used. The macroinvertebrate community scored acceptable (0; Tables 6b and 6c). There were only three EPT taxa found.
