MICHIGAN DEPARTMENT OF ENVIRONMENTAL QUALITY  
WATER RESOURCES DIVISION  
MARCH 2015

STAFF REPORT

BIOLOGICAL SURVEYS OF SELECTED NORTHWEST LOWER PENINSULA STREAMS  
ANTRIM, CHARLEVOIX, EMMET, GRAND TRAVERSE, KALKASKA, AND  
LEELANAU COUNTIES, MICHIGAN  
JULY-SEPTEMBER 2013

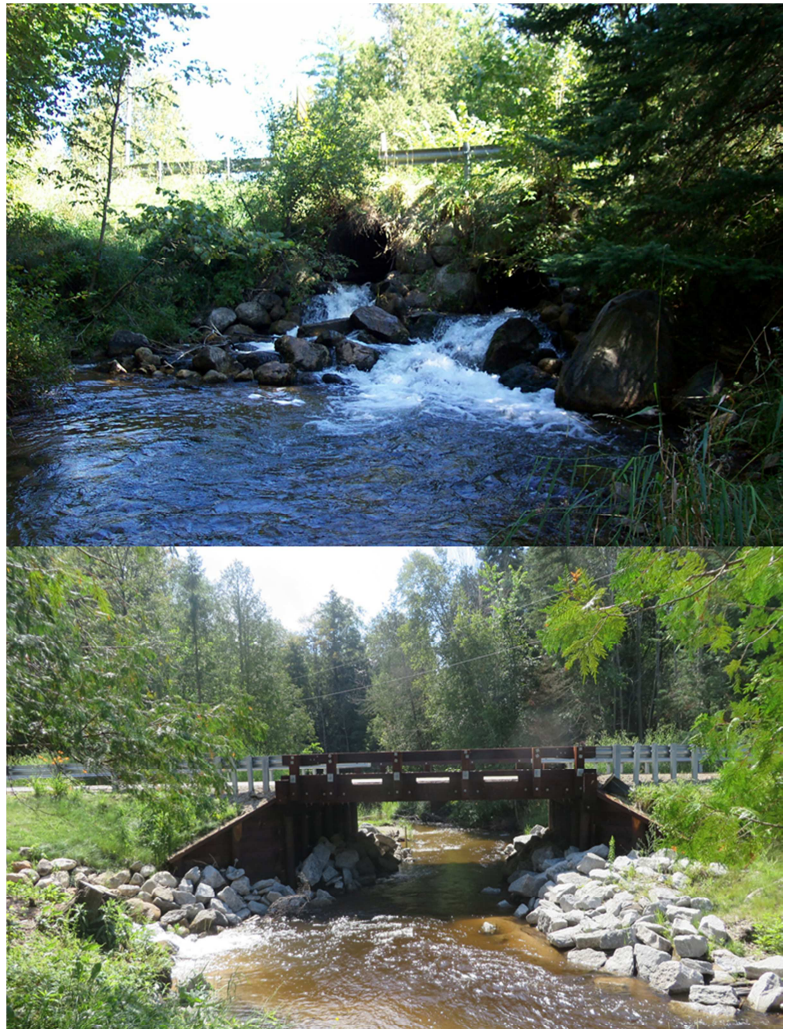
North Branch Boyne River was sampled upstream of Springbrook Road (Station 6). The site was randomly selected, but was coincidentally sampled about one year after improvements were made to the Springbrook Road-stream crossing. Prior to 2012, two undersized, 36-inch culverts were in place. The undersized culverts retained water and sediment upstream of the road berm and the culverts were perched on the downstream side of the road berm. In 2012, a 28-foot span bridge replaced the culverts, allowing a more natural flow under the bridge (Conservation Resource Alliance, 2012; Figure 2).

Figure 2. Before and after photos of Springbrook Road crossing. Photos taken by Kim Balke, Conservation Resource Alliance, and used with permission. Images accessed at [\(The link provided was broken and has been removed\)](#)

About one year prior to the most recent sampling event, an improvement was made to the North Branch Boyne River-Springport Road crossing (Station 6). An undersized, perched culvert was replaced with a span bridge in 2012. The macroinvertebrate community scored excellent upstream of the improved road crossing. However, the banks of the stream were mostly sand, and highly erodible. This sand that is now making up the stream banks is most likely sediment that had been retained by the undersized culvert and associated road berm. We propose targeting this site in 2018 to see if habitat and the stream bank stability have improved.

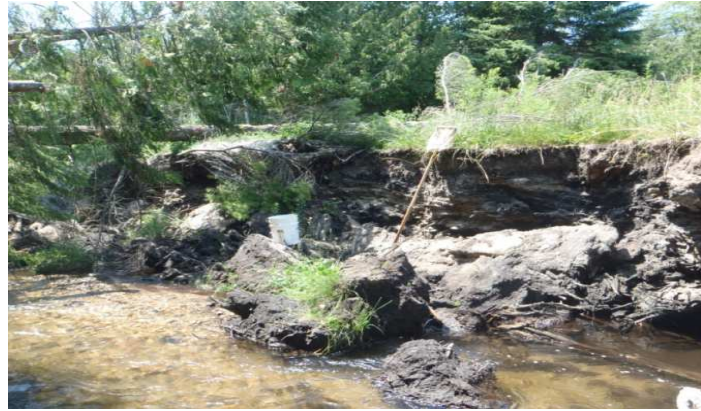
No immediate evidence of flashiness was apparent; however, the banks were very unstable and eroding (Figure 3). The soft nature of the banks was most likely the result of sediment accumulation behind the undersized culverts and associated road berm. Most likely after the culverts were replaced by the span bridge, the unimpeded, natural flow of the stream incised into the soft sediment. Because this site was visited only one year after the improved road crossing was put in place, and new soil was subsequently exposed when the channel narrowed, riparian vegetation still had not become established along the banks. The macroinvertebrate community scored excellent (6; Table 2). Twenty-five different taxa were present including three Ephemeroptera taxa, seven Trichoptera taxa, and four Plecoptera taxa.

Figure 3. Significantly eroding banks were observed in 2013 upstream of Springbrook Road on the north branch of the Boyne River.

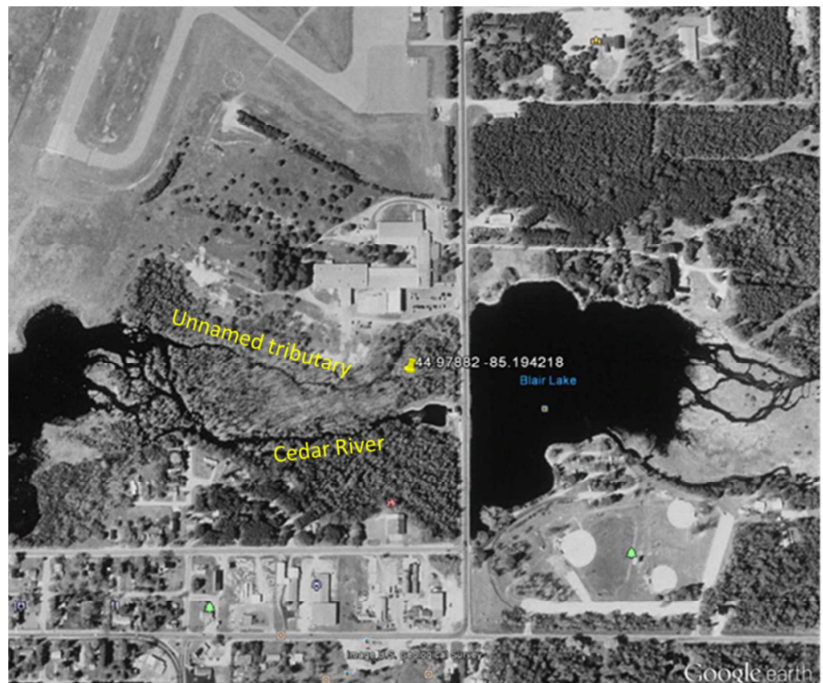
In the 2013 survey, the glide/pool habitat scored excellent (159; Table 3). The stream flows adjacent to the main stem of the Cedar River, below the Blair Lake Spillway/South Derenzy Road (Station 9; Figure 4). The substrate was a sand/silt mixture that contained a high amount of organic matter. Aquatic

Figure 4. Aerial map of an unnamed tributary to Cedar River.

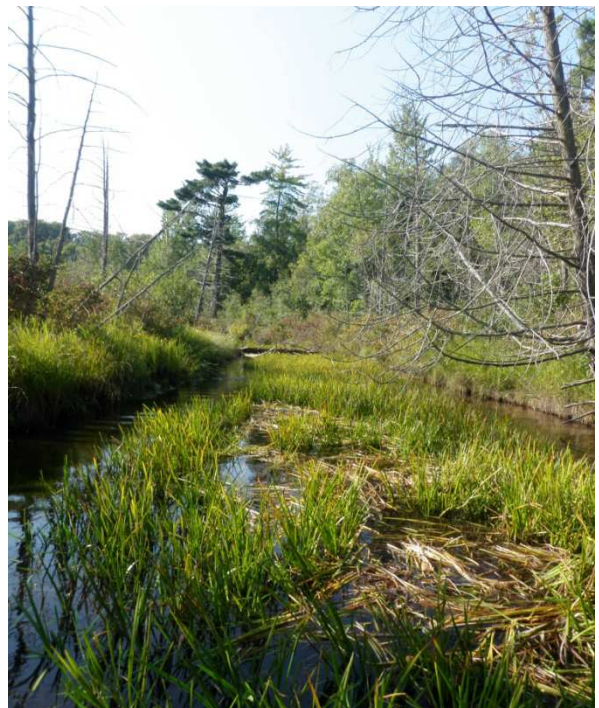
Figure 5. Yuba Creek at Yuba Road. Wetland plants are evident in channel.

The glide/pool habitat of Station 14 scored good (133; Table 3). The substrate was composed of sand and silt, and the water temperature at the time of sampling was 76° F. The stream channel contained an abundance of emergent macrophytes and flowed through a wetland (Figure 5). Undercut banks and rootwads were moderately abundant, but large woody debris and overhanging vegetation were sparse. Although the immediate channel was sinuous and did not exhibit evidence of stream flashiness, heavy sedimentation of fine organic material was evident. Other than a lack of large trees, the

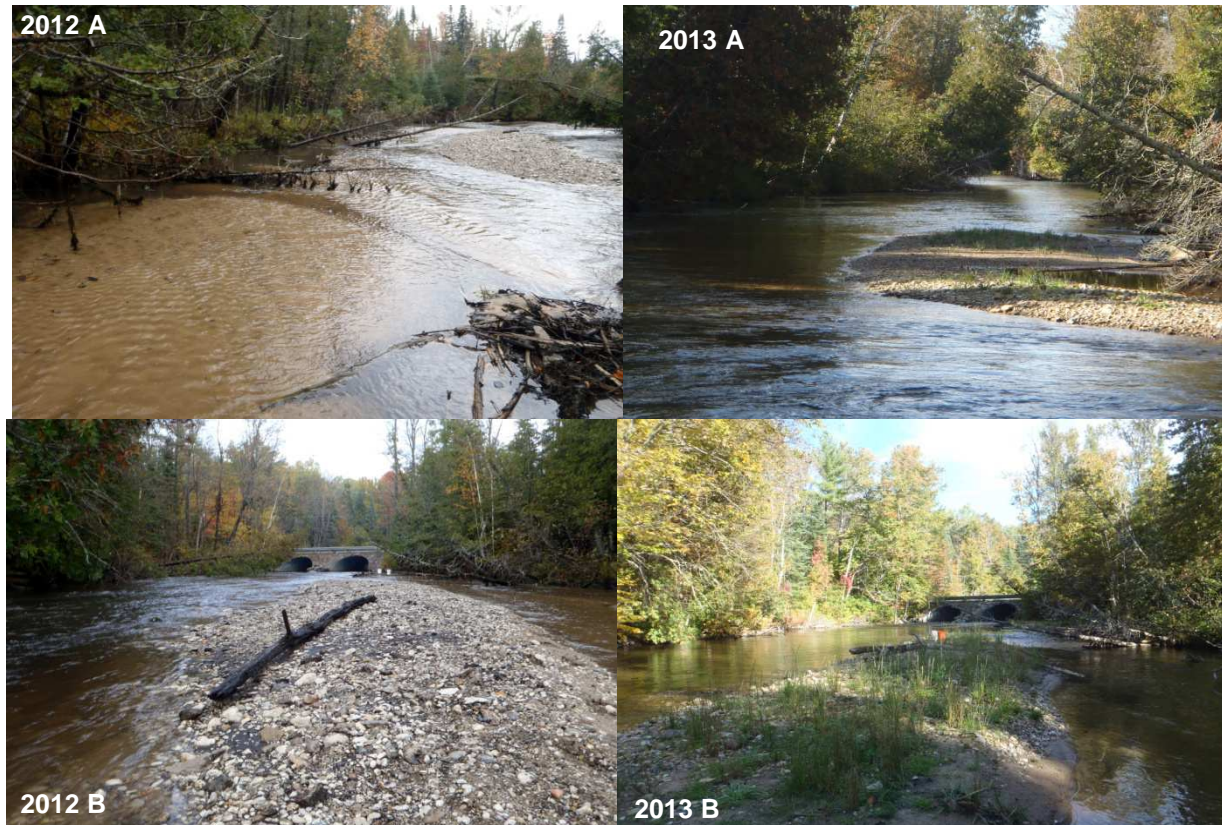
The riffle/run habitat at Station 21 scored excellent (160; Table 3) during the most recent survey. This was a slight improvement from the score it received immediately after the water release (142). The substrate only consisted of about 50% sand and an estimated 40% gravel. Large woody debris was moderately available and all other habitats were sparsely available. Islands with gravel on them added to the channel complexity, which were only recently added by the earlier uncontrolled release of water according to a riparian resident. The banks did not exhibit any signs of flashiness and appeared stable. The immediate riparian area was mostly intact forest, but some residential lawns diminished the riparian area. The greater surrounding area is mostly forested with some residential land use. The macroinvertebrate community scored on the high end of acceptable (4; Table 2). Thirty-one different taxa were collected and the community was dominated by EPT. This was an improvement from the macroinvertebrate community that was sampled immediately after the water release. At that time the community scored -2 (acceptable) and was composed mainly of Amphipoda, Isopoda, and Corixidae taxa. Those taxa are generally more associated with lentic environments, and had probably originated from the upstream impoundment at the time of sampling.

Figure 6. Boardman River on October 10, 2012 and September 25, 2013. Images taken downstream of Brown Bridge Dam Road looking downstream (A) and upstream (B).

Compared to the week following the dam release, the macroinvertebrate community at Station 21 has changed from one that is dominated by lake taxa to high quality stream macroinvertebrates (Table 6). Although there was still some sand and gravel at this location that will continue to move through the system into the near future, the macroinvertebrate community does not appear to be impacted by the dam release at the location. The large swales of sand observed at this site in 2012 were mostly gone in 2013. Large gravel islands or bars that formed in 2012 remained in 2013. At Station 22, which is approximately 7 miles downstream of Station 21, there was more evidence of large amounts of soft sand piles still moving through the stream. The macroinvertebrate community received a lower score in 2013 than in either 2008 (before the dam release) or 2012, and while it is not impacted to the point of not meeting Michigan WQS, the river appears to still be recovering from the large influx of soft sediment.
