MICHIGAN DEPARTMENT OF ENVIRONMENTAL QUALITY
WATER RESOURCES DIVISION
JANUARY 2015

STAFF REPORT

BIOLOGICAL SURVEY OF THE RIVER RAISIN WATERSHED
HILLSDALE, JACKSON, LENAWEE, MONROE, WASHTENAW, AND WAYNE COUNTIES
AUGUST 2013

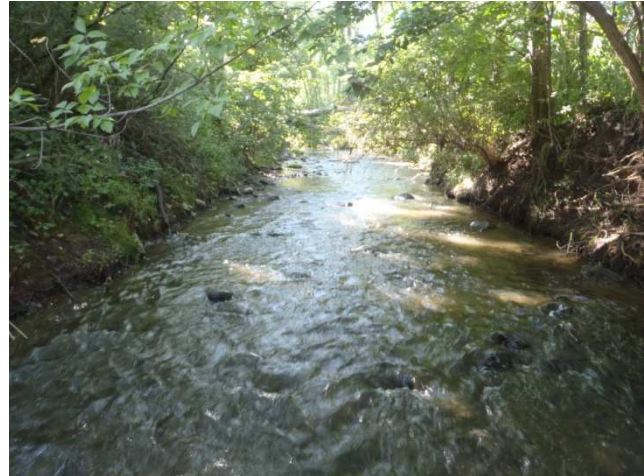
Figure 2. Evans Creek at Carson Highway.

Evans Creek was surveyed at Carson Highway (Station 1, Figure 2) west of the town of Tecumseh. Habitat quality rated excellent with moderate availability of rootwads and overhanging vegetation, undercut banks, and large woody debris present sparsely throughout the stream reach. The stream was approximately 12-feet wide with an average stream depth of 0.5 feet and dominated by gravel and sand. The riparian vegetative zone width was found to be marginal with a zone width of approximately 20 feet. All other habitat parameters rated either excellent or good. The macroinvertebrate community rated acceptable with 27 taxa identified including 2 mayfly and 5 caddisfly taxa. These taxa comprised 54 percent of the total number of individuals counted.

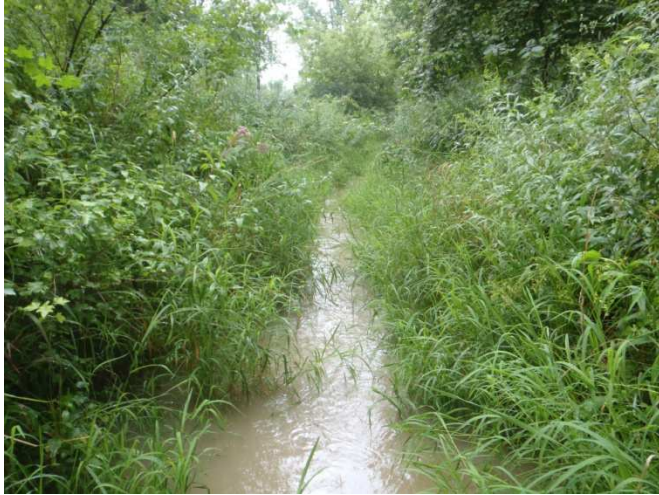
Figure 3. Hazen Creek at Hawkins Highway.

Upstream of Hawkins Highway (Station 3, Figure 3), Hazen Creek runs through a heavily vegetated wetland. The stream at Station 3 is was found to be 6-feet wide and approximately 8-inches deep which looks to be greatly influenced from the recent rain throughout the system. This stream looks to be no wider than 2 feet with water depth around 2 inches during low water flow. Vegetative protection and riparian zone width were excellent with more than 90 percent of the stream bank covered with trees, shrubs, and nonwoody vegetation. Sediments were dominated by clay and gravel, which was marginally embedded. Habitat quality was rated good with moderate overhanging vegetation and

sparse availability of large woody debris, aquatic macrophytes, and rootwads for macroinvertebrate colonization. The macroinvertebrate communities rated acceptable with a total of 29 macroinvertebrate taxa identified within this reach, of which, 15 percent were composed of EPT and dominated by Sphaerid clams and Elmid.

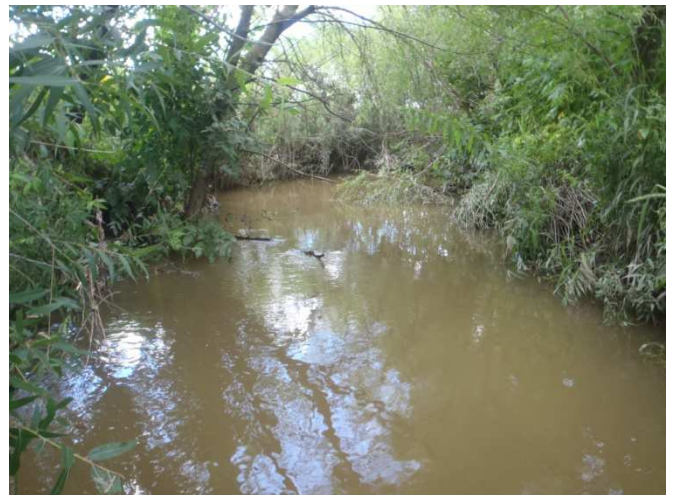
Figure 4. Macon Creek at Welch Road.

During the survey at Macon Creek at Welch Road (Station 5, Figure 4) the local landowner mentioned that the local water levels were approximately one-foot higher than normal due to the recent storm events. The habitat assessment at this location rated good with the creek flowing through predominantly agricultural land. The creek was protected on the west by a buffer strip, increasing the vegetative buffer zone. Very little other vegetation besides understory shrubs was present along the west stream bank. The east bank had a mix of trees, grasses, and various herbaceous plants but the riparian buffer width was poor, estimated at approximately 10-foot wide. Overhanging vegetation, undercut banks, and rootwads were moderate throughout this location with sparse large woody debris available for macroinvertebrate colonization. Sediments were composed of sand with some

gravel throughout the creek. Macroinvertebrate communities rated acceptable with 19 total taxa identified, dominated by Hydropsychids and Elmids. Sixty-five percent of the total individuals in the sample were composed of EPT taxa.

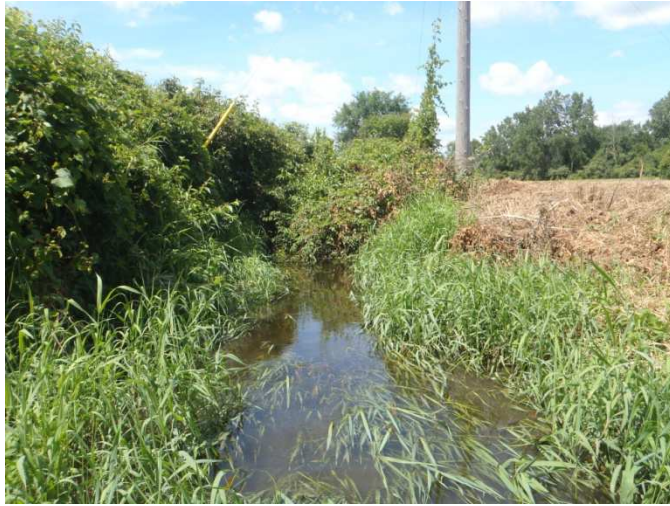
Figure 5. North Branch Willow Run at Baldwin Road.

The north branch Willow Run at Baldwin Road (Station 6, Figure 5) was found to be seven-feet wide, a depth of approximately 1.5 feet with surface velocities of 0.1 feet per second. Staff who

visited this location questioned whether this stream was perennial due to the recent rain events throughout the watershed. Upon sampling this site it was found that the sediments were composed of 100 percent silt with very little macroinvertebrate structures except for overhanging vegetation and some aquatic macrophytes. Habitat rated marginal due to several metrics, which scored poor, including: embeddedness, velocity/depth regimes, sediment deposition, riparian vegetative zone width, and frequency of riffles or bends. The macroinvertebrate community rated acceptable with the presence of 20 total taxa, dominated by Chironomids and Isopods. The EPT Orders composed 2.6 percent and the surface air breathers were found to

compose 1.9 percent (Corixids and Haliplids) of the total individuals identified in the sample.

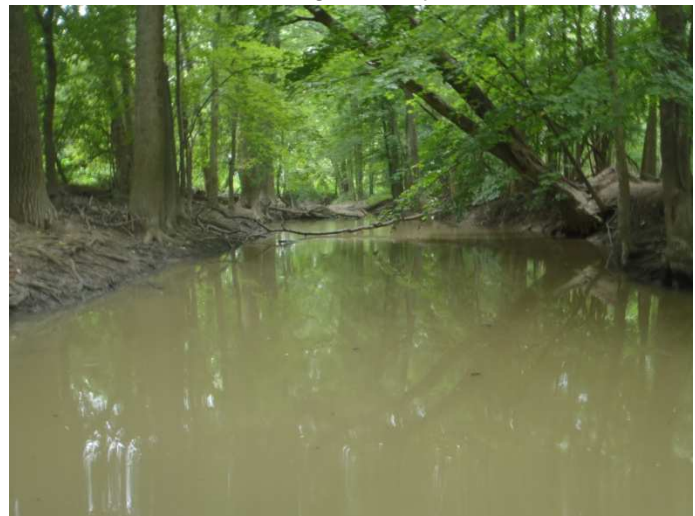
Figure 6. Bear Creek at Mulberry Road.

Bear Creek at Mulberry Road (Station 7, Figure 6) is located approximately three miles from the Michigan-Ohio state border with the headwater portions of Bear Creek originating in Ohio. The watershed is dominated by agriculture with sediments almost completely hardpan clay with very little sand, gravel, and silt suggesting a flashy system. Very little in-stream habitat was found within the active channel at this location with sparse undercut bank, large woody debris, and

rootwads with no aquatic macrophytes or overhanging vegetation. The riparian vegetative zone width was good to excellent with a good mix of trees, grasses, and herbaceous vegetation. Habitat quality rated good with the macroinvertebrate community rating acceptable. However, the macroinvertebrate community was found to be minimally acceptable with a score of -4. Seventeen total taxa were identified in which 35 percent of the individuals were from the EPT Orders. The dominant taxa at this location were comprised of Hydropsychids and Chironomids. The numbers of organisms collected at this location (133) were sparse presumably due to the lack of available colonization structures found throughout this reach.

Bear Creek at Mulberry Road (Station 7)

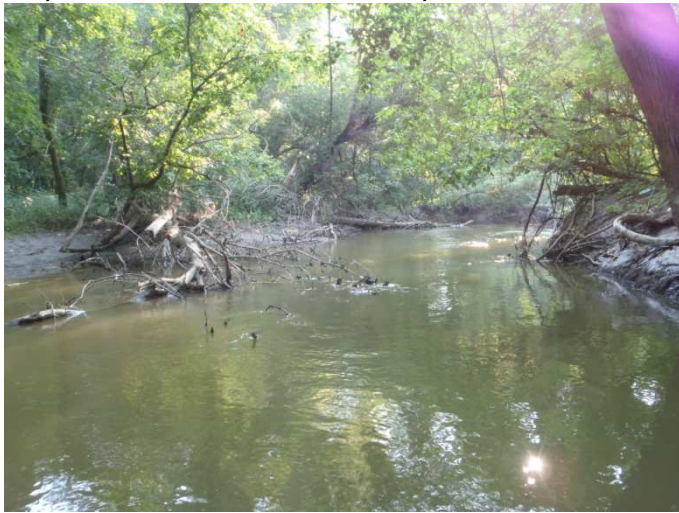
Figure 7. Saline River at Day Road.

Saline River at Day Road (Station 8, Figure 7) was dominated by frequently disturbed, soft sediments including detrital material, fine organic muck, and sand/silt/clay, which composed of 95 percent of the benthos. Steep banks were found along the entire reach and propose a high erosion potential during high water events.

The riparian vegetative zone width was also found to be marginal with approximately 50 feet of vegetation on either side of the river. The habitat quality rated marginal with large woody debris and rootwads moderately available for macroinvertebrate colonization. This section of river was found to be marginally flashy after rain events with the majority of the large woody debris found lying along the stream banks. Macroinvertebrate communities rated acceptable with a total of 19 taxa, dominated by Hydropsychids and Baetids and 56 percent of the total individuals identified were composed of the EPT taxa.

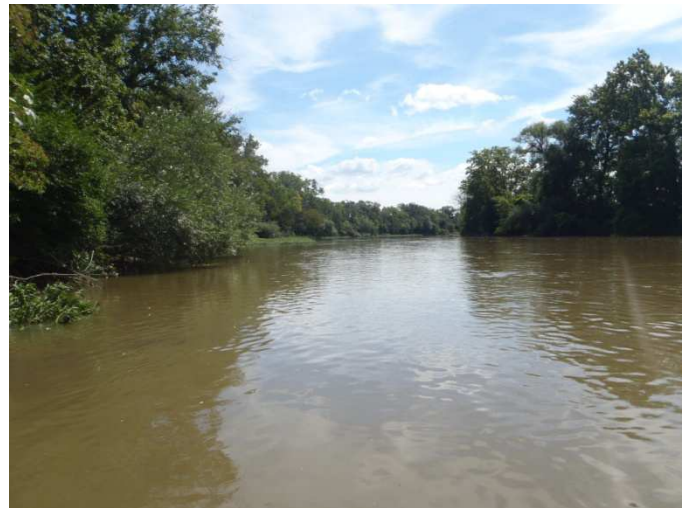
Figure 8. River Raisin off Custer Road.

River Raisin off Custer Road (Station 10, Figure 8) was one of the larger stream sites in the survey. The stream at this location was 210-feet wide with surface velocities near 1 foot per second. Water depth averaged 2-feet deep and was wadeable at all locations at the site. Substrates were composed mainly of cobble with very little fine sediment present. Habitat communities rated good with aquatic macrophytes moderately available throughout the site for macroinvertebrate colonization but all other habitat structure types were sparse. Bank scour and the riparian vegetative zone width were found to be marginal with only 50 to 60 feet of buffer between the river and the road on the left bank and agricultural fields on the right bank. However, macroinvertebrate communities rated acceptable. A total of 31 taxa were identified during the survey with the dominant orders composed of the EPT orders, which made up 57 percent of the total individuals identified in the sample.

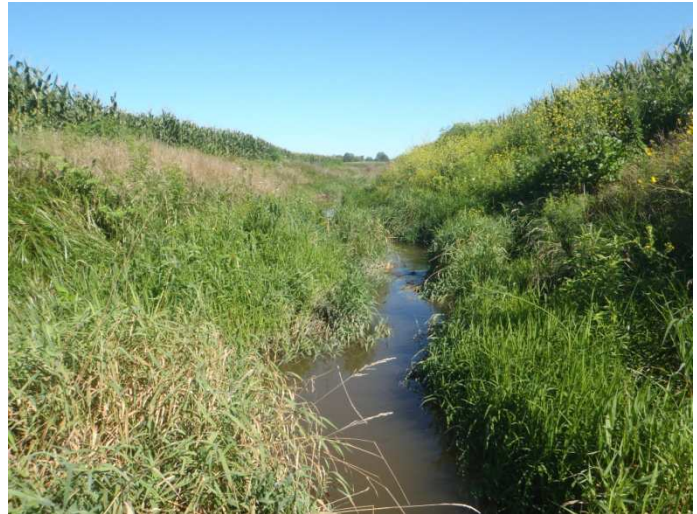
Figure 9. South Branch Macon Creek at Pocklington Road.

Habitat rated poor along the south branch Macon Creek at Pocklington Road (Station 12, Figure 9) due to the absence of any riparian vegetation besides grass, and heavy deposits of sand, which are frequently moving along the stream bed. The vegetative bank width was less than 10 feet and the dominant vegetation in the upland was corn. The stream had recently been channelized and was found to be a very flashy system with no retention devices present within the stream. Even with the poor habitat throughout the reach the macroinvertebrate community rated acceptable with 28 percent of the total individuals composed of EPT taxa and 19 taxa identified. The dominant taxa were identified as Chironomids and Elmids.

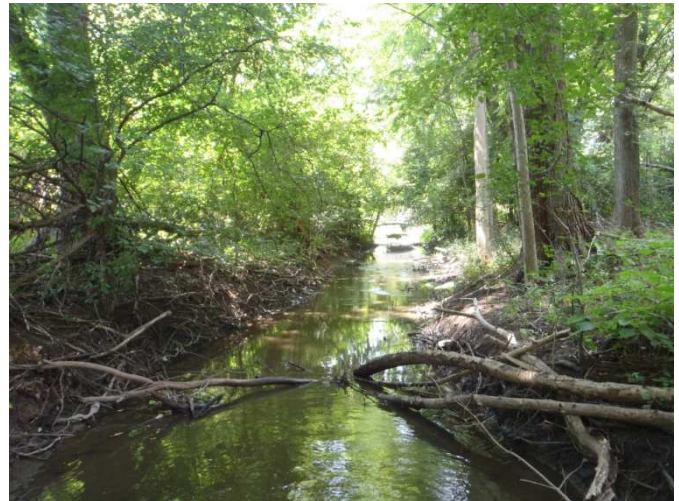
Figure 10. Wood Outlet Drain at Maple Road.

Wood Outlet Drain was surveyed downstream of Maple Road (Station 2T, Figure 10) approximately four miles downstream at the Ann Arbor Municipal Airport where the stream originates. The drain is surrounded by, and flows through, several residential areas before emptying into the Saline River at Mill Park Pond in the town of Saline. It was found to have a good habitat community assessment. In-stream habitat was sparse with no aquatic macrophytes present throughout this sample reach. Sediments were composed of mainly sand and embedded gravel with some silt and cobble. Vegetative protection on the banks was good but the riparian zone width was found to be marginal with approximately 30 feet of buffer on each bank.

Macroinvertebrate communities rated acceptable with 17 total taxa identified, dominated by Chironomids and Hydropsychids with EPT taxa representing 30 percent of the total individuals collected.

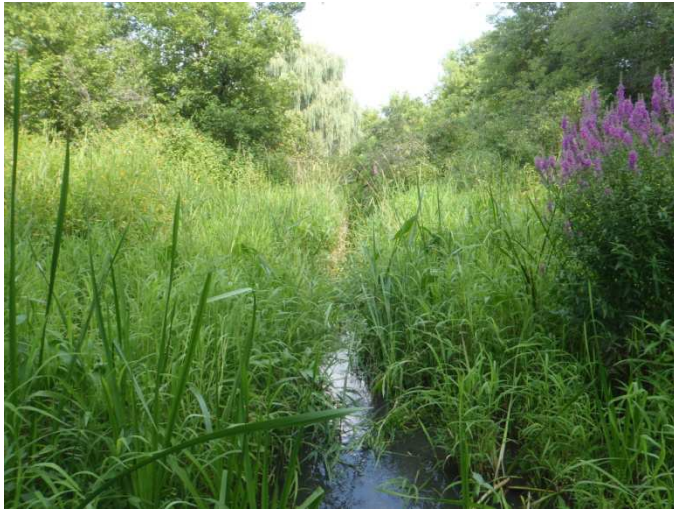
Figure 11. Koch-Warner Drain at Warner Road.

Habitat for the Koch-Warner Drain at Warner Road (Station 4T, Figure 11) rated marginal, displaying sparse habitat structures besides grassy overhanging vegetation, which were very extensive throughout this historically dredged section. This section of drain had heavy deposits of soft silty sediments, which inhibited movement throughout the reach. The local homeowner estimated it has been approximately 13 years since the channel was last dredged. Large woody debris and aquatic macrophytes within the stream were sparse with the only macroinvertebrate habitat available for colonization was the extensive overhanging grasses within this depositional zone. The riparian zone on

the right bank was minimal with less than 10 feet of riparian zone due to human disturbance, while the left bank was marginally better with approximately 75 feet of riparian zone, which was mostly shrubs and other nonwoody vegetation. The macroinvertebrate community rated acceptable, with 24 taxa identified within the reach. The dominant taxa were comprised of Chironomids and Hydropsychids. The EPT taxa made up 31 percent of the total individuals identified in the sample.

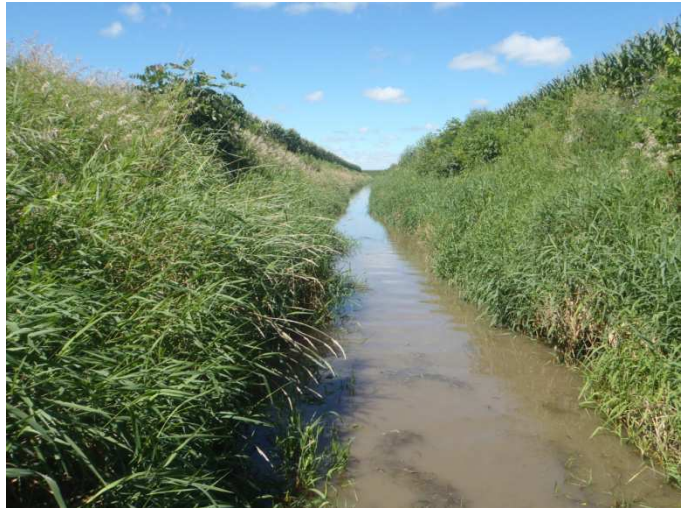
Figure 12. Little River Raisin at North County Line Road.

The Little River Raisin at North County Line Road (Station 8T, Figure 12) was recently dredged with a width of approximately 8 feet. Sediments were dominated by silt and sand with the overall habitat rating marginal. Overhanging vegetation along the stream was moderately available for macroinvertebrate colonization with large woody debris and aquatic macrophytes sparsely available. However, the large woody debris and aquatic macrophytes were covered with a layer of silt reducing the availability to macroinvertebrates. Canopy cover was nonexistent with riparian vegetative buffer zones less than 5-feet wide on each bank. The macroinvertebrate community rated acceptable with the dominant taxa including Chironomids and Coenagrionids with the EPT comprising less than five percent of the entire sample.

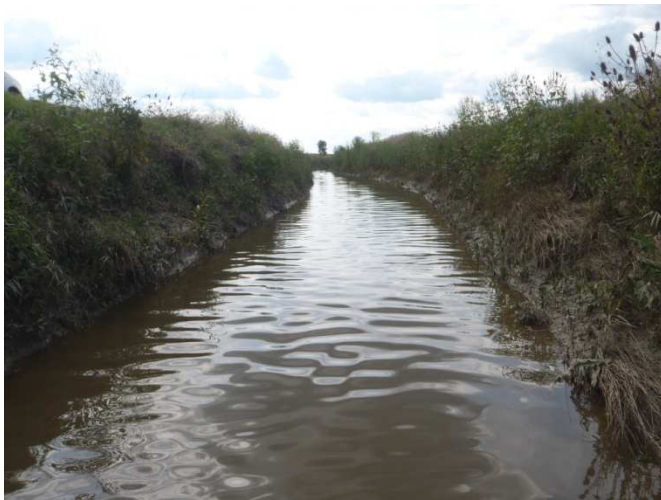
Figure 13. Bear Swamp Creek at Dennison Road.

Bear Swamp Creek at Dennison Road (Station 9T, Figure 13) was recently dredged with very little bank side vegetation, in-stream vegetation, or other macroinvertebrate colonization structures. The only vegetation present was comprised of grasses, which extended on both banks to a width of approximately 50 feet. The sediments were evenly split between heavy deposits of silt and clay. The creek seemed to the investigators to have been recently dredged due to the lack of macrophytes and a noticeable ridge running horizontal throughout the entire reach of the stream, which may be attributed to the reach of the backhoe used to dredge the system. Overall, the habitat of this reach rated poor as did the

macroinvertebrate community. Twenty-two taxa were identified during the survey, of which, only one mayfly family was identified (Caenid) and no caddisflies or stoneflies. Even with one EPT taxa present at this location it comprised 18 percent of the sample and the only taxa that was found more frequent were Physid snails.

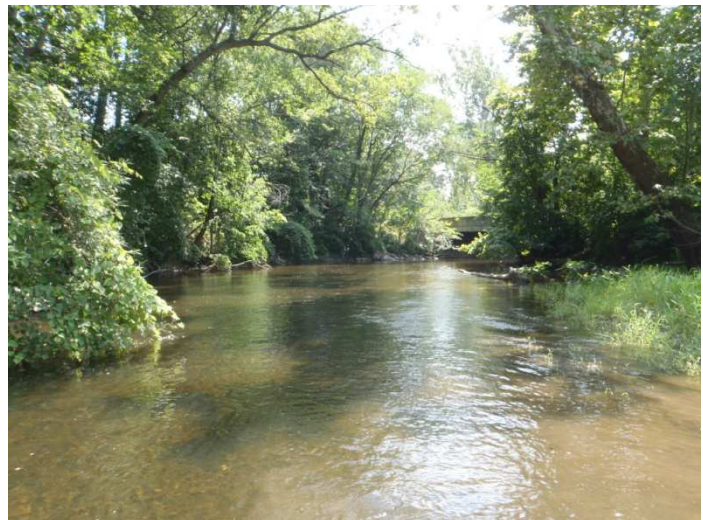
Figure 14. River Raisin at Austin Road.

River Raisin at Austin Road (Station B, Figure 14) was located approximately 0.5 miles east of the village of Manchester and downstream of Manchester Lake. Available habitat rated good at this location consisting of overhanging vegetation and large woody debris with spare amounts of undercut banks, rootwads, and aquatic macrophytes. The sediments are composed of gravel and sand. The macroinvertebrate community rated excellent with 30 taxa identified during this survey. This site was dominated by Calopterygids and Amphipods with 17 percent of the sample composed of EPT taxa. One Stonefly was identified at this location.

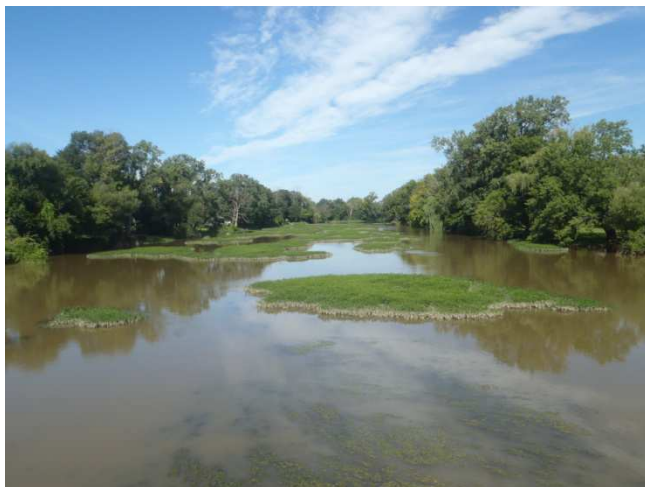
Figure 15. River Raisin at Raisinville Road.

The overall habitat assessment rated good at the River Raisin at Raisinville Road (Station C, Figure 15). This location is approximately seven miles above Lake Erie and two miles above the city of Monroe. The margins of the river are lined with residential buildings and groomed yards with only a small vegetative buffer strip present along the margins composed of large trees and grasses. The substrate is dominated by bedrock throughout this reach of stream with areas of sand and gravel,

which correspond to areas with thick emergent vegetation growth. However, it is only sparsely provided with large woody debris and overhanging vegetation; all other colonization structures for macroinvertebrate colonization are absent in this reach. The macroinvertebrate community survey rated acceptable, consisting of 31 taxa identified for the entire sample. Tricorythids and Hydropsychids dominated this site with 52 percent of the sample composed of EPT taxa.

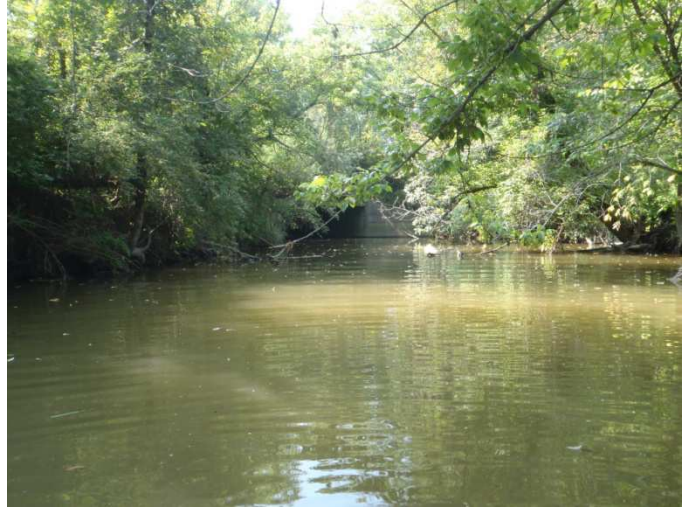
Figure 16. North Branch Macon Creek at Day Road.

The north branch Macon Creek at Day Road (Station D, Figure 16) location was targeted for a

macroinvertebrate community assessment due to being listed in the 2012 Integrated Report (Goodwin et al., 2012) as Not Supporting the Other Indigenous Aquatic Life and Wildlife metric due to historic dredging of the creek. The Holcim Quarry is located directly to the east of the sampling location with a control structure approximately one mile downstream holding water back. The banks of the stream are extremely steep associated with deep flashy water and soft sediments making this site difficult to sample. Habitat rated marginal at this location with sediments dominated by silt and clay with some organic detritus present. Moderate amounts of large woody debris, overhanging vegetation, and undercut banks were present but rootwad availability

was sparse for macroinvertebrate colonization. No aquatic vegetation was present throughout this reach. The well-mixed vegetative buffer zone was approximately 20-feet wide on the right bank and 75-feet wide on the left bank. The macroinvertebrate community rated acceptable with only 17 taxa identified during this survey. The site was dominated by Coenagrionids and Chironomids. EPT taxa composed 14 percent of the total sample collected.

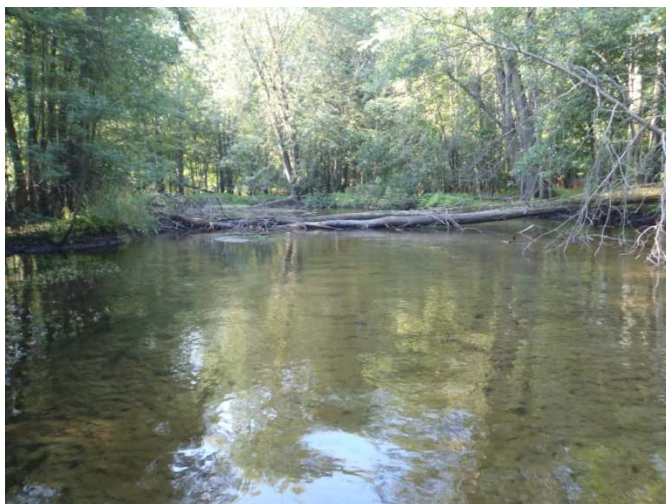
Figure 17. River Raisin at Pierce Road.

River Raisin at Pierce Road (Station E, Figure 17) was the minimally-impacted site requested by the Status and Trend Program. Habitat rated good with moderate amounts of large woody debris available for macroinvertebrate colonization with approximately 25 percent of the reach

composed of detrital material. Undercut banks, overhanging vegetation, and aquatic macrophytes were sparse throughout the reach. Sediments were composed mainly of unstable sand, embedding the available gravel greater than 75 percent. Banks were moderately unstable with patches of bare soil common. The riparian vegetative zone width was excellent on the left bank (>150 feet) but the right bank was reduced to 50 feet due to the river running along Pierce Road. The macroinvertebrate community rated excellent with 32 taxa identified during this survey. The site was dominated by Amphipods and Elmids.

EPT taxa composed 26 percent of the total sample collected with 5 mayfly and caddisfly taxa and 1 stonefly taxon present within this reach of stream.
