MICHIGAN DEPARTMENT OF ENVIRONMENTAL QUALITY
WATER RESOURCES DIVISION
AUGUST 2015

STAFF REPORT

A BIOLOGICAL SURVEY OF THE ROGUE RIVER WATERSHED
KENT COUNTY, MICHIGAN
AUGUST 2013

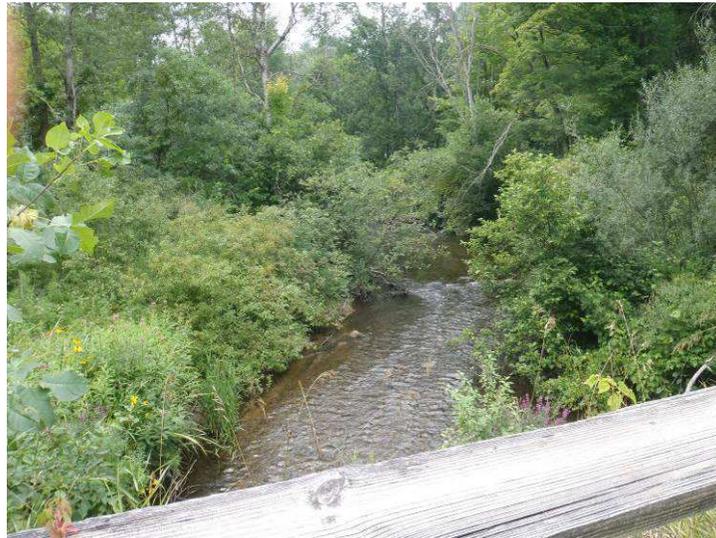
Cedar Creek at Friske Road

Site 1. This riffle/run station had an Excellent (8) macroinvertebrate score and an Excellent (156) habitat score. This station includes a forested buffer on the south side of the creek, but an open canopy over the creek. The substrate is composed of mostly gravel and cobble with sand interspersed throughout the reach. The macroinvertebrate community had a high level of diversity (30 taxa) including mayflies, stoneflies, and caddisflies.

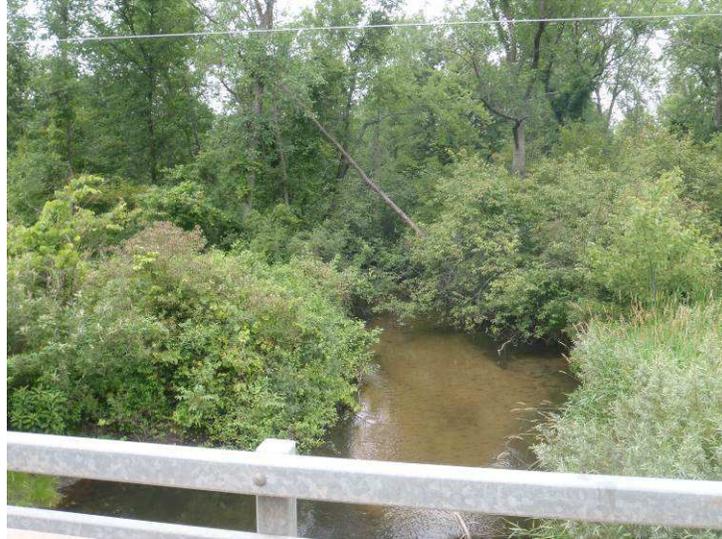
Duke Creek at 17 Mile Road

Site 2. This glide/pool site had an Acceptable (4) macroinvertebrate score and a Good (108) habitat score. The site was dominated by sand substrate, had forested wetlands surrounding the reach, and consisted of moderate undercut banks and overhanging vegetation. The macroinvertebrate community consisted of mayflies, stoneflies, and caddisflies but also had high levels of tolerant taxa including dipterans and amphipods, resulting in a lower score.

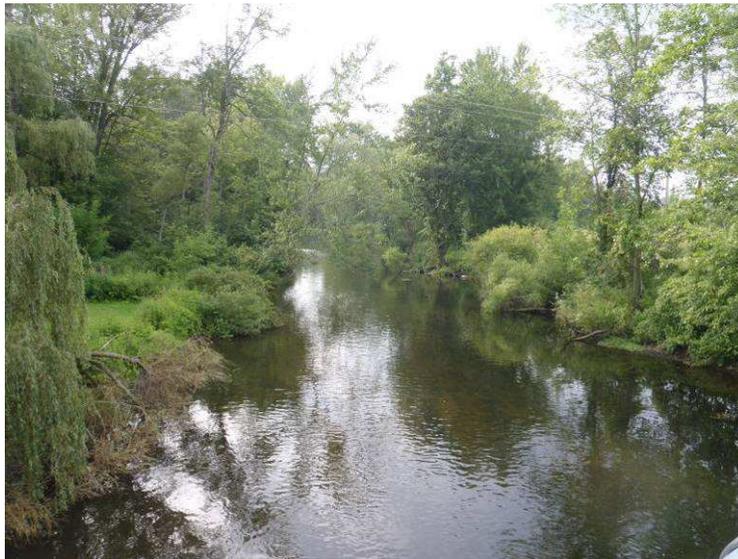
Rogue River at Algoma Avenue

Site 3. This riffle/run site had an Acceptable (3) macroinvertebrate community and a Good (134) habitat score. The substrate was dominated by sand with some gravel and cobble. The stretch was surrounded by forested wetlands and had a moderate level of aquatic macrophytes throughout the stretch. This site had little habitat with sparse amounts of large woody debris, undercut banks, and overhanging vegetation. Amphipods, a tolerant taxa, was dominant at this site; however, two taxa of stoneflies (Perlidae and Pteronarcyidae) were present.

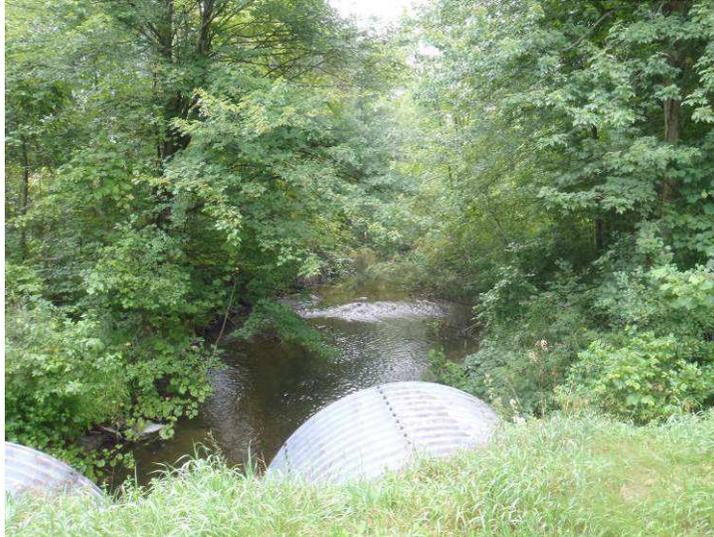
Duke Creek at Hanna Avenue

Site 4. This riffle/run site had an Excellent (7) macroinvertebrate score and an Excellent (166) habitat score. This stretch had a mix of cobble, gravel, and sand for substrate and had trees and shrubs along the banks for vegetative cover. The macroinvertebrate community had a good mix of mayflies, stoneflies, and caddisflies. Thirty-two taxa were found in this stretch of stream.

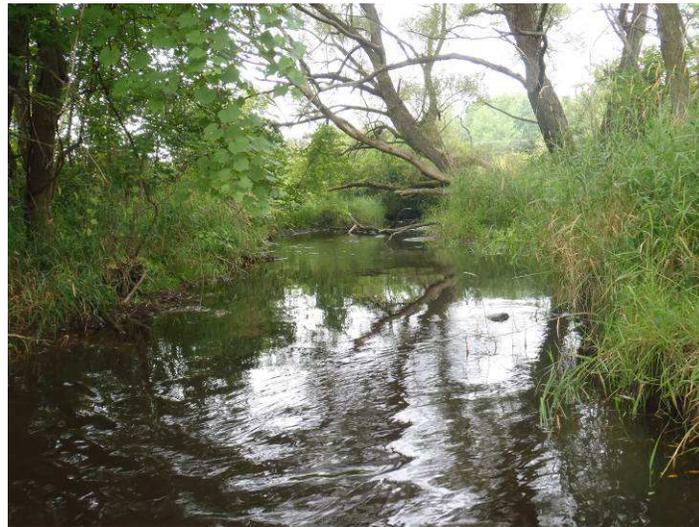
Cedar Creek at 17 Mile Road

Site 5. This glide/pool station had an Acceptable (-3) macroinvertebrate community and a Good (117) habitat score. This stretch of the creek was mostly sand substrate with silty edges and large amounts of garbage most likely from surrounding parking lots and businesses. Minimal structure was available for macroinvertebrate colonization resulting in a majority of tolerant taxa such as amphipods and physids.

The status and trend sites in the Rogue River watershed are in good condition. All sites are meeting the Other Indigenous Aquatic Life and Wildlife designated use. In general, narrow buffers between agricultural fields and streams could be increased and multiple culverts, as seen at Duke Creek Hanna Avenue (2 culverts) and Cedar Creek Friske Road (3 culverts), should be replaced with one appropriate-sized culvert or bridge for the road crossing. In addition, Cedar Creek at 17-Mile Road would benefit from stable habitat, reduced runoff from adjacent parking lots, and additional structure for macroinvertebrate colonization.

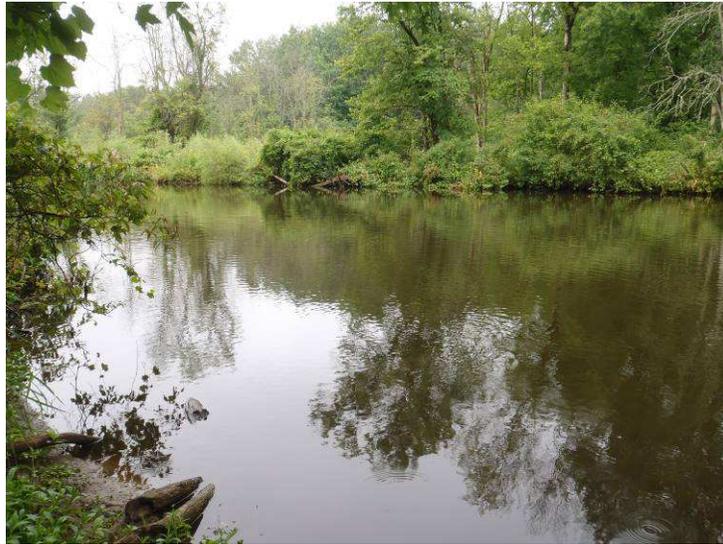
Rogue River u/s Wolverine

Site 6. This glide/pool site scored Acceptable (2) for macroinvertebrate community and Excellent (161) for habitat (Tables 5 and 6). This stretch of the river had cobble substrate with small amounts of sand, silt, and gravel. The community had high numbers of Heptageniidae (44 percent mayflies) along with a few perlids. Sediment and water samples were collected to review the site for hexavalent chromium and metals (Tables 9 and 10). The sediment sample had no exceedances of consensus-based Probable Effect Concentrations (PEC) (MacDonald et al., 2000). The water sample had no exceedances of Michigan's Water Quality Standards (WQS).

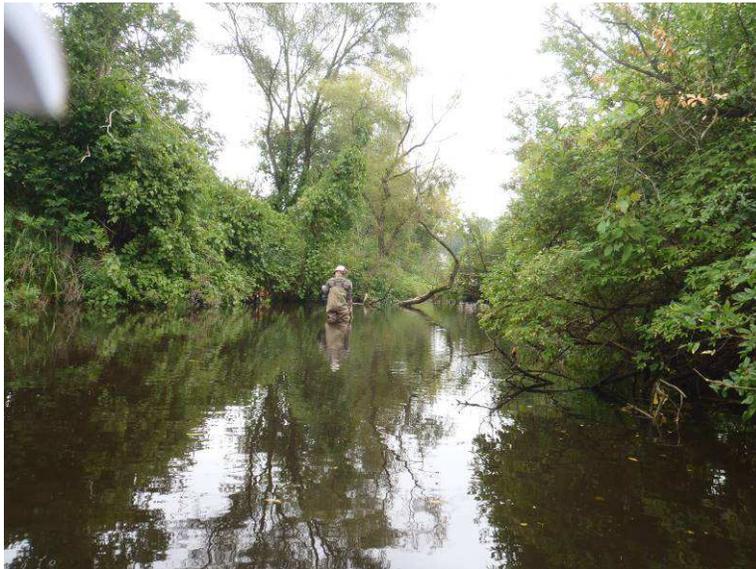
Rum Creek u/s Rogue River

Site 7. This site is a glide/pool with Poor (-6) macroinvertebrate community and Good (109) habitat score (Tables 5 and 6). The site was dominated by corixids, with high numbers of chironomids and amphipods. This is a highly disturbed site with 75 percent silt bottom and very little stable habitat for macroinvertebrates. Sediment and water samples were collected to

review the site for hexavalent chromium and metals (Tables 9 and 10). The sediment sample had no exceedances of consensus-based PECs (MacDonald et al., 2000). The water sample had no exceedances of WQS.

The Rogue River upstream of the Wolverine World Wide tannery site has acceptable macroinvertebrates and excellent habitat. Rum Creek is a highly impacted site with a silted bottom and poor macroinvertebrate scores. Upstream from the sampling location on Rum Creek is a channelized stream with concrete banks causing high levels of runoff from the Wolverine World Wide tannery site. This site would benefit from restoration by removing the concrete channel and stabilizing the banks to improve the macroinvertebrate community. The two downstream locations on the Rogue River are impounded due to the Rockford Dam. All four sites had water and sediment samples taken to assess public concerns with hexavalent chromium and metals from the Wolverine World Wide tannery site. Tanneries are known to have discharged chromium, hexavalent chromium, and arsenic. The water samples showed signs of arsenic, barium, and copper, but all samples were below Michigan's WQS. The sediment samples showed levels of arsenic, barium, cadmium, chromium, copper, lead, mercury, selenium, and zinc; but all samples were below the sediment PECs (MacDonald et al., 2000). Hexavalent chromium was not detected in the sediment or water samples.

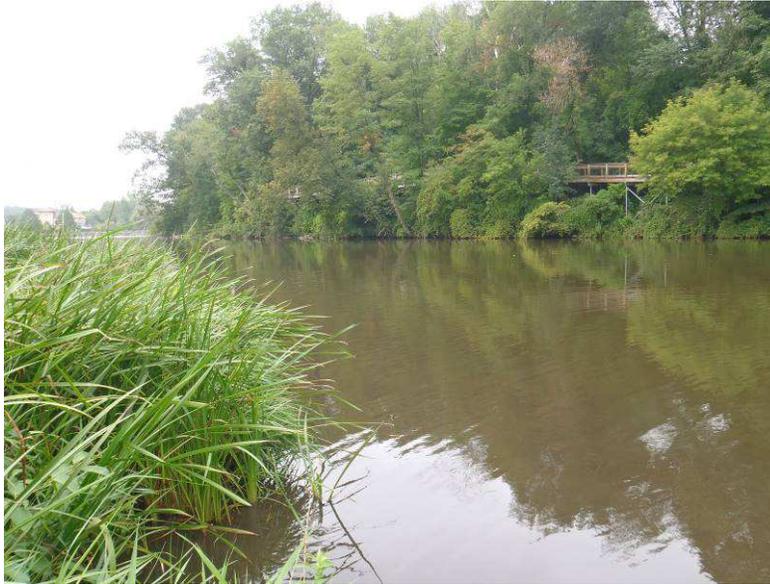
Rogue River d/s Rum Creek

Site 8. Sediment and water samples were collected to review the site for hexavalent chromium and metals (Tables 9 and 10). The sediment sample had no exceedances of consensus-based PECs (MacDonald et al., 2000). The water sample had no exceedances of WQS.

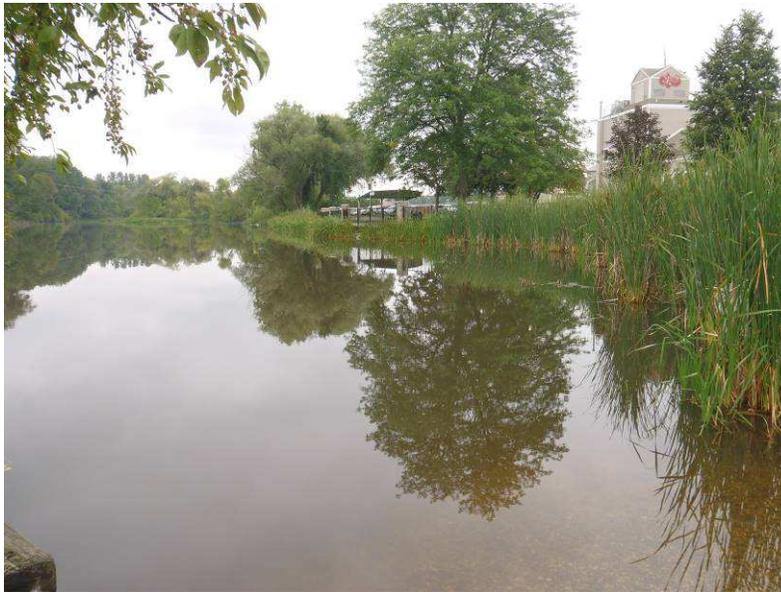
Rogue River u/s Rockford Dam

Site 9. Sediment and water samples were collected to provide data on hexavalent chromium and metals (Tables 9 and 10). The sediment sample had no exceedances of consensus-based PECs (MacDonald et al., 2000). The water sample had no exceedances of WQS.

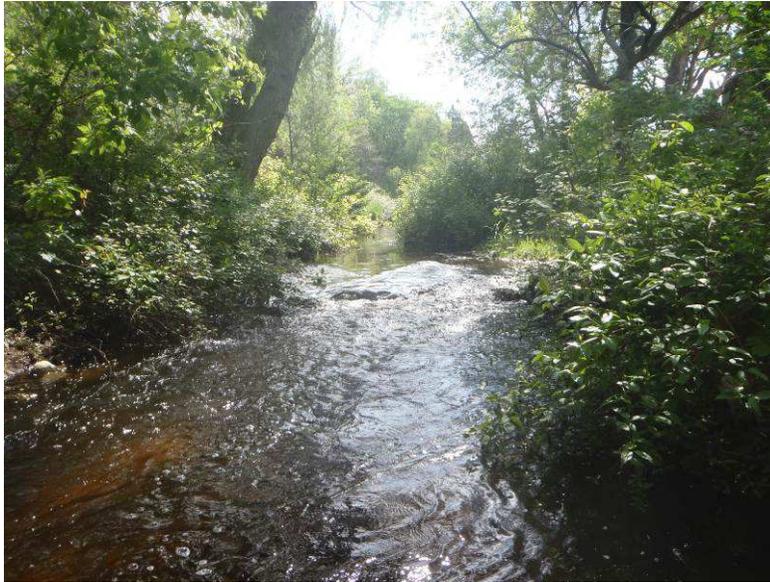
Cedar Creek at Maple Road

Site 10. This riffle/run station had a Good (151) habitat score (Table 7). This stretch had a good mix of cobble, gravel, sand, and silt substrates. There were moderate levels of structure available for macroinvertebrate colonization including undercut banks, overhanging vegetation, and large woody debris. Backpack shocking for fish provided 46 fish with a 12 percent catch of salmonids (four brown trout ranging in size of 7 to 13 inches) (Table 8).

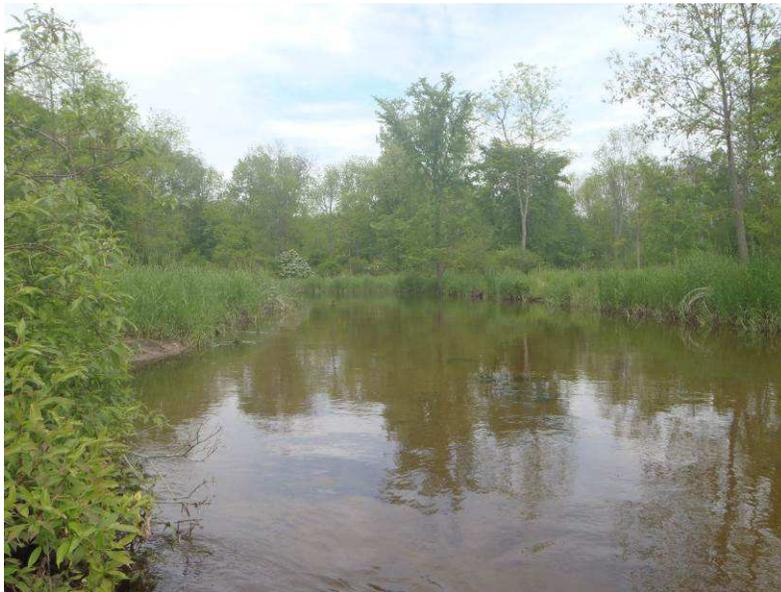
Site 11. This glide/pool station had an Excellent (162) habitat score (Table 7). The substrate through this stretch consisted of sand and gravel. The stream banks were filled with herbaceous vegetation; however, the tree canopy was lacking throughout this reach.

The targeted sites at Cedar Creek showed good cobble/gravel substrate for fish habitat. The banks along these three sites were well vegetated and did not show problems with runoff into the stream. Cedar Creek at Algoma Avenue would benefit from additional tree cover as the canopy is very open and could result in increased water temperatures. The Maple Road site was sampled for the fish community and showed 12 percent salmonids with 4 brown trout ranging in size from 7 to 13 inches (Table 8). Under the guidelines of Procedure 51, fish sampling should occur no longer than 45 minutes. During this survey, sampling occurred for 45 minutes and produced a total of 46 fish. According to the procedure, if less than 50 fish are obtained and/or less than 1 percent of the catch are salmonids, the stream should be labeled poor. After reviewing this site, it does not support a poor designation. Coldwater streams like Cedar Creek generally have fewer numbers of fish than a warmwater stream. One potential reason for a reduced number of fish at this site would be a beaver dam that was viewed upstream of the sampling location, just upstream from the White Pine Trail. Removal of the dam should improve fish passage and improve fish numbers downstream in the sampled site.

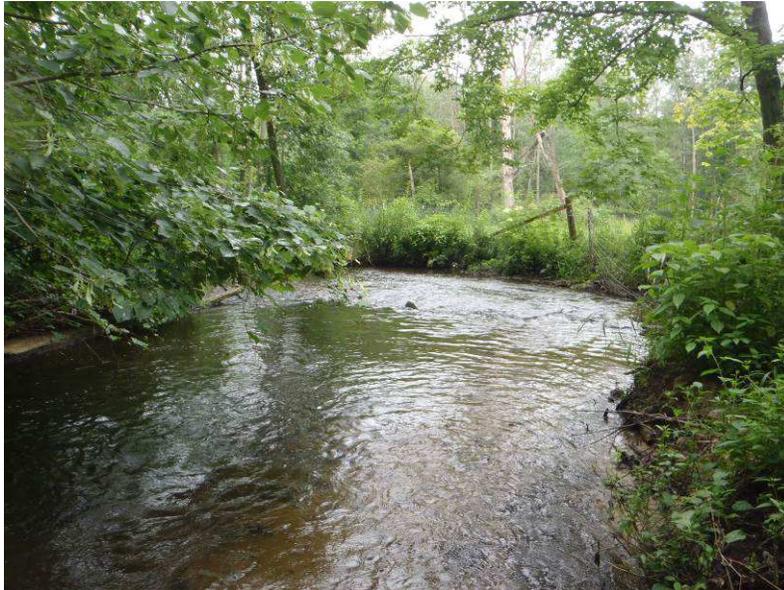
Cedar Creek at Friske Road

Site 12. This riffle/run station had an Excellent (159) habitat score (Table 7). This stretch consisted primarily of cobble substrate with gravel and some sand. Four brown trout were spotted through this stretch while assessing the habitat. The banks of the stream were well vegetated with a mix of herbaceous and tree canopy cover.
