MICHIGAN DEPARTMENT OF ENVIRONMENTAL QUALITY
WATER RESOURCES DIVISION
DECEMBER 2016

STAFF REPORT

Biological and Water Chemistry Surveys of Selected Stations in the Manistee River Watershed in Antrim, Crawford, Grand Traverse, Kalkaska, Missaukee, Lake, Manistee, Mason, Osceola, Otsego, and Wexford Counties, Michigan June-August 2014

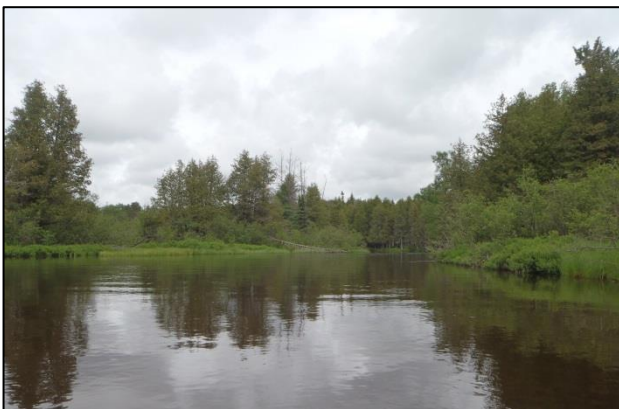
Figure 2. Manistee River off King Road

The upper portion of the Manistee River (from headwaters to US-131) was sampled at four stations (1-4). Three of the 4 stations had excellent (non-impaired) habitat ratings (Table 5) and excellent macroinvertebrate scores (Table 6 and 7). Figure 2 was one of these excellent sites and is a good representation of the size of the river in this area. The Manistee River at Cameron Bridge (Figure 3) was the most upstream station sampled and both habitat and macroinvertebrate community was rated slightly lower but at the high end of acceptable. Shifting sand deposits was the dominant substrate at this station, which may limit where macroinvertebrates can colonize. The slightly lower macroinvertebrate score is caused by a lower percentage of mayfly individuals found and a dominance of *Leptoceridae* caddisflies and *Hydracarina* (water mites), neither of which are indicative of poor water quality.

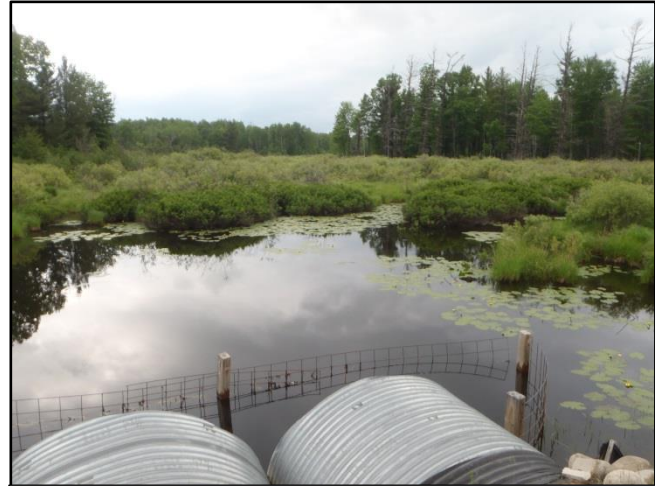
Figure 4. Black Creek at Riverview Road.

In 2014, the same location had a new culvert at Riverview Road (Figure 4). Black Creek was flowing well; however, upstream conditions were not suitable to Procedure 51 due to the natural wetland-like conditions. A macroinvertebrate community survey was not conducted but there was no indication that the macroinvertebrate community would not be meeting WQS. To confirm this assumption, Black Creek was sampled further downstream at the end of Goose Creek Road (Station 5). The glide/pool habitat was rated good (152; slightly impaired; Table 8). The substrate at this station was primarily deep deposits (greater than 2.5 feet, Figure 5) of shifting sand. The stream had a wetland-dominated riparian zone and a braided channel. Beaver activity was evident. Large woody material and overhanging vegetation were the primary epifaunal substrate. The macroinvertebrate community scored acceptable (-1; Tables 9 and 10), which is fairly low compared to the Manistee River, but is still meeting WQS. Therefore, this water body is now listed as attaining the OIALW designated use (Goodwin et al., 2016, in draft). We were not able to sample fish at this station and thus the CWF designated use remains as having insufficient information (Goodwin et al., 2016, in draft). If the CWF designated use is not being met, it is likely due to the beaver activity, lack of spawning habitat, and wetland nature of the stream, not due to a particular water quality issue.

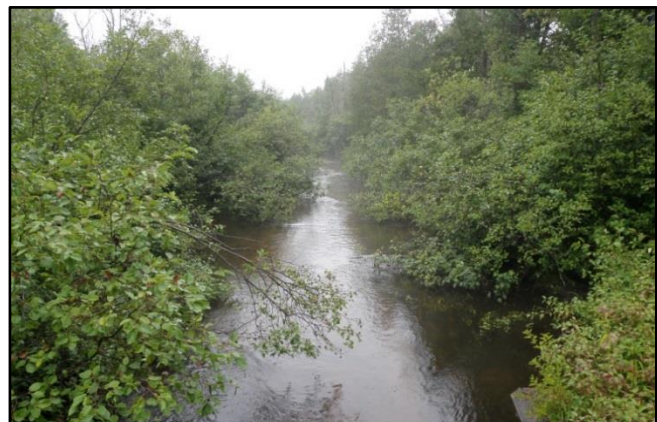
Figure 6. North Branch Manistee at Kniss Road.

Two stations (6 and 7) were sampled in the North Branch of the Manistee River watershed. The headwaters of the North Branch begin at the outlet of Manistee Lake. The confluence of the North Branch with the Manistee River is located along Sharon Road downstream of the confluence of Big Cannon Creek. Station 6 was located at Kniss Road (Figure 6) and Station 7 was located at Mecum Road. Station 6 is an MDNR status and trend station and was actually a replacement for the previous MDNR trend station at Mecum Road. More information about the Mecum Road station can be found below under Objective 3. The glide/pool habitat was rated good at both stations (153 and 145; slightly impaired; Table 8). A slight increase in sediment deposition was found at the Mecum Road station when the two are compared. The macroinvertebrate community scored excellent at both stations (Mecum (7) and Kniss (5), Tables 9 and 10). The coldwater fish community at Mecum Road included 4.6 percent salmonid species (Table 11) and is therefore meeting the CWF designated use. The road crossing at Kniss is very old and the bridge is in need of repair or replacement.

There were several road crossings that should be considered for repair or replacement. These include the North Branch Manistee River at Kniss Road (age of structure), Goose Creek at Goose Creek Road (undersized), Chief Creek at River Road (undersized), Chief Creek at Coates Highway (plunge pool), and Stronach Creek at Java Road (misaligned).

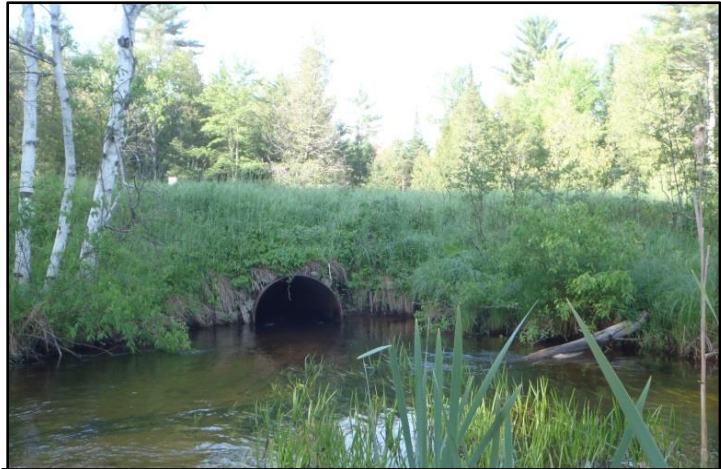
Figure 7. Upstream of Fife Lake outlet looking at East County Line Road crossing

The outlet of Fife Lake was sampled at East County Line (Number 2) Road (Station 9). This road is 12 miles downstream of Fife Lake and seven miles downstream of another small lake. The glide/pool habitat was rated at the lower end of excellent (159, non-impaired; Table 12). Epifaunal substrate was lacking cobble and gravel. Shifting sand deposition was moderate in the pools. The riparian area consisted of a wetland floodplain with emergent grasses and cattail (Figure 7). The macroinvertebrate community scored excellent (5, Tables 13 and 14). The water was relatively warm at 62 degrees Fahrenheit. This would be expected for a lake outlet.

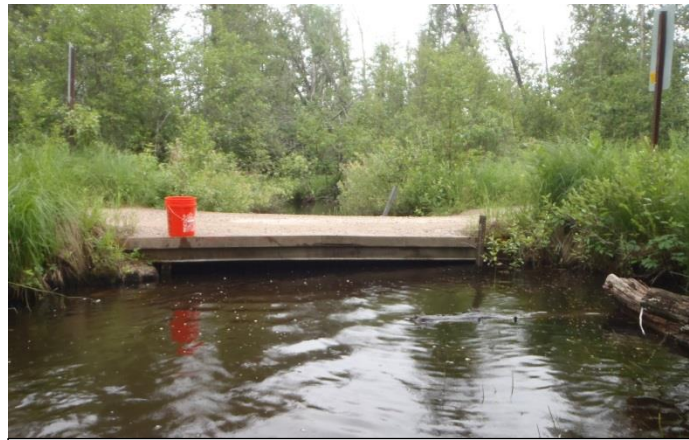
Figure 8. Road crossing over Anderson Creek at County Line Road.

Anderson Creek was sampled at County Line Road and is a trend station (Station 10), and had been sampled in 2009. The glide/pool habitat was rated good in 2014 (141, slightly impaired; Table 12). There was a large amount of siltation at this station. It was common to sink to your knees in silt along the stream margins. Fine particulate organic matter was common and although snags and large woody material were present, it was often embedded in silt. The macroinvertebrate community scored acceptable (-1, Tables 13 and 14). Contributing to this relatively low score was that no stonefly taxa were found and *Chironomidae* were dominant at nearly 40 percent. The bridge crossing at this station looks to be extremely old and if there was a flood event, it seems a large amount of sediment could potentially enter the water body (Figure 8).

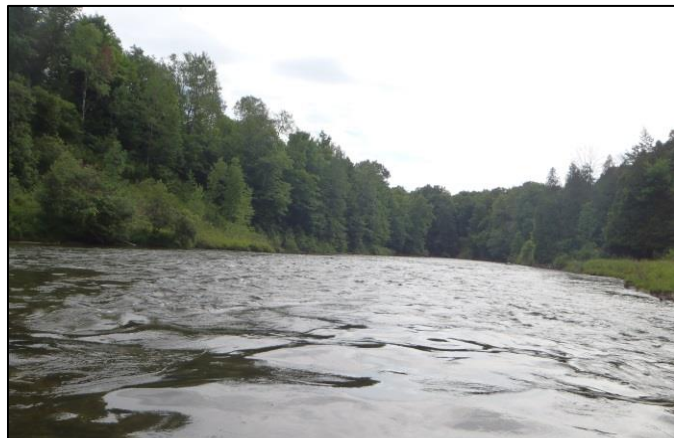
Figure 9. Manistee River downstream of Hodenpyl Dam.

The Manistee River was sampled using Procedure 51 downstream of Hodenpyl Dam off of Upper River Road (Station 11). This station was initially planned as a nonwadeable station and was reached by boat (Figure 9). Upon arrival, SWAS biologists found that a majority of the reach was wadeable. The riffle/run habitat was rated excellent (162, non-impaired; Table 12) with relatively unstable banks, which is not uncommon in the middle and lower portions of the Manistee River. The current was extremely fast at this station and the estimated flow was determined to be 896 cubic feet per second. Large woody material, cobble, and gravel were the dominant epifaunal substrates. The amount of large woody material was fairly sparse and pushed against the river banks. The macroinvertebrate community scored acceptable (0, Tables 13 and 14). No stonefly taxa were found and only two mayfly families. Although it was not deep, sampling all habitats for a large length of river in the fast current was difficult. This station was a status station and if it is ever sampled again, it may be best to use the nonwadeable procedure or use a boat to travel to a variety of habitats over a longer reach of river.

The relatively low score (0) found in the Manistee River downstream of Hodenpyl Dam (Station 11) may be artificially low. Although the reach was wadeable, the current was very quick, and it was difficult to sample all available habitats using the wadeable Procedure 51. If this reach of stream is sampled in the future, the nonwadeable Procedure 22 could be considered for use or alternatively, a boat could be used to get to various habitat types since parts of the reach was nonwadeable.

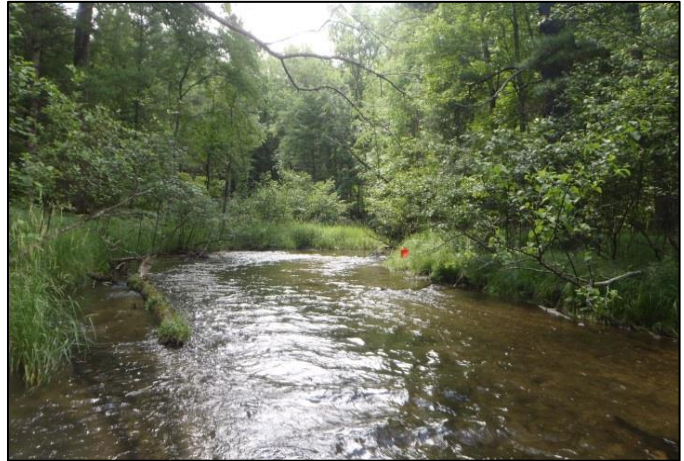
Figure 10. Slagle Creek downstream of S 1 Road.

Slagle Creek was sampled downstream of S 1 Road (Figure 10; Station 12). This is a trend station and thus was sampled in 2009 as well. The riffle/run habitat was rated as excellent (171; non-impaired; Table 12). Epifaunal substrate consisted of gravel mixed with sand and some cobble. There was a large amount of periphyton, filamentous algae, and macrophytes throughout the reach. Vegetation was not at nuisance levels, but was denser than what is typically found in a stream of this size in the Manistee River watershed. The macroinvertebrate community was rated excellent (5) in 2014 (Tables 13 and 14) and acceptable tending towards excellent (3) in 2009 (Lipse, 2010). Based on the macroinvertebrate community, the OIALW designated use is being met.

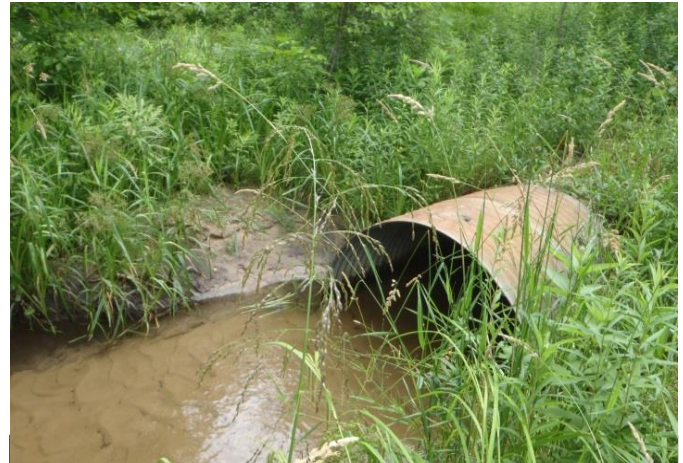
Figure 11. Peterson Creek downstream of 7 Road.

Peterson Creek was sampled downstream of S 7 Road (Figure 11; Station 13). This is a trend station and was sampled in 2009. The glide/pool habitat was rated as good (142; slightly impaired; Table 15). Substrate was dominated by sand with a large amount of large woody material. In an adjacent wetland floodplain area sand could be seen as far back as 30 feet, indicating there is a large amount of sand in this stream during high flow events. As noted in 2009, the road crossing culvert is undersized. The macroinvertebrate community was rated excellent (7) in 2014 (Tables 16 and 17) and in 2009 (Lipse, 2010). This high excellent score is one of five (>7) that was found in the Manistee River watershed in 2014, indicating Peterson Creek is a comparatively high quality water body despite the amount of sedimentation observed. This water body may be one of interest to watershed groups seeking areas that may be in need of attention for protection.

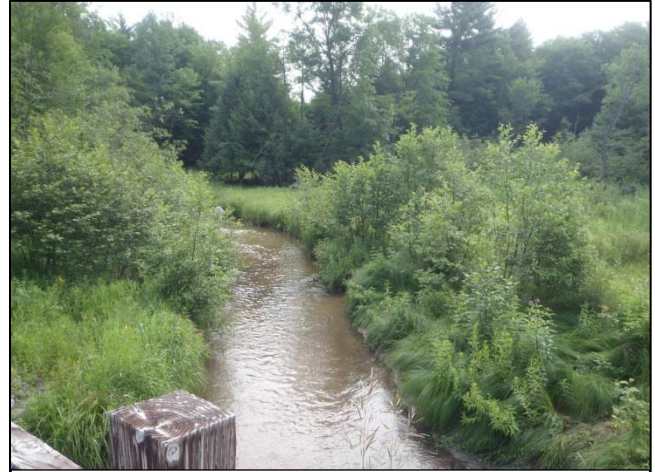
Figure 12. Poplar Creek at 15 Road.

Poplar Creek is a tributary to the Pine River and was sampled at 15 Road (Figure 12; Station 14). This is a trend station and was sampled in 2009. The glide/pool habitat was rated as good (132; slightly impaired; Table 15) in 2014. Substrate was entirely sand with an abundance of embedded large woody material. Undercut banks were extensively available for epifaunal substrate. The riparian area was wetland in nature and beaver activity was noticeable, but the beaver dam observed in 2009 was gone. The macroinvertebrate community was rated acceptable in both 2014 (Tables 16 and 17) and 2009 (Lipsey, 2010) (scores 1 and 3, respectively).

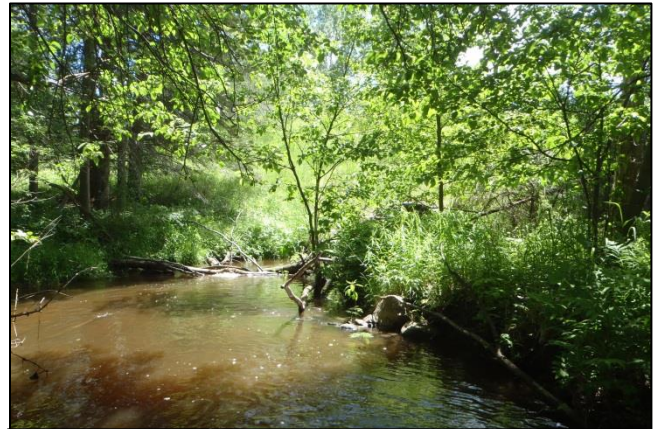
Figure 13. Coe Creek at 20 Mile Road.

Coe Creek is a tributary to the Pine River and was sampled at 20 Mile Road (Figure 13; Station 15). The creek is in a fairly deep valley with a good size riparian zone on the left side when looking downstream. The right side riparian area was bordered by an agriculture field 50 feet from the edge of the stream. The riffle/run habitat was rated good (135, slightly impaired; Table 15). Epifaunal substrate included cobble, boulders, large woody material, and undercut banks. The macroinvertebrate community scored excellent (8, Tables 16 and 17). This was the highest score of the stations sampled in the Manistee River in 2014. A large variety (7 families) of caddisfly (Trichoptera) taxa were found, which is indicative of good water quality.

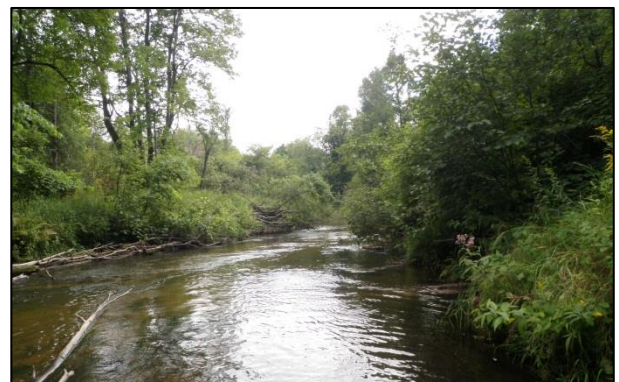
Figure 14. Pine River at 230th Avenue, upstream of access site, looking downstream.

Four stations were sampled on the Pine River (Stations 16-19). The most upstream station was located at 230th Avenue (Figure 14; Station 16). This station was targeted because it is a fixed, long-term trend station for the MDNR, Fisheries Division, and corresponding macroinvertebrate data will complement the Fisheries Division's fish community and habitat data.

In the winter of 2010/2011 a fish cover project was completed in the reach. Large woody structures were placed along the stream edges and out into the channel to provide habitat for salmonids and concentrate flow in the middle of the channel to expose gravel substrate and develop deeper pools (Mark Tonello, MDNR, Fisheries Division;

personal communication). In 2014, the riffle/run habitat was rated excellent (155; non-impaired; Table 18). The river ran very fast at this station with many deep scour pools, which limited access for sampling. Sand, gravel, cobble, and boulders were available for epifaunal substrate and were approximately 40 percent embedded. Attached algae were present on the larger boulders and cobble, and the large piles of woody material were observed. The macroinvertebrate community scored acceptable (1, Tables 19 and 20). *Pteronarcyidae* and *Perlidae* stoneflies, which are indicative of good water quality, were collected. However, no caddisflies were collected, which is unusual for high quality water bodies.

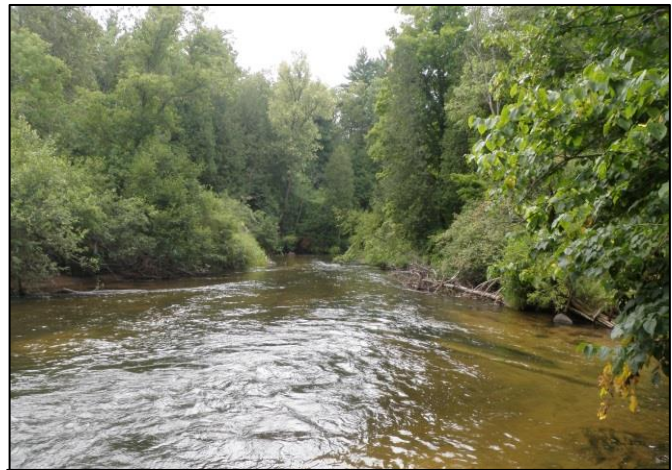
Figure 15. Pine River at Skookum Road canoe launch.

Station 17 was located at the Skookum Bridge canoe launch (0.6 miles downstream of North Skookum Road; Figure 15). The riffle/run habitat was rated excellent (155; non-impaired; Table 18). The river ran very fast at this station with many deep scour pools at the bends, which limited access for sampling. The pools had sandy bottoms with gravel embedded in the riffles by 40 percent. Cobble and large wood provided epifaunal substrate. Some erosion was evident at the bends and sand deposits were evident on the elevated floodplain indicating that spring runoff or other high flows are a source of sediment to the stream banks. A large amount of attached algae and periphyton was observed on the cobble. The macroinvertebrate community scored acceptable (1, Tables 19 and 20).

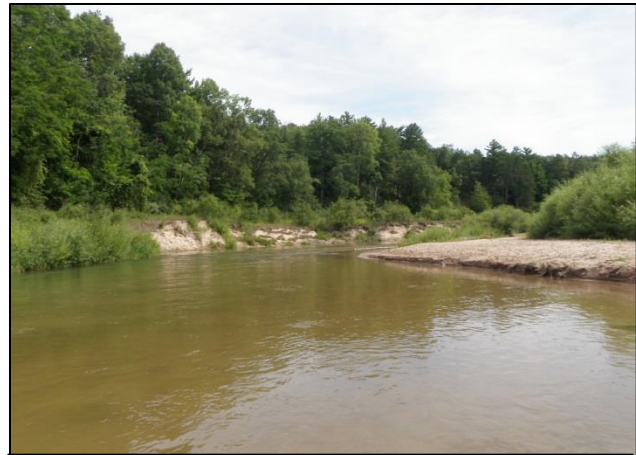
Figure 17. Pine River at Stronach Dam Road.

The most downstream station sampled on the Pine River was Station 19 at the end of Stronach Dam Road (Figure 17). The glide/pool habitat scored Good (105; slightly impaired; Table 18). However, the habitat was much different than that observed at the upstream three stations. The river had much less habitat diversity with a very flat sandy area observed at the outside bend. Large woody structures were not abundant. Gravel was only available in the thalweg (fastest flowing and deepest part of the stream). The macroinvertebrate community scored acceptable (1; Tables 19 and 20), similar to the other reaches sampled on the Pine River.

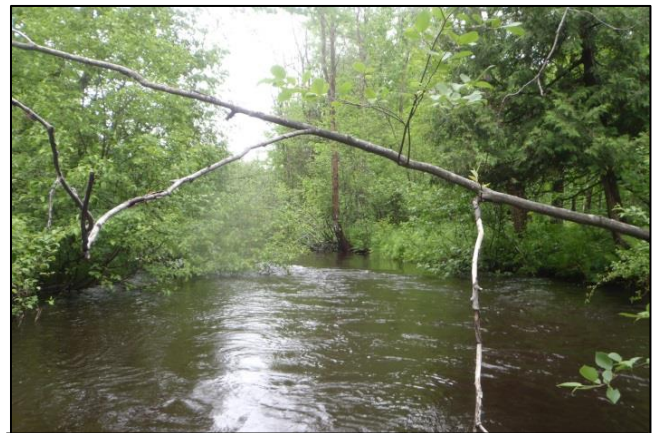
Figure 18. Bear Creek at Leffew Road.

Bear Creek is a tributary to the Manistee River that flows from north to south. The headwaters begin near Bear Lake, located adjacent to US-31, and the confluence with the Manistee River is downstream of Pine Creek. Three stations were sampled in Bear Creek. The most upstream Station 20 was sampled at Leffew Road where a bridge is no longer in service (Figure 18). This is an MDNR, Fisheries Division, status and trend site and was targeted for sampling so that complementary macroinvertebrate data are available for this station. The riffle/run habitat scored excellent (173; non-impaired; Table 21). The creek was a bit high with a fast current due to a recent rain event, making it difficult to see the habitat well. Gravel and cobble were available for epifaunal substrate with some depositional area also evident. Alders and ferns made up the very natural and extensive riparian area. The macroinvertebrate community scored acceptable (2; Tables 22 and 23). Despite the fact that several, pollution-sensitive, *Ephemeroptera*, *Plecoptera*, and *Trichoptera* family taxa were found at this station, there were also several individuals found that are more tolerant to pollution including 38 percent *Amphipoda* and several (6 percent) *Isopoda*. This is not an indicator of poor water quality since the sensitive taxa were found, but is somewhat unique for the 2014 surveys.

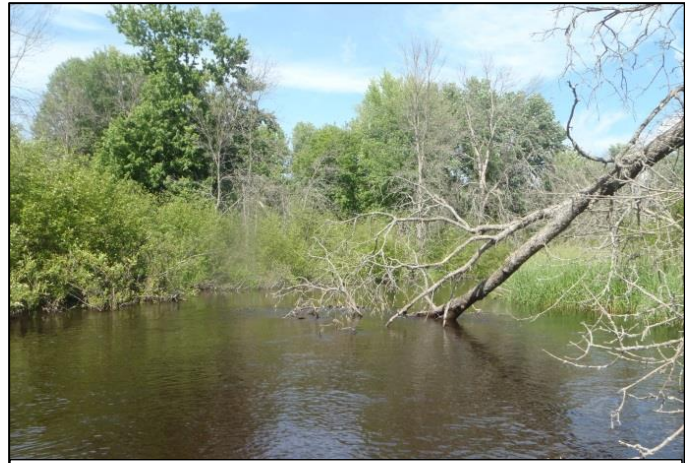
Figure 19. Bear Creek at 13 Mile Road.

Station 21 was sampled in Bear Creek at 13 Mile Road (Figure 19). The glide/pool habitat scored good (140; slightly-impaired; Table 21). Shifting sand and silt dominated the substrate at this site. The aquatic macrophyte *Elodea* and overhanging brush were the dominant epifaunal substrates. The road bridge at this crossing had been recently replaced and vegetation had not yet established resulting in erosion of the bank adjacent to the bridge. The macroinvertebrate community scored at the lower end of acceptable (-2; Tables 22 and 23). A large number of amphipods (54 percent) and a low percentage of caddisfly and mayfly taxa (10 percent and 17 percent, respectively) were found at this station resulting in a lower score. This site should be revisited in future biosurveys to determine if this unusually low score for the Manistee River watershed persists.

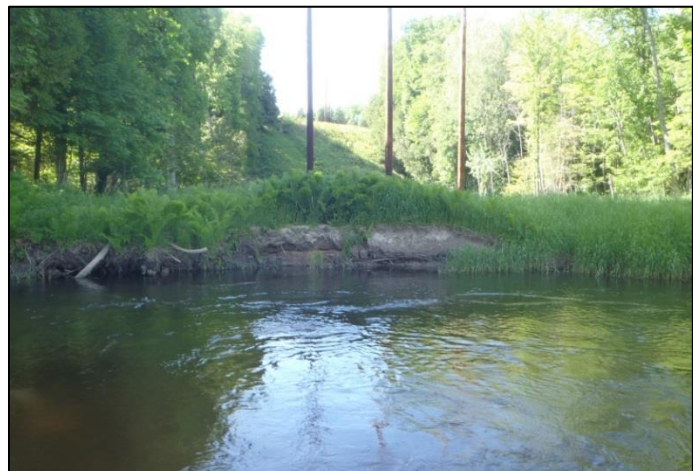
Figure 20. Bear Creek at Coates Highway.

Station 22 was sampled at Coates Highway (Figure 20). The riffle/run habitat scored good (140; slightly-impaired; Table 21). Sand dominated the substrate at this station, especially near the road crossing, but more gravel was available upstream of the first bend. A large pile of woody material slows down the water at the inside of the bend and much of the sand settles out. There is a large amount of sediment deposition at the bend suggesting a large sediment load moving through the stream during high water events. A powerline right-of-way impacts the riparian zone at this site with the removal of trees. The macroinvertebrate community scored excellent (6; Tables 22 and 23) with 4 stonefly taxa found. This large number of stonefly families is somewhat uncommon and an indicator of high water quality.

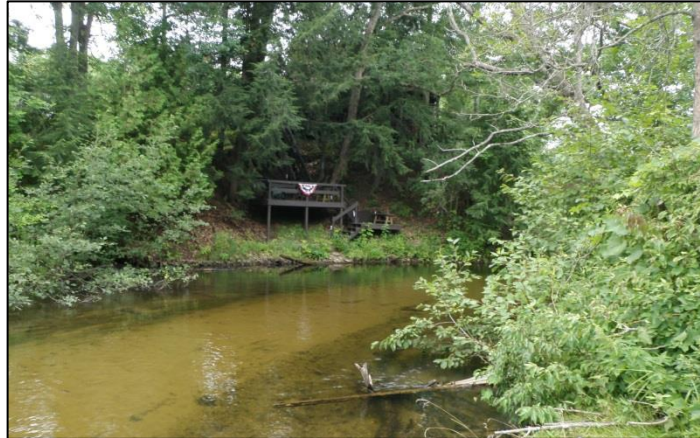
Figure 21. Little Manistee River upstream of Johnson's Bridge.

The Little Manistee River was sampled at two stations. Station 23 was sampled upstream of Johnson's bridge off of private property (Figure 21; Table 24). This station is an MDNR, Fisheries Division, status and trend site and was targeted for SWAS sampling so that complimentary macroinvertebrate data are available for this station. The habitat datasheet for this station was misplaced but it is likely to have scored at the high end of good or low end of excellent. Gravel was present but was very embedded by sand. Large woody structures were available as well as overhanging vegetation. The riparian area on the right bank was dominated

by mowed lawns and the left bank was more natural but very steep. The macroinvertebrate community scored acceptable (2; Tables 25 and 26) with *Chironomidae* dominating (47%) the taxa found. The domination of one family of macroinvertebrates can be an indicator of an environmental stress. However, two stonefly taxa and several caddisfly and mayfly taxa were also found, which are less tolerant of pollution and suggest good water quality.

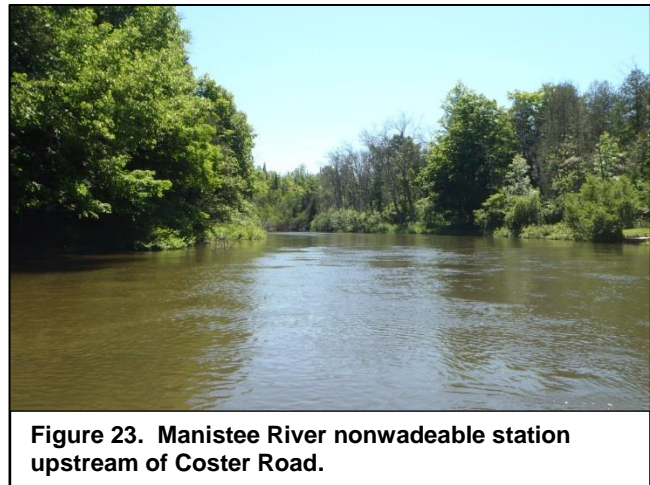
Figure 23. Manistee River nonwadeable station upstream of Coster Road.

Four additional stations on the main branch of the Manistee River were assessed using the SWAS Procedure 22 (MDEQ, 2013). These four stations are labeled NW-1, NW-2, NW-3, and NW-4, (Table 4 and Figure 1). The most upstream station NW-1 was sampled at Coster Road (Figure 23) and was accessed via the boat launch at this crossing. NW-2 and NW-3 were accessed via private property off of River Road. NW-5 was the most downstream station, located approximately 5.2 miles upstream of Caberfae Highway. It was accessed via private property off Peterson Road. Macroinvertebrate community scores were good or excellent (Appendix A).

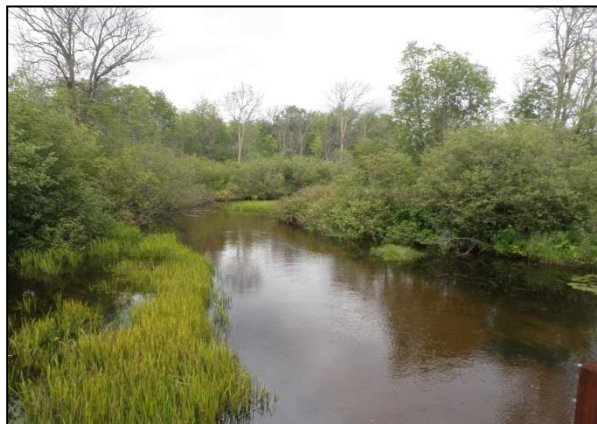
Figure 24. North Branch Manistee River at Mecum Road.

The road crossing at Mecum Road over the North Branch of the Manistee River was replaced in 2012. This crossing previously included five separate culverts placed side by side that restricted the flow of the river and prevented sediment transport. The five culverts were replaced with a timber bridge. Previous to the culvert replacement the MDNR, Fisheries Division, had sampled the North Branch Manistee River at Mecum Road from 2002-2004 and again in 2008 (Tonello, 2015). During the 2008 survey, only two brook trout were caught. It was noted that the habitat within the reach had changed dramatically since the 2004 survey. Silt and sand had filled deeper holes

that formerly provided habitat for trout. The river resembled more of an impoundment than a stream due to numerous kinds of aquatic vegetation and northern pike that were present within the reach (Tonello, 2010). In 2014, SWAS staff conducted fish and macroinvertebrate community and habitat sampling using Procedure 51 at this station (Figure 24). Macroinvertebrates were rated as excellent (7; Table 10), habitat was rated as good (145; Table 8), and salmonid species were 4.6 percent of the fish captured (Table 11). This meets the 1 percent ratio needed to meet the CWF designated use.

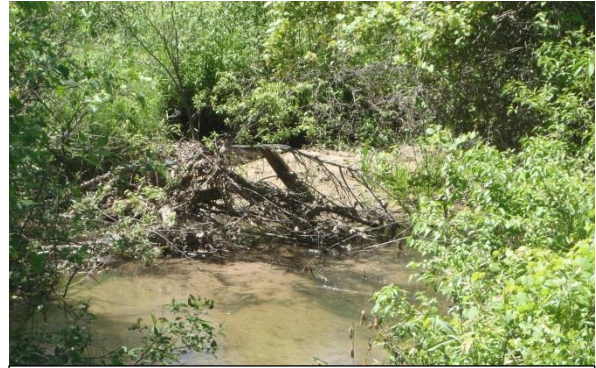
These two stations were observed for NPS of pollution. The culvert at the River Road crossing may be undersized. Chief Creek seems to widen upstream of the culvert and woodchips and sediment deposits were evident (Figure 25), which indicates water likely gets backed up during high flows. A plunge pool is present at the Coates Highway road crossing and the culvert should be replaced to allow for fish passage. The macroinvertebrate community was not assessed at these stations in 2014.

Figure 25. Chief Creek at River Road. Sedimentation upstream of road.

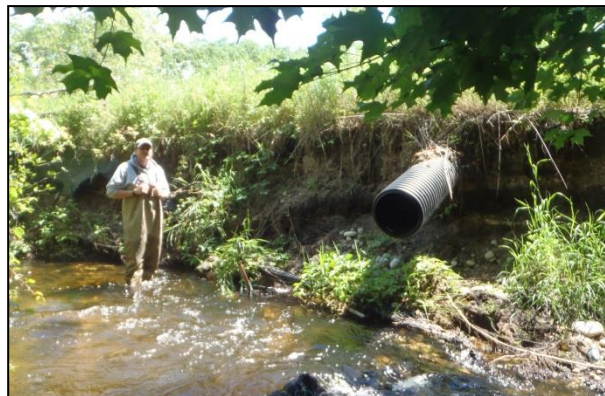
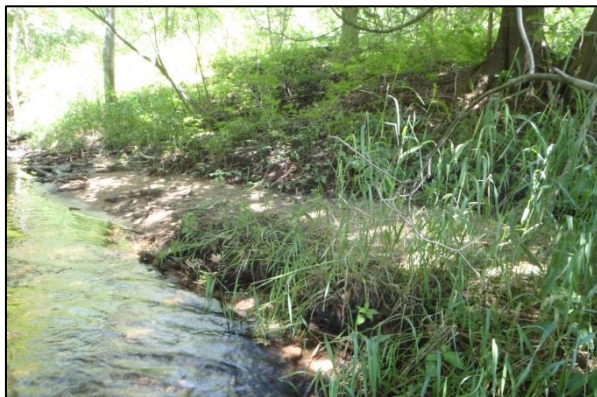
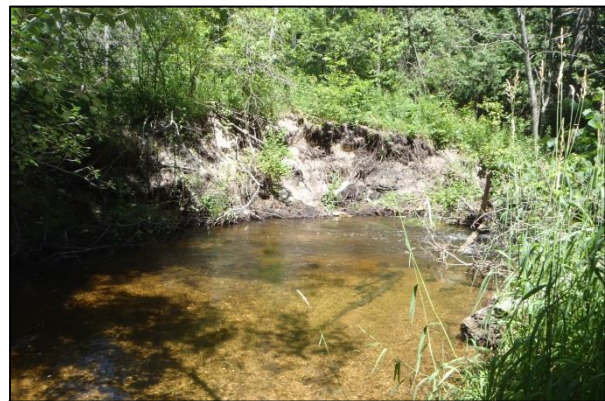
Figure 26. Cedar Creek at Oravainen Road.

Cedar Creek at Oravainen Road was visited in 2009 and revisited in 2014 due to bank stabilization issues that are the result of construction of a pond that periodically discharges to Cedar Creek via an overflow pipe connection. Erosion issues continue at this site (Figures 26, 27, and 28) and efforts to work with the landowner to remediate the impacts would be beneficial to reduce sediment input to the stream.

Bank erosion issues in Cedar Creek at Oravainen Road due to the outfall of a constructed pond adjacent to the creek and in Cool Creek at 12-Mile Road due to cattle access were observed in both 2009 and 2014. Efforts to work with the landowners at each of these stations to remediate impacts would be beneficial to reduce sediment input to the stream. Staff of the Department of Agriculture and Rural Development should be consulted prior to 2019 watershed sampling to determine if actions have been taken to rectify the cattle access issue in Cool Creek, thereby necessitating additional monitoring to document impairment or improvement.

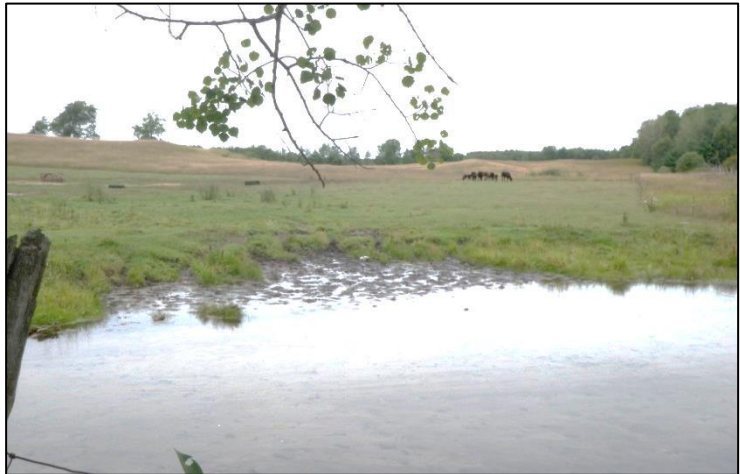
Cattle have direct access to approximately 300 feet of Cool Creek at 12 Mile Road and banks are being trampled causing erosion (Figure 29). Access is limited to north of 12-Mile Road. Water and macroinvertebrate community samples were not collected due to time constraints. In the future, if landowner access is granted, Cool Creek could be assessed upstream and downstream of the cattle access, south of 12-Mile Road. Cool Creek flows from south to north and then south again across 12-Mile Road. It is the MDEQ's understanding that Right to Farm personnel has been alerted to the issue. Staff of the MDEQ, NPS Unit, and Michigan Department of Agriculture and Rural Development should be consulted prior to 2019 watershed sampling to determine if actions have been taken to rectify the problem, thereby necessitating additional monitoring to document impairment or improvement.

Figure 29. Cool Creek upstream (north) of 12-Mile Road. Cattle access causing erosion and sedimentation.
