MICHIGAN DEPARTMENT OF ENVIRONMENTAL QUALITY  
WATER RESOURCES DIVISION  
NOVEMBER 2017

STAFF REPORT

A BIOLOGICAL AND PHYSICAL SURVEY OF SITES IN THE  
MANISTIQUE AND MILLECOQUINS WATERSHEDS  
ALGER, CHIPPEWA, DELTA, LUCE, MACKINAC, AND  
SCHOOLCRAFT COUNTIES, MICHIGAN  
JULY AND SEPTEMBER 2014

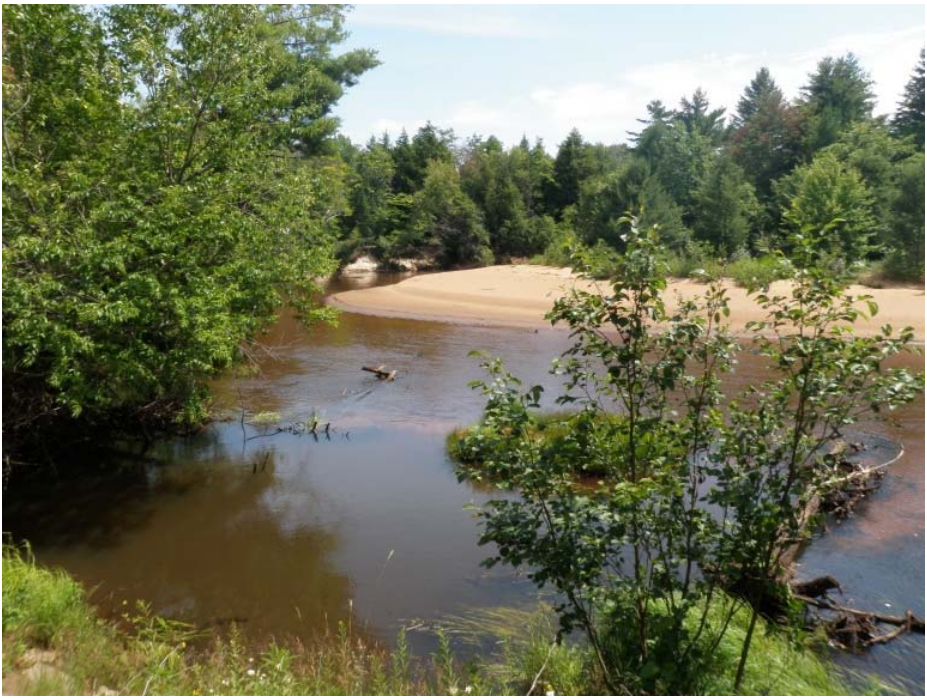
**Figure 2. Site 15-- West Branch Manistique River sand deposition issues.**

Two sites (5 and 15) were surveyed on the West Branch Manistique River. Both locations scored “excellent” for invertebrates and “good” for habitat. These sites had issues with sand deposition in the stream channel and along the banks (Figure 2), which limited in-stream habitat and led to lowered scores in the habitat category. In-stream invertebrate habitat consisted mainly of large woody debris and aquatic vegetation.

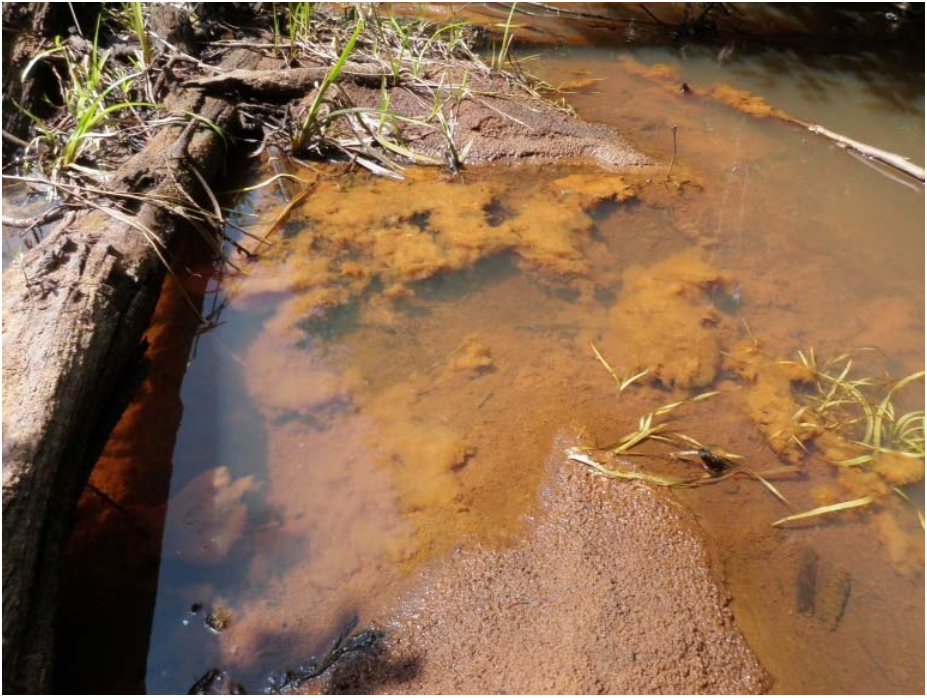
**Figure 3. Iron-oxide deposits located at Walsh Creek (Site 12).**

One site (12) was surveyed on Walsh Creek inside the Seney National Wildlife refuge. Upstream of this location was the focus of a large wetland restoration project conducted within the Seney National Wildlife Refuge (Bork et al., 2013). The survey was conducted downstream of the outlet of the wetland restoration water control structures. Likely due to groundwater or upstream inputs of dissolved iron, significant iron-oxide deposits covered many of the in-stream surfaces (Figure 3). These types of deposits can occur on hot, dry days where flows are sluggish as were the conditions on the day this site was sampled. Invertebrates and habitat scored “excellent.”

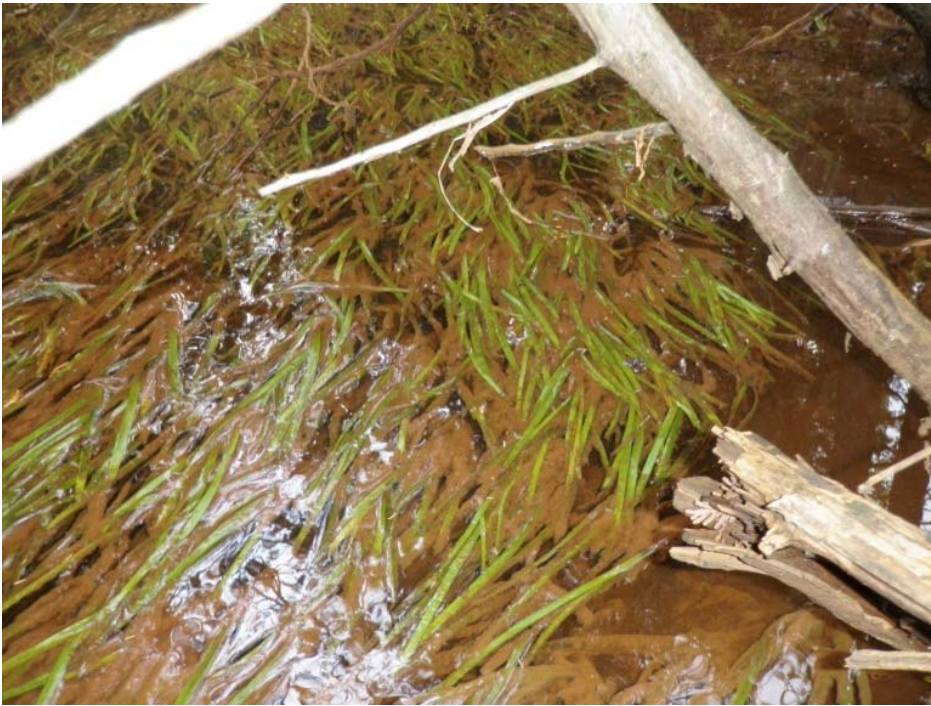
**Figure 4. Iron oxide and aquatic macrophytes located at the site on the East Branch Tahquamenon (3T).**

This location (3T) was pulled as a replacement for a targeted location that had to be dropped due to site condition changes that were discovered. Although outside of the Manistique and Millecoquins watersheds, this site was completed to satisfy statewide trend goals. Rust colored iron oxide deposits and aquatic macrophytes were significant at this location (Figure 4). The abundance of invertebrates was noted as being relatively low as one-half of the entire sample was sorted before 300 individuals was achieved. Invertebrates scored 4 or “acceptable,” which is higher than in 2009 when it scored -1. Habitat scored “good.”

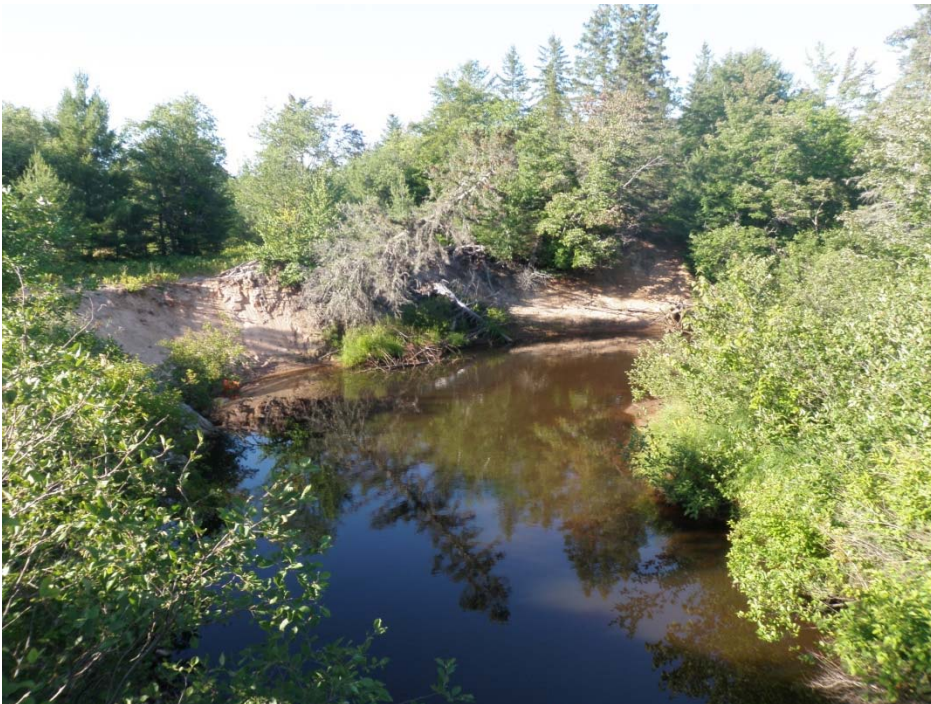
This site (11T) had heavy sand deposits and the banks showed signs of continued erosion (Figure 5). Large woody debris was relatively abundant providing stable in-stream habitat in areas. Invertebrates scored 5/ "excellent" and habitat scored "good."

**Figure 5. Creighton River (Site 11T) bank erosion.**
