MICHIGAN DEPARTMENT OF ENVIRONMENTAL QUALITY
WATER RESOURCES DIVISION
DECEMBER 2016

STAFF REPORT

A BIOLOGICAL SURVEY OF THE CENTRAL UPPER PENINSULA WATERSHEDS OF
THE AU TRAIN-CHOCOLAY, CEDAR-FORD, ESCANABA, RAPID-WHITEFISH, AND
FISH DAM-STURGEON RIVERS
MARQUETTE, ALGER, DICKINSON, DELTA, AND MENOMINEE COUNTIES
JUNE AND JULY 2015

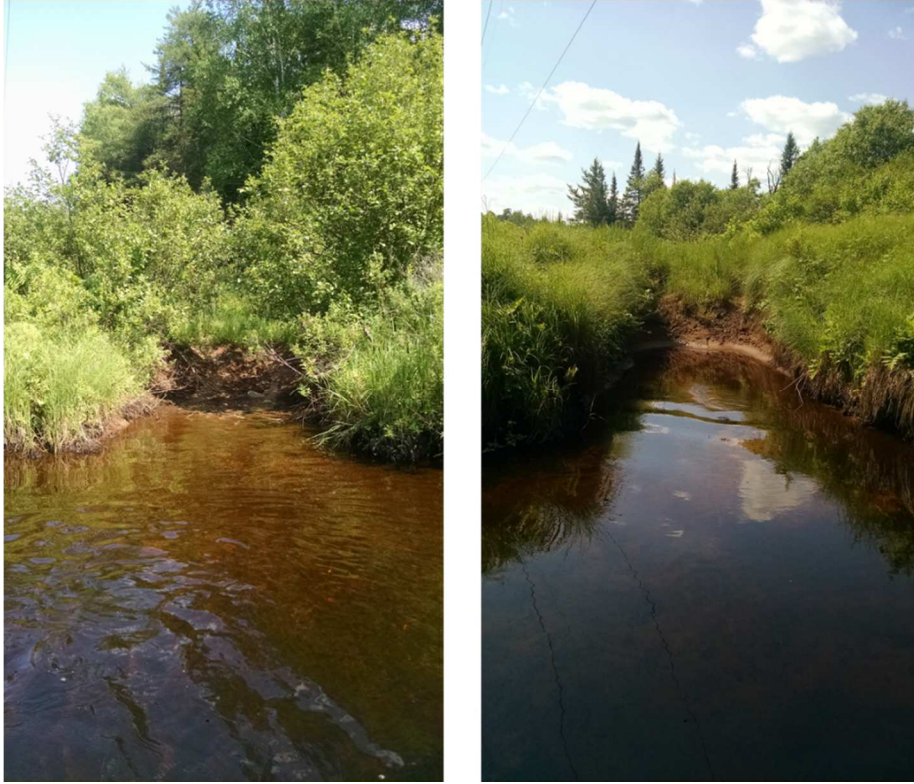
Figure 2. Left (left) and right (right) banks where trucks had driven through the river at Station 3.

Station 3 was sampled at a two-track off of County Road Ch, although the site needed to be accessed from a two-track off of a county road to the east of the river because of impassable road conditions off of County Road Ch. The macroinvertebrate community scored excellent (7: Tables 2A and 2B) and habitat scored good (153: Table 3). Thirty-two different taxa were collected at that station, 18 of which were EPT, indicating good water quality conditions. The water temperature was cold at the time of sampling (58° F) despite an air temperature of 82° F. The bottom substrate was mostly gravel, which provided the most potential habitat for macroinvertebrates. The only other stable habitat that was moderately available was overhanging vegetation. Otherwise, habitat types such as large woody debris and undercut banks were generally lacking. The majority of the station had intact riparian vegetation and the surrounding landscape is mostly intact forest. There was, however, a ~90-foot wide powerline swath, devoid of large trees, that is immediately adjacent to the access point of the monitoring location. Also within the power line swath is a two-track road. The two-track went all the way down to the river and, at one time, trucks had obviously driven through the river, causing localized stream bank erosion on the left and right banks (Figure 2). Both of the two-tracks were largely impassable at steep inclines of the river valley, largely as a result of gully erosion in the two-tracks. Because of the impassability, there did not appear to be any recent vehicle activity at the road crossings. Some vegetation was starting to regrow in the eroded areas, although some bare soil spots were still present.

The Willow and Portage Creek sites should be revisited during the next basin year when construction of the new shopping center is complete to assess any potential impacts the added development may have in the streams. Stations 19 and 23 are trend sites that will be revisited during the next basin year and the areas of erosion concern can be assessed again. Station 3

likely does not need to be revisited since the two-track that used to lead to the river is now impassable.

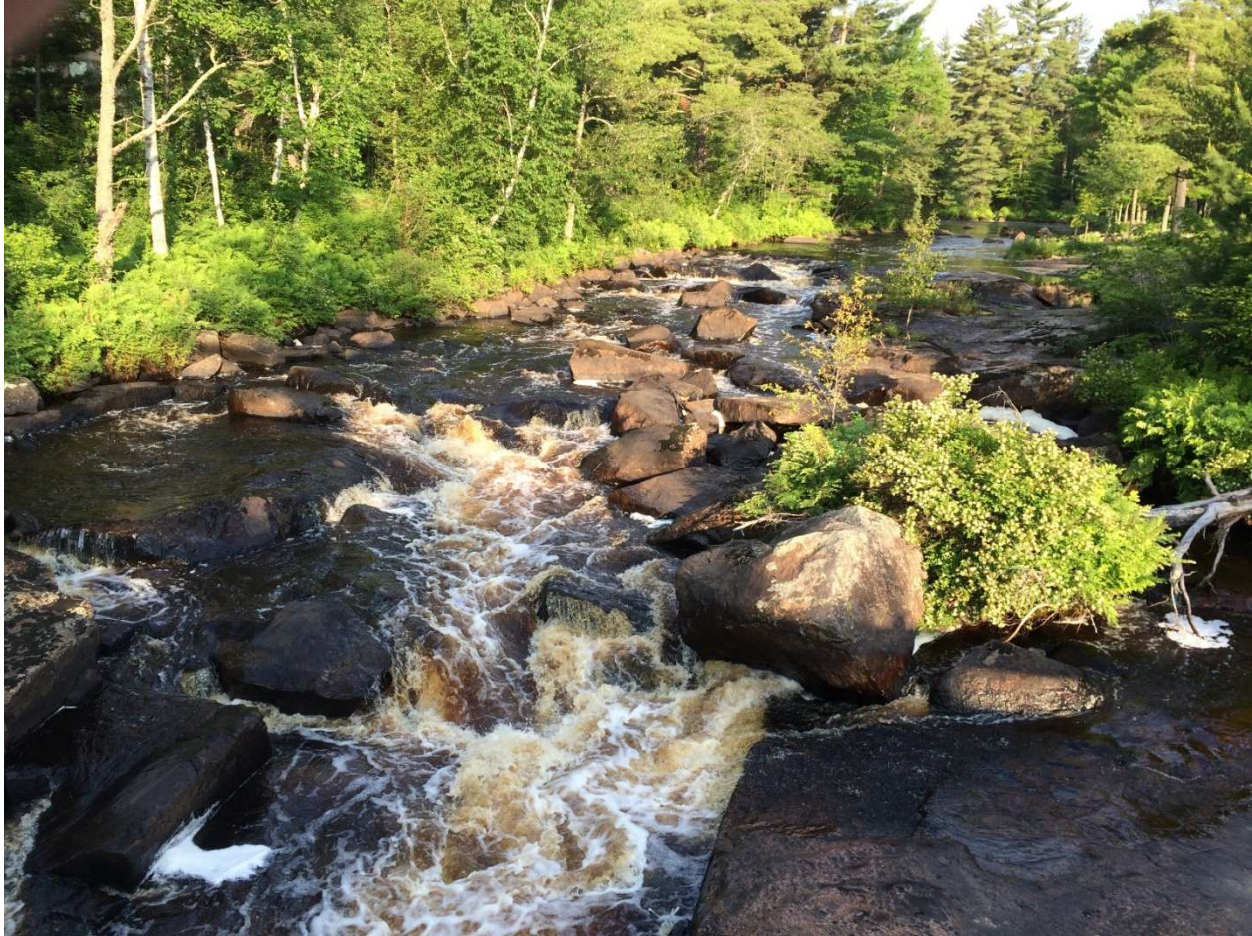
At Station 12 both the macroinvertebrate community and habitat scored excellent (macroinvertebrates: 5 [Tables 2A and 2B], habitat: 175 [Table 3]). Thirty different taxa were collected at Station 12, 15 of which were EPT, indicating high water quality. The station was characterized by the presence of large boulders and cobble, with large, cascading rapids (Figure 3). Other than the predominance of rock substrate, other stable habitat types such as large woody debris and plants were either sparse or absent. Several residential lots in the immediate area diminished the amount of riparian vegetation; however, most of the surrounding area is intact forest.

Figure 3. Station 12: Middle Branch Escanaba River at County Road 565.

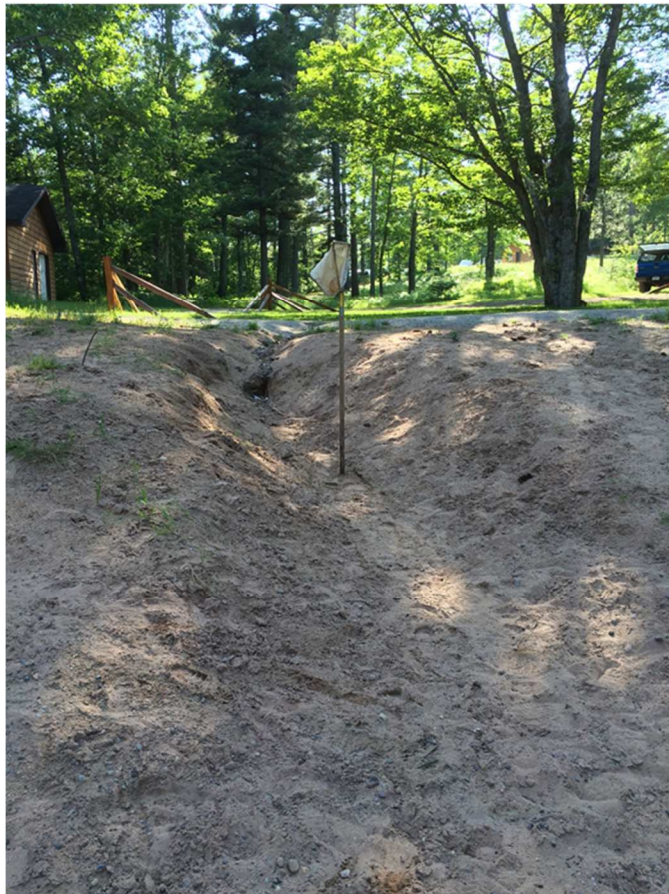
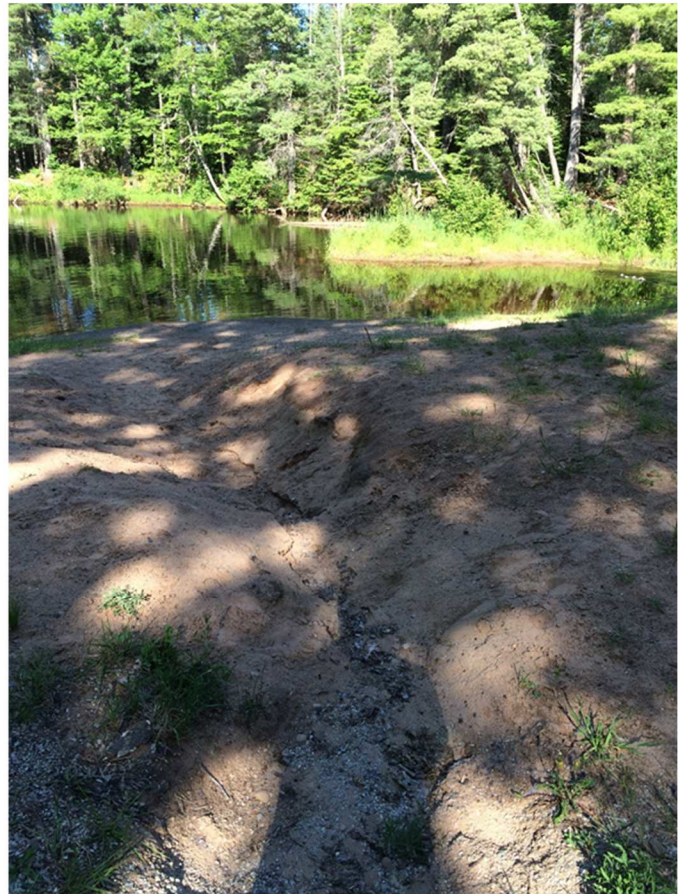
Figure 4. Gully erosion at beach immediately upstream of Station 19.

The macroinvertebrates at Station 19 scored high acceptable (4: Tables 2A and 2B) and habitat scored excellent (162: Table 3). The bottom substrate was mostly gravel (~70%) with the remaining substrate being sand with some cobble. Large woody debris was moderately available, but other habitat types such as undercut banks and overhanging vegetation were sparse. Thirty-one different taxa were collected, 13 of which were EPT, indicating high water quality. The macroinvertebrate score at this station was the same as Taft (2011) reported and the habitat score assigned in 2015 to this station was similar to the one given by Taft (2011; 159). Immediately upstream of Station 19 is a campground beach on the right bank. In one area of the beach, an erosional gully spans the campground parking lot to the water and it is actively eroding sand into the river (Figure 4). The surrounding landscape upstream of station 19 is a mix of intact forest and tree farms. The Sawyer Air Force Base and associated residential area is a prominent development upstream of Station 19.

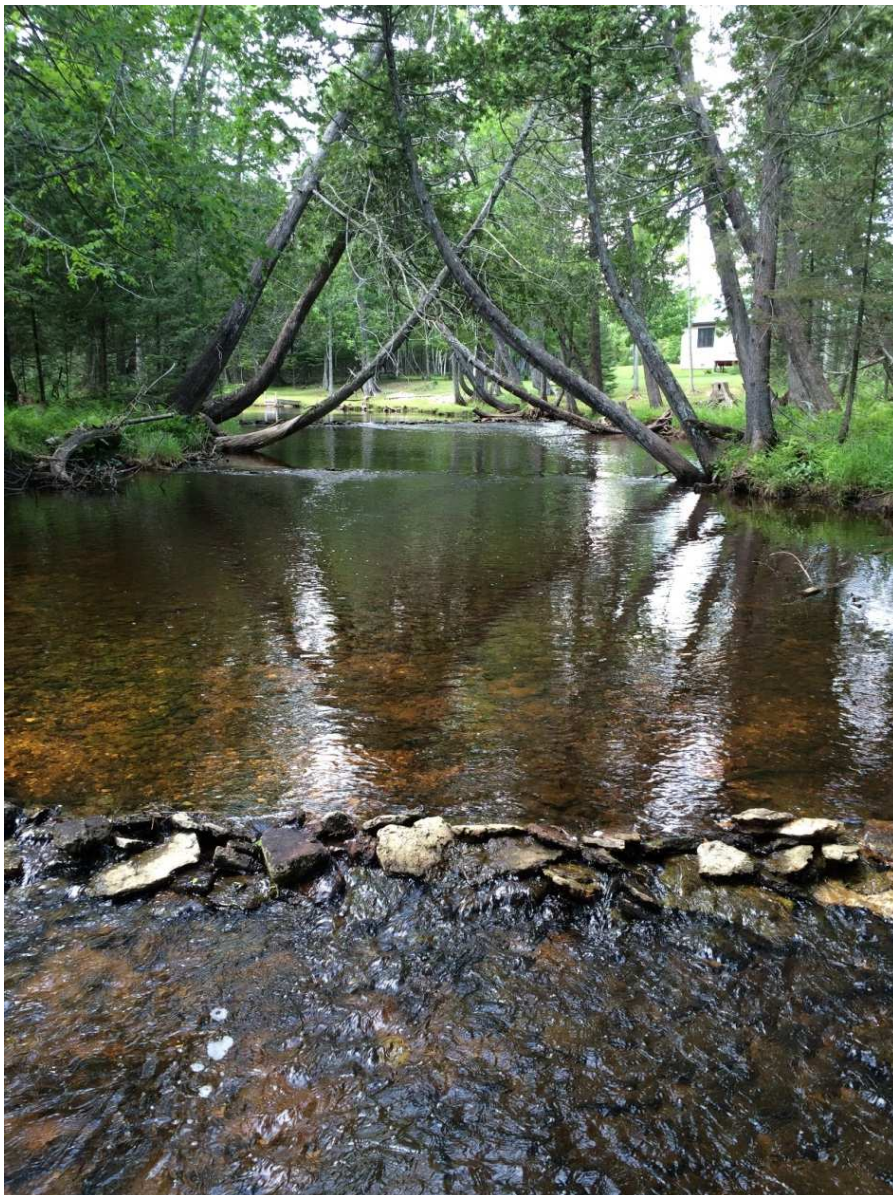
Figure 5. One of three artificially placed, stone dams at Station 27.

At Hunters Brook, upstream of Boney Falls Road (Station 27), at least 3 stone dams had been placed across the stream by people. The small dams were altering the flow of the stream and may be an impediment to fish movement (Figure 5).

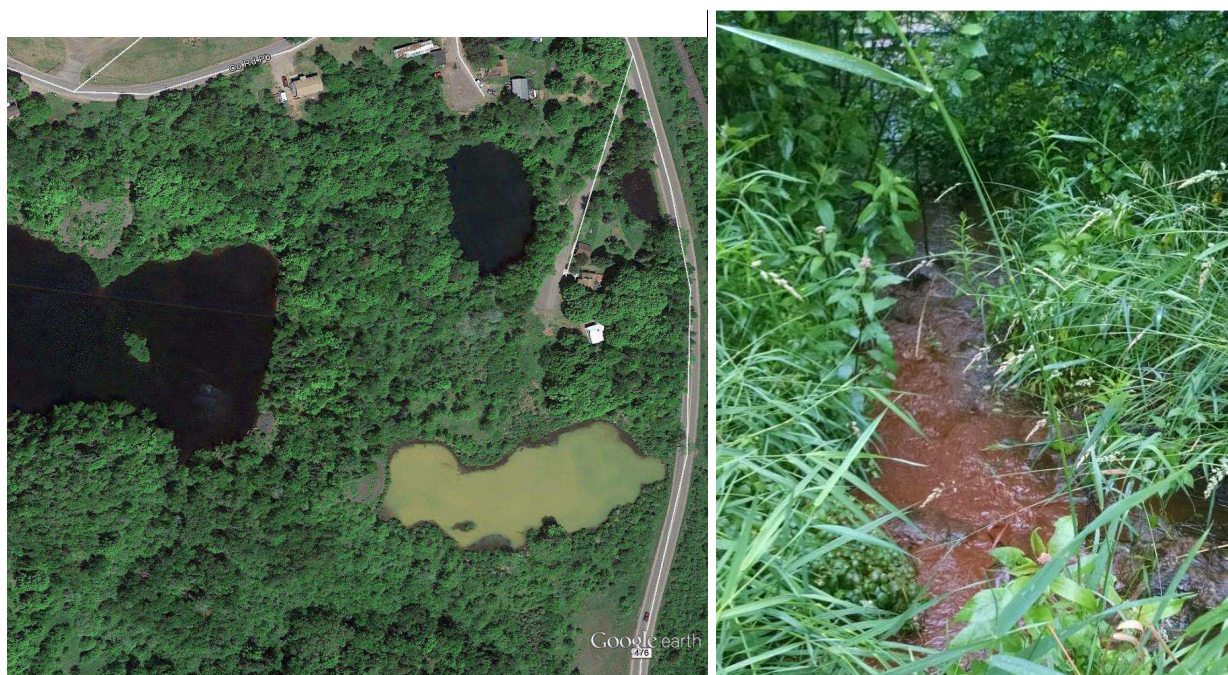
Figure 6. Left: Aerial image of discolored, unnamed pond. Right: Liberated iron in pond discharge after bottom substrate was disturbed.

A water sample was taken from the discharge channel of an unnamed pond near the town of National Mine. The water body was sampled for organics (diesel range organics/oil range organics and semivolatiles), nutrients, and metals. The sampling was performed because of the noticeable discoloration of the water (Figure 6). An ambient water sample was taken upstream from where we sampled. Upon walking in the small discharge stream, iron precipitation that was covering the rocks in the outlet was liberated and caused noticeable discoloration of the outlet and in Ely Creek when it flowed in there (Figure 6). No diesel range organics, oil range organics, or polyaromatic hydrocarbons were detected in the water sample (Table 4). Only 2 of the Michigan ten metals, barium and copper, were detected at low concentrations, and nutrients were also low (Table 4). The unnamed pond is a former mine pit and caving ground that is likely discolored by the oxidation/precipitation of iron (Steve Casey, Pers. Comm.).

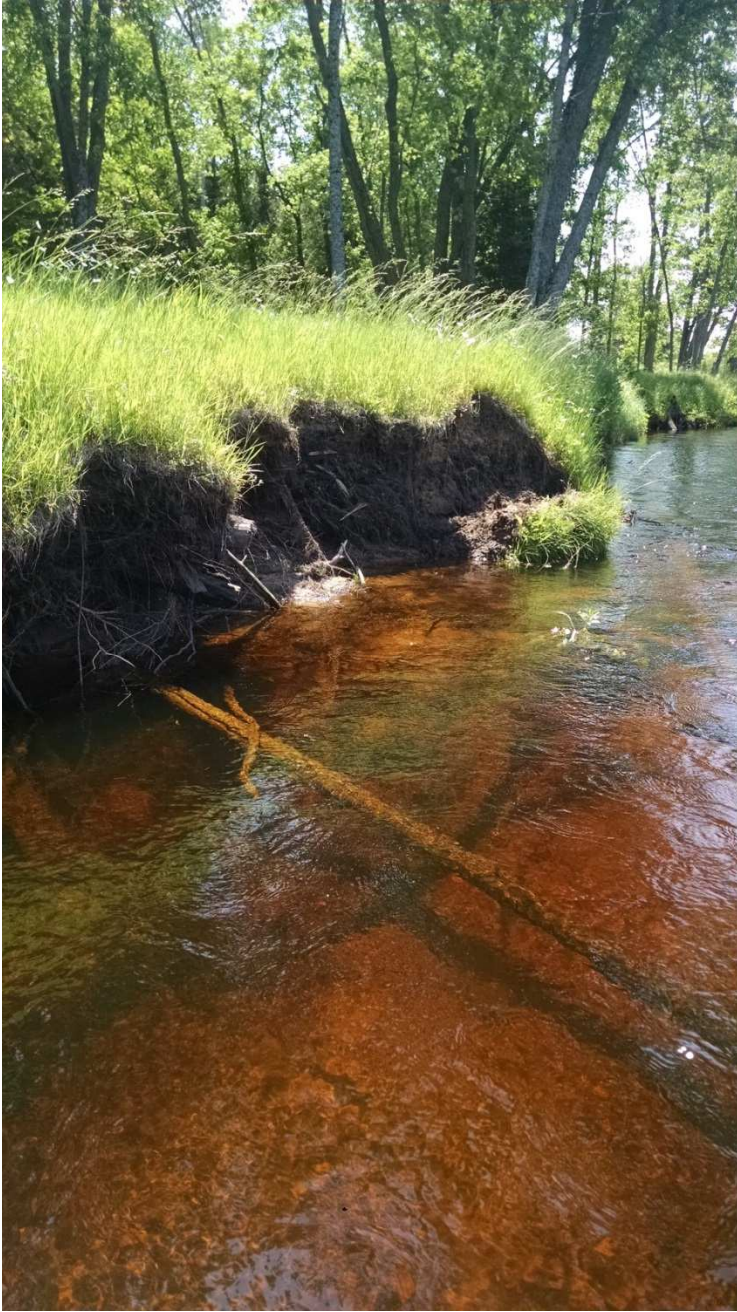
Figure 7. Actively eroding bank and slumping sod at Station 22.

were sparse. Along the right bank, upstream of Cedardale Road, is a residential lot with an actively eroding bank and sod slumping into the river (Figure 7). A review of aerial photos from the last two decades (Figure 8) shows the flow pattern of the Ford River above Cedardale Road shifting. Photos from the 1990s appear to show a typical erosional (left bank)-depositional (right bank) pattern. However, recent photos show the main flow shifting along the right bank, and the former erosional channel largely closed off to water flow. The relatively recent shift in flow pattern may be what is causing the observed erosion on the right bank. Twenty-nine different taxa were collected including 13 EPT, indicating high water quality. A Unionidae mussel that was photographed and identified as *Eliptio complanata* was also found. Generally, Unionidae mussels are considered to be intolerant to stressors (Voshell, 2002). On both sides of the river are residential lots that diminish some of the riparian vegetation. The greater surrounding area consists of intact forest and wetlands.

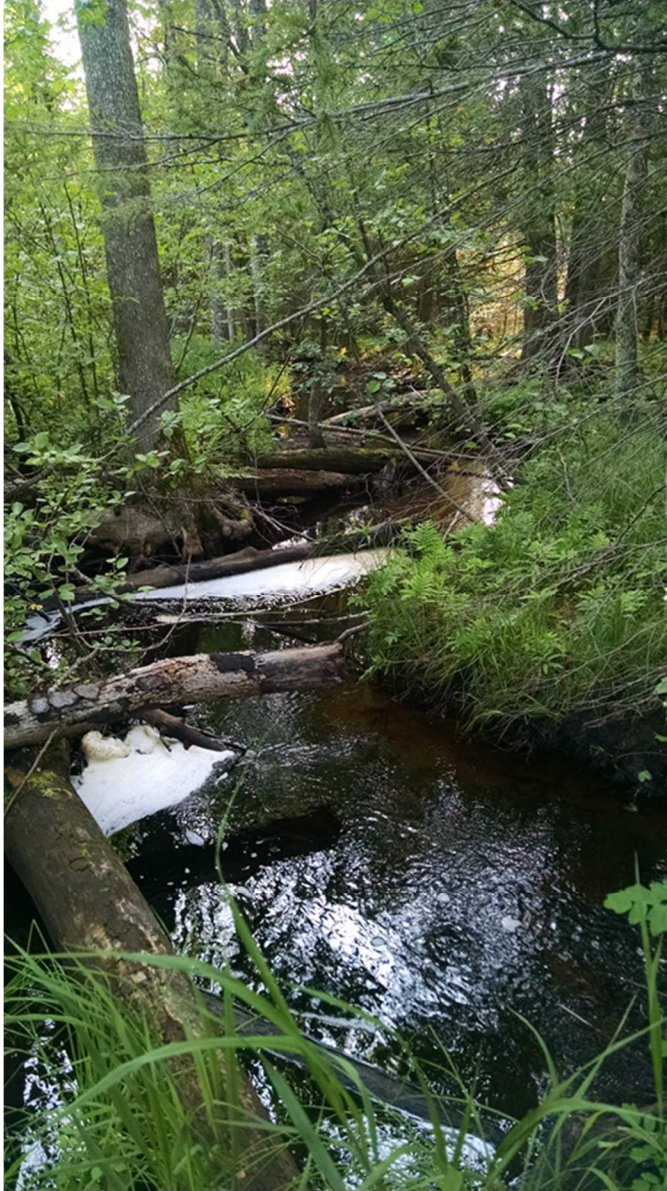
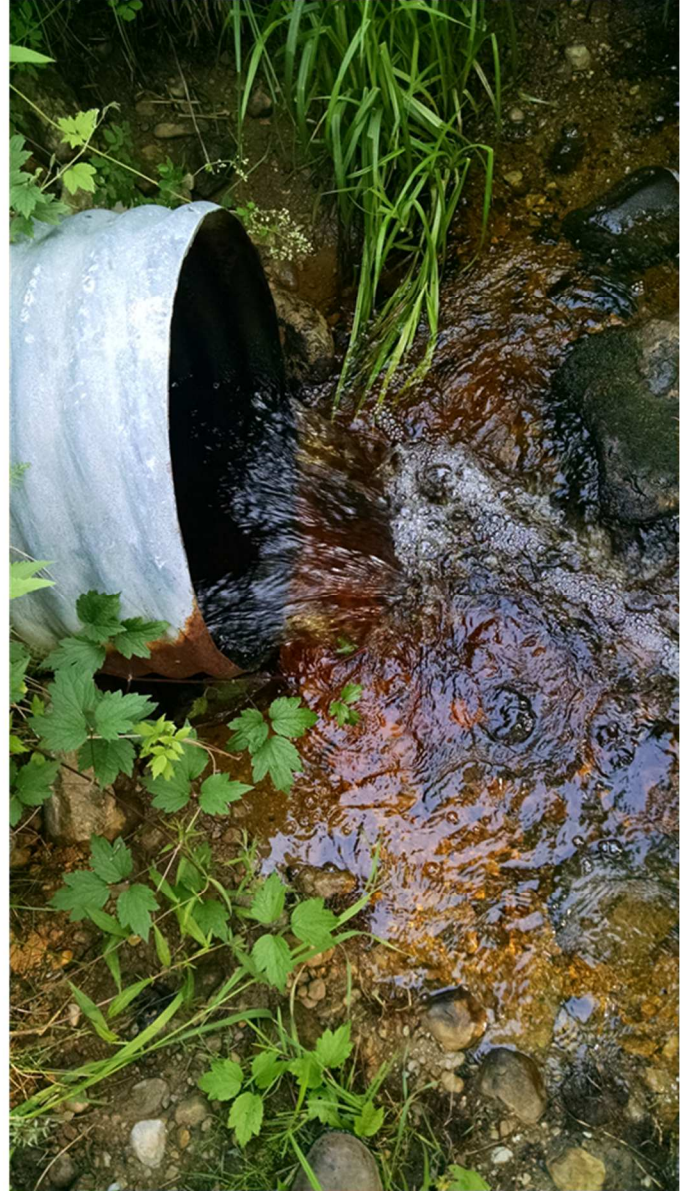
Figure 9. Left: Section of unnamed tributary to Tenmile Creek sampled. Right: Perched culvert at River Road crossing of unnamed tributary to Tenmile Creek.

At the road crossing for an unnamed tributary to Tenmile Creek (River Road; Station 10), the stream is constricted by 2 perched culverts at the crossing (Figure 9). The perched culverts have created an unnatural plunge pool downstream of River Road and may be an impediment to fish movement.

An unnamed tributary to Tenmile Creek was sampled downstream of River Road (Station 10) and scored excellent (182; Table 3) for habitat and the macroinvertebrate community scored high acceptable (3; Tables 2A and 2B). The substrate was mostly sand and silt, which may have reduced the number of macroinvertebrates capable of inhabiting the stream. The stream had heavy amounts of large woody debris in it, along with moderate amounts of undercut banks and overhanging vegetation (Figure 9). The stream was very sinuous and contained a variety of pool depth regimes. Twenty-three different taxa were collected, 9 of which were EPT. Chironomidae larvae made up half of the invertebrates collected. Typically an abundance of Chironomidae is associated with poor conditions; however, Chironomidae larvae have a wide range of tolerances from pollution-tolerant to sensitive (Voshell, 2002). Also, the larvae that we collected were small, likely owing to the cold temperature of the stream (56° F at time of sampling), and red-colored individuals (indicative of anoxic conditions [Voshell, 2002]) were not observed. The abundance of Chironomidae larvae may have been because of the moderate amounts of organic matter being retained by the woody debris in the stream. The riparian area was an intact, mature forest that provided dense canopy cover. The culverts at the River Road crossing are undersized and perched (Figure 9). An unnatural plunge pool has formed below River Road and the perched culverts may be an impediment to upstream fish movement. The greater surrounding area is mostly forest.

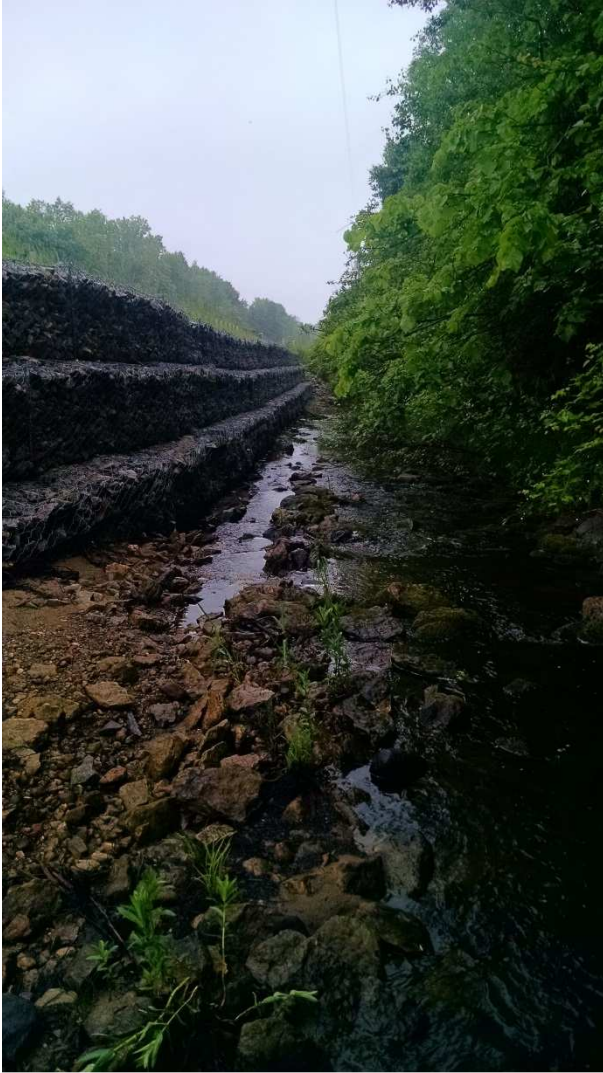
Beattie Creek is a small stream northeast of the city of Menominee that is a direct tributary to Lake Michigan. This water body was targeted because no biosurveys were previously conducted on this water body. Taft (2006) performed an abbreviated survey of the site we sampled at M 35 (Station 24) in 2005, noting the presence of EPT taxa and meeting WQS. The 2015 macroinvertebrate community scored acceptable (1; Tables 2A and 2B) and habitat scored low good (116; Table 3). Sampling was done downstream of M 35 because the property upstream had several “No trespassing” signs near the stream. Downstream of M 35, Beattie Creek flows straight alongside the highway for about 175 feet before making a sharp bend towards Lake Michigan. Along the right bank was a residential lot, although large trees were present on the stream bank. The left bank, alongside M 35, was an artificial embankment of gabion baskets in a “stair step” pattern that make up 168 feet of the stream bank (Figure 10). The gabion baskets were installed between Beattie Creek and M 35 in 2014 and replaced a soil embankment. The stream substrate was a mix of cobble, gravel, and sand. Twenty-one different taxa were collected, including 3 Ephemeroptera and 5 Trichoptera, indicating intermediate water and habitat quality. Amphipoda and Baetidae were the dominant taxa. Amphipoda are facultative and tend to dominate in disturbed systems. Baetidae have a wide tolerance to stressors, but we typically observe high numbers in intermediately disturbed systems. Upstream of Station 24, Beattie Creek drains mostly forested land with some residential use.

Figure 10. Beattie Creek along M 35 looking downstream.
