MICHIGAN DEPARTMENT OF ENVIRONMENTAL QUALITY WATER RESOURCES DIVISION AUGUST 2017

STAFF REPORT

Biological surveys from the Cheboygan, Black, Thunder Bay, Swan, Ocqueoc, and Little Black Rivers watersheds within Michigan's Northeastern Lower Peninsula, located in Alpena, Alcona, Cheboygan, Emmet, Montmorency, Oscoda, Otsego, and Presque Isle Counties, August and September 2015.

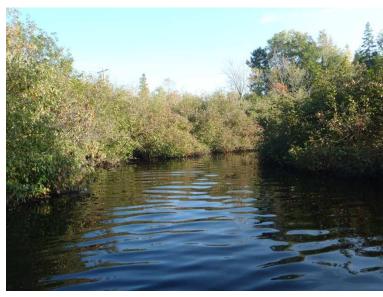
The West Branch Maple River was surveyed at Pleasantview Road (Station 8; Figure 4), approximately four miles upstream of the Emmet County Airport and village of Pellston. The river originates just upstream of the sample location in the Pleasant View Swamp and has an average width of 28 feet and depth of 3 feet, with an estimated flow of 41.7 cfs. Habitat quality rated excellent (159) with heavy to very heavy availability of large woody debris, aquatic macrophytes, and overhanging vegetation. respectively. Cladophora was very heavy at this location covering approximately 75 percent of the

Figure 4. West Branch Maple River at Pleasantview Road.

stream width but was not considered a nuisance. Pools were large and deep with the substrates dominated by sand and silt. All in-stream vegetation was observed to have a thin layer of silt covering the available habitat. Along the riparian zone, shrubby vegetation was heavy but missing large trees, with the road and a residential house within 100 feet of river. The macroinvertebrate community rated acceptable (2) with 34 taxa identified within this reach. Twenty-three percent of the total individuals identified at this location were either Ephemeroptera or Trichoptera. No Plecoptera were found at this location. The dominant taxa within this reach were Amphipods and Isopods.

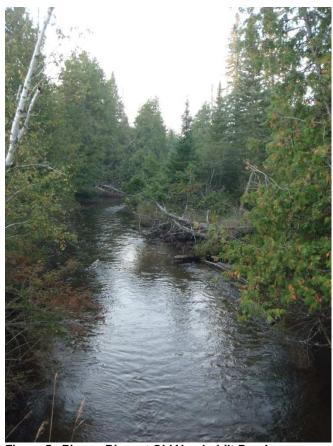
The riffle run habitat at Old Vanderbilt Road (Station 10; Figure 5) rated excellent (188) with substrates composed mainly of gravel, cobble, and sand that was less than 25 percent embedded due to swift currents. Watercress was observed sparsely as in-stream vegetation with undercut banks, overhanging vegetation, and rootwads occurring moderately. Large woody debris was very heavy throughout this section providing ample structure for macroinvertebrate colonization. Width was found to be approximately 29 feet with average depth of 1.5 feet and flow of 132 cfs. Macroinvertebrate communities rated excellent (6), dominated by Hydropsychids, with 86 percent identified as EPT taxa.

Figure 5. Pigeon River at Old Vanderbilt Road.

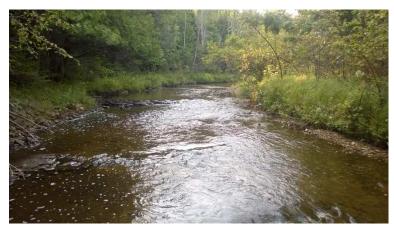
Milligan Creek at North Eastern State Trail (Station 6; Figure 7), immediately west of Kleber Dam, six miles northwest of the town of Onaway, is 0.25 miles upstream of the confluence with the Upper Black River. The North Eastern State Trail is a 71-mile bicycle trail which connects the cities of Alpena and Cheboygan on the former Detroit and Mackinaw Railway. Milligan Creek at this location is approximately 23-feet wide with a depth of approximately 5 inches and estimated flow of 19 cfs.

Figure 7. Milliken Creek at two-track (North Eastern State Trail) off Kleber Road.

Substrates were composed mainly of bedrock and cobble with very little fine sediment or organics throughout the reach due to high velocities. Habitat rated excellent (196) with undercut banks, overhanging vegetation, large woody debris, and rootwads all sparsely available. Stream bank vegetation and vegetative width was found to be excellent with very little human impacts along the riparian zones. The macroinvertebrate community rated excellent (6) with 34

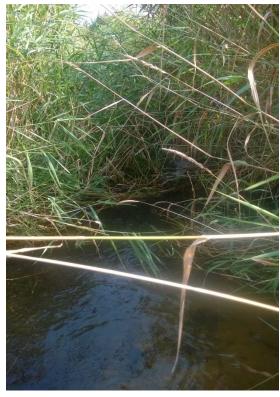
Mullett Creek was surveyed at South Extension Road (Station 13; Figure 11), approximately 2.5 miles south of the town of Riggsville, where Mullett Creek originates. Mullett Creek empties into Mullett Lake 3.2 miles southeast of the sample location, south of Veery Point. This glide/pool section of wetland stream has an average width of 10 feet, depth of 1 foot, with an estimated flow of 10 cfs. Habitat quality rated good (138) with heavy to very heavy availability of undercut banks and overhanging vegetation. Pools, when available, were small and deep with the substrates dominated by sand and silt. There was moderate rootwad and no submerged vegetation or large woody debris present. However, the free-floating Lemna sp. was observed at this location. Long grasses covered the banks and the immediate riparian zone so densely that the bank margins were not visible (Figure 11). No shrubby vegetation or large trees were present along this section of wetland stream. The macroinvertebrate community rated acceptable (1) with 27 taxa identified within this reach. Forty-seven percent of the total individuals identified at this location were composed of EPT taxa. The dominant taxa

Figure 11. Mullett Creek at South Extension Road.

within this reach were Limnephilids, Baetids, and Chironomids. Since the 2010 survey, the habitat score has improved from 121 to 138; however, the rating has remained good. The macroinvertebrate community rating has declined from excellent (5) to acceptable (1) (Noffke, 2011).

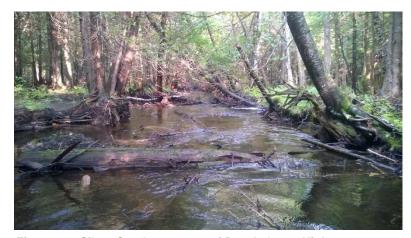
Silver Creek upstream of Beech Grove Highway (Station 3: Figure 13) is the second of three locations that the HPWC requested for targeted monitoring. Station 3 is located nine miles west of the town of Rogers City, within the Mackinaw State Forest. Silver Creek was found to be 12-feet wide and 9-inches deep with an estimated flow of 9 cfs. Substrates were composed mainly of sand and cobble with a heavy load of coarse detrital material throughout this riffle/run section. Rip rap has recently

Figure 13. Silver Creek upstream of Beech Grove Highway, east crossing.

been placed immediately upstream of the new culvert/stream crossing to help control erosion of these banks. Habitat rated excellent (178) with heavy availability of large woody debris for macroinvertebrate colonization. Undercut banks and rootwads were sparse with overhanging vegetation and aquatic macrophytes absent from this reach. Stream bank vegetation was excellent and allowed to grow naturally on both banks. The vegetative width was also found to be excellent with very little human impacts along the riparian zones. The macroinvertebrate

community rated acceptable (4) with the presence of 35 total taxa, dominated by Chironomids and Heptageniids. EPT taxa composed 46 percent of the total individuals identified in the sample. Water chemistry data was collected at this location and can be found in Table 3.

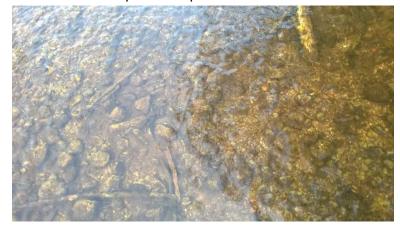
Monitoring at Pigeon River at Sturgeon Valley Road (Station 11; Figures 14 and 15) was requested by the MDNR to evaluate the release and potential deposition of silt downstream from the Song of the Morning Ranch/Lansing Club dam during the dam's drawdown and eventual removal during the summer 2015. The Pigeon River at Sturgeon Valley Road is located approximately one mile below the old Song of the Morning/Lansing Club dam, 10 miles east of the town of Vanderbilt. The river has an average width of 45 feet, depth of 9 inches, with an estimated flow of 87 cfs. In-stream habitat quality rated good (151) with moderate availability of undercut banks, large woody debris, and overhanging vegetation. Aquatic macrophytes and rootwads were sparsely

Figure 14. Pigeon River at Sturgeon Valley Road, sediments.

available within this reach. Substrates were composed of sand, cobble, and gravel within this riffle/run section of stream. Sand was observed to be actively moving along the bottom as well

as depositing fine sediment at obstructions and bends. In areas of coarse substrates, cobble was embedded at approximately 50 percent. Vegetative protection was good along the left bank, but was missing large trees. The right bank was excellent with all plants allowed to grow naturally. The riparian zone width was excellent on the right bank and good on the left bank due to the road being within the riparian zone. The macroinvertebrate community rated excellent (6) with 40 taxa identified within this reach. Seventy percent of the total individuals identified at this location were EPT taxa. The dominant taxa within this reach were Baetids and Ephemerellids.

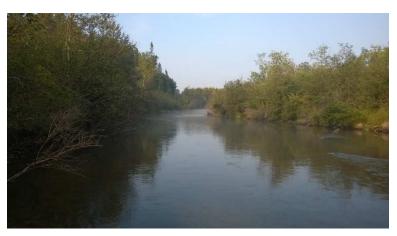
Figure 15. Pigeon River at Sturgeon Valley Road.
