MICHIGAN DEPARTMENT OF ENVIRONMENTAL QUALITY
 WATER RESOURCES DIVISION
 JULY 2017

STAFF REPORT

**Biological and water chemistry surveys in the Pentwater River watershed in
 Oceana County, Michigan, June-July 2015**

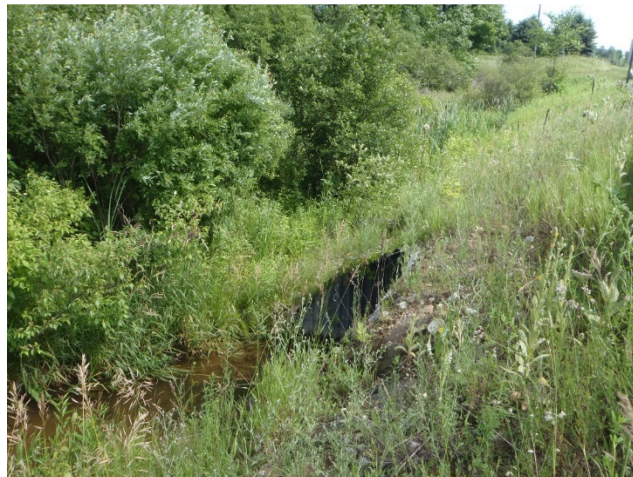
Crystal Creek at 120th Avenue had a new culvert installed in 2010. The culvert was not installed at the proper angle, which will lead to erosion on the upstream side of the culvert. The stream must make a turn where the culvert starts, which will increase sedimentation and disturb habitat downstream. This site should be monitored to document if water flow is degrading the culvert and to review any sedimentation occurring downstream of the culvert for impacts to stable habitat.

Crystal Creek at 120th Avenue, the Unnamed Tributary to Huftile Creek at 112th Avenue, and the Unnamed Tributary to Huftile Creek at 116th Avenue all have improperly sized and installed culverts. The culverts should be replaced for proper size and alignment with the natural stream flow. These sites should be monitored during the next watershed year.

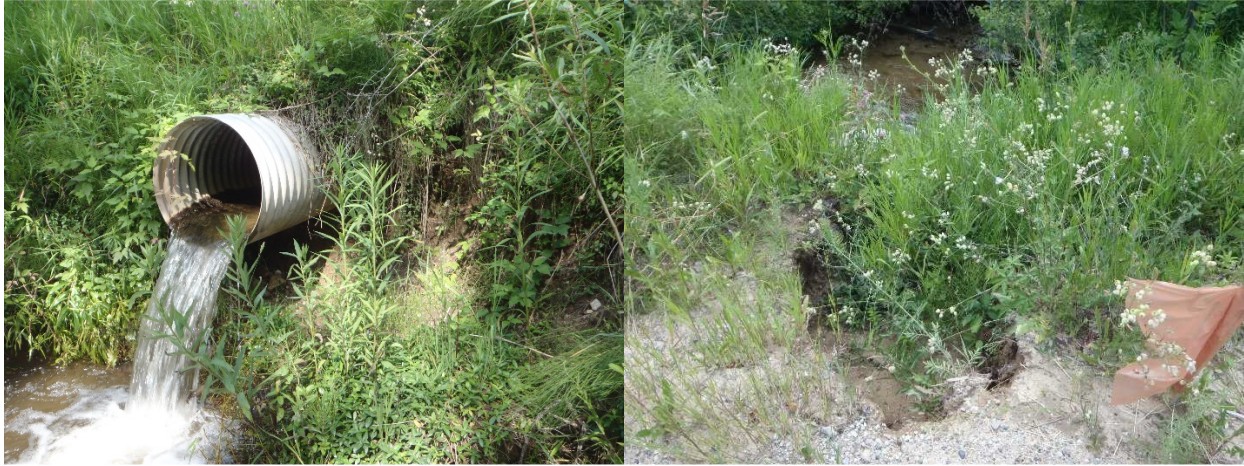
The Unnamed Tributary to Huftile Creek downstream of 112th Avenue has a two-foot perched culvert on the downstream end that has created a plunge pool widening and deepening this

portion of the stream. In addition, the culvert was placed at an improper angle for the stream flow and has caused extensive erosion along the road. 112th Avenue has orange flags marking eroded areas to avoid as you drive down the road. This site would benefit from a properly installed culvert at the correct depth, angle, and diameter for this stream. The proper placement of the culvert would allow connectivity for fish and would prevent erosion issues at the creek. The site should be repaired and monitored within the watershed year.

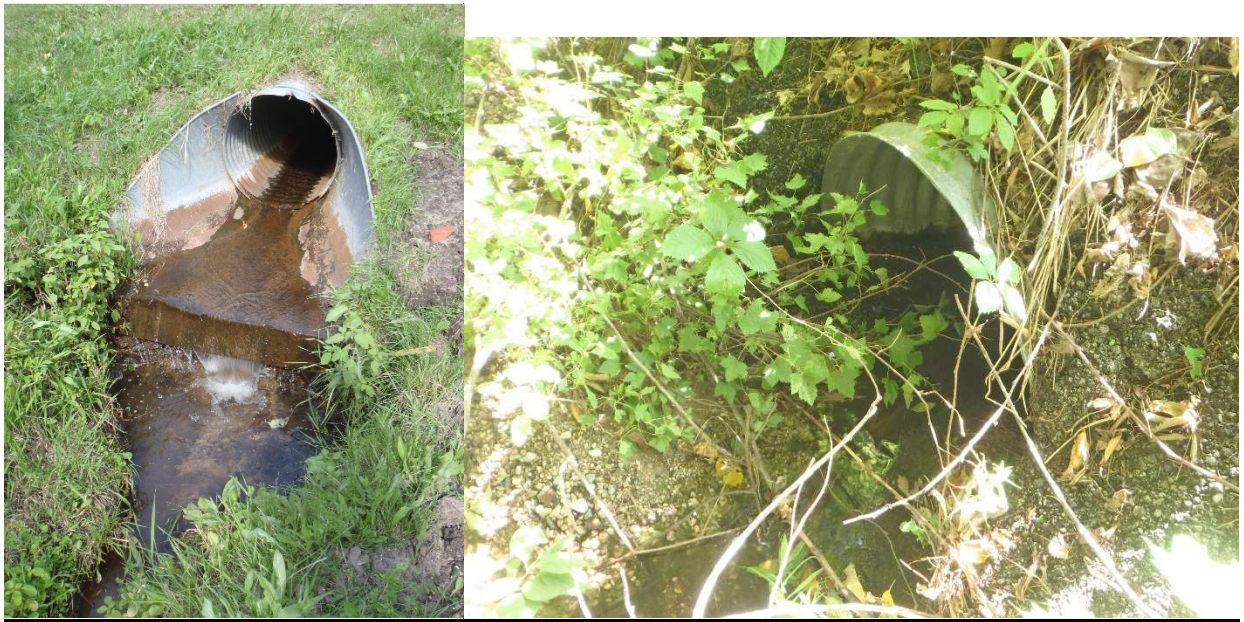
The Unnamed Tributary to Huftile Creek at 116th Avenue has a perched culvert on the downstream end with wingwalls on the sides. The culvert is too small and too high to properly connect this tributary. The upstream end shows the improper angle of culvert installation with a 90 degree turn for the stream. In addition, it is clear that the culvert size and alignment are not adequate for this stream. This culvert should be removed and replaced with a culvert at least twice the diameter along with aligning to the natural direction of the stream. The increased culvert size would allow connectivity of the stream for fish and would restore the site to its normal flow. This site should be monitored again in five years.
