MICHIGAN DEPARTMENT OF ENVIRONMENTAL QUALITY
WATER RESOURCES DIVISION
MARCH 2017

STAFF REPORT

BIOLOGICAL SURVEYS OF SELECTED SITES IN THE PERE MARQUETTE RIVER
WATERSHED IN LAKE, MASON, NEWAYGO, AND OCEANA COUNTIES, MICHIGAN
AUGUST 2015

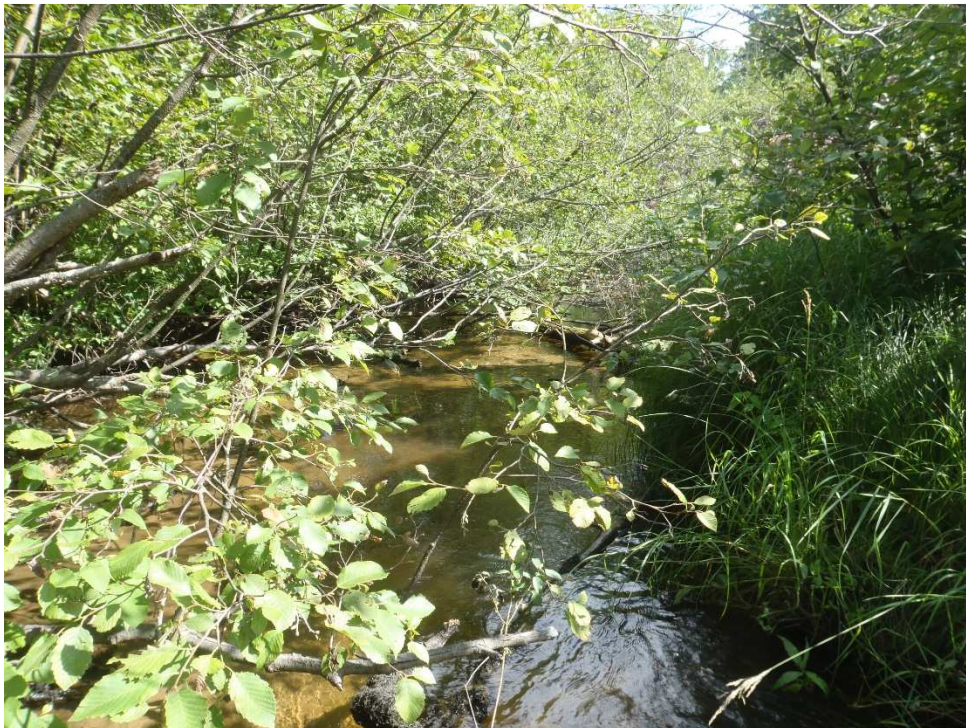
Figure 4. The stream bed in Tank Creek (Site 6) was composed of almost 100% sandy substrate.

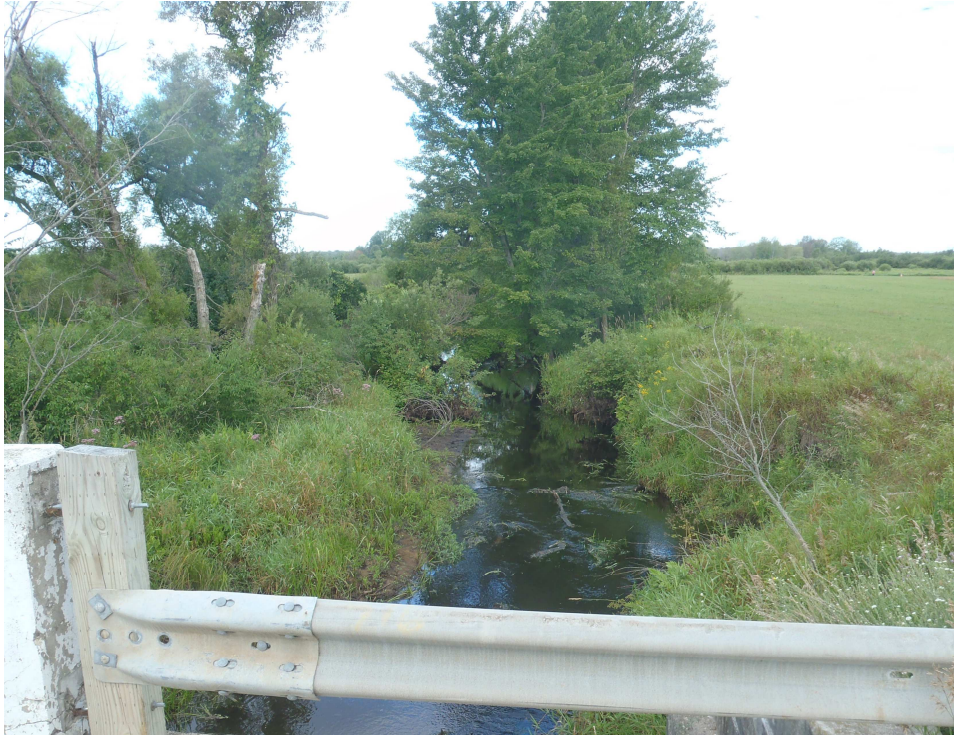
Figure 5. Beaver Creek at 198th Street (Site 7T) was a trend site with a marginal habitat rating. Bank scour due to flashiness can be seen, and the stream bed was deep muck and sand bars indicating an issue with sediment deposition. The vegetated riparian zone is very narrow and offers little protection from runoff.

Most of the survey sites were within the Newaygo Outwash Plain (Subsection VII.3.) in the central part of the watershed (Sites 3-11 and 12-18T) (Albert, 1995). Large streams, like the Main and South Branch Pere Marquette Rivers, tend to trench deeply in the sandy soils, creating tall eroding banks. Stream beds in sandy areas tend to support a lower diversity of macroinvertebrates due to a lack of habitat diversity; for example, Tank Creek had a bed of only sand (Figure 4) providing little habitat diversity (such as layered cobble or gravel), and therefore the macroinvertebrate diversity is not as high as expected for a stream with such intact natural surroundings. This is mainly due to the geography and geology, and not due to human activity; although the sandiness of the soils make the banks sensitive to damage by increased flow flashiness (instability) in agricultural areas (see Figure 2) and other activities. The outwash portion of this subsection has occasional kettle lakes. White and black oak are dominant trees since white pine regeneration was poor following logging. Some areas support prairie-like vegetation rather than forests, due to frost pockets caused by ice block depressions following deglaciation. Wind erosion and the rapid loss of nutrients from soils makes farming cultivation difficult. Nonetheless, agricultural land makes up 25% of the land area in the Beaver Creek subwatershed (040601010401 - Table 2), likely resulting in the evidence of flashiness that was observed (Figure 5 and Figure 6).

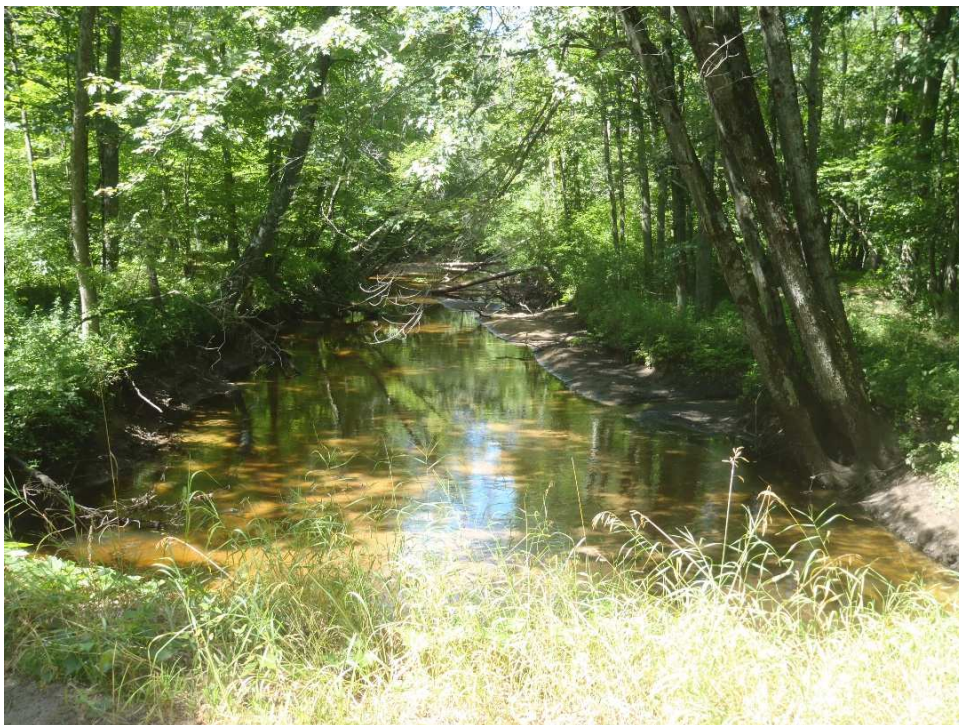
Figure 6. Bank scour due to flow flashiness at Beaver Creek at Green Avenue (Site 9).

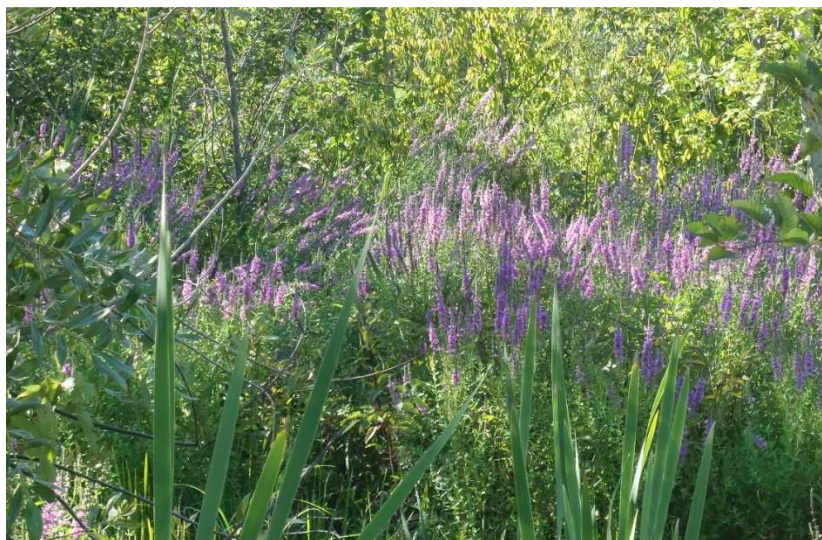
Figure 7. Purple loosestrife, an invasive species, near the Pere Marquette River - Reek Road canoe launch (Site 18T).

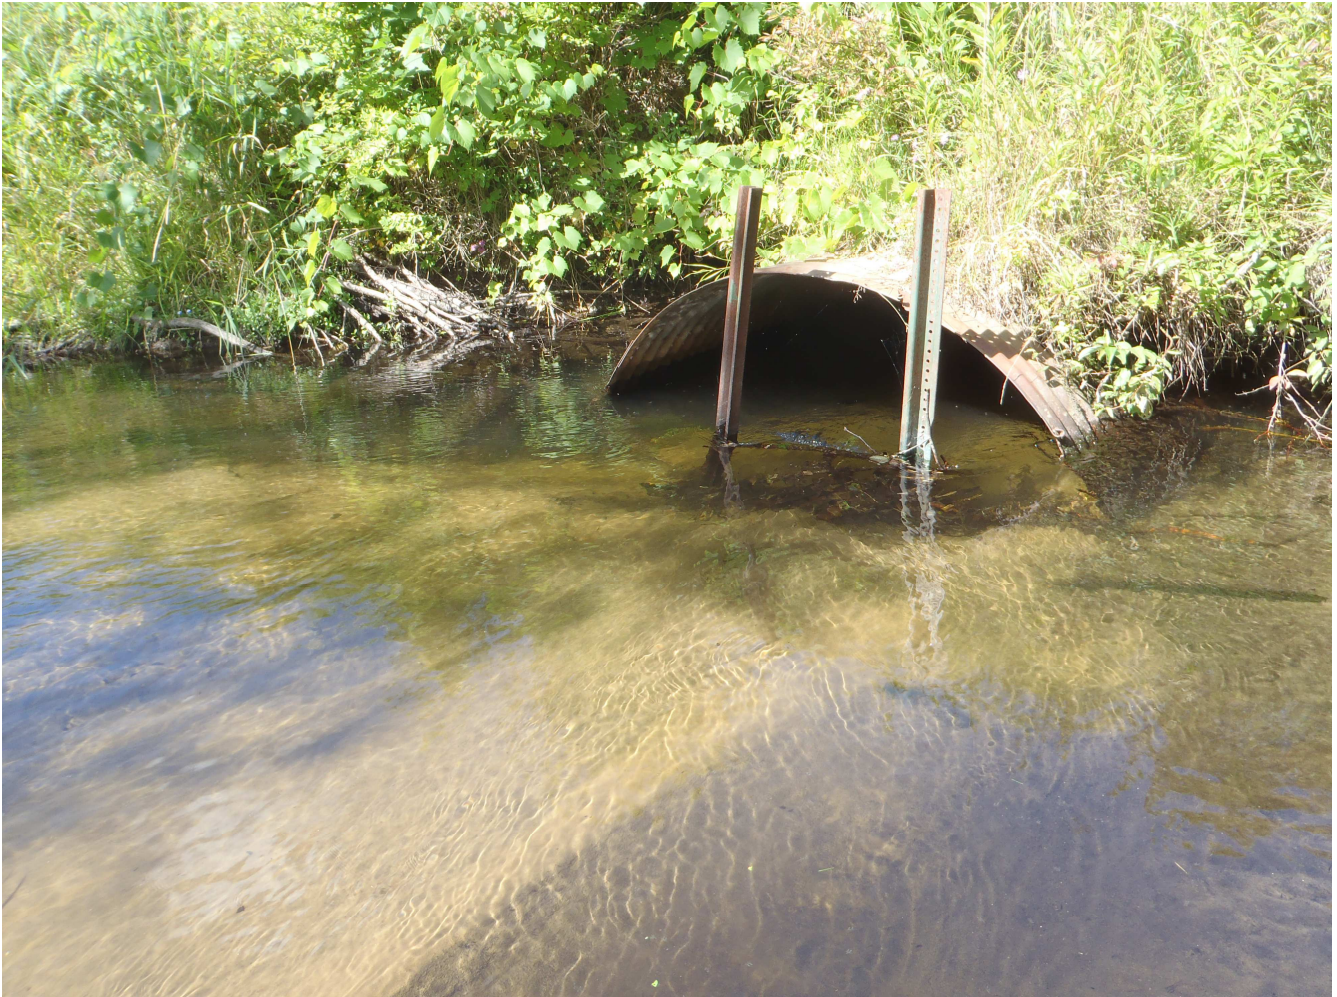
Figure 8. Water and sediment tend to accumulate upstream of under-sized culverts, as seen here on Sanborn upstream of Foreman Road (Site 15).

Sanborn Creek was monitored at four sites, three of which (13T, 14T and 15) were randomly selected and one additional site (12) was targeted at 40th Street. Sanborn Creek has a series of undersized and perched culverts, some of which have already been replaced (as was the case at Site 12 at 40th Street). Undersized and perched culverts cause erosion and sediment transport issues (Figure 8), and perched culverts (Figure 9 and Figure 10) can also cause fish passage issues. Several of the remaining old culverts are in the process of being replaced to reduce these issues. In 2015, three of the sites (Site 13T at Spruce Road, 14T at Broadway Street, and 15 at Foreman Road) were located upstream of culverts that were scheduled for replacement but the work had not been completed yet. All of these sites scored within the excellent range for habitat. Sites 13T (Spruce Road) and 14T (Broadway Street) had acceptable macroinvertebrate communities, while sites 12 (40th Street) and 15 (Forman Road) had excellent rated macroinvertebrate communities. The differences in macroinvertebrate community ratings were only slight, and likely were not caused by the presence of new versus older culverts.

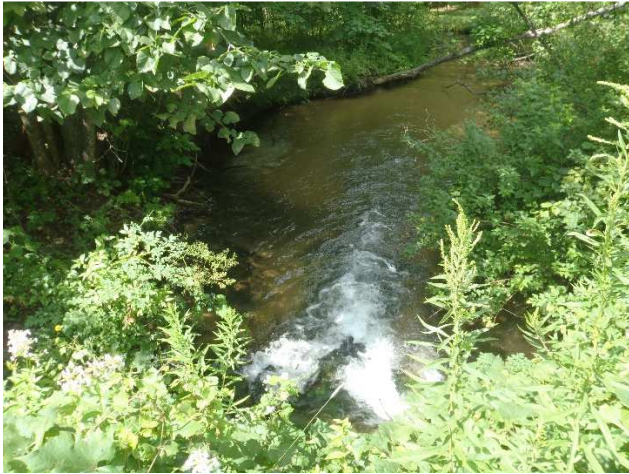
Figure 9. Perched culvert in Sanborn Creek, looking downstream at Spruce Road (Site 13T).

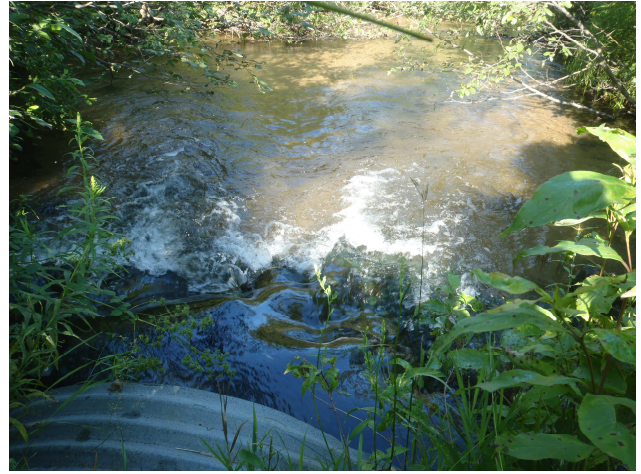
Figure 10. Perched culvert in Sanborn Creek, looking downstream at Broadway Street (Site 14T)

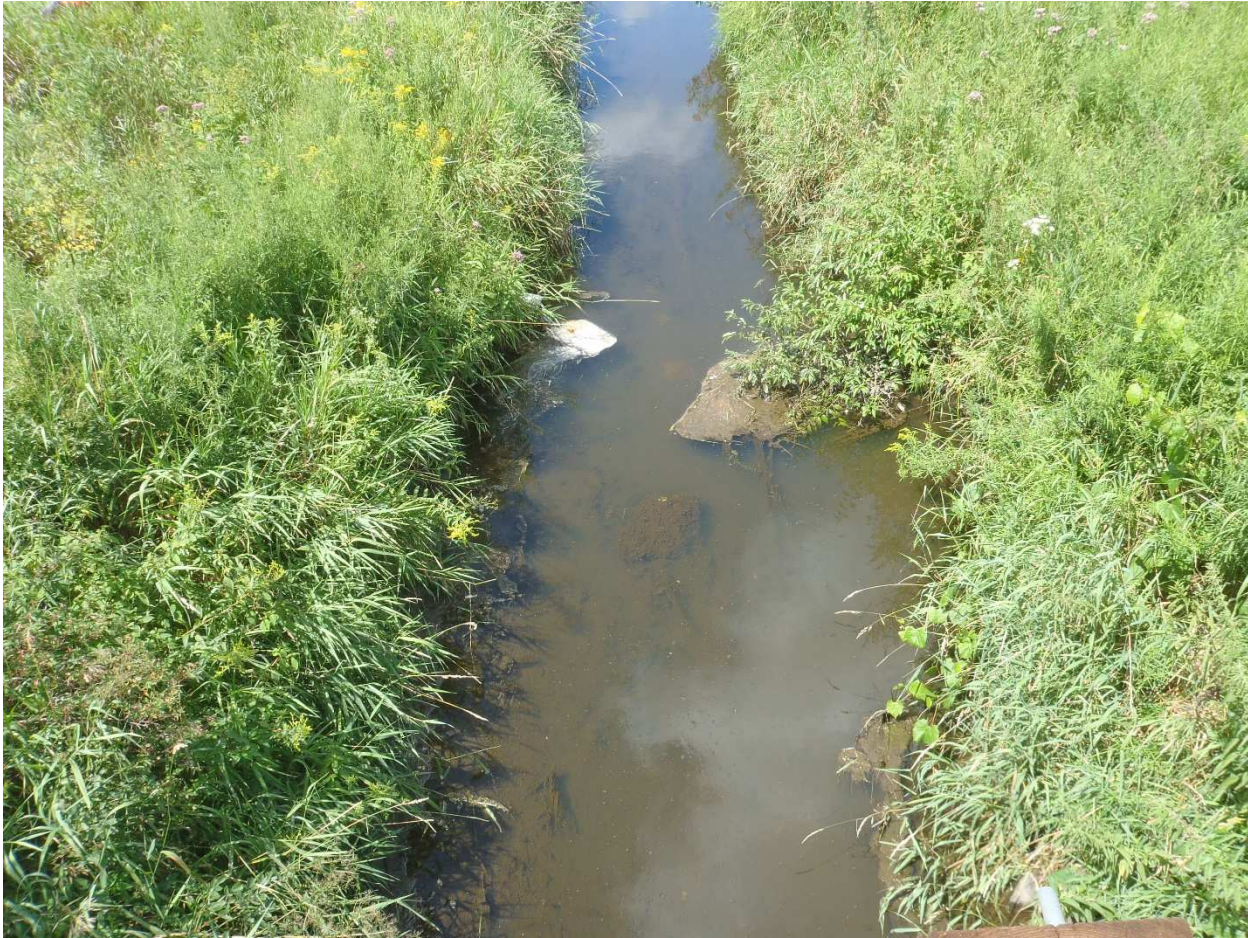
Figure 11. Flocculent organic matter covered all surfaces at Freeman Creek (10T), leaving little habitat for macroinvertebrates. The organic matter was not collected or identified.

The macroinvertebrate community in Freeman Creek at Maple Island Road (Site 10T) rated -6 (poor) in 2015, and showed a dramatic decline since the previous survey in 2010 where it scored +4 (Knoll-Wilmes, 2013) and previous surveys where it scored as high as +9 (Kohlhepp, 2004). It was noted during the 2015 survey that floating dead organic matter was present (Figure 11) and the instream macroinvertebrate habitat was also nearly completely covered with this unknown flocculent material (samples were not collected for analysis). This decaying matter likely lead to a dominance of the macroinvertebrate community by blood worms (a very tolerant type of Chironomidae) (Appendix 1). Habitat scores were in the marginal category in 2015 and 2010. This area has also been impacted by drainage activities and is a designated county drain (personal communication with Oceana Drain Commissioners Office, December 20, 2016). The MDEQ is investigating the cause of this issue and plans to revisit this site and monitor the macroinvertebrate community for recovery.
