MICHIGAN DEPARTMENT OF ENVIRONMENTAL QUALITY
WATER RESOURCES DIVISION
MAY 2017

STAFF REPORT

Biological and Water Chemistry Surveys of Selected Stations in the Paw Paw River Watershed in Berrien and Van Buren Counties, Michigan, August 2016.

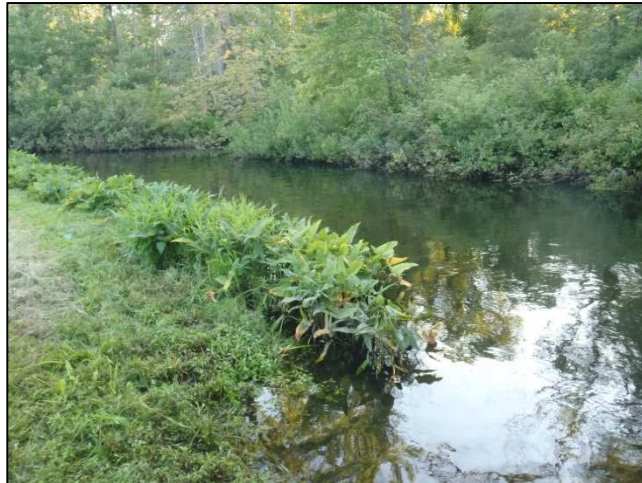
Figure 2. North Branch Paw Paw River downstream of Stevens Road.

The North Branch Paw Paw River is designated as a coldwater stream and was sampled downstream of Stevens Road (Station 1; Table 4; Figure 2) because the stream is ponded and very deep upstream. The glide/pool habitat scored at the low end of good (108; Table 5). The entire left bank of this reach is a yard that is mowed to the edge and includes an area where the residents access the stream to swim. Shifting silt and some sand were the dominant substrate types. In-stream and overhanging vegetation were the only epifaunal substrates. The property owner indicated erosion of the property is frequent. The macroinvertebrate community was rated acceptable (-2; Tables 6 and 7). There was a large number of taxa. However, air breathers and amphipods were fairly abundant leading to negative scores for those metrics.

The culvert or road crossing of the North Branch Paw Paw River at Stevens Road (Station 1; Table 4) may need realignment and an old cement structure that serves as hardened shoreline

downstream of the crossing may need to be removed. Upstream of the road the stream is ponded and very deep. Downstream of the road crossing, the left bank is a maintained lawn, and the property owner reports that erosion has occurred consistently over the past several years. Current erosion was not evident due to the depth of the water. The water temperature was 78 degrees Fahrenheit, which is fairly warm for a coldwater stream and is likely at least partially due to the ponding at the road crossing. The property owner was directed to the district office for information concerning the erosion at their property.

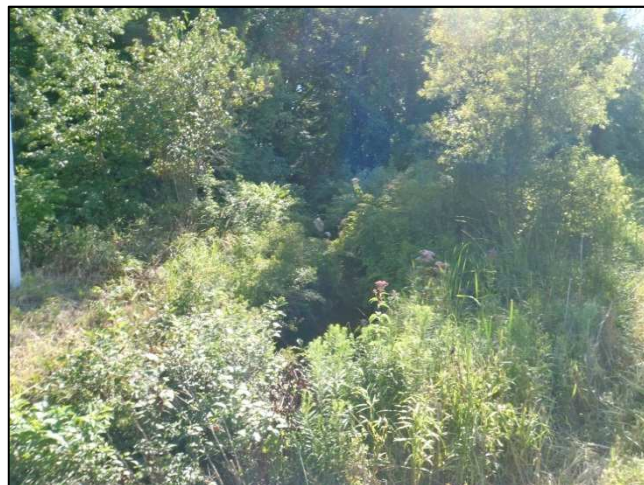
Figure 3. Brandywine Creek downstream of M-40.

Brandywine Creek was sampled downstream of M-40 (Station 2; Table 4; Figure 3), and is designated as a warmwater stream. The riffle/run habitat was rated good (135; Table 5). The stream banks were incised approximately two feet, indicating some flashy flows, but were moderately stable. Large woody debris and some gravel was available for epifaunal substrate, but the dominant substrate was sand. The macroinvertebrate community was rated acceptable (0; Tables 6 and 7). There were no stonefly taxa and only two individual mayflies found. Both of these families are sensitive to pollution.

Amphipods were very dominant at 70% of the macroinvertebrate community. A dominance of any one taxon may be an indicator of some type of environmental perturbation.

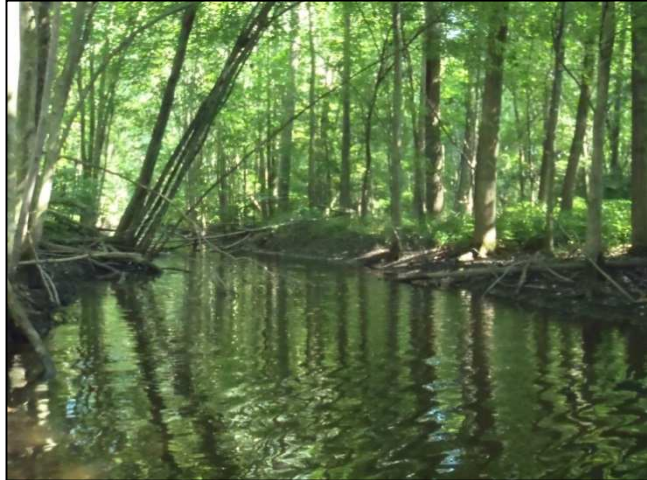
Figure 4. Unnamed Tributary to Mud Lake at County Road 372/52nd.

The Unnamed Tributary to Mud Lake was sampled at County Road 372/52nd (Station 3; Table 4; Figure 4), and is designated as a warmwater stream. The glide/pool habitat was rated as fair (91; Table 5). This station had no pool diversity and was uniform in depth. The substrate consisted of nearly three feet of silt/muck that was very unstable and anoxic. Large woody structures and some aquatic vegetation were present, but covered in silt and not suitable for epifaunal substrate. The straight channel is obviously maintained as a county drain, but the floodplain and riparian area were intact. The macroinvertebrate community was rated as acceptable and scored 1 point away from poor (-4; Tables 6 and 7). Only two families and seven individuals from the Ephemeroptera (mayflies), Plecoptera (stoneflies), and Trichoptera (caddisflies) (EPT) orders were found. These orders are sensitive to pollution, including sedimentation, and a lack of these families in a stream indicate stressed environmental conditions.

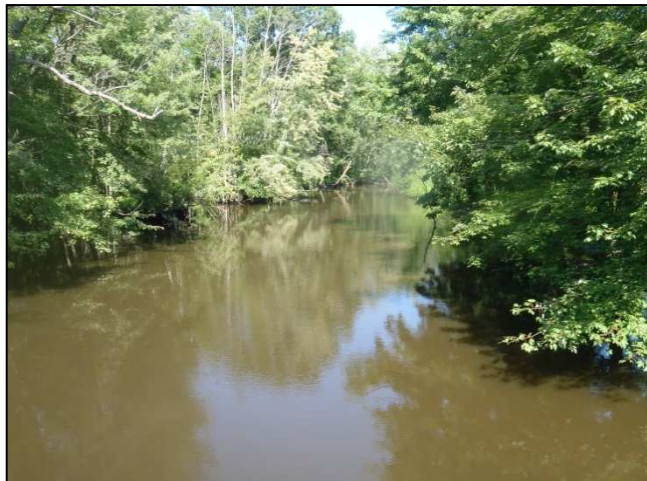
Figure 5. Paw Paw River at 45th Street.

The Paw Paw River was sampled at 45th Street (Station 4; Table 4; Figure 5), and is designated as a warmwater stream. The glide/pool habitat was rated as good (139; Table 8). The river is wadeable at this site, but is fairly deep and much of the mid-portion of the river is more than five feet deep. Small numbers of large woody structures were present, but were covered with silt and not suitable as epifaunal substrate. The stream bottom substrate was dominated by shifting sand. There was an intact floodplain and you could see where silt would settle during high water events. The macroinvertebrate community was rated acceptable (-1; Tables 9 and 10). No stonefly were found and there was a fairly high percentage (35%) of surface air breathers. These two metrics contributed to the low acceptable score.

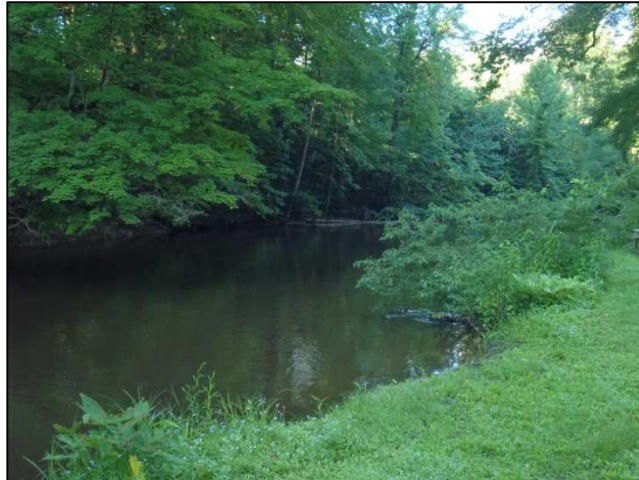
Figure 6. Paw Paw River off of M-140.

The Paw Paw River was sampled at M-140 (Station 5; Table 4; Figure 6), and is designated as a warmwater stream. The glide/pool habitat was rated good (141; Table 8). This station is within a campground area and at the inside portion of a large bend in the river. The mid-portion and outside of the bend cannot be reached in most places due to the depth of the river. Large woody material and overhanging vegetation are the only available substrates. The macroinvertebrate community was rated excellent (5; Tables 9 and 10). This relatively high score is despite the low numbers of individuals and high

percentage (35%) of air breathing taxa that were collected. Eight taxa in the EPT families were found, and no one taxa was dominant, both of which indicate good water quality.

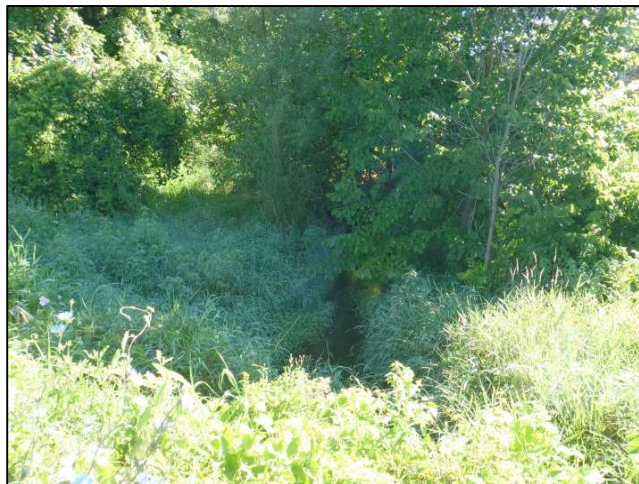
Figure 7. Eagle Lake Drain at 42nd Street.

The Eagle Lake Drain is a coldwater stream that was sampled at three stations. The most upstream station was 42nd Street (Station 6; Table 4; Figure 7). The glide/pool habitat was rated fair (93; Table 11). Silt was the dominant substrate in the area sampled. Further upstream the stream narrows and has more sand substrate. This appears to be the area where any dredging done at the road stops. Submergent vegetation was the only epifaunal substrate available. Woody structures were covered by silt.

The macroinvertebrate community was rated acceptable, one point away from poor (-4; Tables 12 and 13). Of the EPT families, only one caddisfly family was found. There was a relatively large percentage (35%) of snails that dominated the macroinvertebrate community. The large percentage and dominance of snails both indicate a likely environmental perturbation is impacting the macroinvertebrate community at this station.

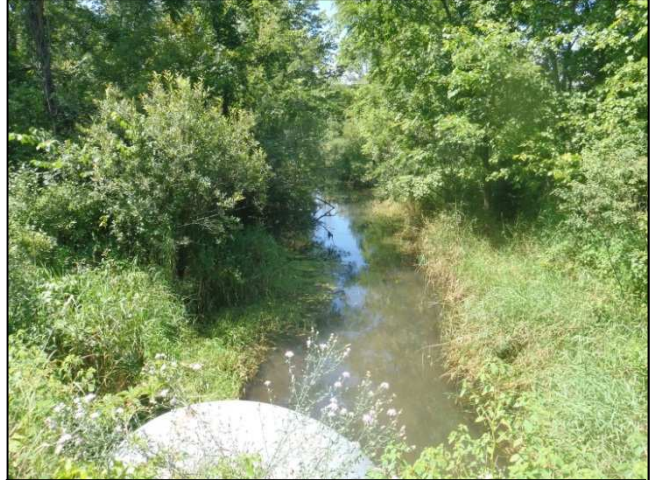
Figure 8. Eagle Lake Drain at 40th Street.

Eagle Lake was also sampled at 40th Street (Station 7; Table 4; Figure 8), and was relatively cold for this watershed at 62 degrees Fahrenheit. The glide/pool habitat was rated fair (91; Table 11). There was a large amount of shifting silt along the stream bottom. Pools were present, but were partially filled with silt and the water level was very low. Aquatic vegetation was abundant and was the only epifaunal substrate present. The macroinvertebrate community scored acceptable (-3; Tables 12 and 13). None of the pollution-sensitive mayfly or stonefly taxa were present and chironomids were 54% of the individuals found, which reflects the large silt deposits at this station.

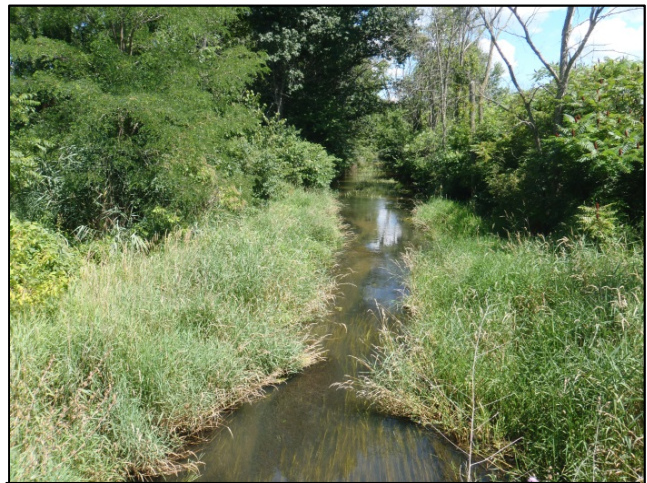
Figure 9. Eagle Lake Drain at 39th Street.

The Eagle Lake Drain was sampled furthest downstream at 39th Street (Station 7; Table 4; Figure 9). The glide/pool habitat was rated as good (107; Table 11). The wetted width was wider at this station due to aquatic vegetation holding in water along the edge. The vegetation was silt laden. There was a small amount of gravel substrate at this station but silt deposits were dominant. The aquatic macrophytes and overhanging vegetation were the dominant epifaunal substrate. Pool diversity was greater than the two upstream sites in Eagle Lake Drain. The macroinvertebrate community scored acceptable (-2; Tables 12 and 13). There was a noticeably larger diversity and percentage of EPT taxa at this station, especially Trichoptera families, than was found at the upstream stations. Snails, oligochaetes, and chironomids were found to be the most abundant families, all of which can indicate environmental stressor impacts.

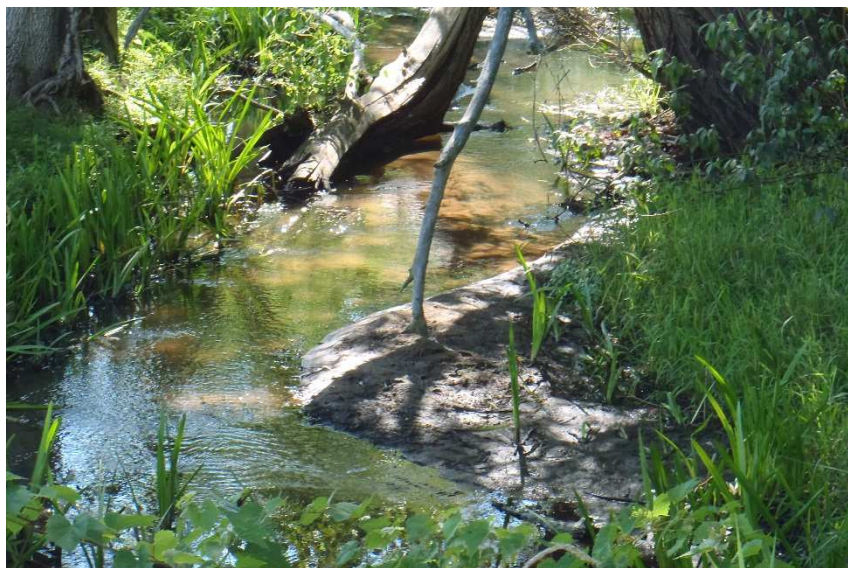
Lawton Drain at County Road 665 was revisited due to previous observations of unrestricted livestock access in 2011 and 2006 (Figure 10). Unrestricted livestock access is a concern due to the trampling of banks, which can cause excessive erosion, and livestock standing in the stream has the potential for pathogen contamination from livestock feces. Evidence of unrestricted livestock access (erosion and a lack of taller understory vegetation) was observed along an approximate 0.25-mile stretch of the drain upstream of the road crossing. MDEQ district staff is aware of the issue and will visit the stream again in the summer of 2018 and take appropriate actions with the Michigan Department of Agriculture and Rural Development, Right to Farm Program, if needed.

Figure 10. Lawton Drain at County Road 665. Sedimentation evident due upstream trampling of banks from unrestricted livestock access.

- 1) Lawton Drain at County Road 665 can be revisited to determine if improvements have been made in restricting livestock access to the drain, and if not, report conditions to district staff and/or the Michigan Department of Agricultural and Rural Development. In addition, *E.coli* samples could be taken.
