MICHIGAN DEPARTMENT OF ENVIRONMENTAL QUALITY
WATER RESOURCES DIVISION
JUNE 2017

STAFF REPORT

Biological and water chemistry surveys of selected stations in the upper Grand River and Red Cedar River watersheds in Eaton, Ingham, Jackson, and Livingston Counties, Michigan, July-September 2016.

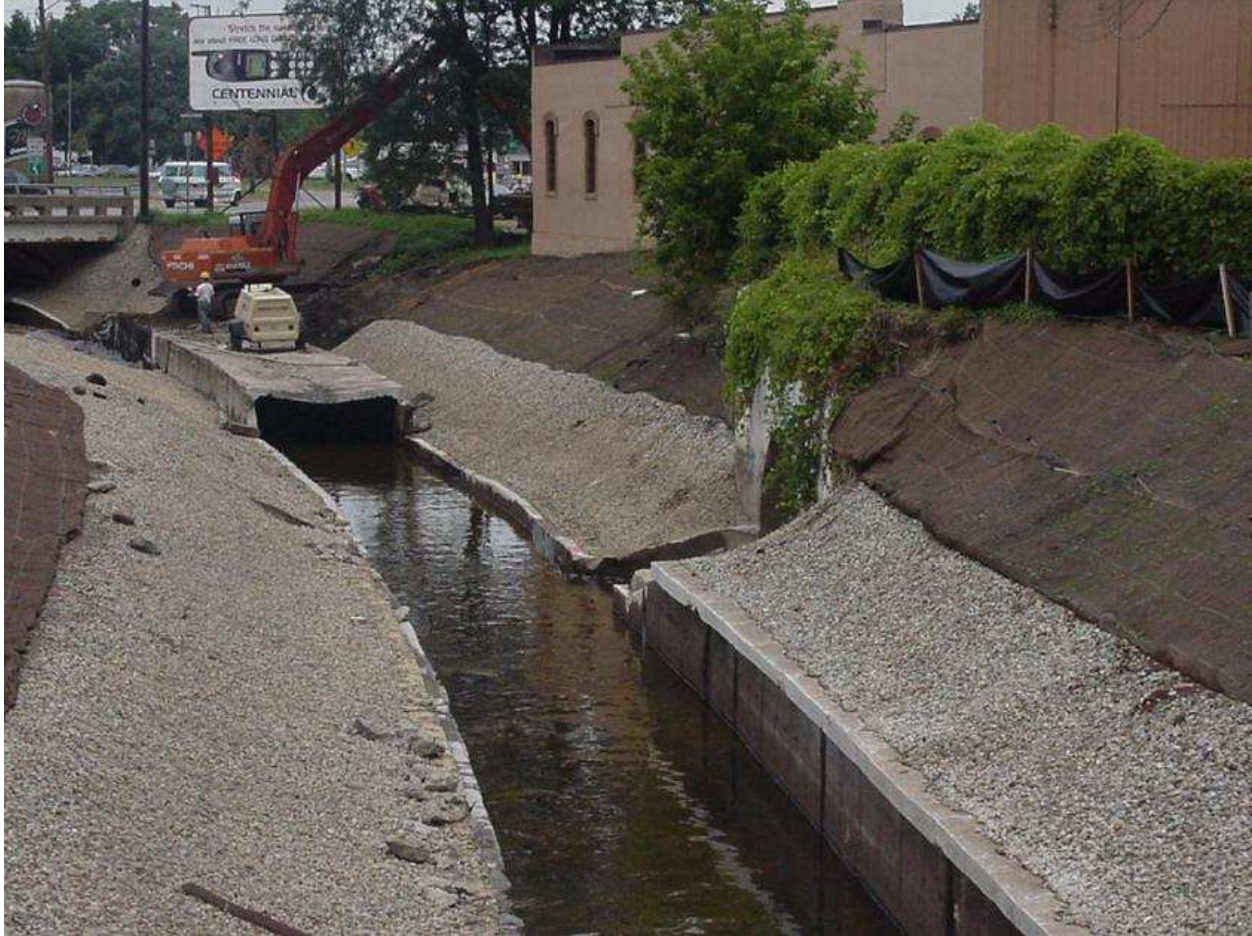
Figure 2. Concrete cap being removed from over top of the Grand River in downtown Jackson in 2000 (photo by K. Price, <https://rodmalloy.com/tag/kenny-price/>).

The Grand River has a long history of manipulation and pollution. The main stem river was historically used for disposal of raw sewage by the city of Jackson. As early as 1890, residents began complaining about the river pollution and associated odors (Ennis, 2011). Between 1914 and 1920 the city of Jackson channelized the Grand River in an effort to increase the flow of the river and flush raw sewage away from the city faster (Price, 2013). However, channelizing the river did not ameliorate the pollution problem. Starting in 1936, the city of Jackson again reconfigured the Grand River by constructing a concrete river bottom and concrete vertical walls for the river banks in an attempt to speed up flow. Additionally, a 2,580-foot long concrete "cap" was placed over top of the river in an attempt to eliminate odors originating from it (Price, 2013). By the 1990s, the cap, along with safeguards put in place to prevent people from going near the entrance to it, began to deteriorate. As a result, several children drowned after being swept under it. Eventually, the concrete cap was removed in 2000 both for safety and aesthetic reasons (Price, 2013; Figure 2).

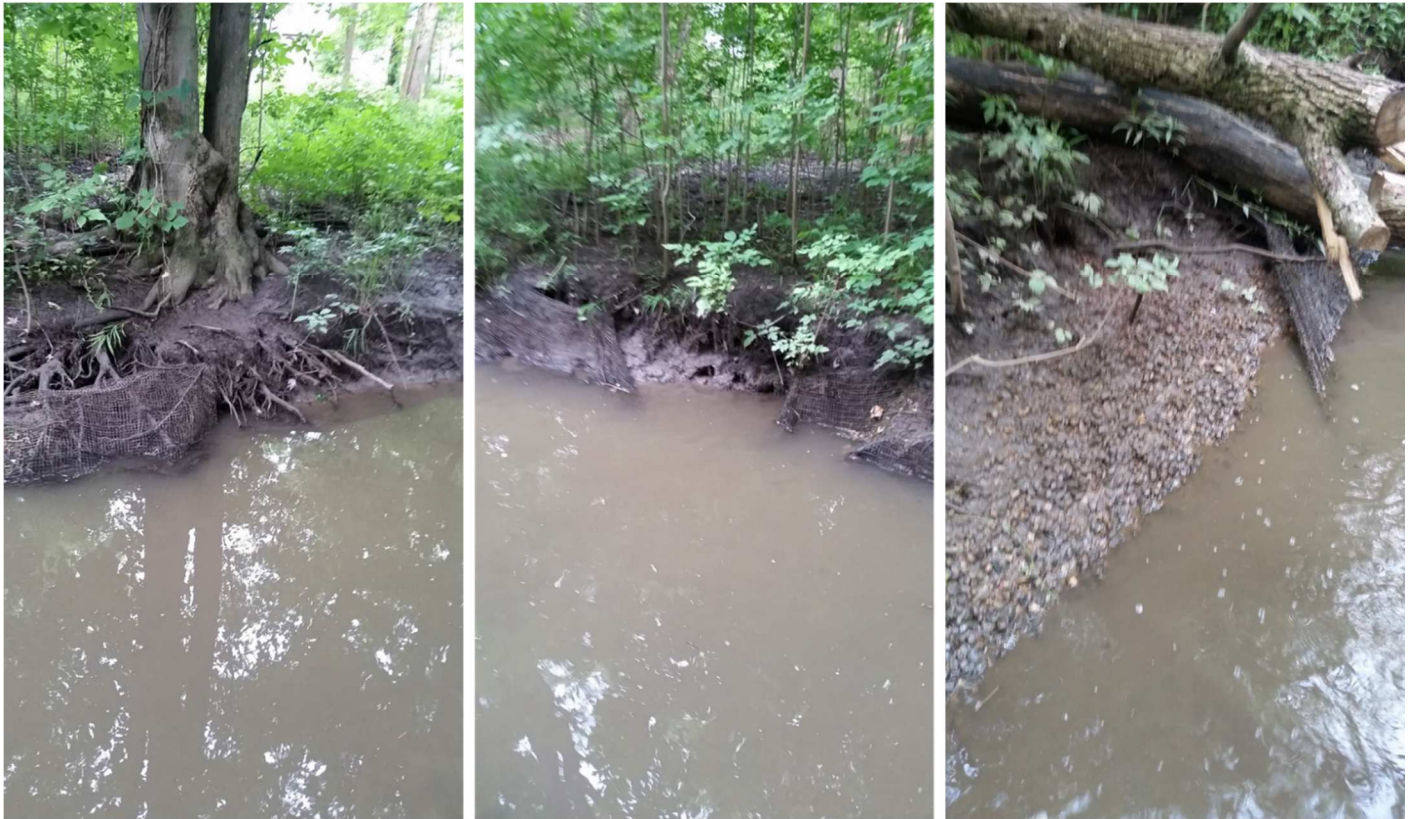
Figure 6. Exposed erosion control netting along banks at Station 1.

community scored low acceptable (-4) and habitat scored low good (115). The macroinvertebrate score was the same as Holden (2007) reported. The 2016 low acceptable score comes after slight improvements were reported in 2009 and 2011 (Table 5). The habitat score was higher than had previously been reported (Table 6). Eighteen different macroinvertebrate taxa were collected. Only two Trichoptera taxa were collected indicating poor water and habitat quality. One Unionidae mussel, the slippershell (*Alasmidonta viridis*) was found at the station and returned to the stream. The slippershell is a state threatened species and the individual that was sampled was a juvenile, indicating that some recruitment is occurring (Joseph Rathbun, Pers. Comm.). Corixidae was the most abundant taxa collected, which are very tolerant to stressors (Voshell, 2002). This station had meanders restored and erosion control netting installed along the banks. The substrate was mostly hard pan clay (60% visual estimate) and sand (29% visual estimate). Clay substrate is largely considered to provide poor habitat for macroinvertebrates, which tend to prefer irregular substrate and interstices that they can burrow into, as opposed to smooth, hard surfaces (Allan, 1995). Small amounts of gravel were present, but were embedded in fine sediment. Habitat such as large woody debris and undercut banks was sparse throughout the station. The stream appeared to be flashy and the banks were eroded greater than 20 inches above the water surface. A riparian resident that we spoke with at the station described flashy stream flow conditions during rain events. In several areas along the bank, water had scoured out the soil behind erosion control netting that had been installed on the banks in the 2000s and in some areas, the netting was slumping into the stream (Figure 6). The left bank had patchy sections of intact forest alongside the stream punctuated by residential lawns. The right bank had mostly intact forest. Large trees are on both sides of the stream, which provide good canopy cover.

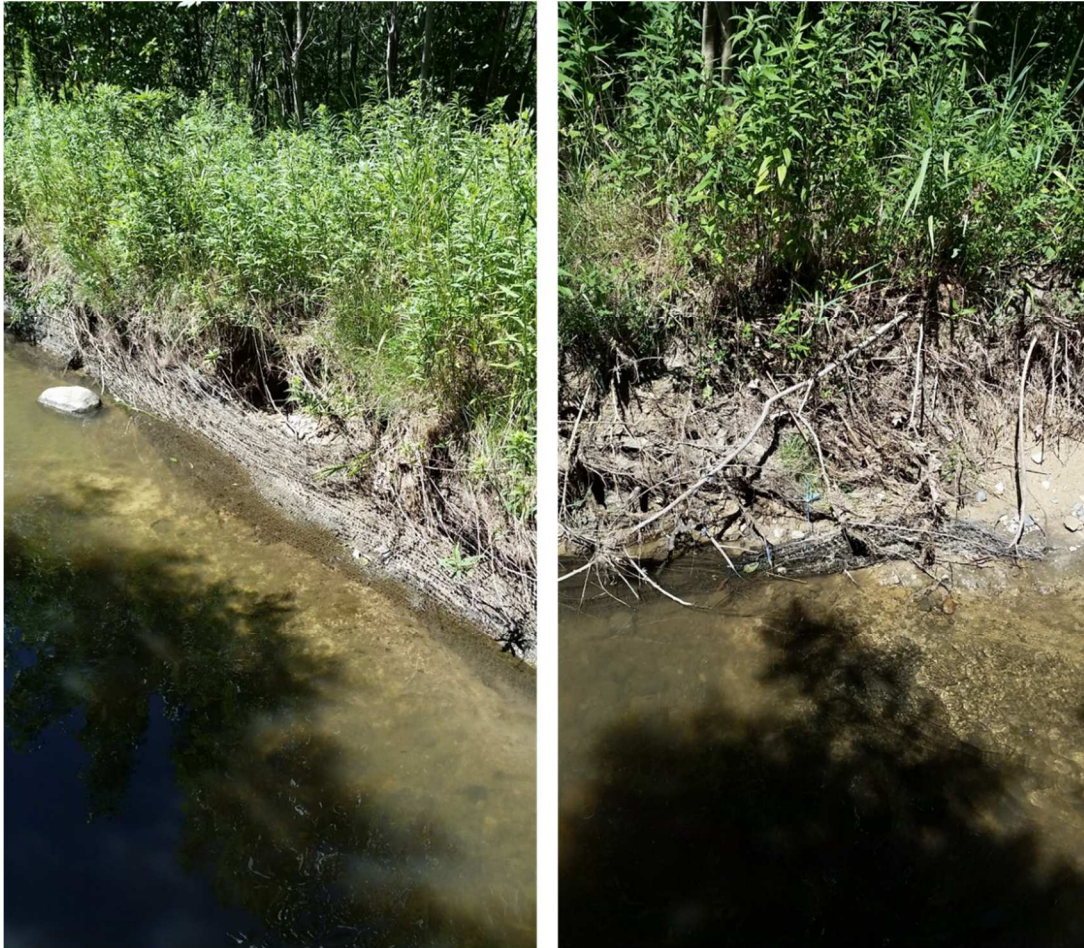
Figure 7. Exposed erosion control netting at Station 11.

Station 11 was sampled near Willow Woods Lane (Figure 5). The macroinvertebrate community scored low acceptable (-4) and habitat scored good (129). Twenty-two different taxa were collected, of which two were Ephemeroptera and one was Trichoptera, indicating low water and habitat quality. Amphipoda, Isopoda, and Hydropsychidae were the dominant taxa collected. Amphipoda and Hydropsychidae have a tendency to dominate in degraded to moderately degraded habitats, and Isopoda are somewhat tolerant to organic pollution (Voshell, 2002). The macroinvertebrate community scores had increased at this station in 2009 and 2011, but this latest score is the lowest that has been recorded for that station (Table 5). This station is in a section of Carrier Creek where artificial meanders were constructed as part of the restoration effort. Artificial riffles and rock substrate were also installed at this station. The rocks and gravel

were embedded by fine sediment and the majority of the stream substrate was hard pan clay and silt. Besides the rocks, other habitat types such as large woody debris, undercut banks, and macrophytes were sparse. The station showed signs of flashiness with bank scour occurring greater than 20 inches above the water surface. On some of the banks where erosion control netting had been installed to stabilize the banks, erosion was occurring behind the netting and the nets were slumping into the stream (Figure 7). The immediate riparian area contained some forest and meadow, as well as some residential lawns. Large trees to provide canopy cover are lacking because the restoration activities, which occurred less than two decades ago, required clearing land along the stream.

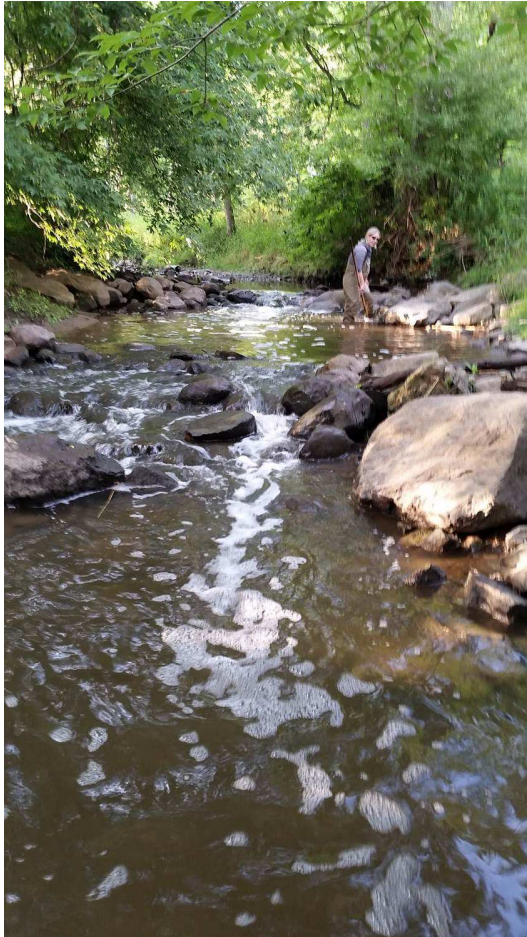
Figure 8. Carrier Creek upstream of Old River Trail.

Station 9, was sampled at Old River Trail, just upstream of Carrier Creek's confluence with the Grand River (Figure 5). The macroinvertebrate community scored acceptable (-1) and habitat scored good (152). The macroinvertebrate score at this station was the highest score in Carrier Creek and was the same as the score that was reported in 2011 (Table 5). Sixteen different taxa were collected, of which two were Ephemeroptera and one was Trichoptera, indicating poor-intermediate water and habitat quality. The macroinvertebrate community was dominated by Amphipoda and Hydropsychidae. The stream bottom is mostly covered with cobble that was artificially placed in the stream and several riffles composed of large boulders are present (Figure 8). Other than the rocks, habitat types such as large woody debris, undercut banks, and overhanging vegetation were either sparse or absent. The banks did show signs of flashiness with scoured banks 9-18 inches above the water surface. Also noteworthy is that the

water temperature at the time of sampling was 86° F (air temperature was 68° F). A rain event had occurred the night before we sampled so the high water temperature may have been a result of warm runoff water entering the stream (Marsalek et al., 2008). Along the right bank the riparian area had intact forest. Along the left bank was a residential lot. Both sides had large mature trees, which provide good canopy cover. The greater surrounding area contains a mix of land use including a large park, residential areas, and a WWTP (which discharges to the Grand River).

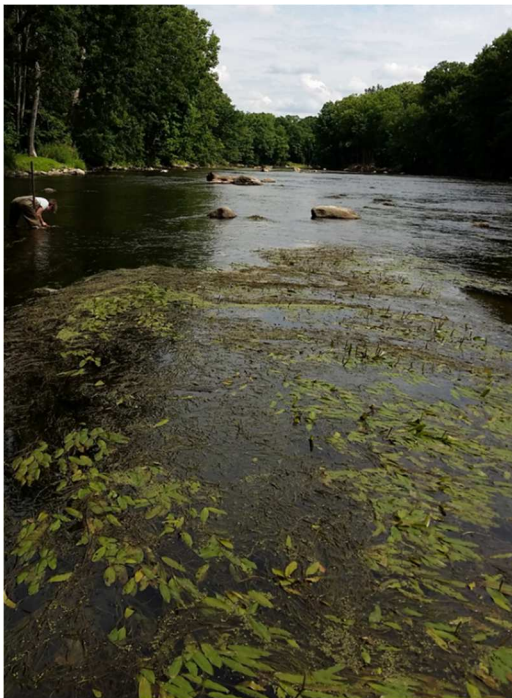
Figure 9. Grand River upstream of Waverly Road in Delhi Charter Township (Station 7).

The main stem Grand River was also sampled at Waverly Road in Delhi Charter Township (Station 7). The macroinvertebrate community scored excellent (8) and habitat scored good

(145). These results were similar to past findings at this station. Goodwin (2000) reported excellent fish and macroinvertebrate communities in 1996 and Rockafellow (2003a) reported an excellent macroinvertebrate community in 2001. Both of the previous biosurveys had used a different scoring methodology than this most recent one. In this latest survey, 30 different taxa were collected, of which 15 were EPT taxa, indicating good water quality. Hydropsychidae dominated the macroinvertebrate community. Hydropsychidae are facultative (occur in wide-ranging environments), but tend to dominate in rivers with moderate amounts of nutrients and/or organic matter (Voshell, 2002). The Grand River is approximately 170-feet wide at this station, but was only about a foot deep at the time of sampling. The river was also warm (82° F). The bottom substrate was mostly cobble (75% visual estimate) with some sand and gravel interspersed. Scattered throughout the station were also numerous large boulders (Figure 9). Other habitat types such as large woody debris, undercut banks, and rootwads were sparse, although macrophytes were dense in the river (Figure 9). Large trees were present along the immediate riparian land, although residential lots made up all of the land use on both sides of the river. The greater surrounding area is a mix of residential and agricultural land use, with some forested areas near the river.

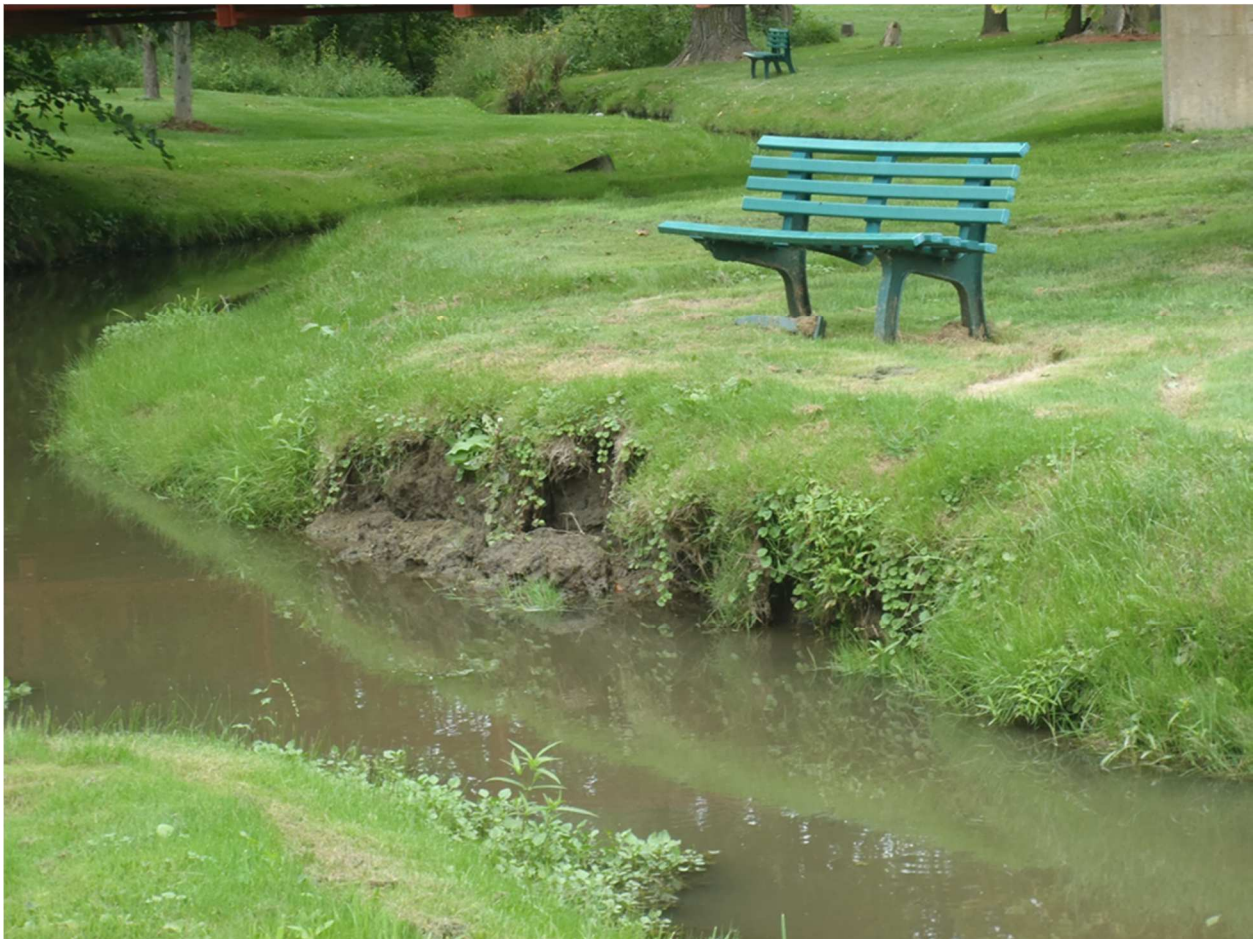
Figure 10. Atzinger Drain near Corwin Road and East Grand River Avenue (Station 25).

Atzinger Drain was sampled near the intersection of Corwin Road and East Grand River Avenue in the city of Williamston (Station 25). Erosion was a serious problem at this station, with portions of the bank slumping into the stream (Figure 10), and the banks are entirely mowed lawn (grass). The macroinvertebrate community scored low acceptable (-4) and habitat scored marginal (89). Twenty-one different taxa were collected, of which only 1 individual Ephemeroptera specimen was collected, indicating poor water and habitat quality. Oligochaeta and Coenagrionidae were the most abundant taxa collected. Oligochaeta are a diverse group of organisms with a wide range of tolerances, for the most part, though their dominance indicates a disturbed system (Voshell, 2002). Coenagrionidae are somewhat, to very, tolerant to stressors (Voshell, 2002). Although Atzinger Drain is a designated county drain, the watercourse at this station was sinuous and did not appear to have been dredged in recent years. The average depth of the drain was less than 1 foot with little pool variability.

- Throughout Carrier Creek, flashy conditions following precipitation events appeared to be having the greatest impacts on the stream.
- At Atzinger Drain (Station 25), portions of the bank are slumping into the stream (Figure 10). This is a grassy, park-like area surrounded by residential apartments and may benefit from planting more substantial riparian vegetation (trees and shrubs) to stabilize the banks.
