**MICHIGAN DEPARTMENT OF ENVIRONMENTAL QUALITY
WATER RESOURCES DIVISION
AUGUST 2018
STAFF REPORT**

Biological and water chemistry surveys of selected stations in the Maple River watershed in Clinton, Gratiot, Ionia, and Montcalm Counties, June-September 2017.

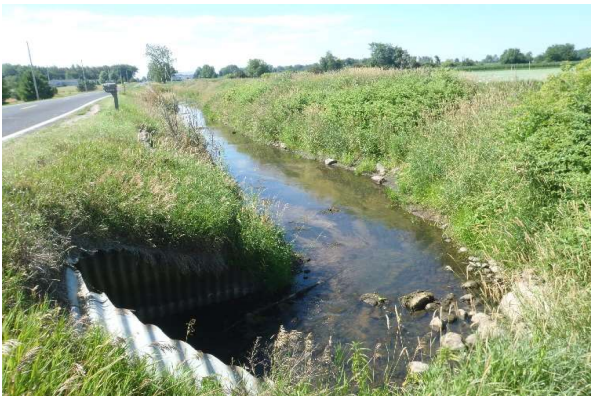
The Little Maple River was sampled at Saint Clair Road (Station 1). The glide/pool habitat was rated at the lower end of marginal (71; slightly impaired, Table 4). The river at this station is a maintained drain with steep banks and it runs right along the road. As a result, there is very little riparian area between the river and the road and the river and cultivated fields (Figure 2). The substrate at this station consisted primarily of sand and small gravel with no overhanging vegetation or large woody debris (LWD). The water was very clear until the fine layer of silt covering the substrate was kicked up. The macroinvertebrate community scored at the higher end of acceptable (3; Tables 5 and 6) due to a large number of caddisfly and mayfly taxa, which are more sensitive to pollution and a high number of total taxa found (30). It is likely the biological community would score excellent if there was cleaner substrate, pool variability, and LWD available for colonization.

Figure 2. Little Maple River upstream of St. Clair Road, Clinton County, Michigan, July 2017.

The glide/pool habitat in the Little Maple River at Saint Clair Road (Station 1) was rated at the lower end of marginal (71; Table 4), but the macroinvertebrate community scored at the higher end of acceptable (3; Tables 5 and 6). It is possible the biological community health has the potential to improve if there was more clean substrate, pool variability, and LWD available for colonization. Currently, the river is a maintained drain that runs right along Saint Clair Road with very little riparian area between the river and the road and the river and the crop fields (Figure 2). It has very steep banks and little to no sinuosity. This site would be a good candidate for NPS best management practices (BMP) that would allow for reduced siltation and increased riparian vegetation, LWD, and pool variability in the channel.

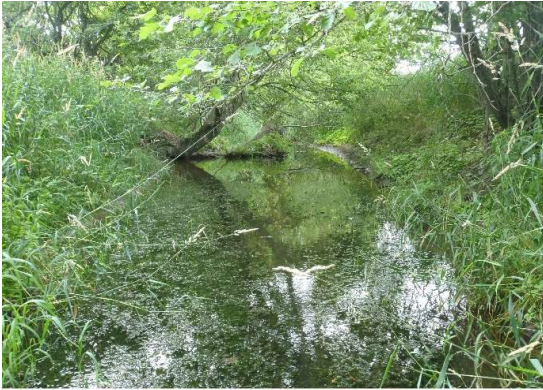
Baker Creek was sampled at Meridian Road (Station 2). It is a small tributary that has been historically maintained as a drain. The bridge at this crossing was creosote timber with an open bottom. The glide/run habitat was rated marginal (92; Table 4). Grass was the dominant riparian vegetation (Figure 3). There was a large amount of Elodea and overhanging grass limiting flow and habitat diversity (Figure 4). Vegetation was the only colonizable substrate. Banks had sloughed in the past and the substrate consisted of a mix of silt, sand, and clay. The macroinvertebrate community scored at the lower end of acceptable (-3; Tables 5 and 6). Only 1 mayfly taxa and 2 caddisfly taxa were found and more than 60% of the individuals found were *Physidae* snails, which are very tolerant of environmental stressors.

Figure 3. Baker Creek upstream of Meridian Road, Clinton County, Michigan, July 2017.

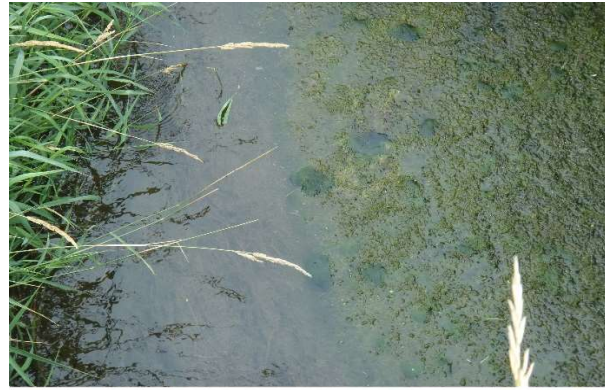
Figure 4. Thick *Elodea sp.* in Baker Creek upstream of Meridian Road, Clinton County, Michigan, July 2017.

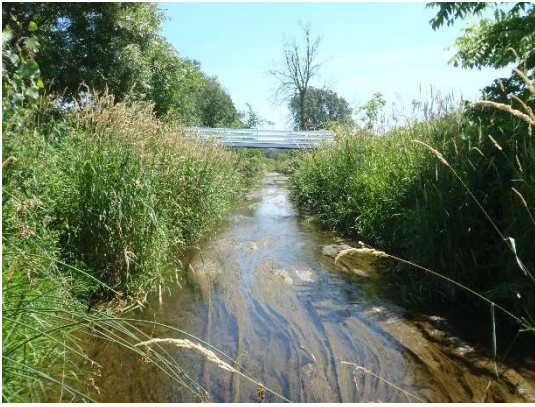
Muskrat Creek was sampled at Price Road (Station 3). It is a moderately sized stream that has been maintained as a drain. The riffle/run habitat at this station is somewhat unique for the Maple River watershed and habitat was rated at the low end of good (114; Table 4). There was a large amount of cobble available as epifaunal substrate; however, it was heavily embedded with cladophora (Figures 5-7). Muskrat Creek is part of the watershed that is listed as impaired due to excessive nutrients, which likely explains the nuisance-level cladophora conditions observed throughout this stream reach that had very little riparian vegetation available for shade. The macroinvertebrate community scored at the higher end of acceptable (3; Tables 5 and 6). This is attributed to a large number of taxa (34) found including several caddisfly and mayfly.

Figure 5. Cladophora in Muskrat Creek upstream of Price Road, looking upstream.

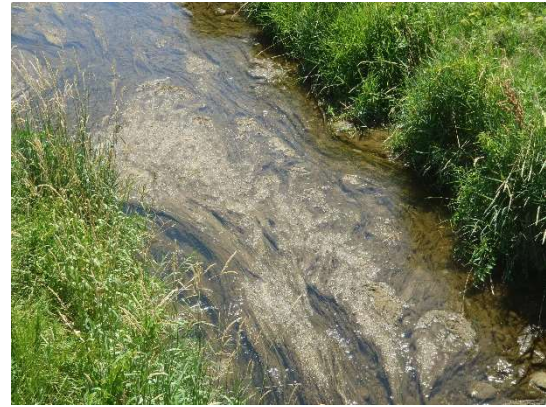
Figure 6. Close-up of nuisance conditions observed in Muskrat Creek.

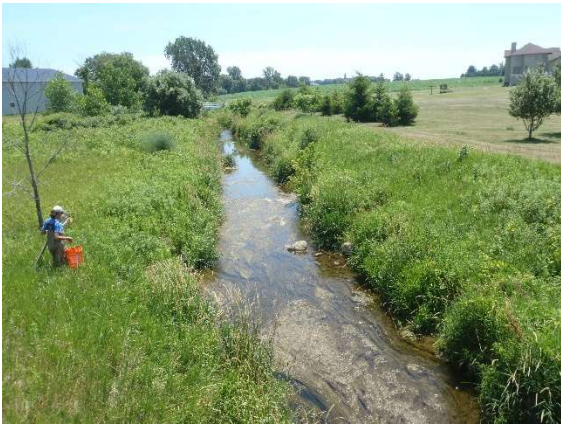
Figure 7. Muskrat Creek upstream of Price Road. Note the straight channel indicative of a maintained drain.

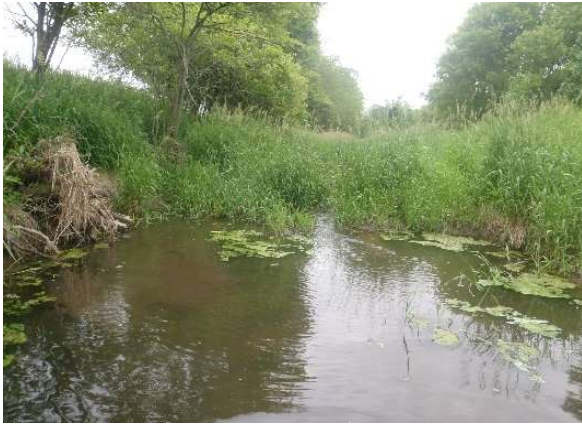
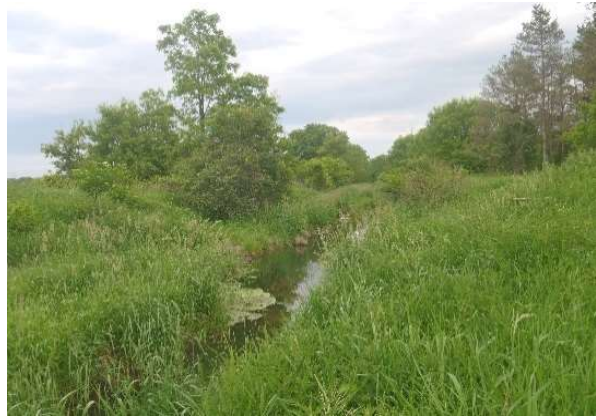
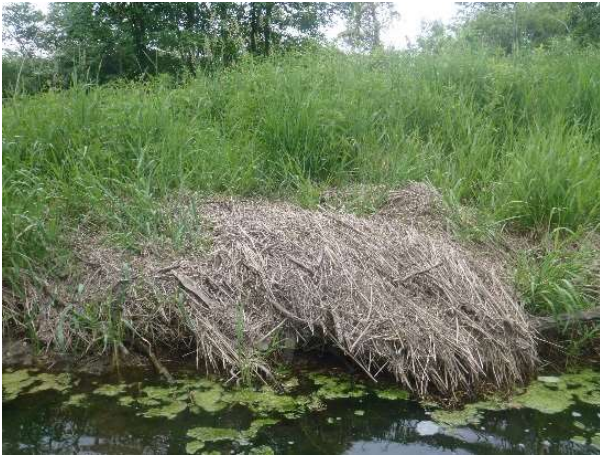
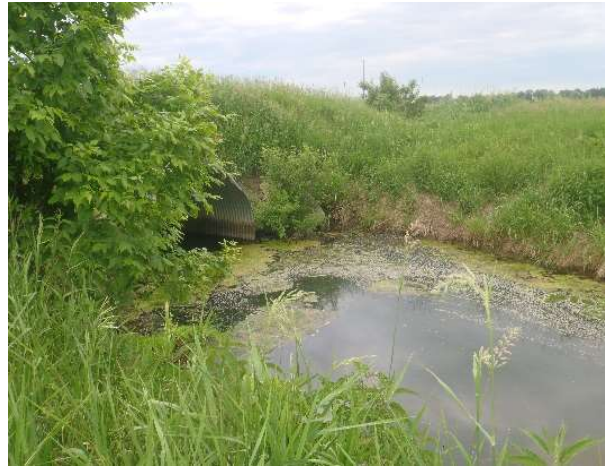
Cox Drain was sampled at Essex Center Road (Station 4). It is a small, historically maintained drain with sloughing banks and a large amount of sediment deposition allowing for islands of emergent grass. The deposition was so prevalent that the stream was a series of very shallow constricted areas and shallow pools. It also appeared to be somewhat flashy, with debris piled up on the banks. The glide/pool habitat was rated at the high end of marginal (104; Table 4). There was a substantial amount of LWD in the channel but very little other epifaunal substrate. About 50% of the habitat in the reach consisted of floating and attached algae (Figures 8-11). The macroinvertebrate community scored at the low end of acceptable (-4; Tables 5 and 6), which is just 1 point away from scoring poor. Isopods and chironomids dominated the taxa found and both are tolerant to environmental stress.

Figures 8-11. Cox Drain upstream of Essex Center Road, Clinton County, Michigan, June 2017.

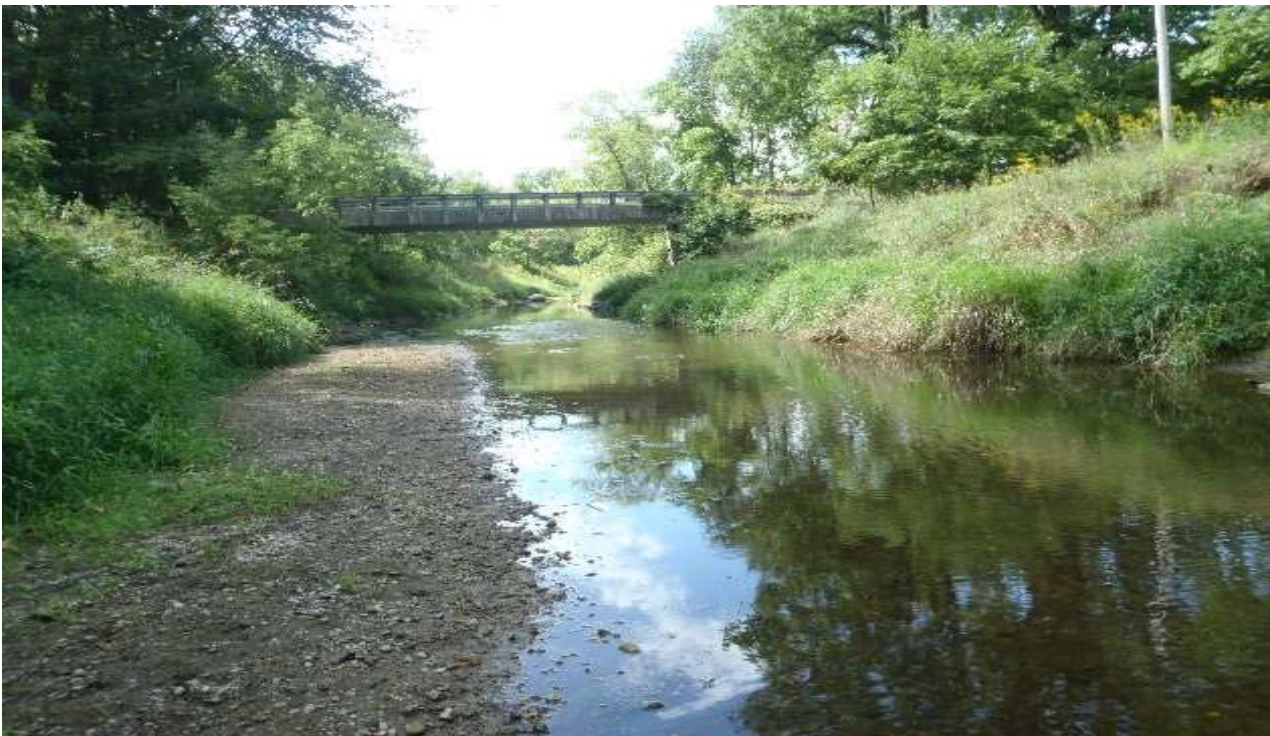
Hayworth Creek was sampled at Bauer Road (Station 5). It is a fairly large drain that has had some in-stream habitat improvement work, including the periodic placement of several j-hooks. These habitat improvements are increasing flow in the thalweg of the channel and exposing clean gravels. The drain has been historically maintained and is deeply incised (>50 feet; Figure 12). Although there are areas of clean gravel, there is a fine layer of silt covering most of the substrate and the backwater areas near the j-hooks are very black due to the silt deposition. Upstream of the j-hooks, floating algae collects. The riffle/run habitat was rated at the lower end of good (114; Table 7). No LWD was available for colonization and there were few larger trees in the riparian area that would provide for future woody structure. The macroinvertebrate community scored acceptable (1; Tables 8 and 9). Thirty-eight taxa were found at this station. However, there were no stoneflies found, and the percentage of isopods and snails found was high enough to deduct points for these metrics indicating that there may be some type of environmental stressor impacting the biological community.

Figure 12. Hayworth Creek upstream of Bauer Road looking downstream, Clinton County, Michigan, September 2017.

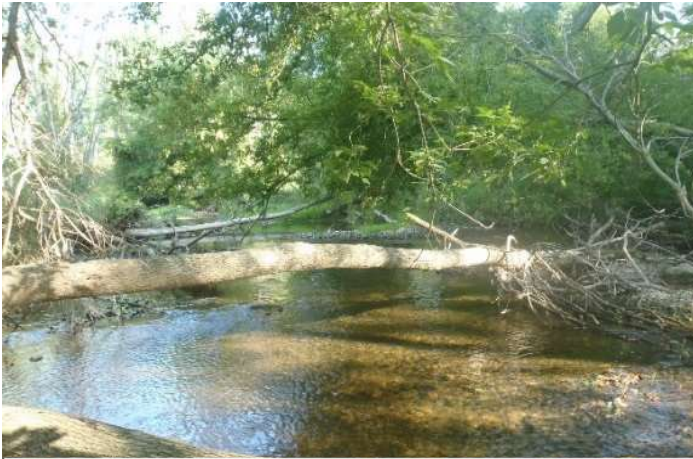
Pine Creek was sampled at Cleveland Road (M-57; Station 6). It is a relatively large stream that was in a relatively natural state when compared to other stations sampled in 2017. The riparian area was wide with many large trees and dead ash. There was a lot of LWD in the channel as well as cobble and gravel for colonization (Figures 13 and 14); however, the substrate had a fine layer of silt and attached algae on it, which may prevent the most sensitive species from colonizing it. The stream appeared flashy due to the substantial number of very large LWD jams and debris located as high as 5 feet above the surface of the water, which was less than 1-foot deep on average. The riffle/run habitat was rated as good (140; Table 7). The macroinvertebrate community scored at acceptable (0; Tables 8 and 9). Although there was a large diversity of macroinvertebrates found, many of them were from taxa orders that are more tolerant of pollution. No stonefly taxa were found and of the 36 taxa found, 8 were from the most sensitive groups.

Figure 13. Pine Creek upstream of M-57, Clinton County, Michigan, September 2017.

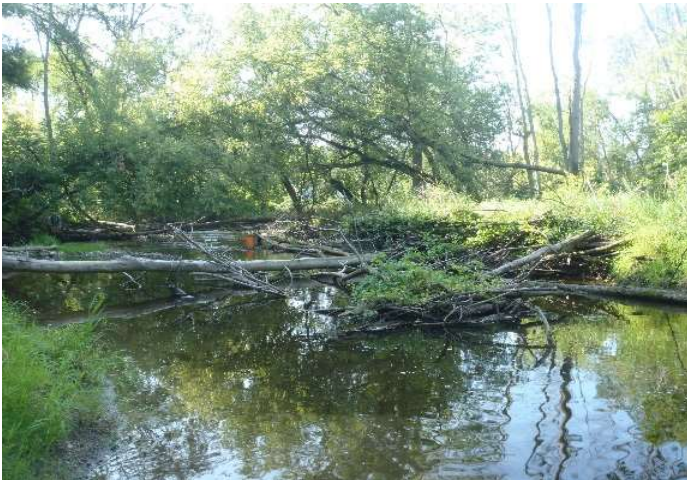
Figure 14. Woody structure in Pine Creek upstream of M-57.

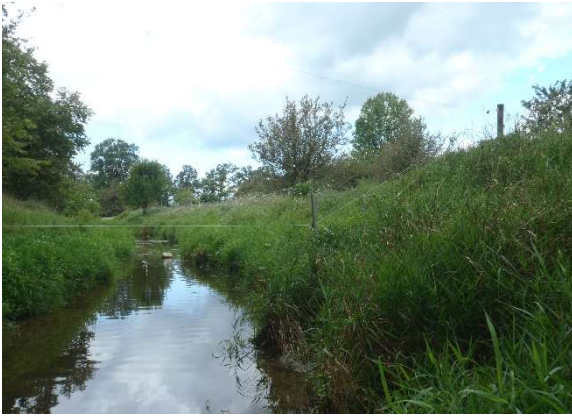
North Shade Drain was sampled at Ennis Road (Station 7). It is a small stream that has current and historic direct livestock access, although current access is limited to horses (Figure 15). More details regarding this can be found in the nonpoint source targeted monitoring section below. The glide/pool habitat was rated as marginal (84; Table 7). The pool substrate was gravel and cobble, but was covered with silt, and the pools were almost nonexistent. There was very little LWD and the riparian zone was very narrow with steep eroding banks on the right side. The macroinvertebrate community scored at the low end of acceptable with flatworms comprising nearly 50% of the total individuals collected (-3; Tables 8 and 9). Less than 1% of the individuals were mayflies or caddisflies indicating an environmental stressor is impacting the macroinvertebrate community.

Figure 15. North Shade Drain upstream of Ennis Road, Gratiot County, Michigan, September 2017.

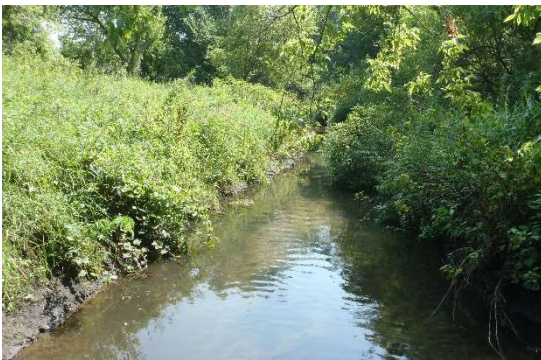
Fish Creek is a coldwater tributary located in the lower portion of the Maple River watershed and was sampled at 3 locations. The upstream station (Station 8) was sampled at Pine Grove Road. The glide/pool habitat was rated as marginal (99; Table 10). Firm sand was the prevalent substrate with a large amount of siltation and sediment deposition, especially along the edges. There was only 1 pool, very little LWD, and the only colonizable substrate was aquatic vegetation (Figure 16). The water level seemed a bit low. The macroinvertebrate community scored acceptable (1; Tables 11 and 12) with midges dominating (47%) the macroinvertebrate community. Caddisflies and mayflies were not abundant and no stonefly taxa were found, all indicating some amount of environmental stress. The water temperature was the coldest measured in the Maple River watershed at 59 degrees Fahrenheit.

Figure 16. Fish Creek upstream of Pine Grove Road, Clinton County, Michigan, July 2017.

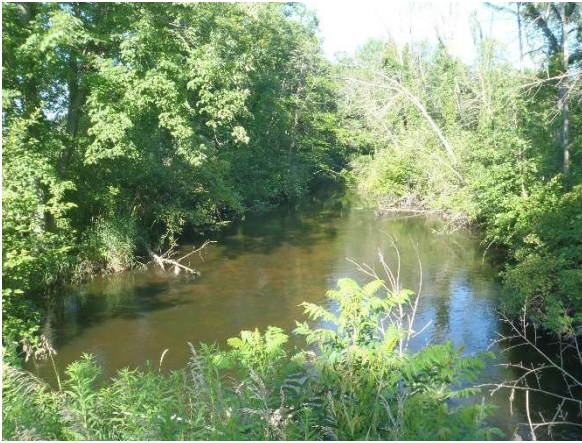
The second station to be sampled in Fish Creek was 1 mile downstream at Vickeryville Road (Station 9). The glide/pool habitat was rated good (137; Table 10). Although sand was the prevalent substrate there was less sediment deposition, more LWD, and a little bit of gravel (Figure 17). Banks were fairly stable except for 1 area that had a lot of erosion; however, tree roots were stabilizing the bank. The macroinvertebrate community scored acceptable (3; Tables 11 and 12) with 9 species of pollution-sensitive mayflies, caddisflies, and stoneflies found and no one taxa dominating the community. Local fishermen have been reported to catch brown trout at this station also indicating a healthy stream. There is an additional tributary that joins Fish Creek approximately a half mile upstream of this station that provides additional flow.

Figure 17. Fish Creek upstream of Vickeryville Road, Clinton County, Michigan, July 2017.

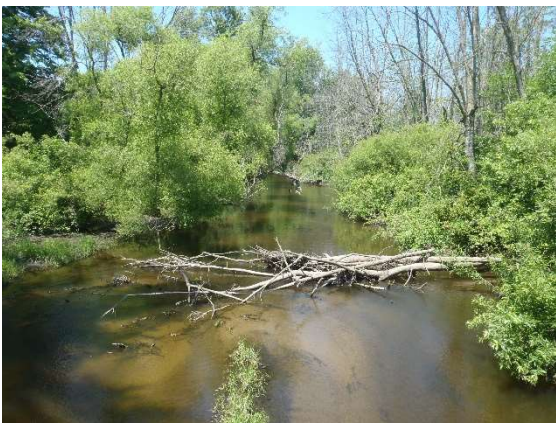
The third and most downstream station (Station 10) in Fish Creek was sampled at Bollinger Road. The glide/pool habitat was rated good (144; Table 10). There was a mix of cobble, gravel, sand, and silt. Clay was also exposed at 1 undercut bank. There was only 1 pool and a very LWD jam, indicating the stream may be flashy at times. Dead ash trees were also present in the riparian zone, which may be contributing to woody debris jams, and also impacted the amount of shade provided by taller trees (Figure 18). The macroinvertebrate community scored acceptable (2; **Error! Reference source not found.** with 10 species of pollution sensitive mayflies, caddisflies, and stoneflies found and 33 total taxa, indicating a large amount of diversity. There was a large number of water boatman (family: Corixidae) found, which are considered air breathers and therefore more tolerant to degraded conditions.

Figure 18. Fish Creek upstream of Bollinger Road, Clinton County, Michigan, July 2017.

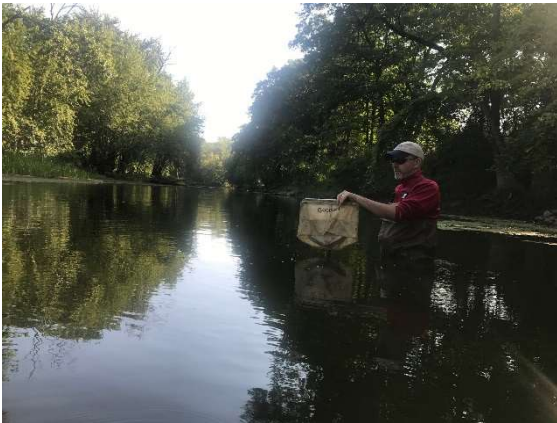
Figure 19. Maple River upstream of Tallman Road, Clinton County, Michigan, August 2017.

The glide/pool habitat was rated good (122; Table 13) upstream at the trend station (Figure 19), and excellent (156) downstream of Tallman Road (Figure 20). The Maple River is very large at this point in the watershed being 60- to 100-feet wide and averaging more than 3 feet deep with much of the thalweg and pools nonwadeable. Silt and sand are the dominant substrate with little LWD. Aquatic vegetation provides some additional epifaunal substrate. The river is very slow moving and is slow to rise and fall and remains fairly turbid throughout the monitoring season. The macroinvertebrate community scored acceptable (-1 and 0; Tables 14 and 15). Both upstream and downstream communities were diverse with 34-35 taxa found. No stoneflies were found and the percentage of mayfly and caddisfly taxa was somewhat low.

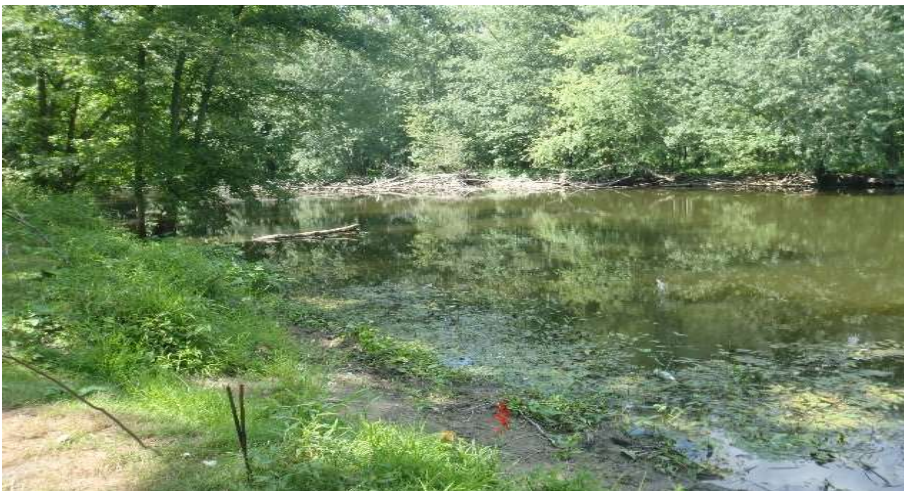
Figure 20. Maple River downstream of Tallman Road, Clinton County, Michigan, August 2017.

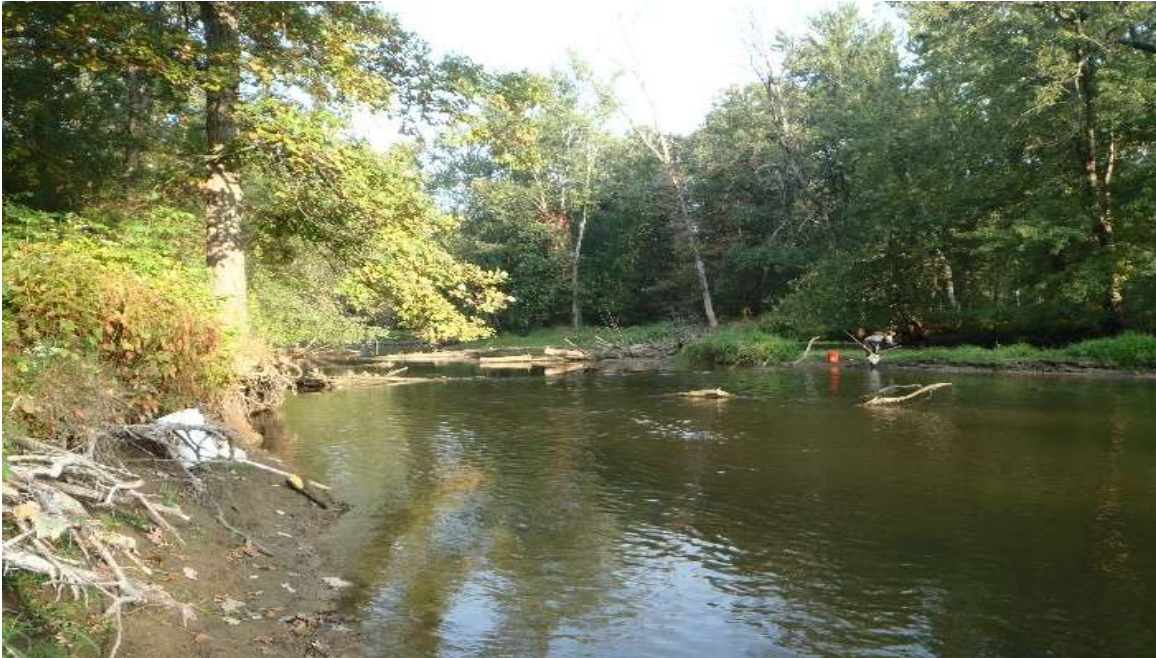
The most downstream station sampled in the Maple River was at Nickel Plate Road (Station 13). The water level at this station remained high throughout most of the sampling season. It was wadeable at the end of September (Figure 21). The sampling station began just upstream of the confluence of the tributary that comes from the northeast. The glide/pool habitat was rated good (144; Table 13). There was a large depositional area of sand near the tributary confluence. Rootwads were abundant. The riparian area was a large intact floodplain with naturally little understory. One small area was

maintained on the right bank for river access. Several species of mussel shells were found. The banks were steep due to down cutting of the clay banks. The water was very turbid and slow moving with sand, silt, and clay dominating. There were very few macrophytes but a fair amount of large woody structure but all substrate was covered by a thin layer of silt. The macroinvertebrate community scored acceptable (2; Tables 14 and 15). The community continued to be diverse with 36 taxa found. No stoneflies were found and the percentage of caddisfly taxa found was somewhat low. Amphipods were nearly a third of the taxa found, indicating some amount of environmental stressor is impacting the biological community.

Figure 21. Maple River upstream of Nickel Plate Road, Clinton County, Michigan, September 2017.

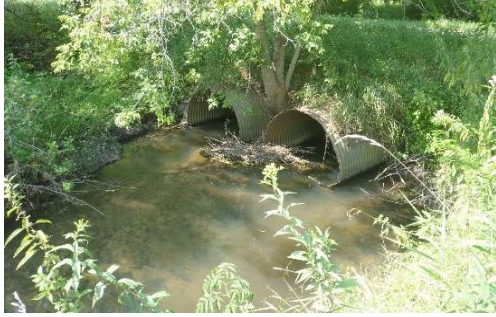
The road crossing at Pine Grove Road is a dirt road with twin 2-foot culverts that appear undersized for the channel width (Figure 22). This site would be a good candidate for road crossing replacement if funds are available. The macroinvertebrate community scored acceptable (1; Tables 11 and 12).

Figure 22. Undersized culverts for Fish Creek at Pine Grove Road, Clinton County, Michigan, July 2017.

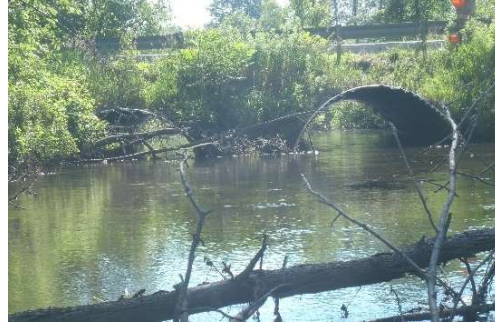
Figure 23. Culverts for Fish Creek crossing at Vickeryville Road, Clinton County, Michigan, July 2017.

The road crossing of Fish Creek at Vickeryville Road consists of 2 large culverts and a paved approach (Figure 23). However, the alignment of the culverts at this station may not be appropriate for the stream's geomorphology, and causing siltation on one side of the channel and erosion on the other. Pool variability was good. The macroinvertebrate community scored acceptable (3; Tables 11 and 12).

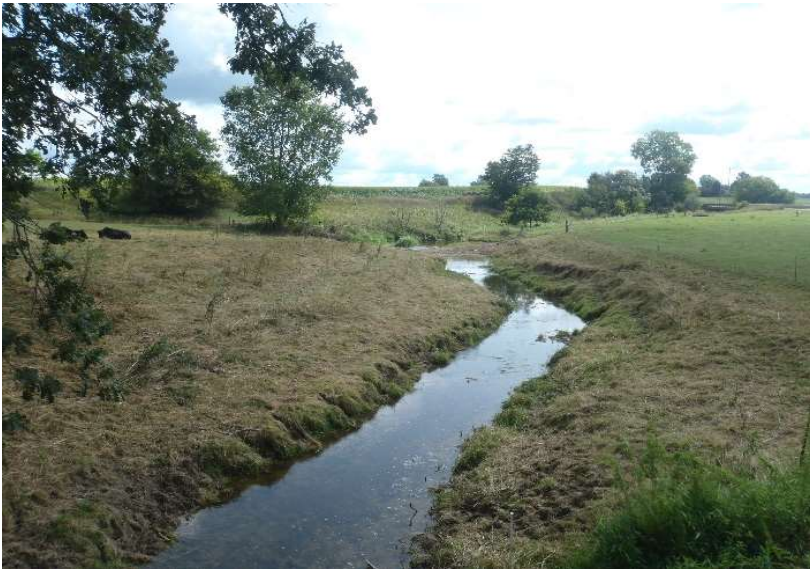
Downstream of South Ennis Road several cows were observed with unrestricted access to both North Shade Drain (~240 feet; Figure 24) and the Pine River upstream and downstream of the confluence with North Shade Drain (~1100 feet; Figure 25). Trampled banks due to cattle frequently crossing the stream and animals defecating in the stream were both obvious sources of sedimentation and pathogen contamination.

Figure 24. North Shade Drain downstream of Ennis Road, Gratiot County, Michigan, September 2017. Confluence of Pine Creek is located at the tree line at upper portion of photo.

MDEQ staff will return to these stations during the next cycle year in North Shade Drain and Pine Creek to determine if Right-to-Farm staff were successful in working with the landowners to install appropriate livestock exclusion BMPs. Additional water chemistry, habitat, and macroinvertebrate community monitoring may be conducted.

- 1) North Shade Drain and Pine Creek at South Ennis Road can be revisited to determine if improvements have been made in restricting livestock access to the drain, and if not, report conditions to district staff and/or the Michigan Department of Agricultural and Rural Development. In addition, *E.coli* samples could be taken to better document if the partial body contact recreation designated use is being met.

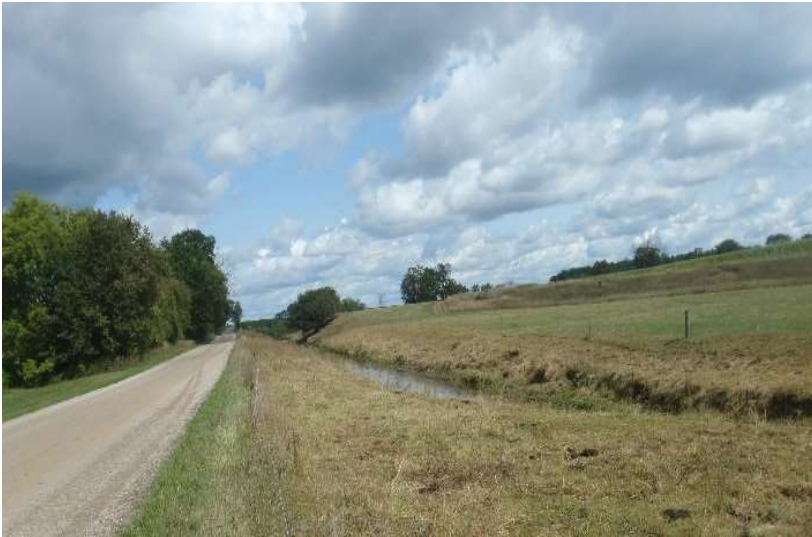
The South Ennis Road location is just upstream of the confluence of North Shade Drain with the Pine River. The macroinvertebrate community in the Pine River was sampled upstream of the North Shade Drain confluence in 2012 (Holden, 2013) and was rated as poor (-5). Cattle access has been noted at this station from at least 2007, and is likely the cause of nonattainment.

Figure 25. Pine Creek along South Ennis Road, Gratiot County, Michigan, looking north, September 2017.
