Bradley Drain two-stage ditch improves stream channel stability

Waterbody improved: Bradley Drain (part of AUID number 040500050208-02) is in the Collier Creek subwatershed within the Upper Maple River watershed located in Clinton County, Michigan. Collier Creek is listed on the Clean Water Act Section 303(d) list of impaired waters. Collier Creek is not meeting the Other Indigenous Aquatic Life and Wildlife Designated Use due to phosphorus. A phosphorus Total Maximum Daily Load was completed in 2009.

GRTS number: 97547411-05

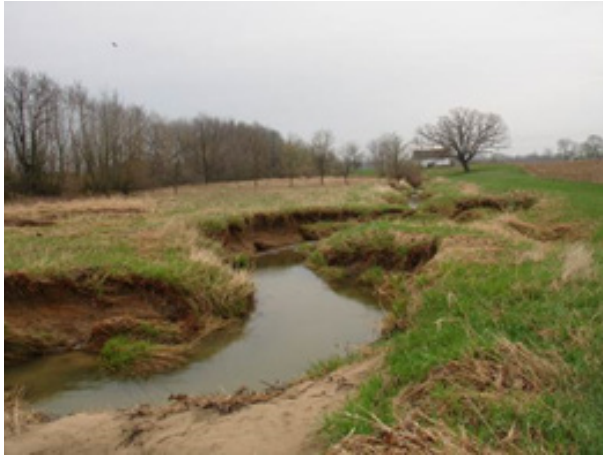
Figure 1. Before construction picture of Bradley Drain with extensive stream bank erosion.

Problem: The Upper Maple River Watershed Management Plan identified Bradley Drain as a critical stream bank erosion site. Stream bank erosion and sediment loading were excessive (Figure 1). Preliminary data indicated that the erosion rate on the Bradley Drain was 0.2 to 0.6 feet per year. The dominant land use in the Bradley Drain watershed is agriculture. While land use has not changed recently, factors such as lack of riparian buffers, increased field drainage, and loss of wetlands has increased flow in the Bradley Drain.

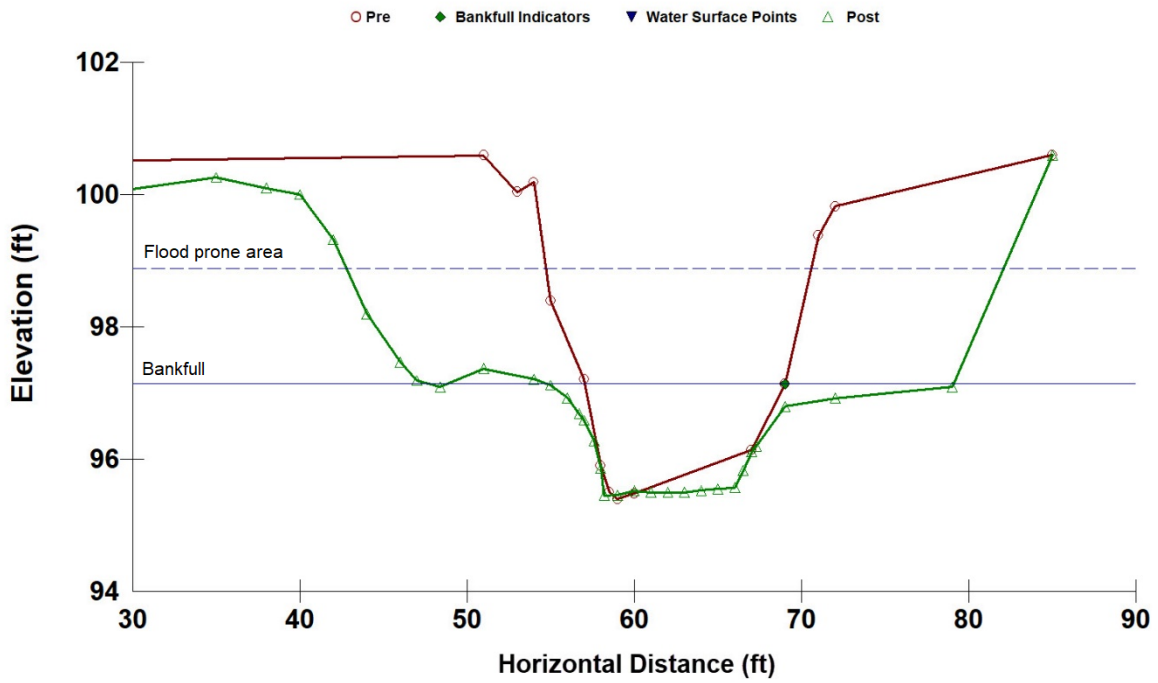
Figure 2. Bradley Drain pre- and post-restoration channel cross section.

Results: Cross section data prior to construction shows the shape of the incised stream channel and the post-construction cross section shows the creation of the two-stage ditch with the increased flood prone area (Figure 2). Post-construction photographs demonstrate the increased connectivity with the floodplain and the progression of vegetation establishment within the two-stage ditch (Figure 3). The width of the flood prone area roughly doubled in the post-construction channel (Table 1 and Table 2). Channel entrenchment ratio (an expression of floodplain access) increased and bank height ratio (an expression of channel incision) decreased after construction (Table 3 and Table 4). Using the Environmental Protection Agency's stream function assessment protocol, entrenchment ratios and bank height ratios were "Not functioning" prior to channel construction, and "Functioning" after construction. Annual loads were estimated to be reduced by 1,044 tons of sediment; 1,201 pounds of phosphorus; and 2,401 pounds of nitrogen.

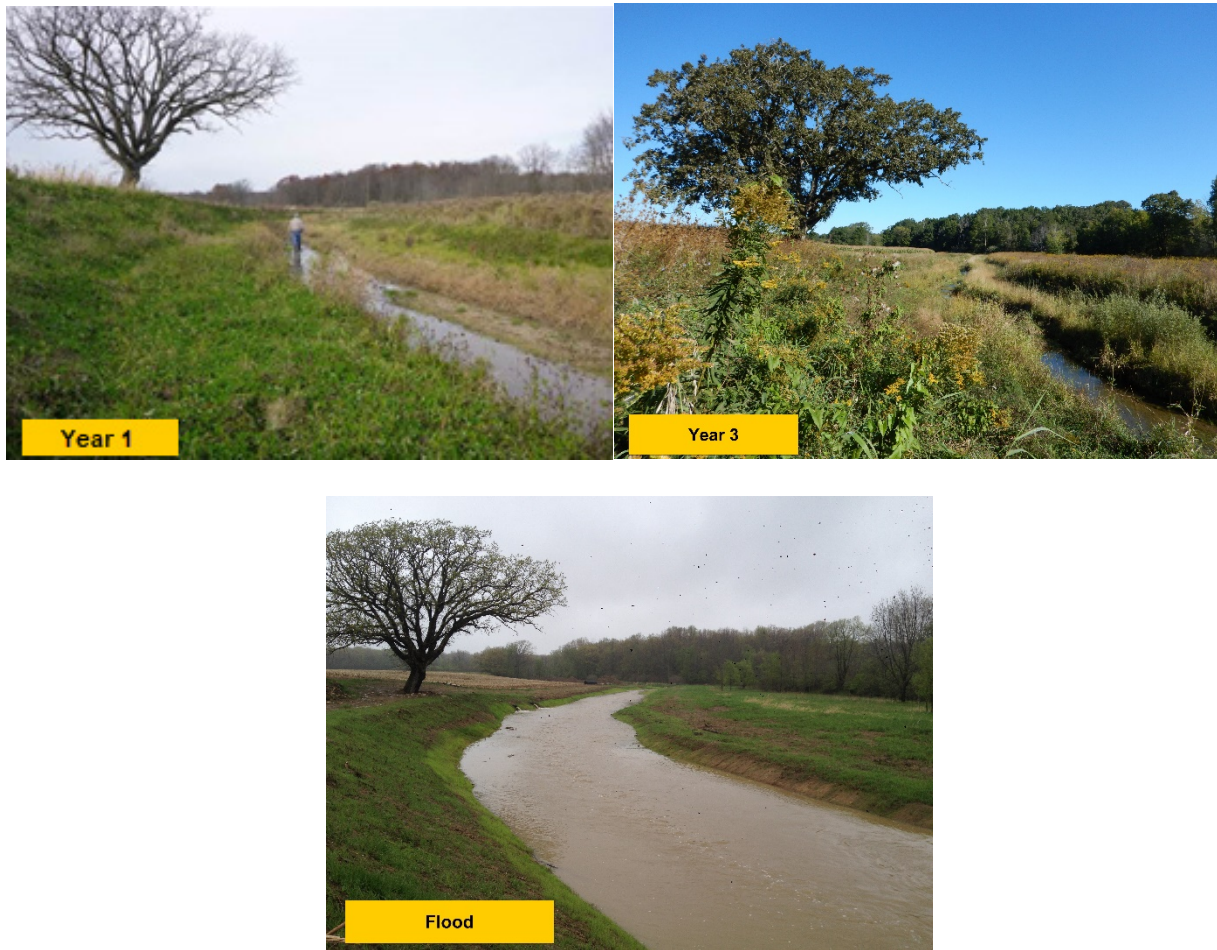
Figure 3. Bradley Drain one year and three years post-construction of a two-stage ditch during base flow conditions (top) and during high flow after rain (bottom).
