Kids Creek Restoration - Phase II

9/1/14 through 6/30/18

Before/After BMP Photos

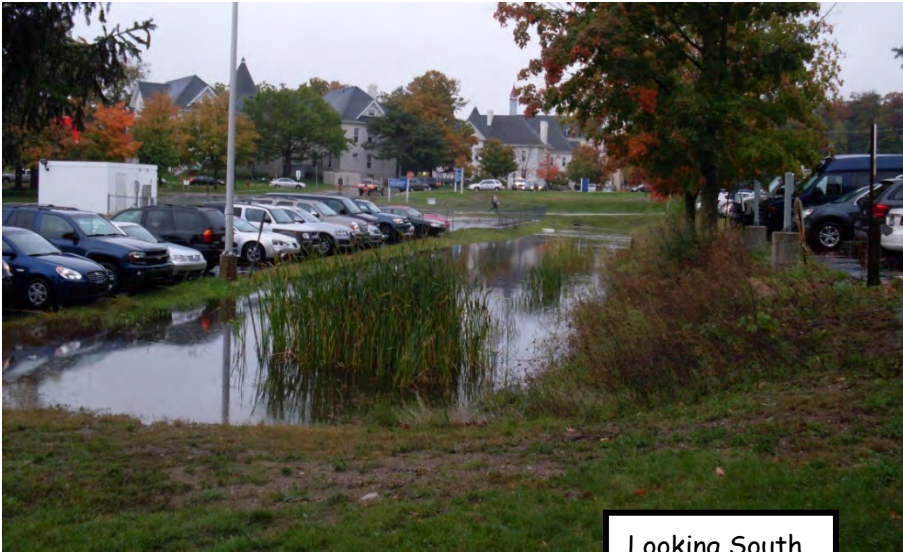
Looking South

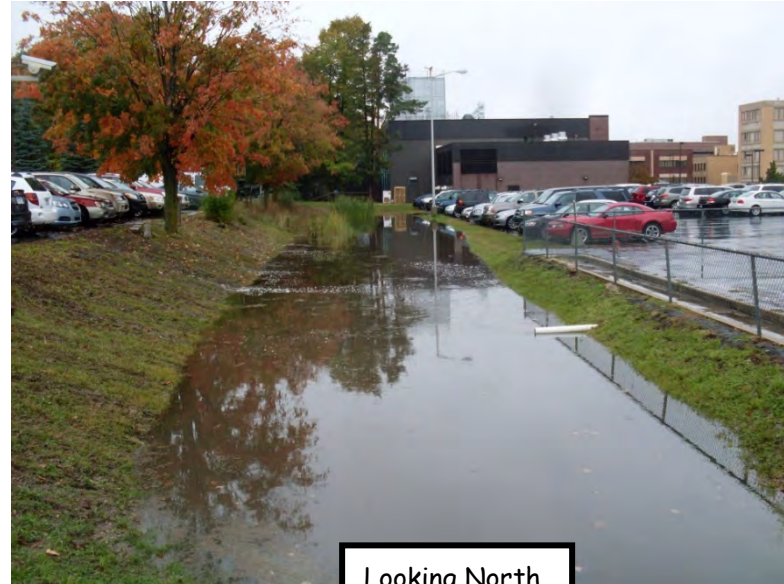
Looking North

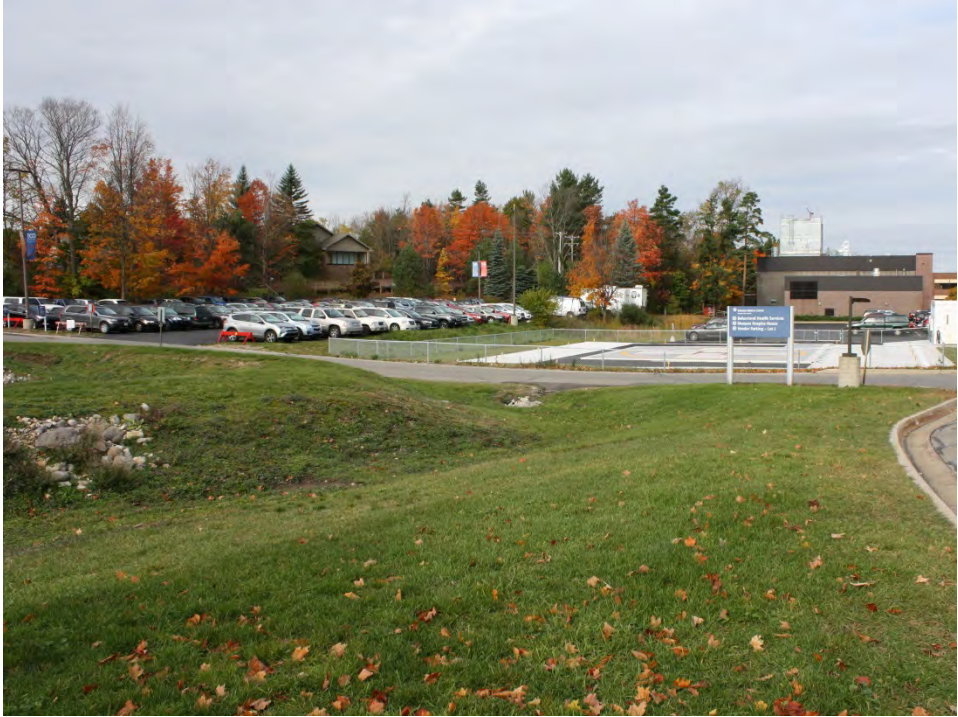
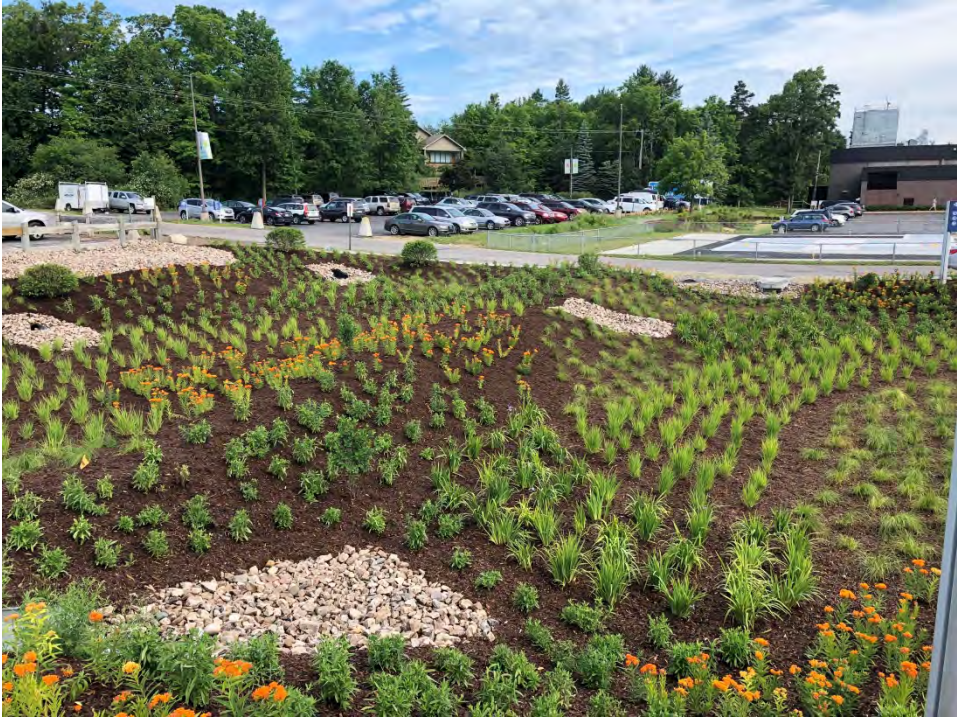
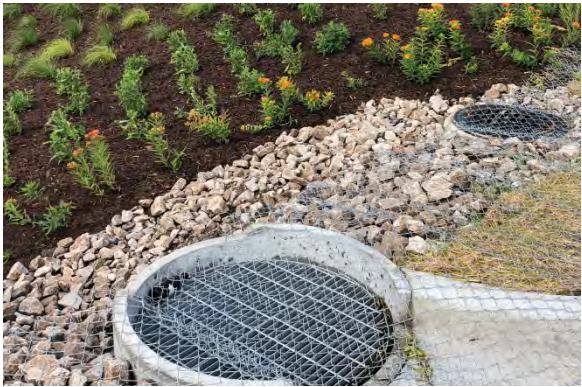
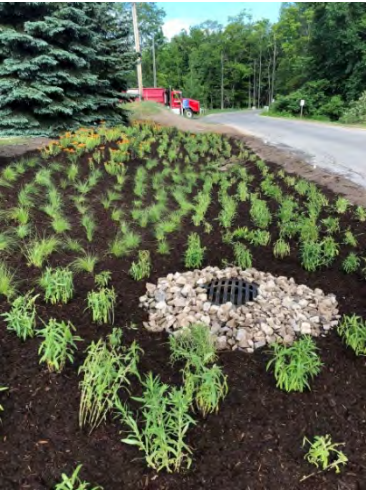
Munson Medical Center - Medical Campus Drive: Rain Garden #4

Pre-treatment structures:
Far Left - Rain Garden Turret
Immediate Left - Vegetated Swale

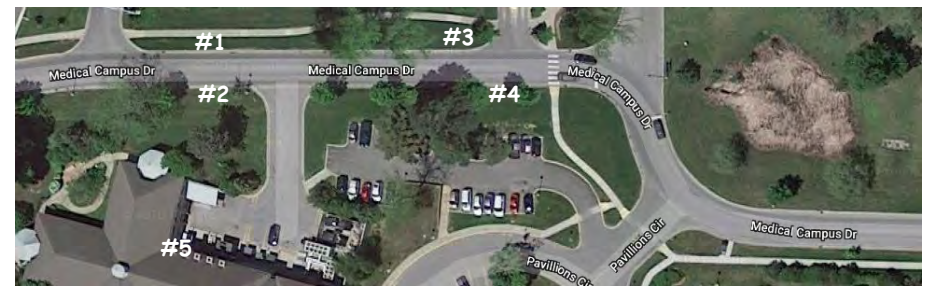
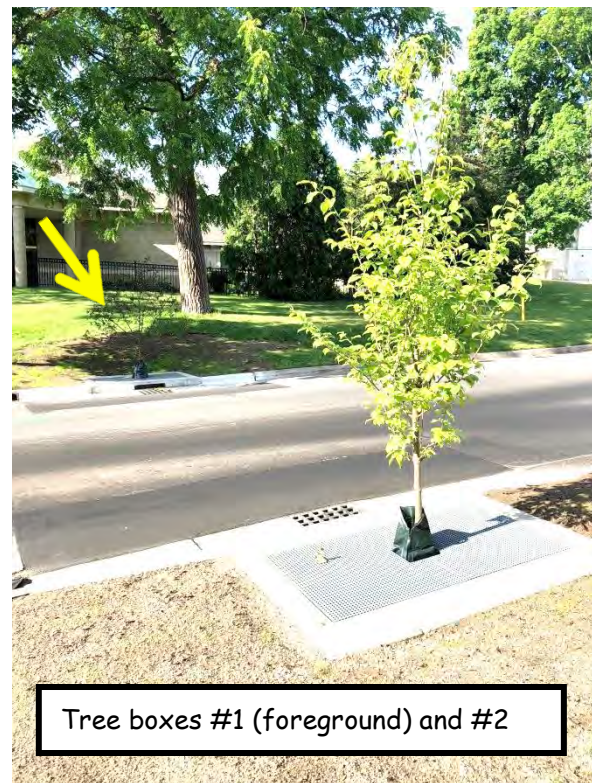
Tree boxes #1 (foreground) and #2

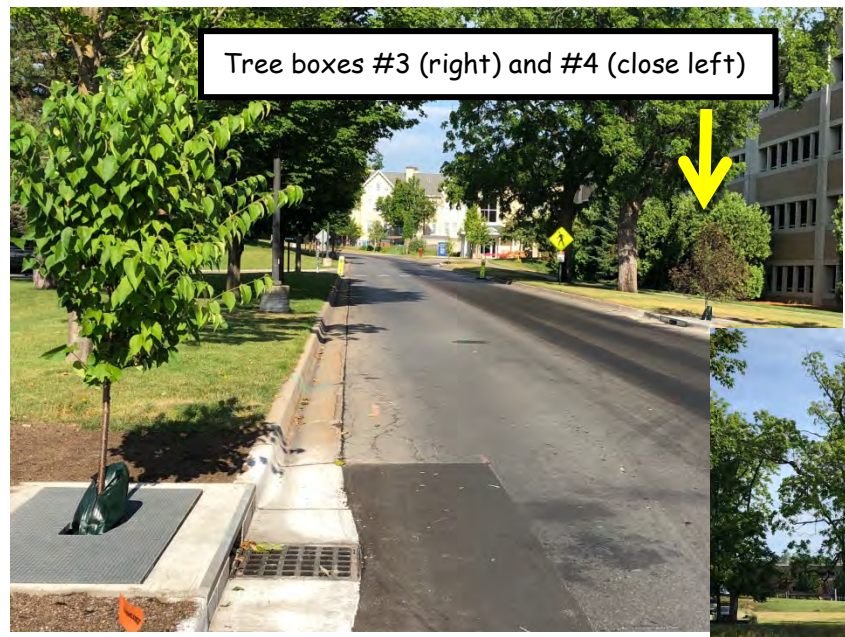
Tree boxes #3 (right) and #4 (close left)

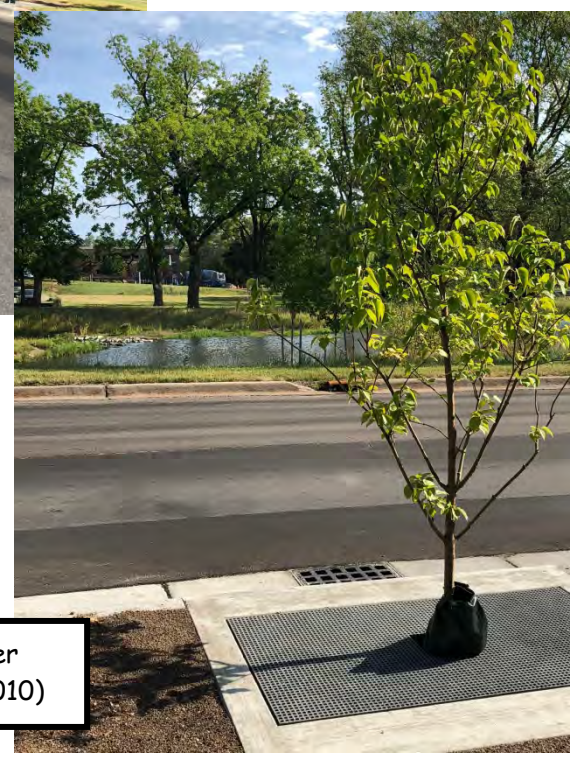
Tree box #5 (across from stormwater wetland from DEQ project #2013-0010)

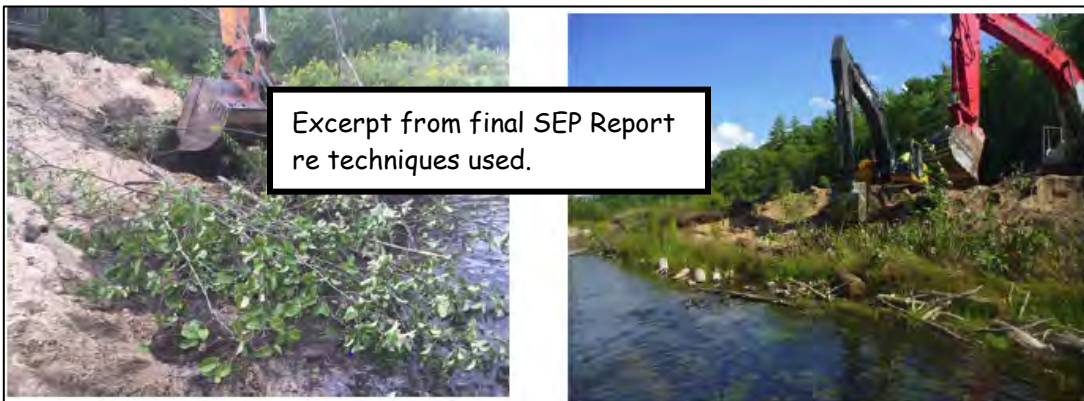
Figure 1. Technique 1. Bank is excavated and the tops of alders are placed underneath transplants. Technique 1 is used when the toe is devoid of vegetation.

Figure 2. Technique 2. In many places, vegetation was established along the bank toe, so the bench was simply excavated behind the vegetation. This photo shows the toe vegetation being preserved and the transplants being placed on the excavated bench.

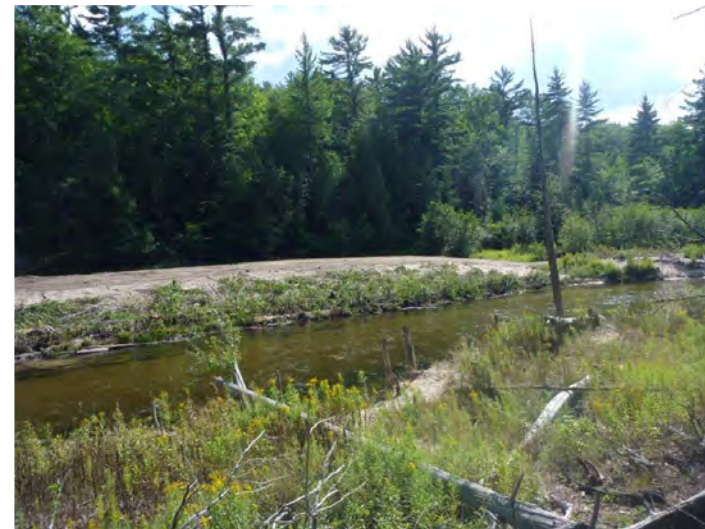
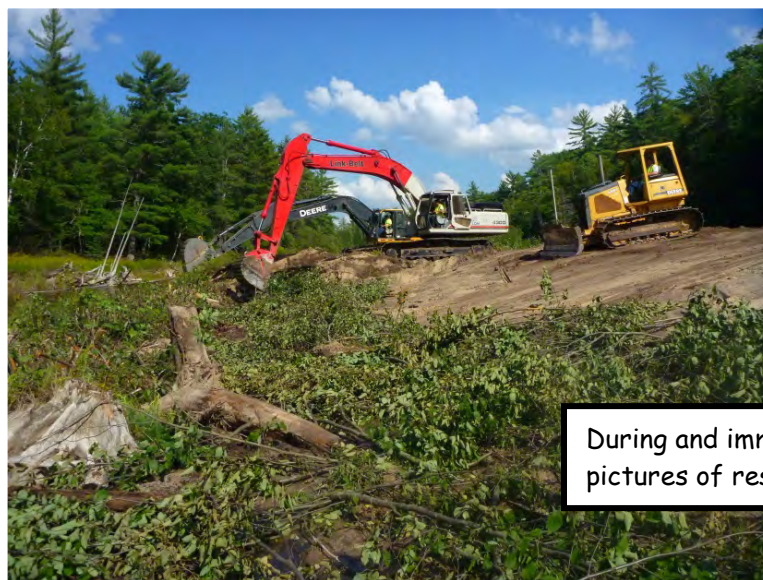
During and immediately after pictures of restoration site.
