Title: Excluding cattle improves channel stability, instream habitat and macroinvertebrate populations in Fitzgerald Creek.

Waterbody Improved: Fitzgerald Creek (HUC 04030108), a tributary to the Menominee River in Dickinson County, Michigan. Fitzgerald Creek is not on Michigan's **nonattainment** list.

GRTS Number: Grant number 97547404, Project number 25.

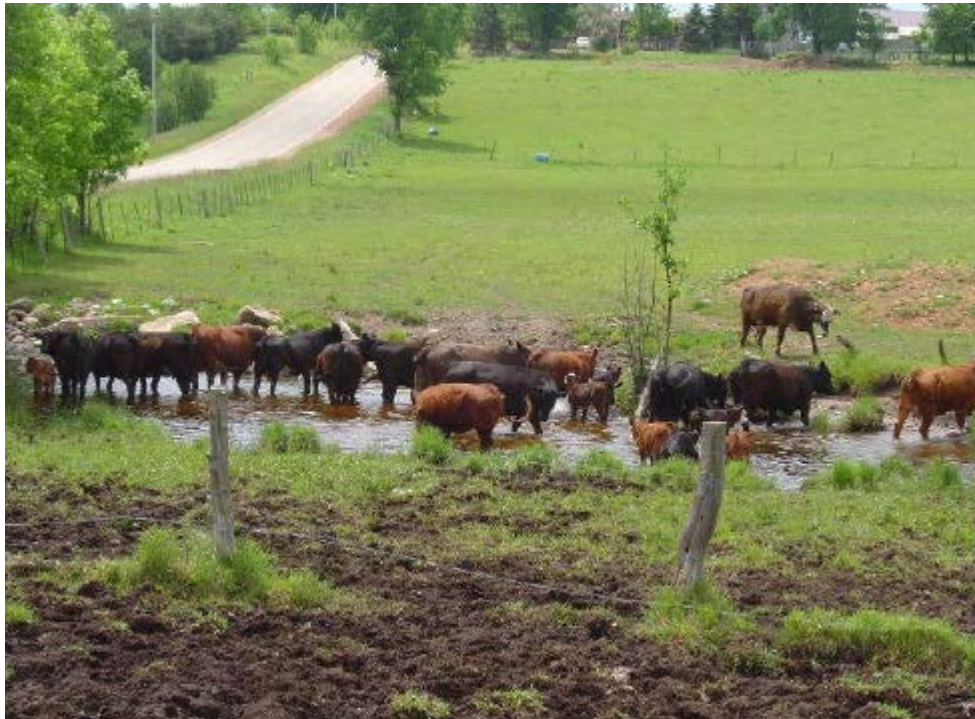
Figure 1. Cattle in Fitzgerald Creek in 2002, Prior to Exclusion

Problem: Unlimited cattle access to the creek created a wide, muddy wallow in the stream channel, destabilized the stream banks, and degraded instream habitat and macroinvertebrate populations.

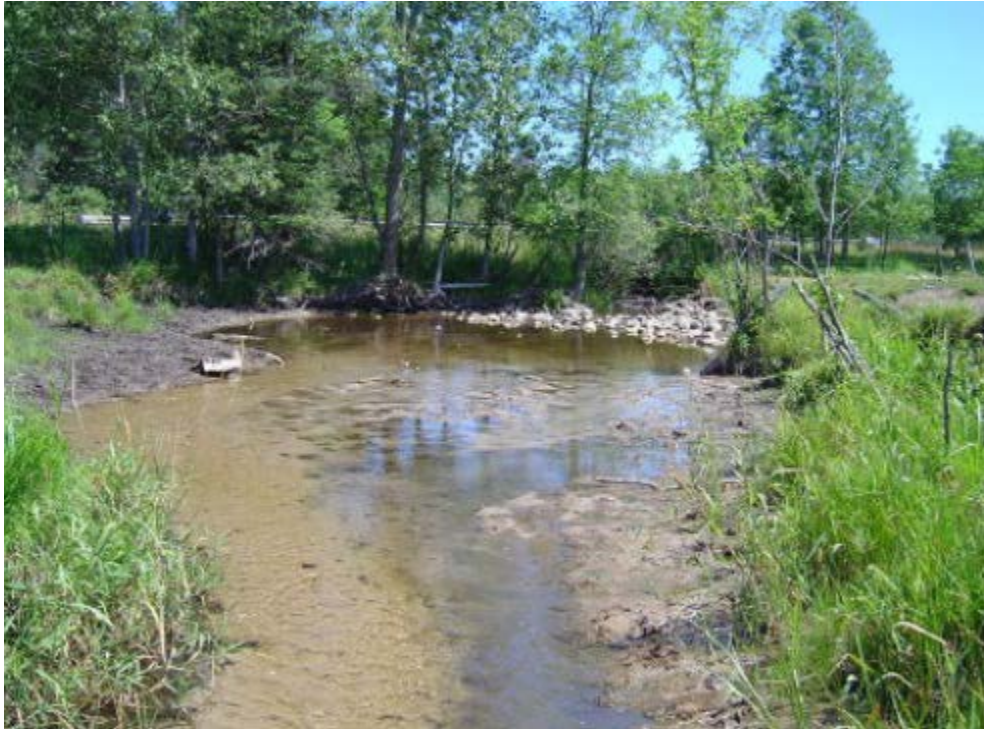
Figure 2. Over-Wide Channel in 2002, Prior to Cattle Exclusion

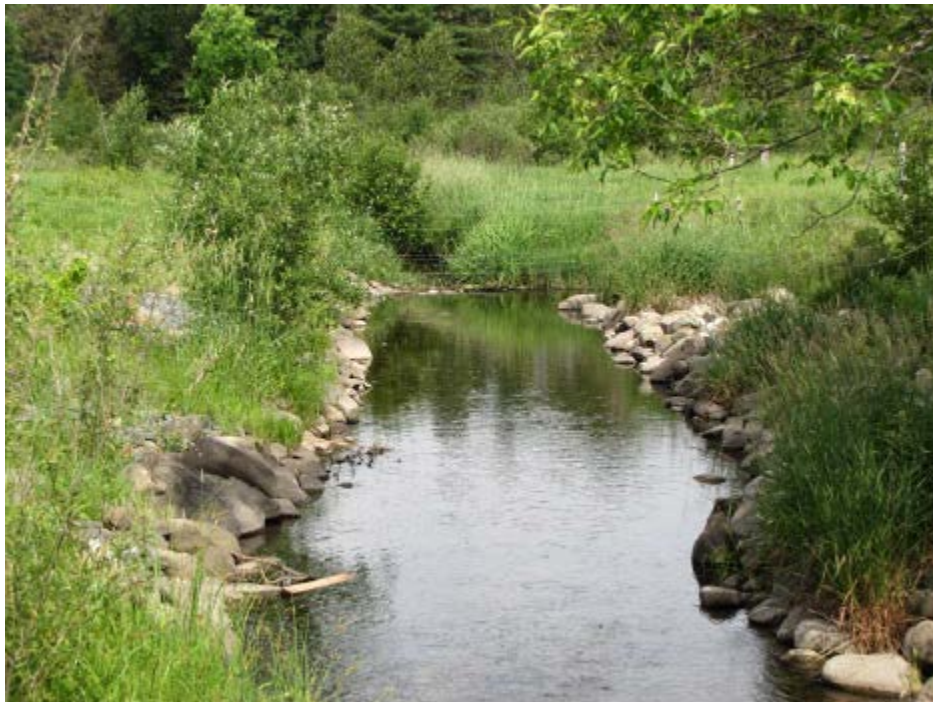
Figure 3. Restored Channel in 2012, After Cattle Exclusion

- Scores for instream habitat metrics (cover, pool variability, sediment deposition), riparian conditions (bank stability and vegetation) and channel sinuosity improved substantially.
- Channel width decreased by 53 percent
- Maximum channel depth increased by 30 percent
- Average sediment particle diameter increased from 5.5 mm (fine gravel) to 72 mm (small cobble), due to the placement of stone on the streambed
- Total macroinvertebrate taxa increased by 17 percent.
- The number of sensitive taxa (mayflies, stoneflies and caddisflies) increased by 43 percent.

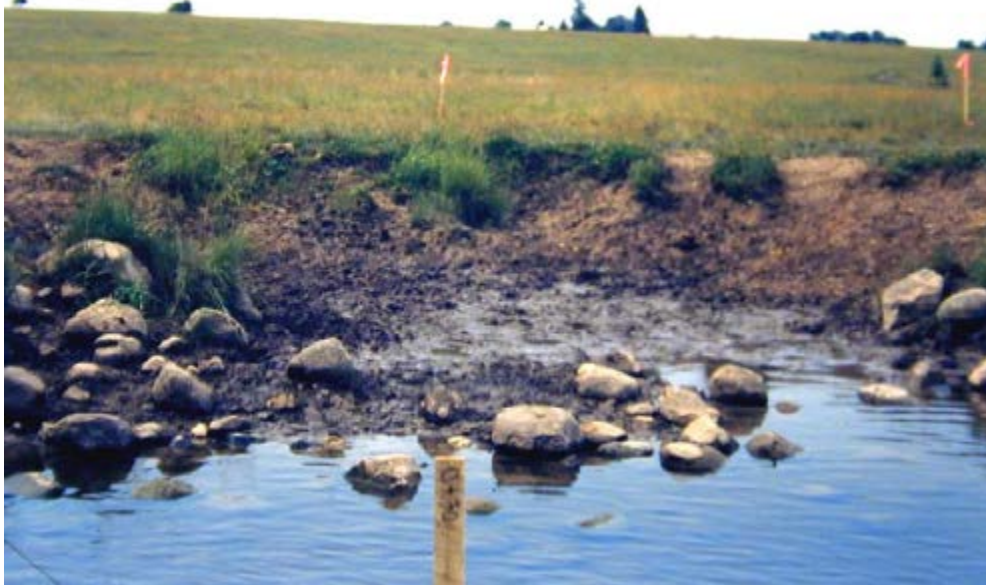
Figure 4. Eroding Bank in 2002, Prior to Cattle Exclusion

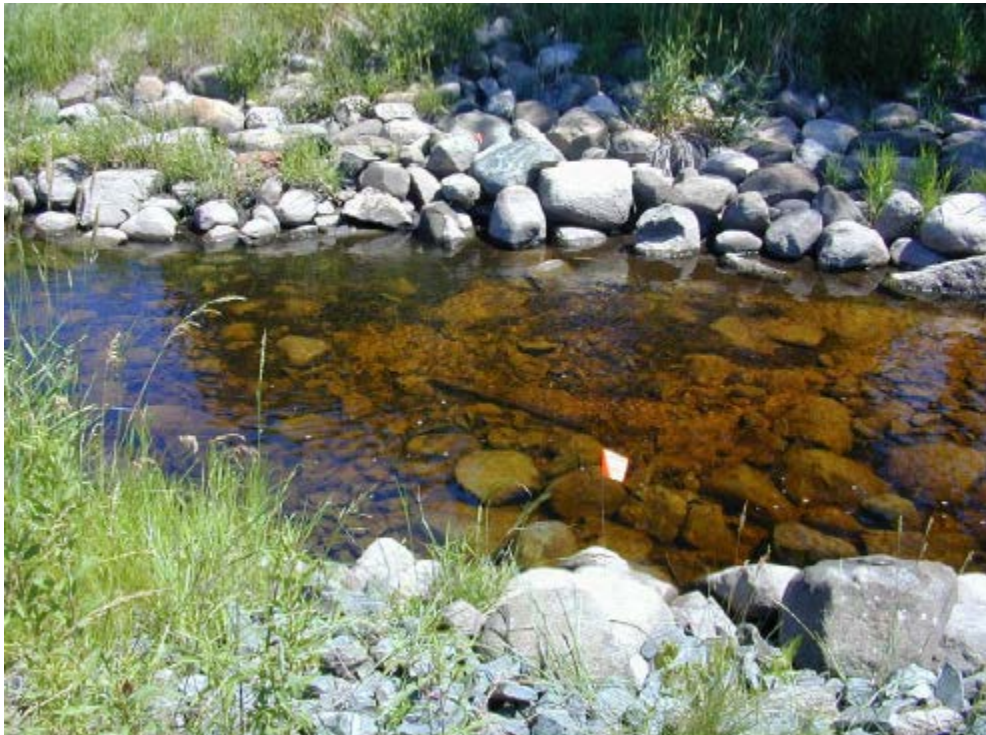
Figure 5. Same Location as Figure 4 in 2012, After Cattle Crossing Installation

Project Highlights: Best management practices installed in 2007 were 5,510 feet of cattle-exclusion fencing, a rock-lined stream crossing, and 240 feet of bank stabilization.
