Title: Channel restoration of Big Creek

Opening paragraph: Excessive sedimentation altered the stream channel and damaged instream habitat in Big Creek. Volunteers removed excess woody debris and blocked braided side channels to divert flow and recreate a single main channel, which transported fine sediment out of the reach and re-exposed gravel riffles suitable for fish reproduction. These improvements have persisted for 10 years and counting.

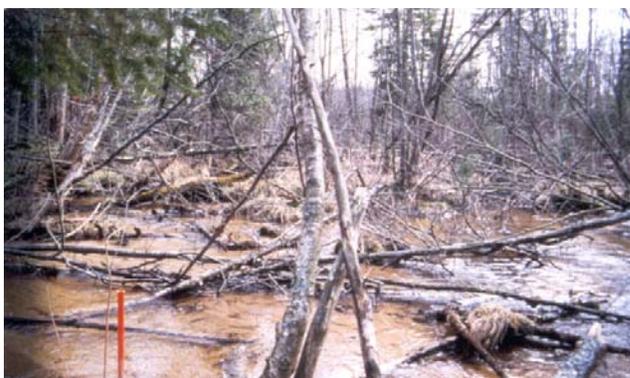
Problem: Historic timber harvest practices and eroding road/stream crossings deposited large amounts of sediment in the channel of Big Creek, a tributary to the Chocoday River in Marquette County in Michigan's Upper Peninsula. This excessive sedimentation raised the streambed, buried the natural gravel bottom, widened and braided the channel, degraded macroinvertebrate populations, and destroyed fish habitat necessary for trout and salmon reproduction.

Figure 1. Before and After Thalweg Restoration

Project Highlights: In 1994 and 1995, volunteers organized by the Marquette Conservation District restored a 1.5 mile reach of Big Creek by removing instream debris and blocking braided side channels to divert flow and recreate a single main channel (a "thalweg"). Normal stream flows through the new main channel were expected to mobilize fine sediments and re-expose gravel riffles.

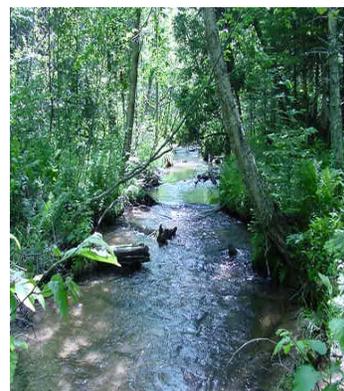
2005

Results: By late 1995, just months after completion of the restoration, stream channel width had narrowed by over 50%, which removed sand from the channel and re-exposed the gravel substrate preferred by young trout and salmon (Table 1). The habitat improvements have persisted through 2005, with no additional interventions. Fish numbers also increased in a short time (Table 2).
