**Title: Cass River and Saginaw Bay Watershed Livestock Exclusion**

Opening Paragraph: The Cass River and Saginaw Bay Watershed Livestock Exclusion Program addressed livestock access problems throughout the Saginaw Bay Watershed. This program was intended to reduce sediment and nutrient inputs to Saginaw Bay by implementing Best Management Practices with 28 landowners. The specific project described in this success story was on Carrow Creek, where installation of fencing, cattle crossings and alternate watering sources improved riparian vegetation, aquatic habitat, and fish and macroinvertebrate communities.

One of the 29 severely degraded sites was on the Schunk dairy farm, on Carrow Creek. The CMI-NPS grant spent \$26,870 to install one alternate water source for cattle and three livestock crossings on the farm. This work was completed in June of 2002. Pre-BMP monitoring was performed in September 2001, and post-BMP monitoring was performed in September 2004. All monitoring was supported by Section 319 funds.

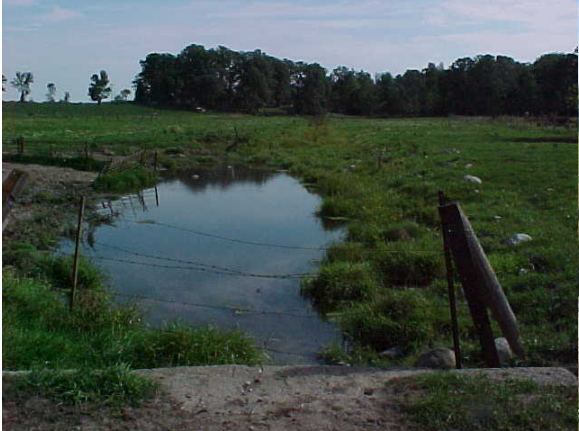
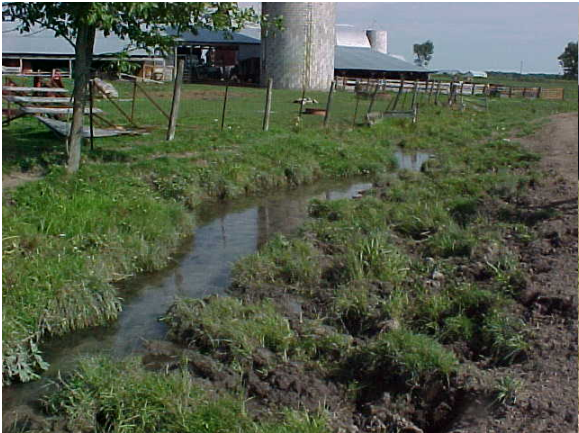
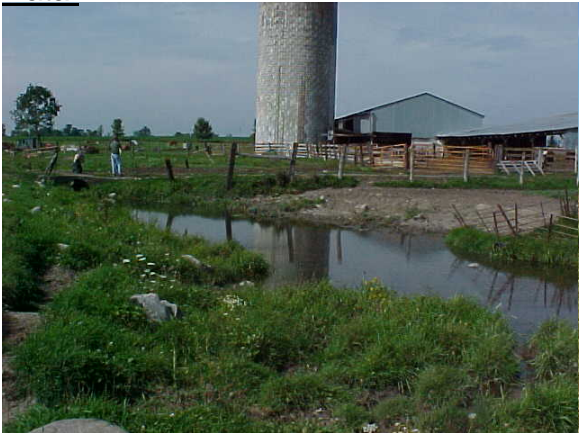
**Before BMP installation**

Problem: Carrow Creek is a tributary to the Cass River, in Sanilac County. Much of the Cass River watershed is rural, and in 1996 MDEQ surveys identified 44 eroding livestock access sites throughout the watershed, including 29 sites that were considered to be severely degraded. Excessive sedimentation negatively impacted instream habitat and the resident fish and macroinvertebrate populations.

Results: Pre- and post-BMP photographs suggested that the BMPs described above improved riparian and instream habitat conditions in this reach of Carrow Creek (photographs, below), and biological monitoring conducted before and after the BMPs were installed confirmed their effectiveness (Tables 1, 2 and 3). Aquatic and riparian habitat features related to bank erosion and sedimentation improved substantially after BMP installation, and this improved habitat was

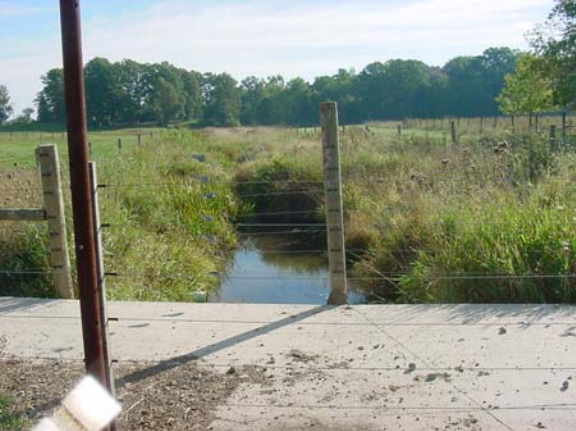
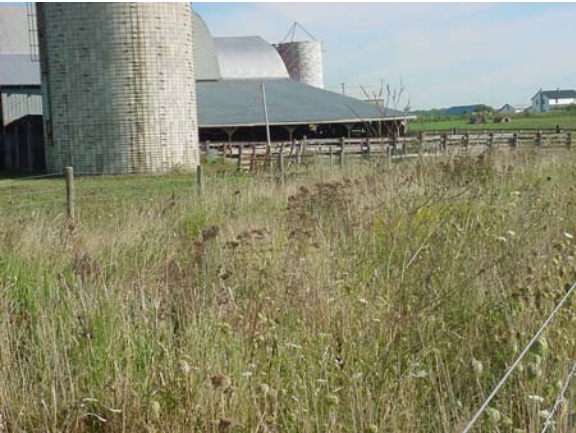
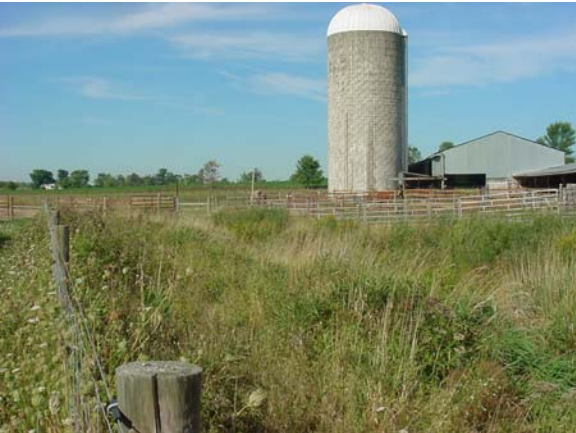
**After BMP installation**

reflected in the biological data. While the total number of fish and the number of fish species in the sampled reach of this very small stream did not increase substantially, the dominant fish changed from a species tolerant of turbid water, silty sediments and low dissolved oxygen concentrations (central mudminnow) to two species that prefer clear water, stable stream bottoms and higher dissolved oxygen concentrations (creek chub and brook stickleback). Similarly, the total number of macroinvertebrate taxa did not change with BMP installation, but the composition shifted from taxa tolerant of poor water quality to more sensitive taxa (mayflies, caddisflies, and stoneflies).
