**Title: Eagle River Stamp Sand Restoration**

Michigan AUID Number: 040201030404

GRTS Number: 97547405-24

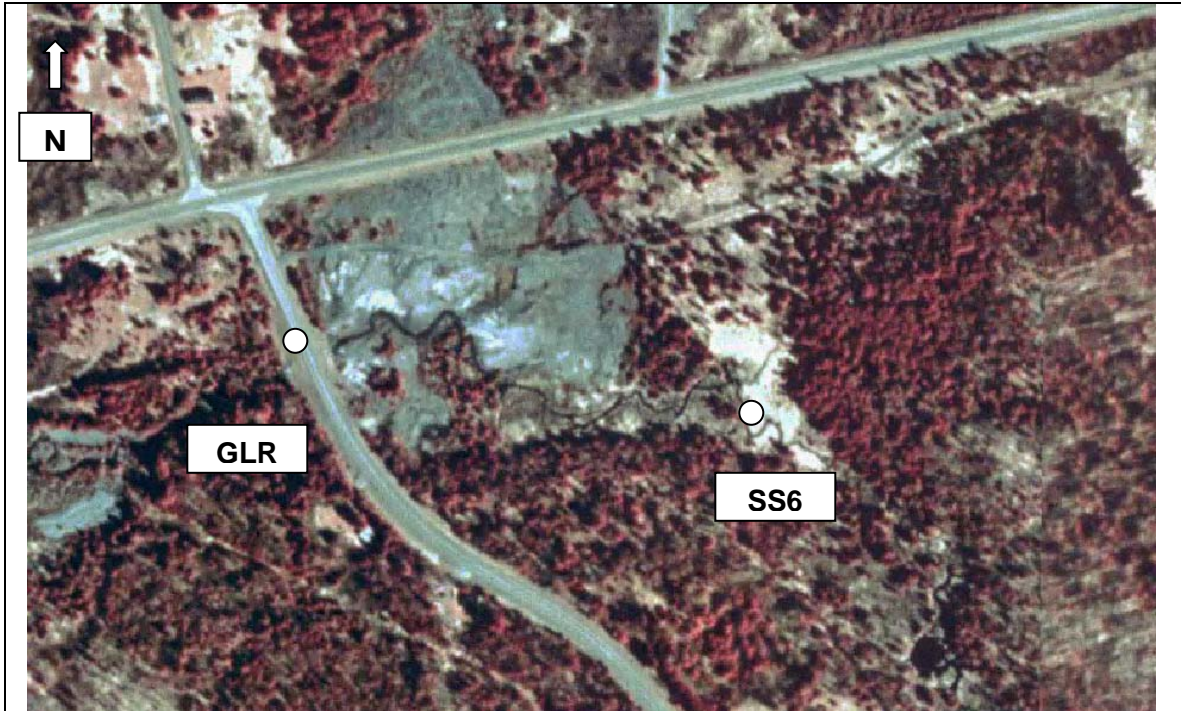
Figure 1. Map of the water sampling sites at Central Mine #1. (SS6 upstream reference reach; GLR = Gratiot Lake Road, downstream of the Central Mine #1 deposit)

Pre-construction monitoring of water quality, macroinvertebrates, and channel stability was performed in 2007 and 2008, and post-construction monitoring was initiated in 2010 (Figure 1).

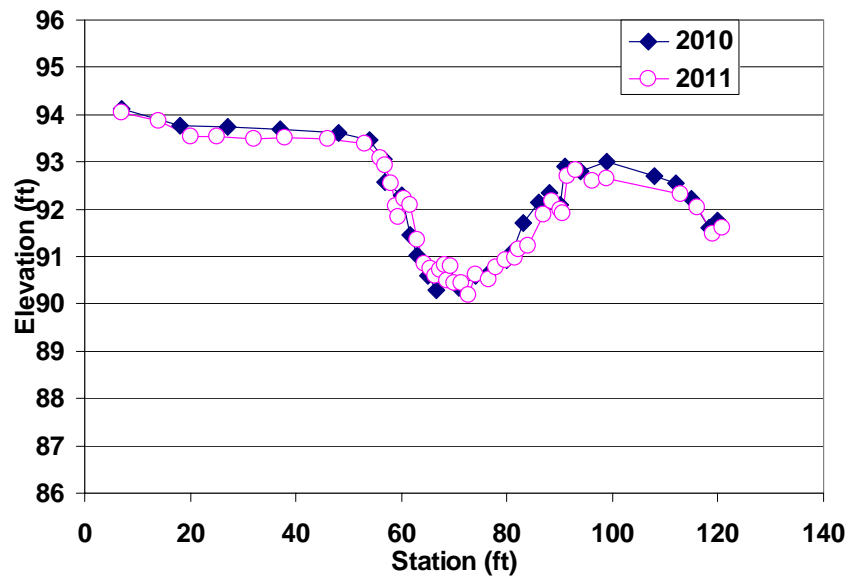
Figure 2. Cross-channel transect at Central #1, one and two years after construction.

One year after construction (2010), the stream channel appeared to be stable (i.e., the channel dimensions, especially channel depth and width, did not change over the first two years post-construction; Figure 2) and upland herbaceous vegetation was well-established (Figure 3). Aqueous copper concentrations at the sampling site downstream of the Central #1 stamp sand deposit had fallen significantly, by approximately 75 percent (Figure 4), although all measured concentrations still exceeded Michigan's hardness-corrected chronic water quality standard for total copper.

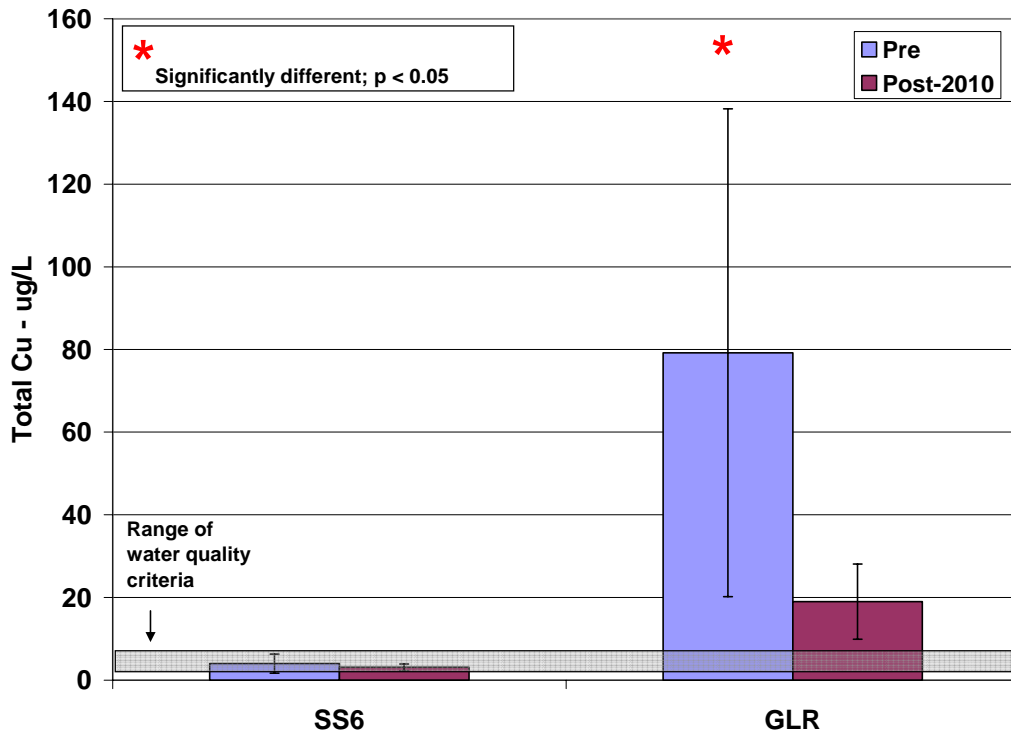
Figure 4. Comparison of aqueous copper concentrations, before and after construction. (Refer to Figure 1 for station locations.)

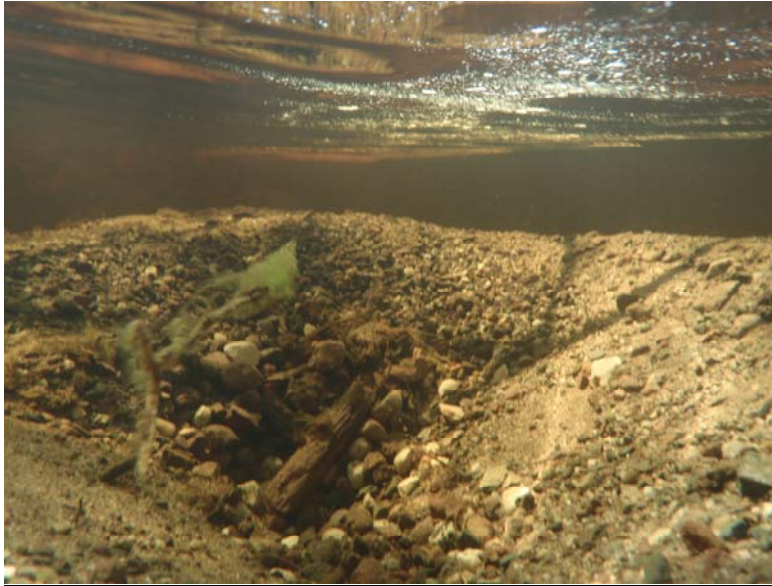
Figure 5. Fish spawning “redd” at Central Mine #1.

Also, a fish spawning “redd,” probably made by creek chubs (*Semotilus atromaculatus*), was observed in the Central Mine #1 reach after construction in 2010 (Figure 5), but not prior to construction. Improvements in the macroinvertebrate community and fish spawning habitat are probably due as much to improvements in bank stability and benthic habitat and substrate as to lower aqueous copper concentrations. Four riffles were installed in the Central #1 reach, and a fifth riffle has formed naturally. Prior to construction the channel lacked riffles and was dominated by fine particles (silt and sand), while after construction the riffles are dominated by gravels and cobbles (Table 3) and fine particles are largely restricted to pools behind the riffles.
