SEVEN BRIDGES NATURAL AREA MANAGEMENT PLAN

PREPARED FOR:
GRAND TRAVERSE REGIONAL LAND CONSERVANCY

URS JANUARY | 19 | 2007

Seven Bridges Management Plan

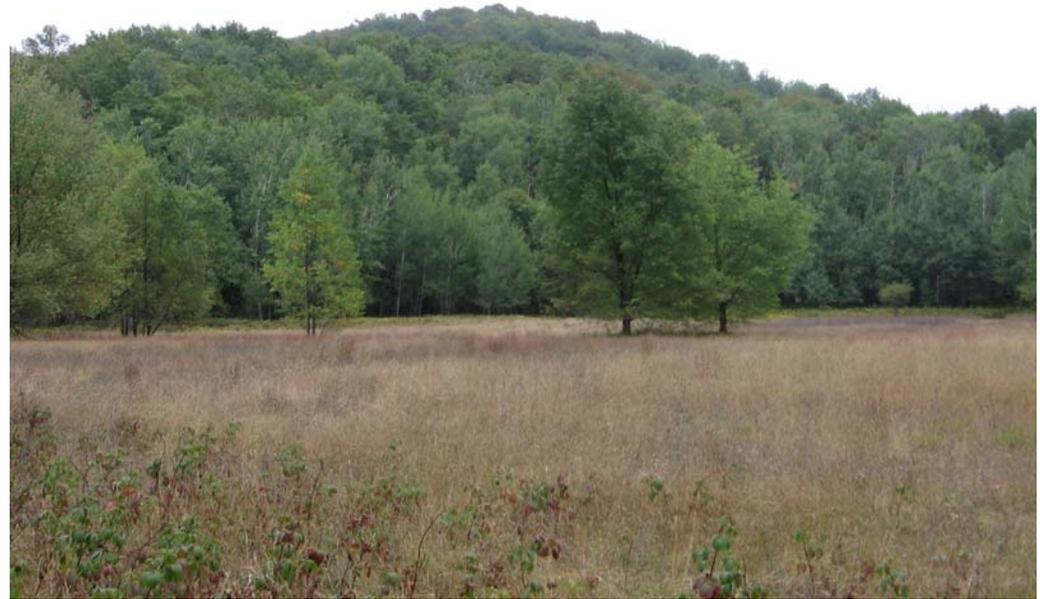
Meadow habitat at northeast portion of Seven Bridges.

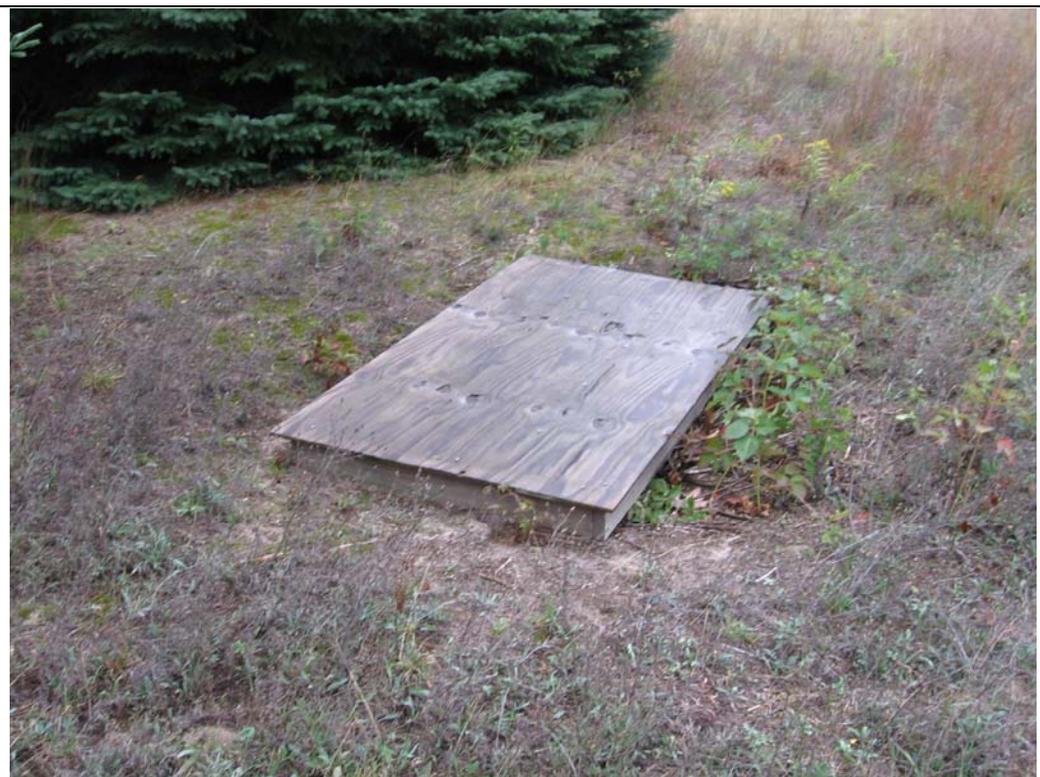
Photo No. 2	Date: 9/12/06
------------------------------	-------------------------

Wooden box over well that needs to be properly abandoned in meadow.

Recommended management practices include habitat management, two-track improvement and well abandonment. Due to the diversity that this habitat provides, actions consistent with preserving its current character are recommended. Actions that set back shrub and tree encroachment are desirable. These may include manual clearing of progression northern hardwood forest species and other shrubs that grow in the transition zone. Other management activities that will maintain the habitat quality and prevent the spread of spotted knapweed or other invasive species may be conducted. In addition, prescribed burns may be beneficial in maintaining the opening and native vegetation. If this becomes a feasible option, and agreed to by both the DNR and GTRLC coordinated efforts related to prescribed burns would be consistent with this plan. It should be noted that since the meadow habitat was created by human activity, allowing its reversion to northern hardwood forest is also consistent with this management plan.

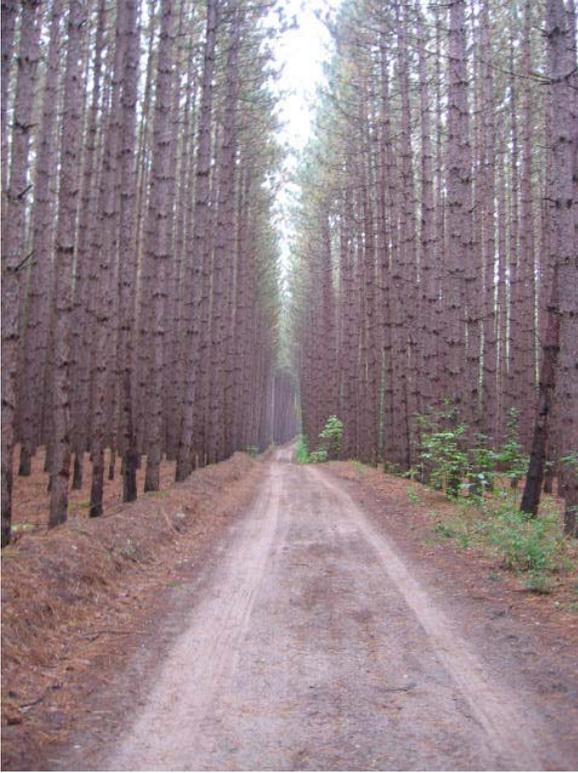
Client Name: Seven Bridges Natural Area		Site Location: Kalkaska County, Michigan	URS Project No. 02151706
Photo No. 3	Date: 9/13/06

Direction Photo Taken: South			
Description: Red pine stand, notice how closely together the trees were planted.

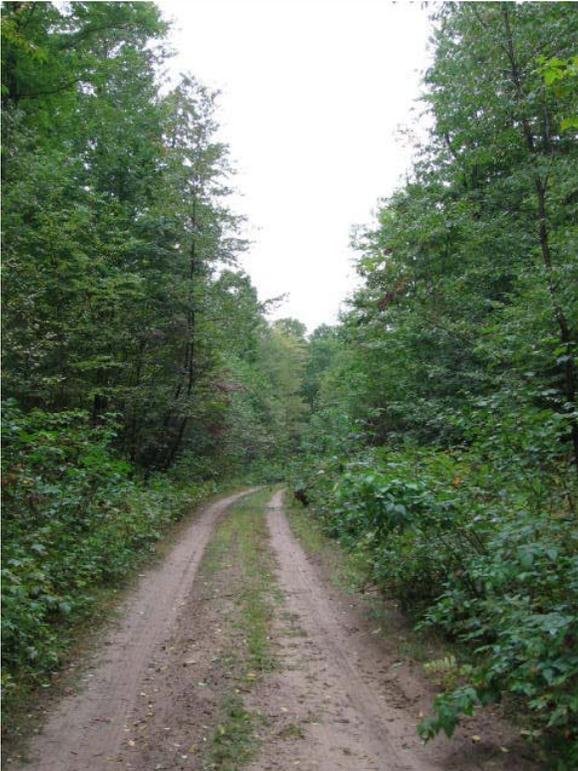
Photo No. 4	Date: 9/13/06

Direction Photo Taken: South			
Description: Upland forest dominated by sugar maple, beech, and other upland trees.

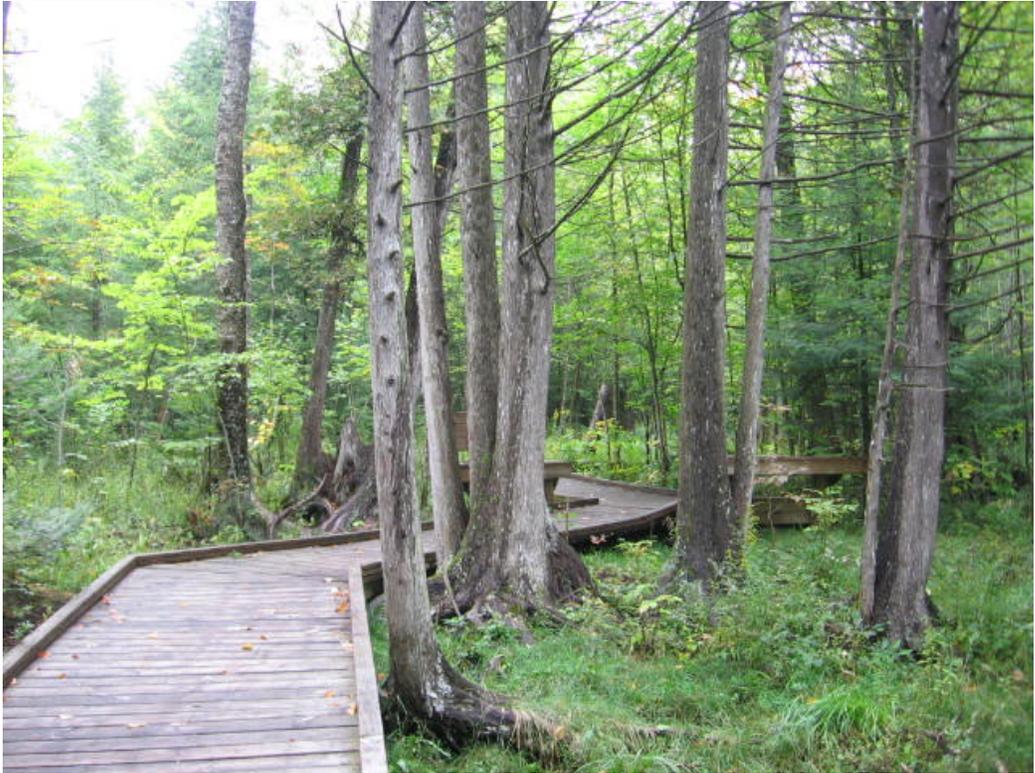
Client Name: Seven Bridges Natural Area		Site Location: Kalkaska County, Michigan	URS Project No. 02151706
Photo No. 5	Date: 9/12/06

Direction Photo Taken: North			
Description: Floodplain forest habitat, notice boardwalk and northern white cedar.

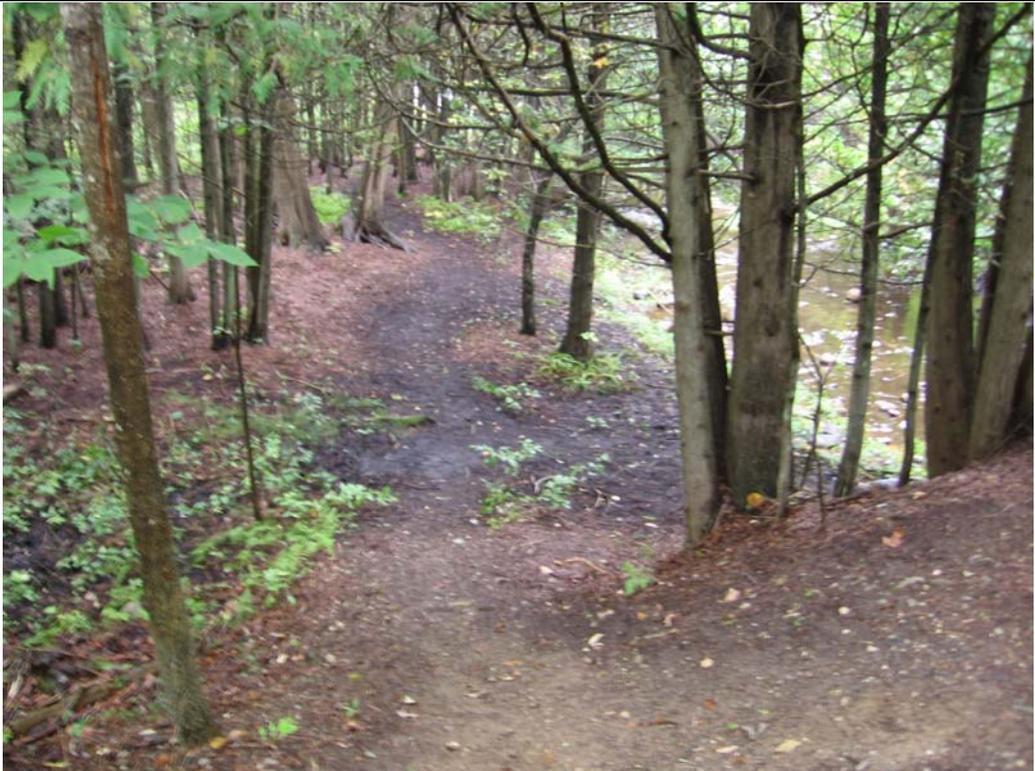
Photo No. 6	Date: 9/12/06

Direction Photo Taken: North			
Description: Area of bare soil and an unauthorized trail contributing to erosion and sedimentation.

discouraged to protect the river and its banks. Simply restricting access to these trails with temporary fencing and warning signs would most likely result in more unauthorized trails. The recommended solution is to create new marked walking trails providing access to visitors and anglers to these same locations. This way the new trails could be designed to be small, easily maintained, and avoid areas susceptible to erosion. With the public using the new trails, the unauthorized trails could then be fenced off and seeded to lessen erosion. Viewing platforms could also be constructed to focus access to the river to a few specific locations, effectively reducing bank erosion.

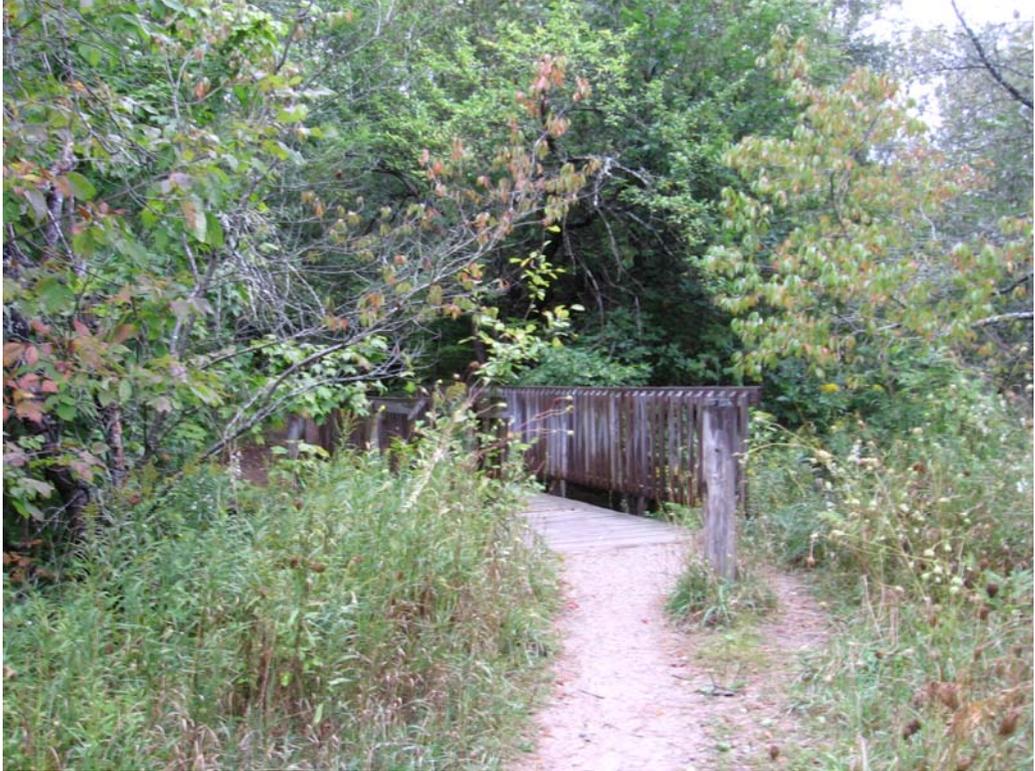
Client Name: Seven Bridges Natural Area		Site Location: Kalkaska County, Michigan	URS Project No. 02151706
Photo No. 7	Date: 9/12/06

Direction Photo Taken: East			
Description: Bridge 1 near current parking area.

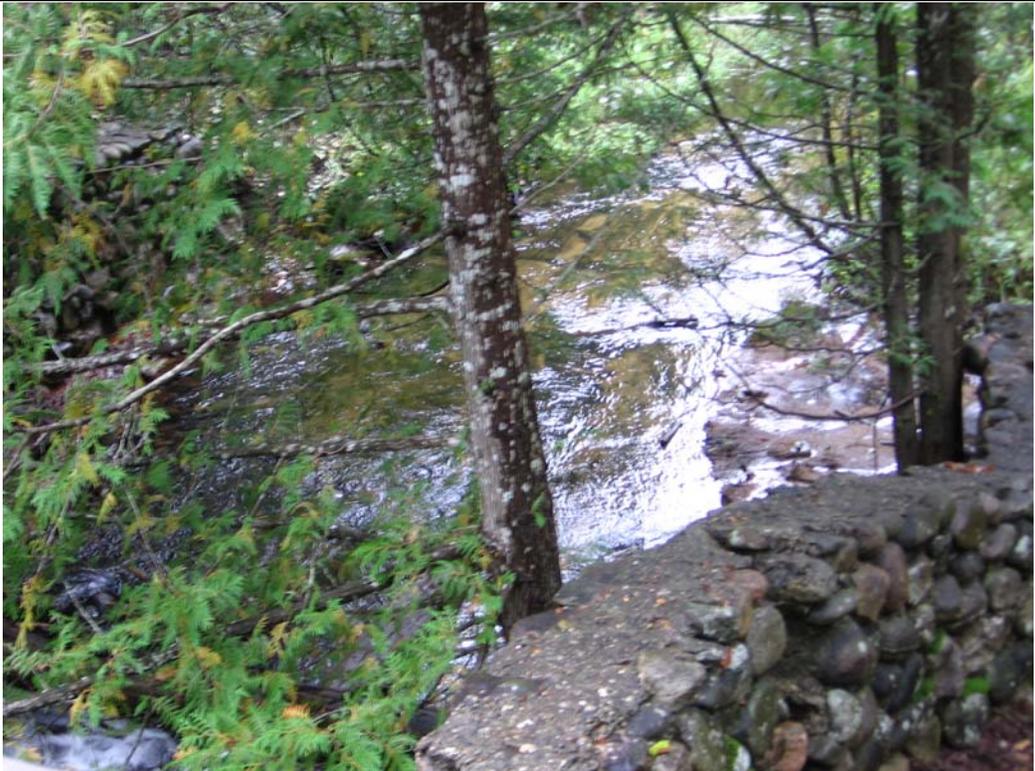
Photo No. 8	Date: 9/12/06

Direction Photo Taken: Northwest		
Description: Bridge 1 area, notice unnatural retaining wall and altered riverbanks.

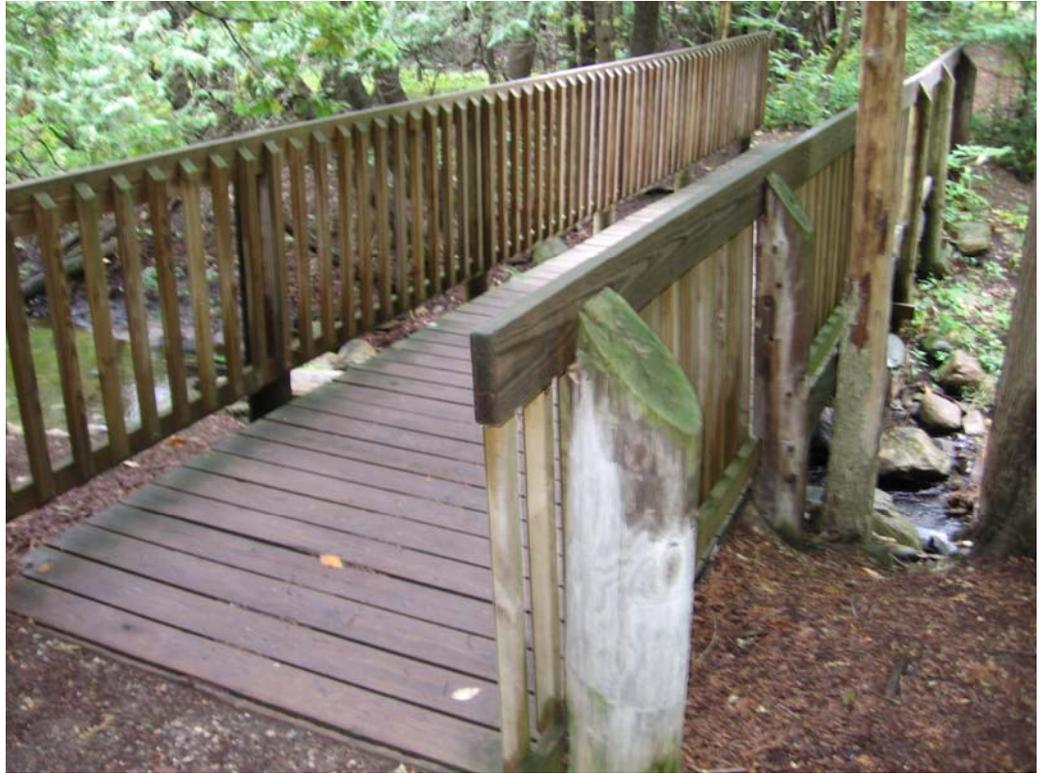
Bridge 2 over old dam.

Maintain existing bridges and trails in accordance with the American's with Disability Act (ADA), as applicable. Evaluate the structural stability and safety of the dam remnants periodically to insure that the bridges are safe. If stability of the bridges becomes an issue restoration of the stream channel, potentially including removal of the dam remnants, should be investigated to reduce erosion and restore the stream to a more natural condition. Since the dam remnants may qualify as historical structures any invasive actions should consider local input.

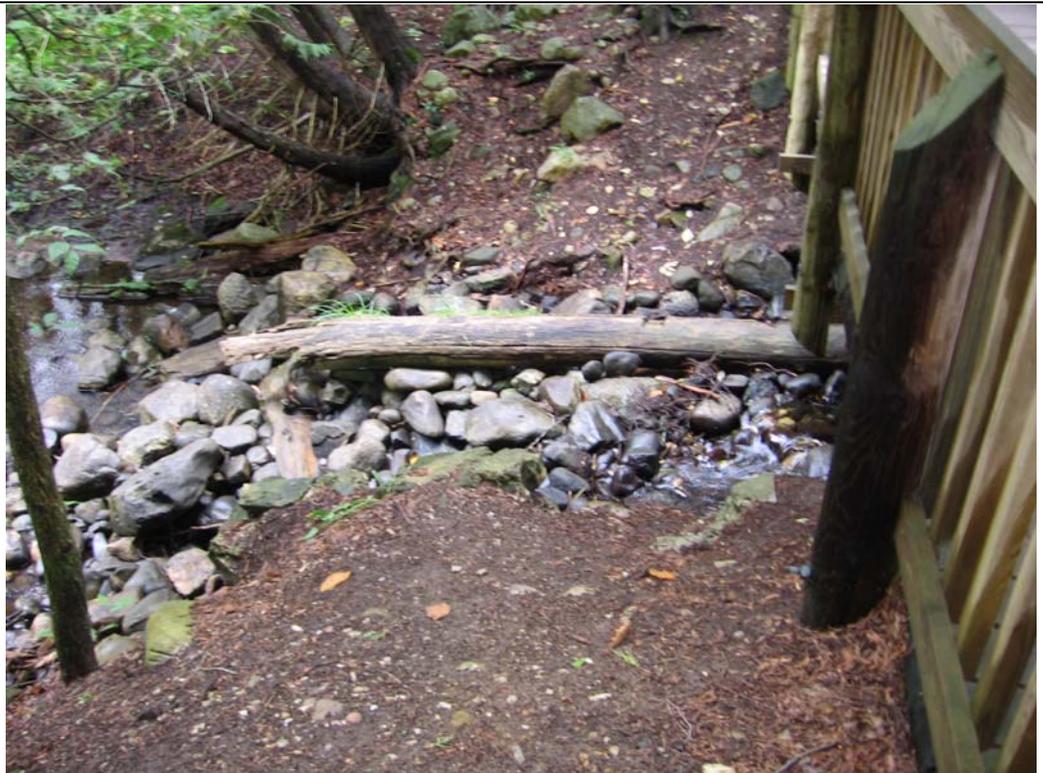
Photo No.
10

Old dam remnants under Bridge 2, notice how the dam restricts natural water flow and aquatic animal movement.

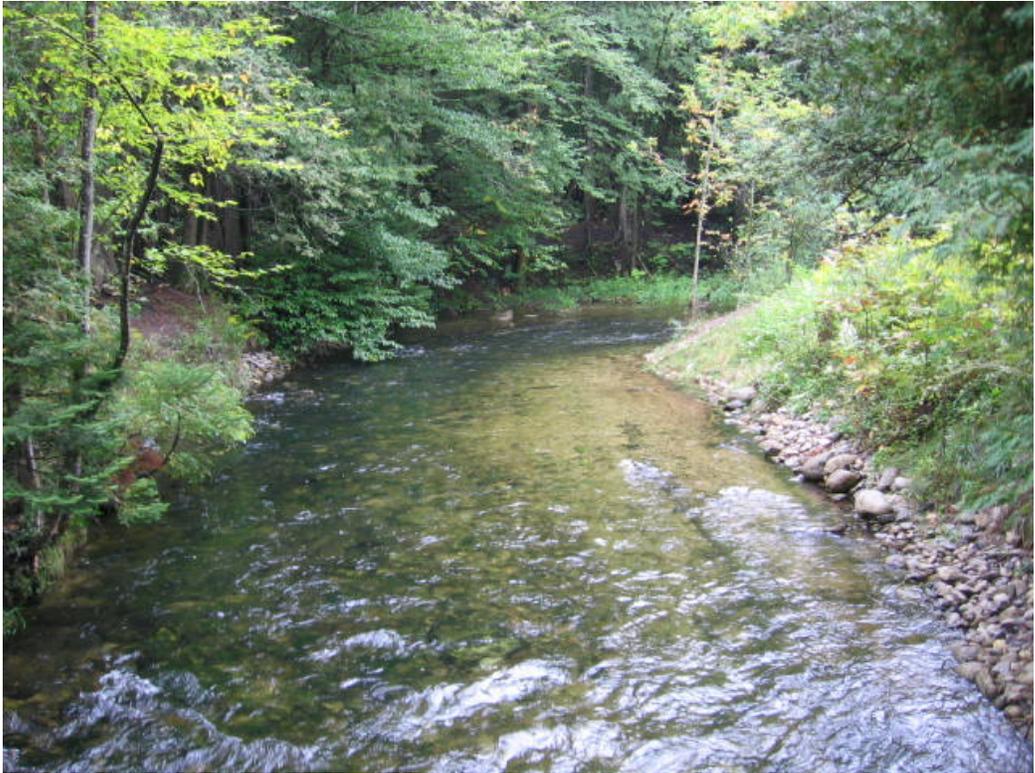
Client Name: Seven Bridges Natural Area		Site Location: Kalkaska County, Michigan	URS Project No. 02151706
Photo No. 11	Date: 9/12/06

Direction Photo Taken: South			
Description: The main channel of the Rapid River near the Bridge 3 area.

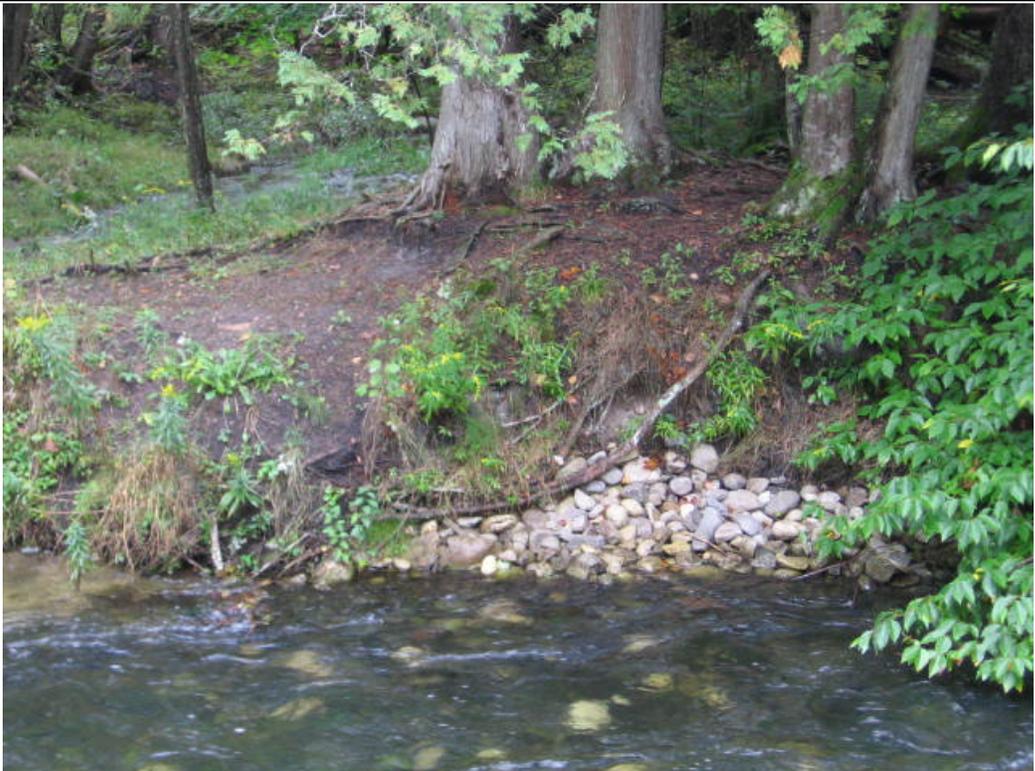
Photo No. 12	Date: 9/12/06

Direction Photo Taken: West			
Description: Example of unauthorized trail leading to bare soil spots and bank erosion near Bridge 3, notice attempt to remedy by placing riprap along banks.

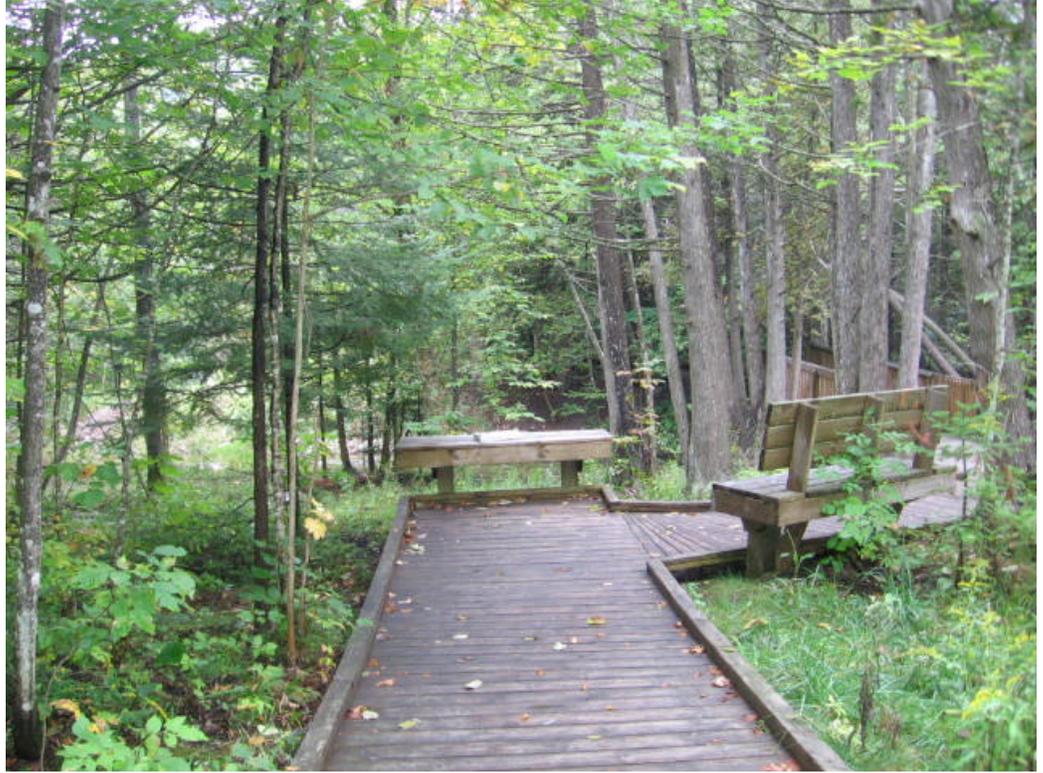
The Bridge 3 area, notice Bridge 3 in the background.

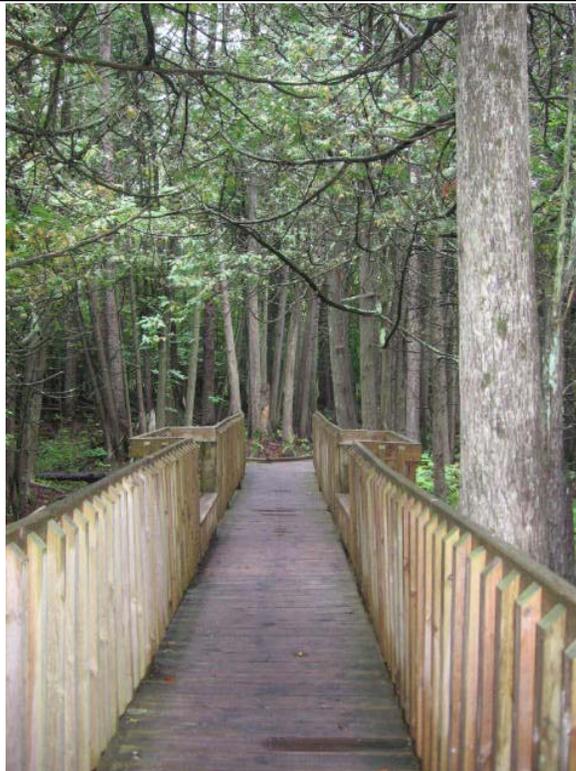
Photo No.
14

Bridge 4

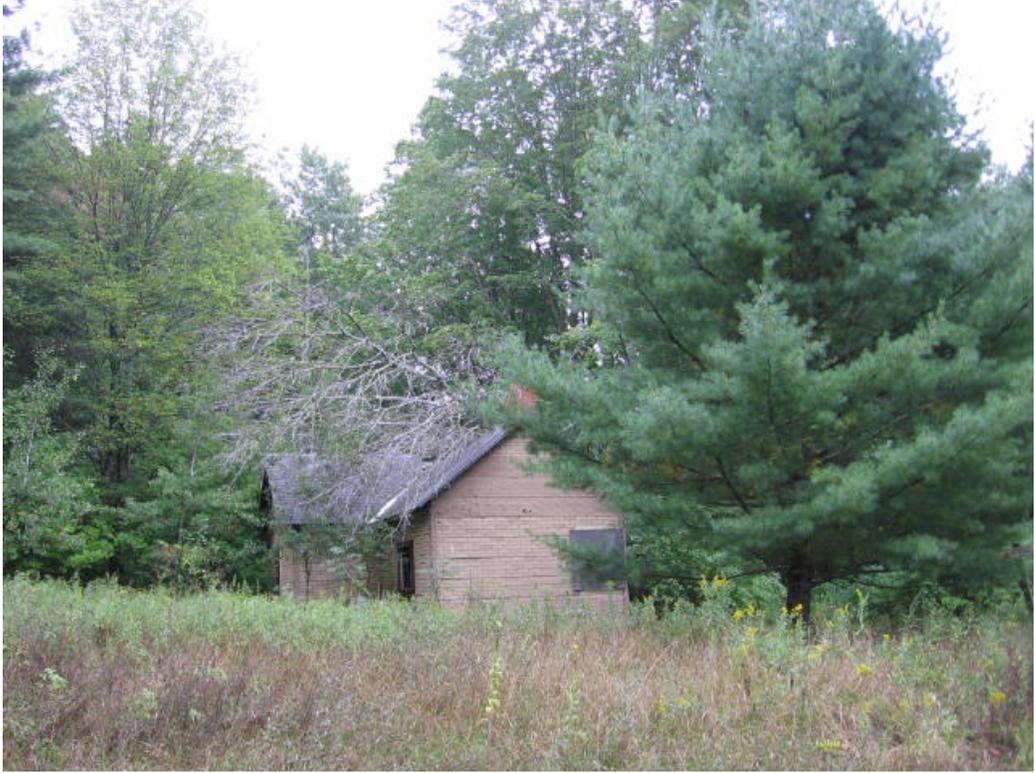
Client Name: Seven Bridges Natural Area		Site Location: Kalkaska County, Michigan	URS Project No. 02151706
Photo No. 15	Date: 9/13/06

The hunter's cabin is a structure located near the southern boundary of Seven Bridges. It can be accessed from the eastern two-track and is near Dundas Road. The cabin is a modest structure of approximately 800 square feet. Neither the design, construction material, or apparent age indicates that this structure has any historical significance. The cabin is stick-built, has an asphalt shingled roof, and manufactured siding. The cabin is in disrepair. A tree has fallen on the structure and partially demolished the building. It is uninhabitable and the damage sustained by lack of maintenance and the fallen tree make repair or salvage uneconomical. It is recommended that the hunter's cabin be removed and its water supply well (if one exists) be properly abandoned. In the near-term "no-trespassing" and "keep-out" signs should be posted and the buildings monitored for illegal activity.

Direction Photo Taken: South			
Description: Cabin near Dundas Road, it is an example of a structure on Seven Bridges property that should be torn down.

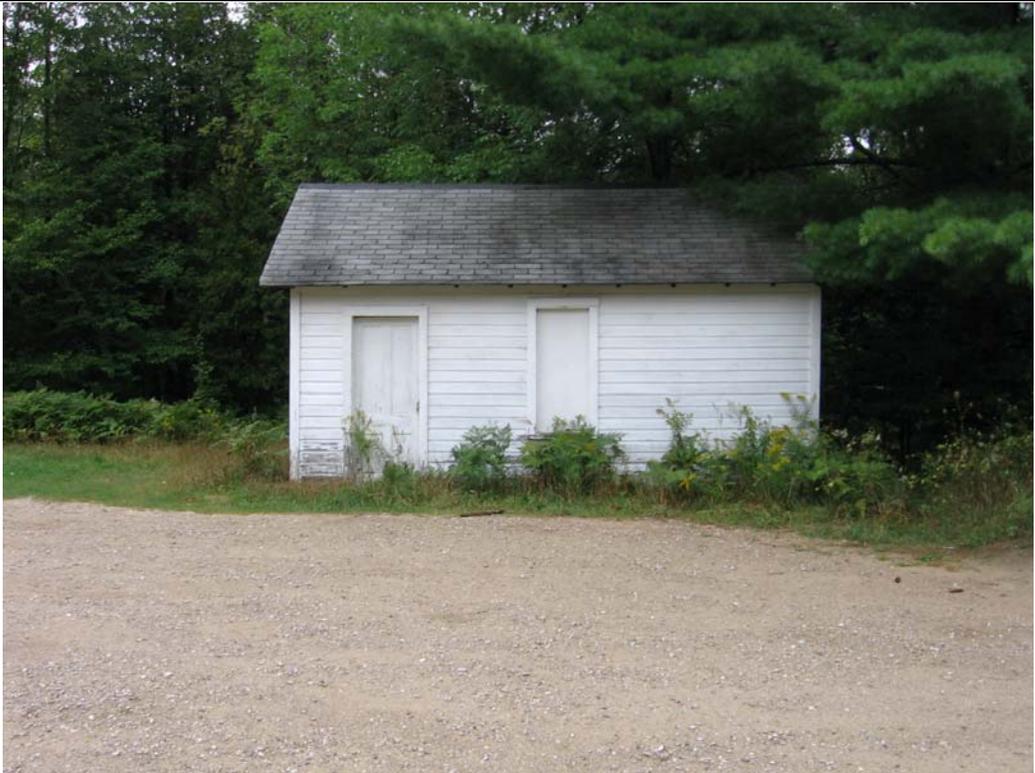
Photo No. 16	Date: 9/13/06

Direction Photo Taken: East		
Description: Shed near current parking area, it is an example of a structure that could be rehabilitated.

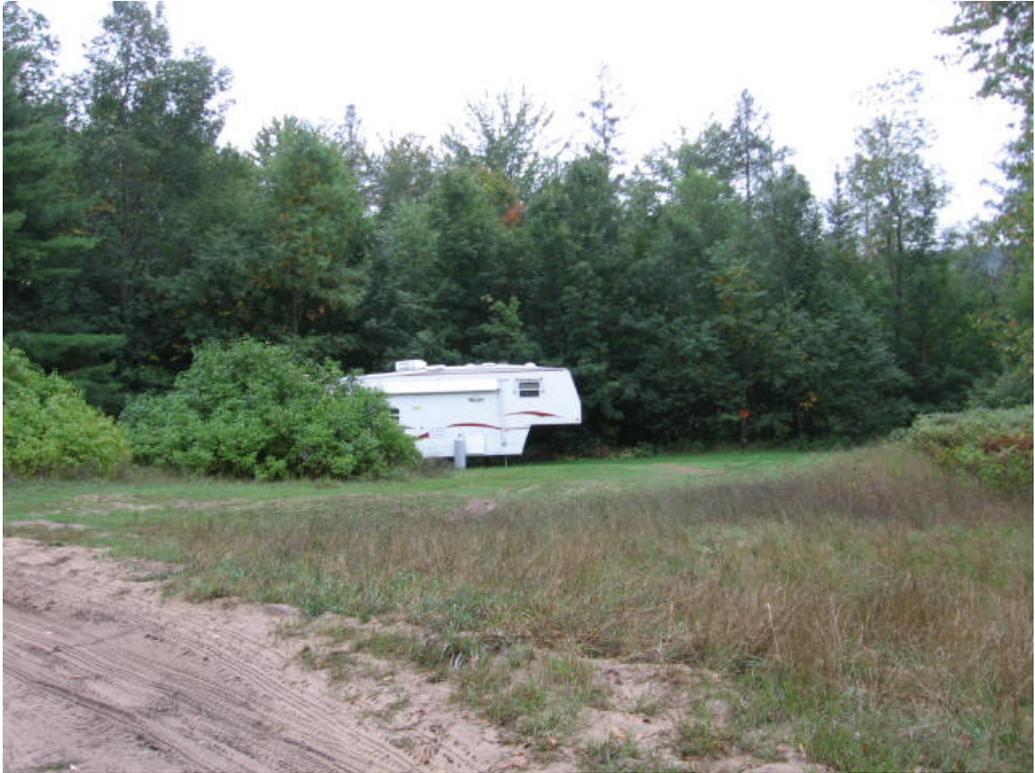
Client Name: Seven Bridges Natural Area		Site Location: Kalkaska County, Michigan	URS Project No. 02151706
Photo No. 17	Date: 9/13/06

Direction Photo Taken: East			
Description: One of several trailers on a small section of property neighboring Seven Bridges near Dundas Road. It is an example of why the Seven Bridges property boundaries should be surveyed and marked. The trailers may actually be on Seven Bridges property.

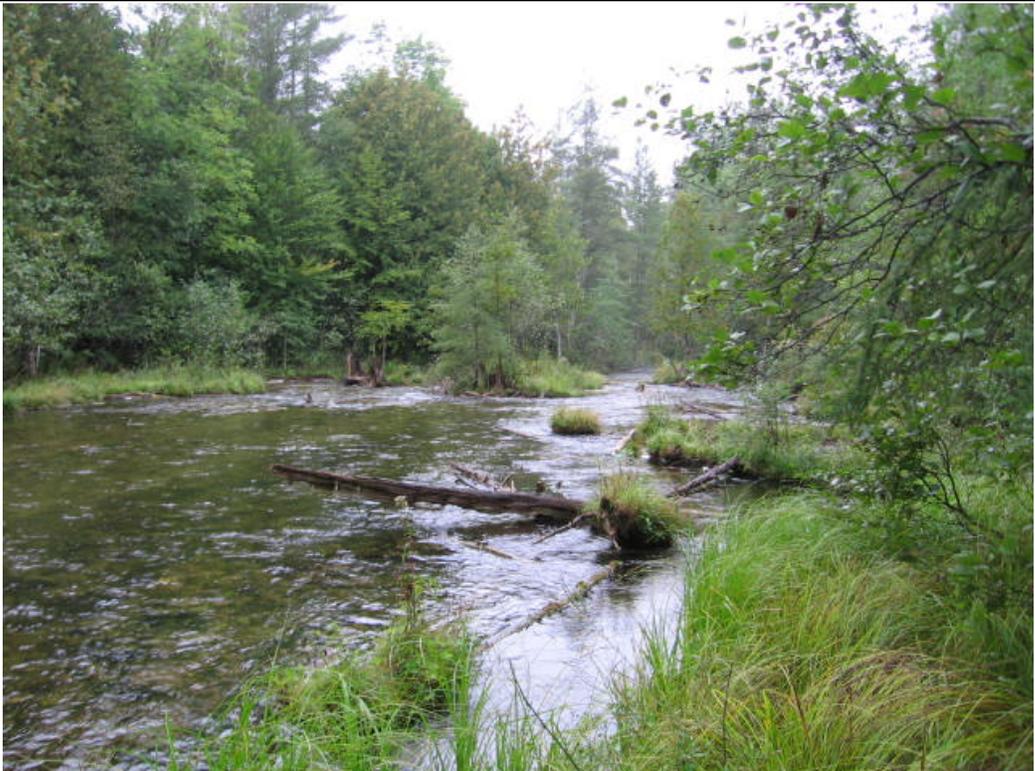
Photo No. 18	Date: 9/13/06

Direction Photo Taken: South		
Description: The Rapid River near the Root property, notice how wide the river is in this location. This may not be a suitable location to build a bridge.
