Shiawassee River - Chesaning Rock Ramp
Saginaw County, T09N/R03E/S16
Shiawassee River Watershed

Joseph M. Leonardi, Fisheries Biologist

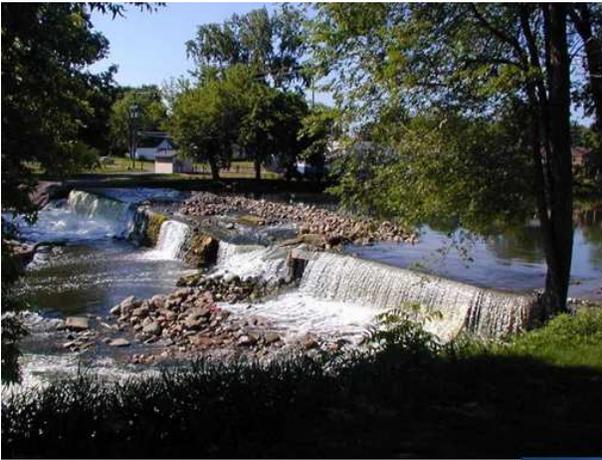
Figure 2. Photographs of the breached Chesaning Dam and the 2009 Chesaning Rock Ramp.

Chesaning Dam breached 2005

Although Chesaning Dam had been in need of repair for a number of years, conditions worsened in March 2005 when a center portion collapsed requiring emergency repair (Figure 2). After considering options, the Village decided to replace the existing dam with a rock ramp that would preserve the water level of the upstream impoundment and provide improved natural stream function and fish passage. The Village engaged Wade-Trim Engineering who sub-contracted with Ellen Rivers LLC. for design, engineering, and project oversight.

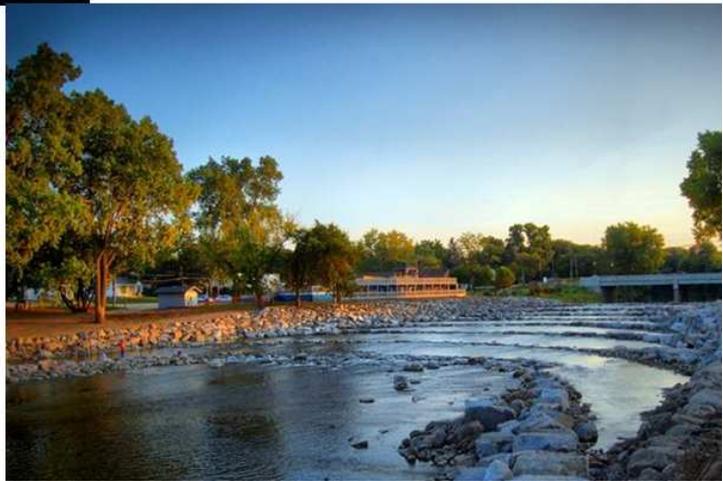
Chesaning Rock Ramp, 2009

In 2008, MDEQ issued the Village of Chesaning a permit (DEQ File 08-73-0045-P) and in 2009, the Chesaning Dam was removed and replaced with a low-slope rock ramp (Figure 2). The Chesaning Rock Ramp is approximately 200 ft. wide by 600 ft. long and consists of seven weirs in a stair-step configuration at an overall 3% slope. Channel morphology at Chesaning was considered incised because "bankfull" flow occurred well below the top of existing banks (S. Verry, Ellen Rivers LLC., personal communication). Thus, design parameters included keeping most of the weir heights at bankfull elevation to decrease the velocity of bank-side water flows and minimize erosion potential. By design, fish passage is encouraged bank-side where stream velocity is reduced. The 3% slope was determined necessary to pass most fish common to the Shiawassee River. In particular, allowing passage of Saginaw Bay spawning Walleye was an objective of the rock ramp. Four additional "J-hook" rock structures were placed downstream to help protect stream banks from erosion.

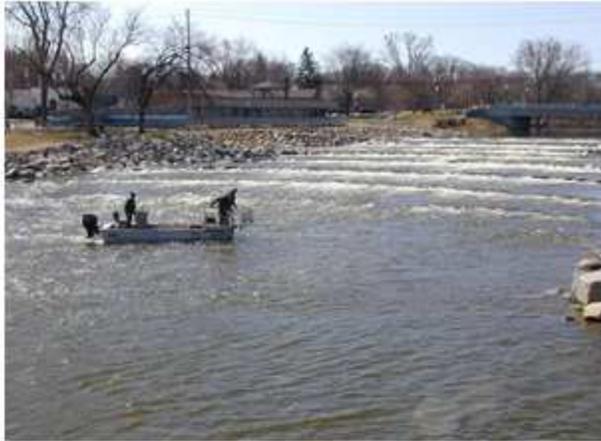
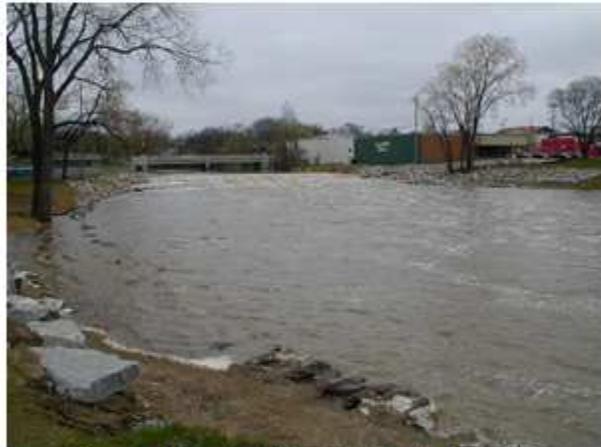
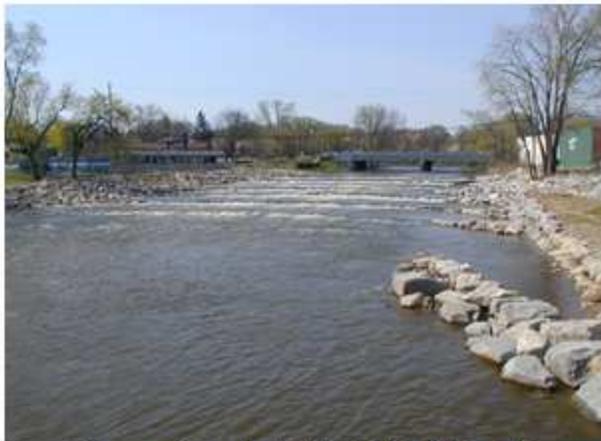
Figure 6. Photos of the Chesaning Rock Ramp at three different discharge values.

Photo taken April 1, 2010 (330 cfs)

Photo taken April 8, 2010 (1,680 cfs)

Photo taken April 15, 2010 (650 cfs)
