Foch Lakes

Montmorency County, T32N, R01E, Section 28
Black River watershed, last surveyed 2018

Tim A. Cwalinski, Senior Fisheries Biologist

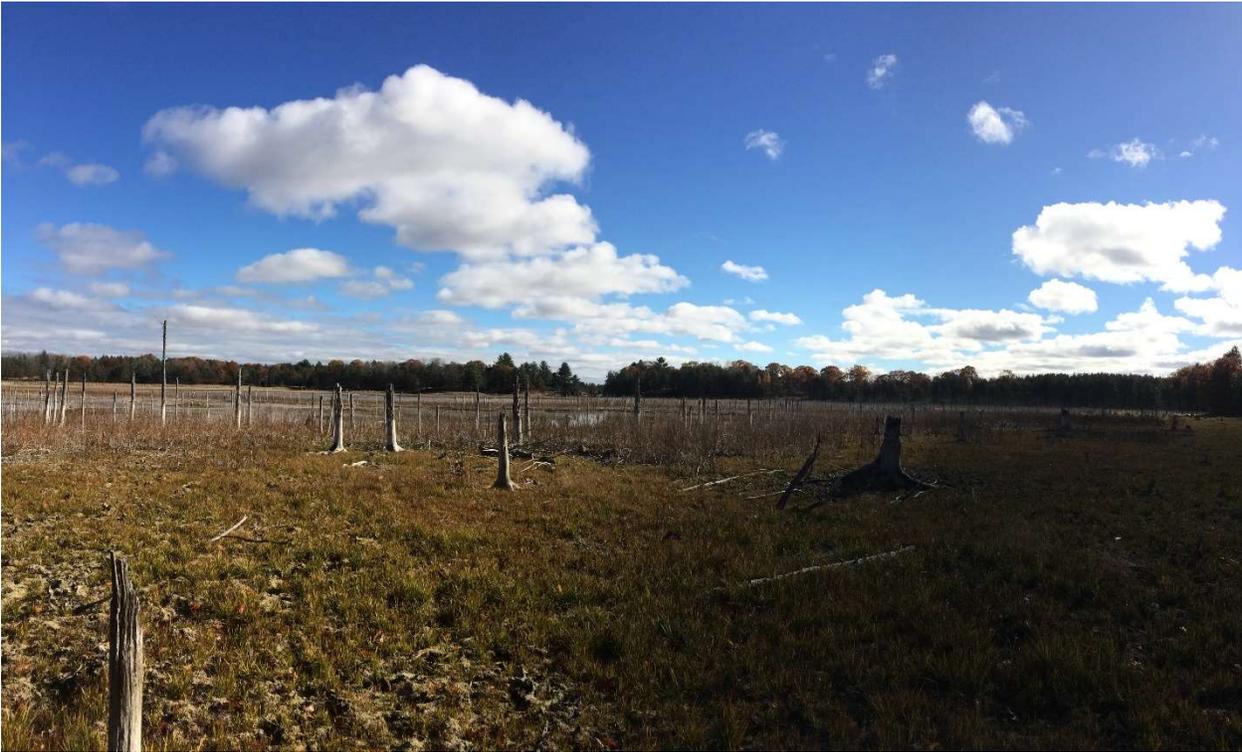
Photo 1. Foch Lakes bottom substrate and environment under recent drawdown.

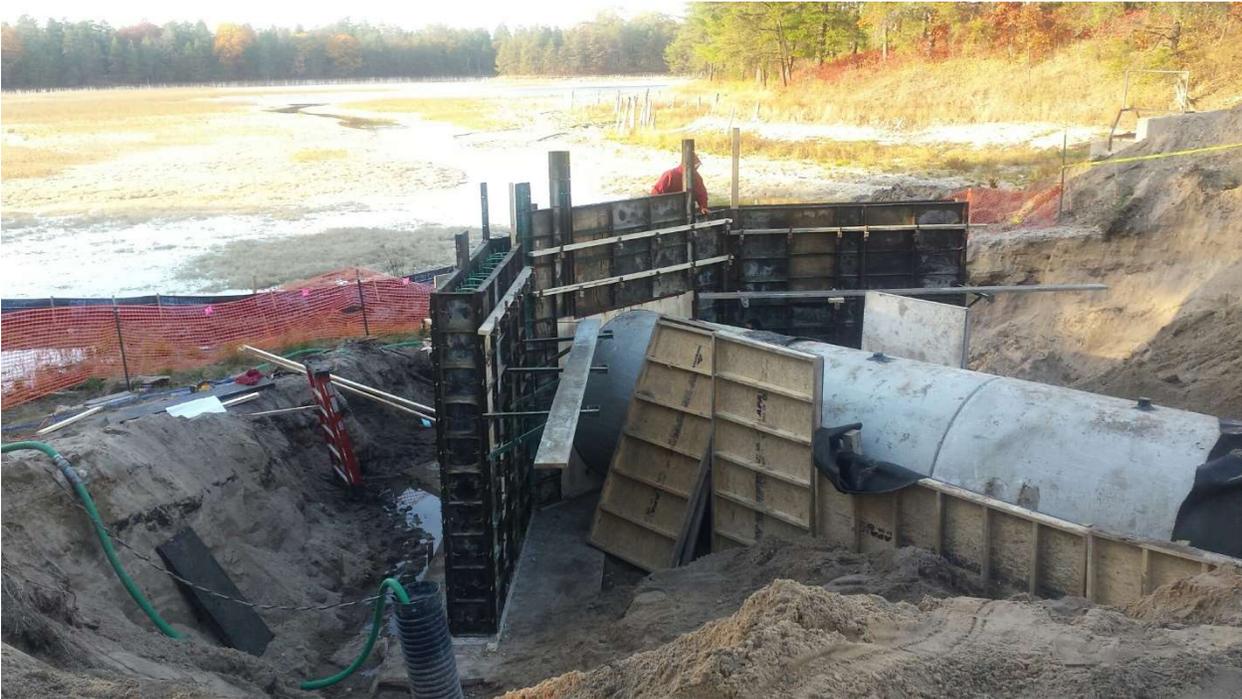
Photo 3. Foch Dam control structure under renovation in 2016.

The control structure of Foch Lakes floods approximately 85 surface acres when all stoplogs are inserted. The flooding was first created in 1955 but only impounded a surface area of approximately 23 acres. The flooding was modified for repairs in 1963 to expand the surface acreage to what it is today. The control structure is owned by the Michigan Department of Natural Resources (MDNR) Fisheries Division, which is responsible for its routine structural inspections and maintenance. Despite multiple repairs over the decades, the structure continued to deteriorate and a 2011 MDEQ safety inspection required complete drawdown of the flooding and return to the natural lake basins to allow better examination of the structure. Local fisheries managers heard from many users of the flooding regarding the drawdown, and weighed the options of complete removal or renovation. In 2013, Fisheries Division received significant funding from the MDNR Dam Management Grant program with lesser matching funds from local entities to renovate the entire structure. The flooding was drawn down in 2014, the control structure and outlet were completely replaced in the fall of 2015, and the flooding was restored to its normal pool elevation.

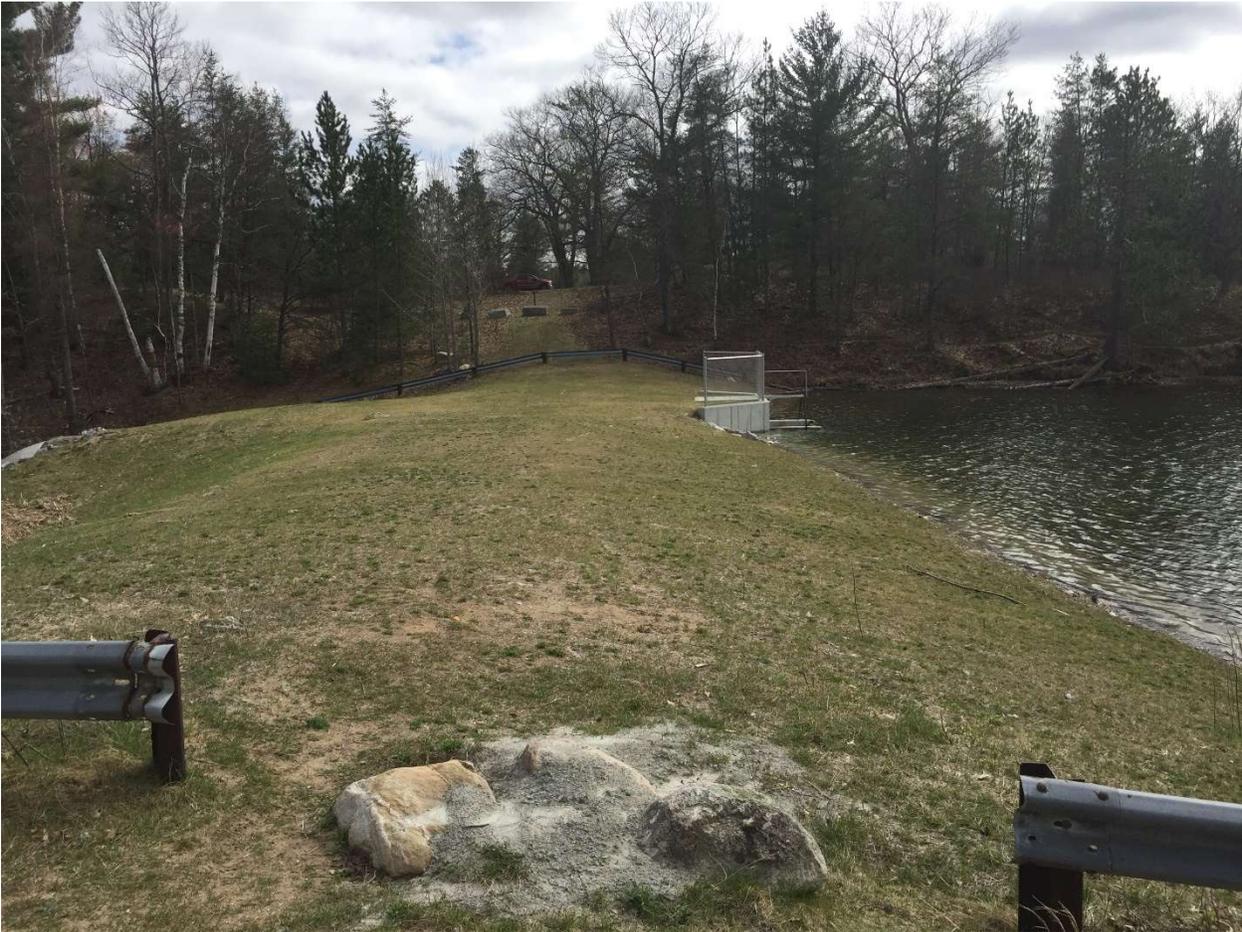
Photo 4. Foch Dam control structure and levee post renovation 2016.
