FINAL REPORT

TIME CRITICAL REMOVAL ACTION

LAKE LINDEN RECREATION AREA –
AREA A

October 2019

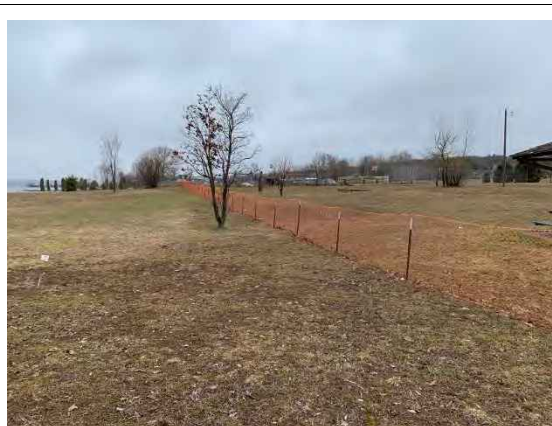
Temporary Construction Fencing

Access to the upland support area was restricted via the use of temporary fencing. Orange construction fencing was utilized around the upland remediation support area (see **Figure 4.1**) and was installed on April 29, 2019. Temporary chain link fencing was utilized around the contractor support area, where the temporary office trailers and imported fill stockpiles were located, and the temporary chain link fencing was installed on May 3, 2019. Overnight security personnel were not employed during the Work.

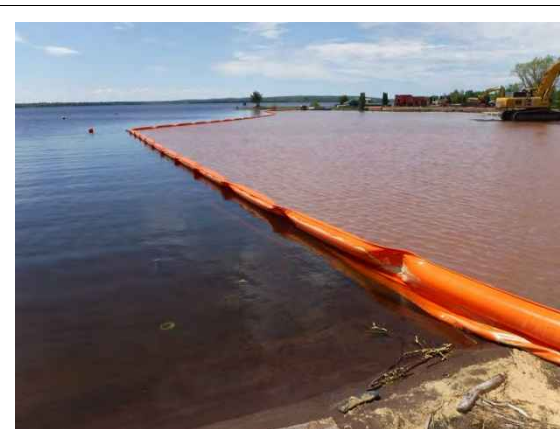
Turbidity Curtain

Within the lake, Severson deployed a turbidity curtain around the TCRA area (see **Figure 4.1**). The turbidity curtain was installed on May 15, 2019, and remained in place throughout the duration of dredging and backfilling activities. The turbidity curtain was constructed of a pervious geotextile fabric designed to allow water to flow through the barrier while retaining fine sediment particles.

The turbidity curtain was constructed with variable skirt lengths, ranging from 1-foot depth in the near shore locations to 15-foot depth in the center (deepest) portion of the turbidity curtain deployment area. The turbidity curtain was affixed to a 10-inch diameter floatation collar, with a ballast chain attached to the bottom of the geotextile fabric. The turbidity curtain was installed approximately 30 to 60 feet to the east of the eastern boundary of the TCRA area and anchored in place using a concrete bin block at the north and south shoreline and five Danforth anchors placed at regular intervals along the length of the curtain. Severson inspected the turbidity curtain daily during construction activities.

Water quality monitoring was conducted outside of the turbidity curtain during dredging and backfill activities to monitor the effectiveness of the turbidity curtain. Water quality monitoring results are summarized in Section 5.2.2.

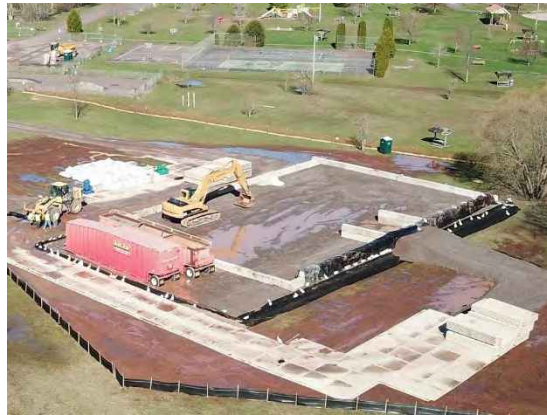
Sediment Processing Pad

4. A geotextile layer, placed as a cushioning layer atop the LLDPE liner
5. A gravel layer approximately 6 inches thick, constructed using MDOT 21AA gravel, that was placed to allow heavy equipment to operate atop the LLDPE liner without damaging the liner and to filter construction water as it drained toward the construction water collection sump

6. A perimeter wall constructed using 2-foot by 2-foot by 8-foot concrete bin blocks, to contain stabilized sediment stockpiled atop the sediment processing pad, and to prevent access by vehicles and personnel into the sediment processing pad

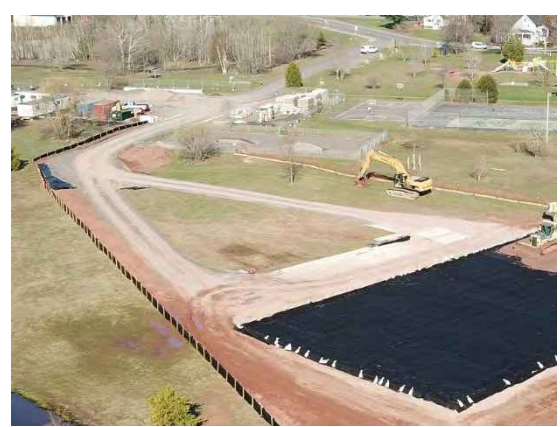
Temporary Access Road

TCRA area, Severson constructed a temporary access road from the contractor support area to the sediment processing pad. The temporary access road was constructed using 6 to 8 inches of gravel that met the Michigan Department of Transportation (MDOT) specification for 21AA gravel. The MDOT 21AA gravel was underlain by a geotextile layer. The temporary access road was constructed in a loop so trucks would not have to back up during loading operations.

A dump truck loading area was constructed adjacent to the sediment processing pad using high density polyethylene (HDPE) mats. This alignment allowed dump trucks to pull up adjacent to the dewatering pad to be loaded with amended sediment so the trucks did not need to enter the exclusion zone and could always remain on the temporary access road.

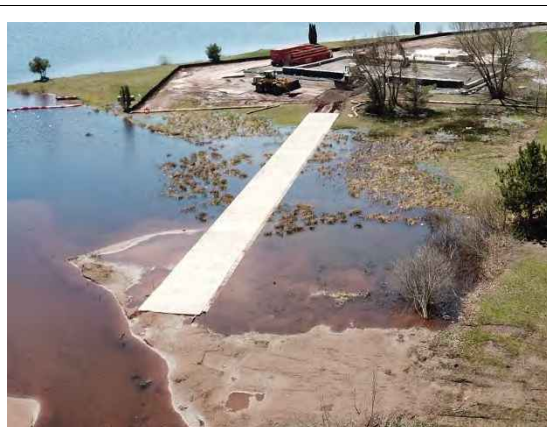
**HDPE Mat Access Road**

Because the majority of the TCRA area was in portions of the lake characterized by shallow water (less than 4 feet water depth), dredging and backfill operations were completed using conventional land based earthmoving equipment, consisting of a Komatsu PC400 long-reach excavator and two Hydrema off-road trucks. To access the TCRA area, Severson constructed a temporary road using interlocking HDPE mats. Upon completion, the HDPE mat road was approximately 180 to 200 feet long and 28 feet wide, and this road was used as a working platform for the land-based equipment.

The east end of the TCRA area was characterized by deeper water (8 to 12 feet water depth), and the effective working radius of the long-reach excavator was insufficient to reach the east end of the TCRA area from HDPE mat road. Therefore, to reach the east portion of the TCRA area, Severson constructed three “finger roads” perpendicular to the HDPE mat road at the north end, center, and south end of the HDPE mat road. The finger roads were constructed using timber crane mats. For the center and south finger roads, MDOT 21AA gravel was also placed under the timber crane mats to raise the elevation of the finger roads above the water surface elevation. Section 4.5 discusses the decommissioning of the temporary finger roads and the reuse of the gravel material used in road construction.

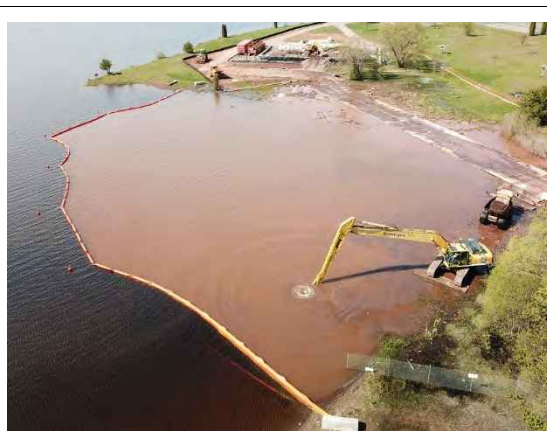
**Dredging in TCRA Area**

Dredging activities were conducted from May 24, 2019, through June 11, 2019, for a total of 13 workdays. Approximately 1,578 in-place cubic yards (cy) of contaminated sediment were removed from the TCRA area, based on survey comparison between pre- and post-dredge surfaces. Dredging was guided using real-time kinematic differential global positioning system (RTK-GPS) and Hypack’s DREDGEPAK position tracking software system for accuracy in equipment location, bucket placement, and dredging operations. As discussed in Section 5.4, dredge verification was conducted via survey comparison.

Dredge depths generally ranged from 2 to 4 feet, with limited areas deeper than that range. The deeper removal depths were located in the vicinity of the existing channel outfall area, as designed, and near the top of the slope above the east end of the TCRA area. The pre-construction survey conducted prior to the start of dredging showed an existing sloping area, with slopes steeper than 3 feet horizontal to 1 foot vertical in some areas, with the toe of the slope located along the east edge of the TCRA area. Following dredging and dredge verification, it was observed that sloughing was likely occurring along this slope with material being deposited at the toe of slope. Due to this sloughing, although dredging operations were observed by the Field Construction Oversight along the east end of the TCRA area, dredging did not appear to meet the design grades in this limited area. The dredge design template was met over 95% of the TCRA area, as specified in the design; therefore, dredge depths less than the 2 feet required by the design were observed at approximately 5% of the TCRA area (non-contiguous) and comply with the performance requirements outlined in the RWP. The toe of slope area along the east TCRA boundary was not included in this computation based on communication and concurrence with USEPA dated June 11, 2019, regarding the sloughing issue, as further discussed in Section 5.5.

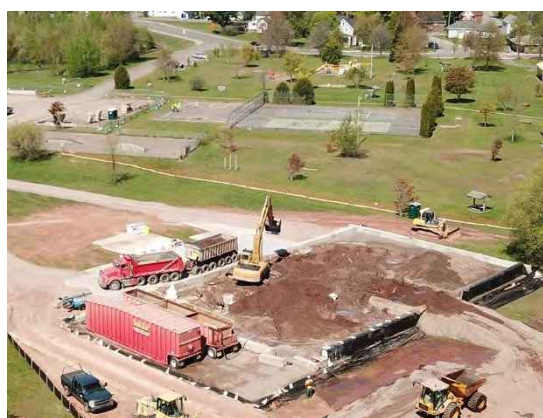
Dredged Material Management

Dredged sediment was transferred to the sediment processing pad using Hydrema off-road trucks, where Calciment was added to the dredged sediment using a Caterpillar 330CL excavator. Calciment was added to the dredged sediment to stabilize the sediment prior to off-site transport and disposal.

The amount of Calciment added to the dredged sediment was dependent upon the portion of the TCRA area from which the sediment was removed, consistent with the RWP. A Calciment dose of minimum 5% by dry weight was added to sediment removed from Dredge Unit (DU) 1. For DU-2, DU-3, and DU-4, Calciment was added to the dredged sediments at a minimum Calciment dose of 2.5% by dry weight.

Following amendment with Calciment, the sediment was stored on the sediment processing pad for a minimum of 24 hours, and generally for at least 72 hours, to react with the Calciment and stabilize prior to off-site transport and disposal. Any water that drained from the sediment during processing was directed to a sump

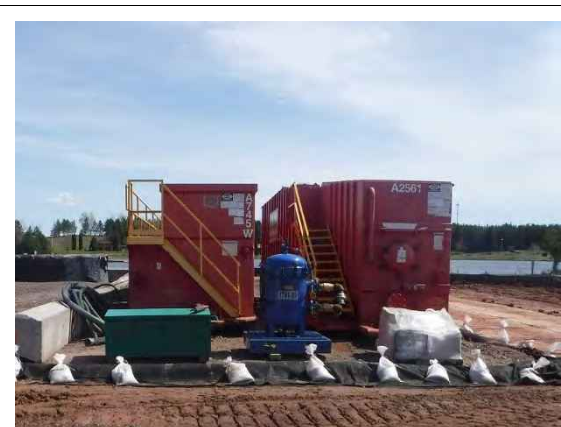
Construction Water Treatment System

After being collected and filtered, the treated water was stored in the fractionation tank prior to transport to the PLWSA of Houghton, Michigan, for final treatment. Severson collected a sample of the construction water for the parameters requested by the PLWSA (see Section 5.3.3). All sample results were within the required parameters for acceptance by the PLWSA except for pH, which was measured at 10.2. The elevated pH was likely the result of contact with

the Calciment used as a stabilizing agent for the dredged sediments. With approval from the PLWSA, Severson added muriatic acid to the construction water within the fractionation tank until the pH was lowered to approximately 8.5.

Once the pH was in the required range, the filtered construction water was transported to the PLWSA by Superior Service Towing of Houghton, Michigan, using 1,500-gallon-capacity tanker trucks. Twelve truckloads of construction water with a cumulative volume of 17,250 gallons were transported to the PLWSA between June 11 and 13, 2019. Non-hazardous waste manifests for the transport of the construction water are included in **Appendix D**.

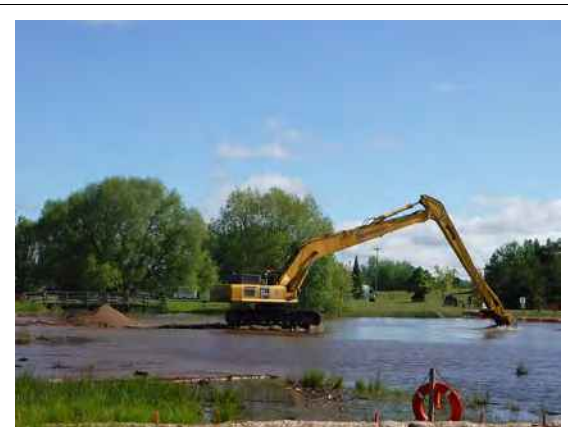
Clean Backfill Placement

As noted earlier in this section and further discussed in Section 5.5, conditions observed during the Work resulted in a field modification to the design of the backfill. The steeper slopes first observed during dredging operations also posed a challenge for clean material placement. When the gravel armor stone was first placed in the sloped portion of the TCRA area, it was observed through survey verification that the gravel was not holding as intended on the dredged

slopes and, in some cases, was mounding at the toe of the slope. The result of this mounding was areas where gravel was placed in excess of the design thickness and placement tolerance (i.e., greater than 6 inches plus 3 inches). **Figure 4.3** presents the as-built range of gravel placement thicknesses across the TCRA area (see Section 5.4 for additional information regarding material placement verification). Subsequent sand placement in this area (DU-1 through DU-3) was originally designed to be approximately 18 inches to return the area to pre-construction grades (assuming a 2-foot dredge cut).

However, given the observed challenges with gravel stability on the slopes and the resulting excess thickness of gravel placed in some areas, the design and

construction team recommended that the sand be placed using a thickness approach, rather than attempting to match pre-construction grades, as a practical means to meet the intent of the TCRA. Specifically, in the areas with significant mounding of gravel from over-placement, the construction contractor was required to place at least 6 inches of sand above the gravel to meet the objective of the TCRA of placing at least some sand over the entire TCRA footprint, but to not result in excess placement causing a major anomaly in post-construction bathymetry. Elsewhere in the TCRA where the placed gravel thickness was not in excess of the design, the construction contractor was required to place 18 inches of sand backfill. In the majority of DU-1 through DU-3, this essentially returned the area to pre-construction grade with the exception of areas where there was excess over-dredging or where the slopes sloughed, which alleviated the need for the construction contractor to attempt placement of a considerable thickness to match the pre-construction grade. This approach was approved by USEPA on June 18, 2019. **Figure 4.4** presents the as-built range of sand placement thicknesses across the TCRA area.

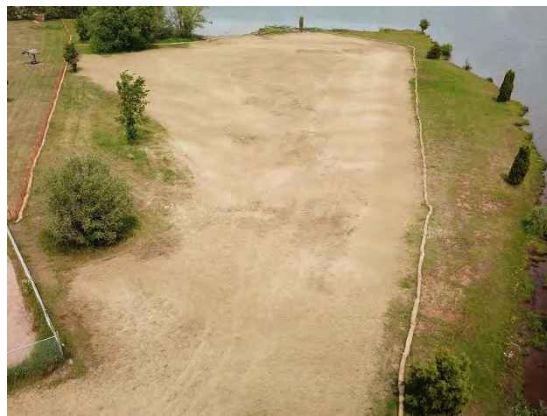
Seeded and Mulched Ground Surface

Following removal of the sediment processing area and temporary access roads, in-kind restoration activities were performed for the ground surface at the upland remediation support area. First, a Harley Rake was used across the upland remediation support area to loosen the soil. Then a turf grass seed mix was applied to the ground surface, followed by fertilizer and mulch, to re-establish a grass cover. Seeding and mulching was performed by Halonen Landscaping of

Atlantic Mine, Michigan, on June 27 and 28, 2019. To further re-establish grass cover, application of fertilizer was performed on July 30, 2019, and periodic applications of water will occur in August and September 2019.

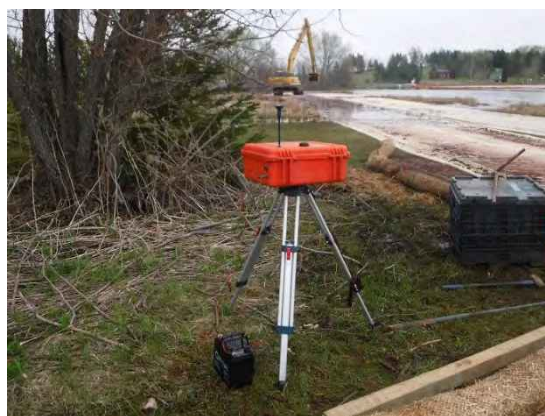
Dust Monitoring Station

In accordance with its HASP, Sevenson conducted air monitoring for dust for the duration of dredging and sediment stabilization activities to monitor potential worker exposure to respirable dust. Air monitoring was conducted at a fixed station near the shoreline, adjacent to the southwest corner of the TCRA area and approximately 50 feet north of the sediment processing pad (**Figure 4.1**).

Dust monitoring was conducted from May 24, 2019, through June 14, 2019. Air monitoring results are included in **Appendix H**. Dust monitoring results remained below the action level specified by Sevenson's HASP (250 micrograms per cubic meter) throughout the duration of dredging and sediment stabilization activities, with a maximum recorded dust measurement of 86 micrograms per cubic meter.

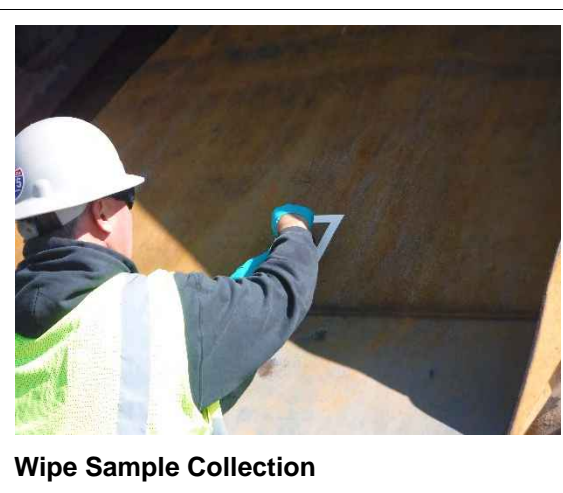
Wipe Sample Collection

Equipment that had been in contact with, or potentially in contact with, dredged materials was decontaminated via pressure washing prior to use for backfill activities or demobilization from the Site. Decontamination water generated during equipment decontamination was managed as described in Section 4.4.1. To verify the effectiveness of decontamination, wipe samples were collected from the decontaminated equipment and submitted for laboratory analysis of PCBs.

Wipe samples were collected from the following equipment: a Komatsu D61 dozer, both Hydrema 912HM off-road trucks, a Komatsu WA380 front-end loader, the Komatsu PC400 long-reach excavator, and a CAT 330CL excavator. All sample

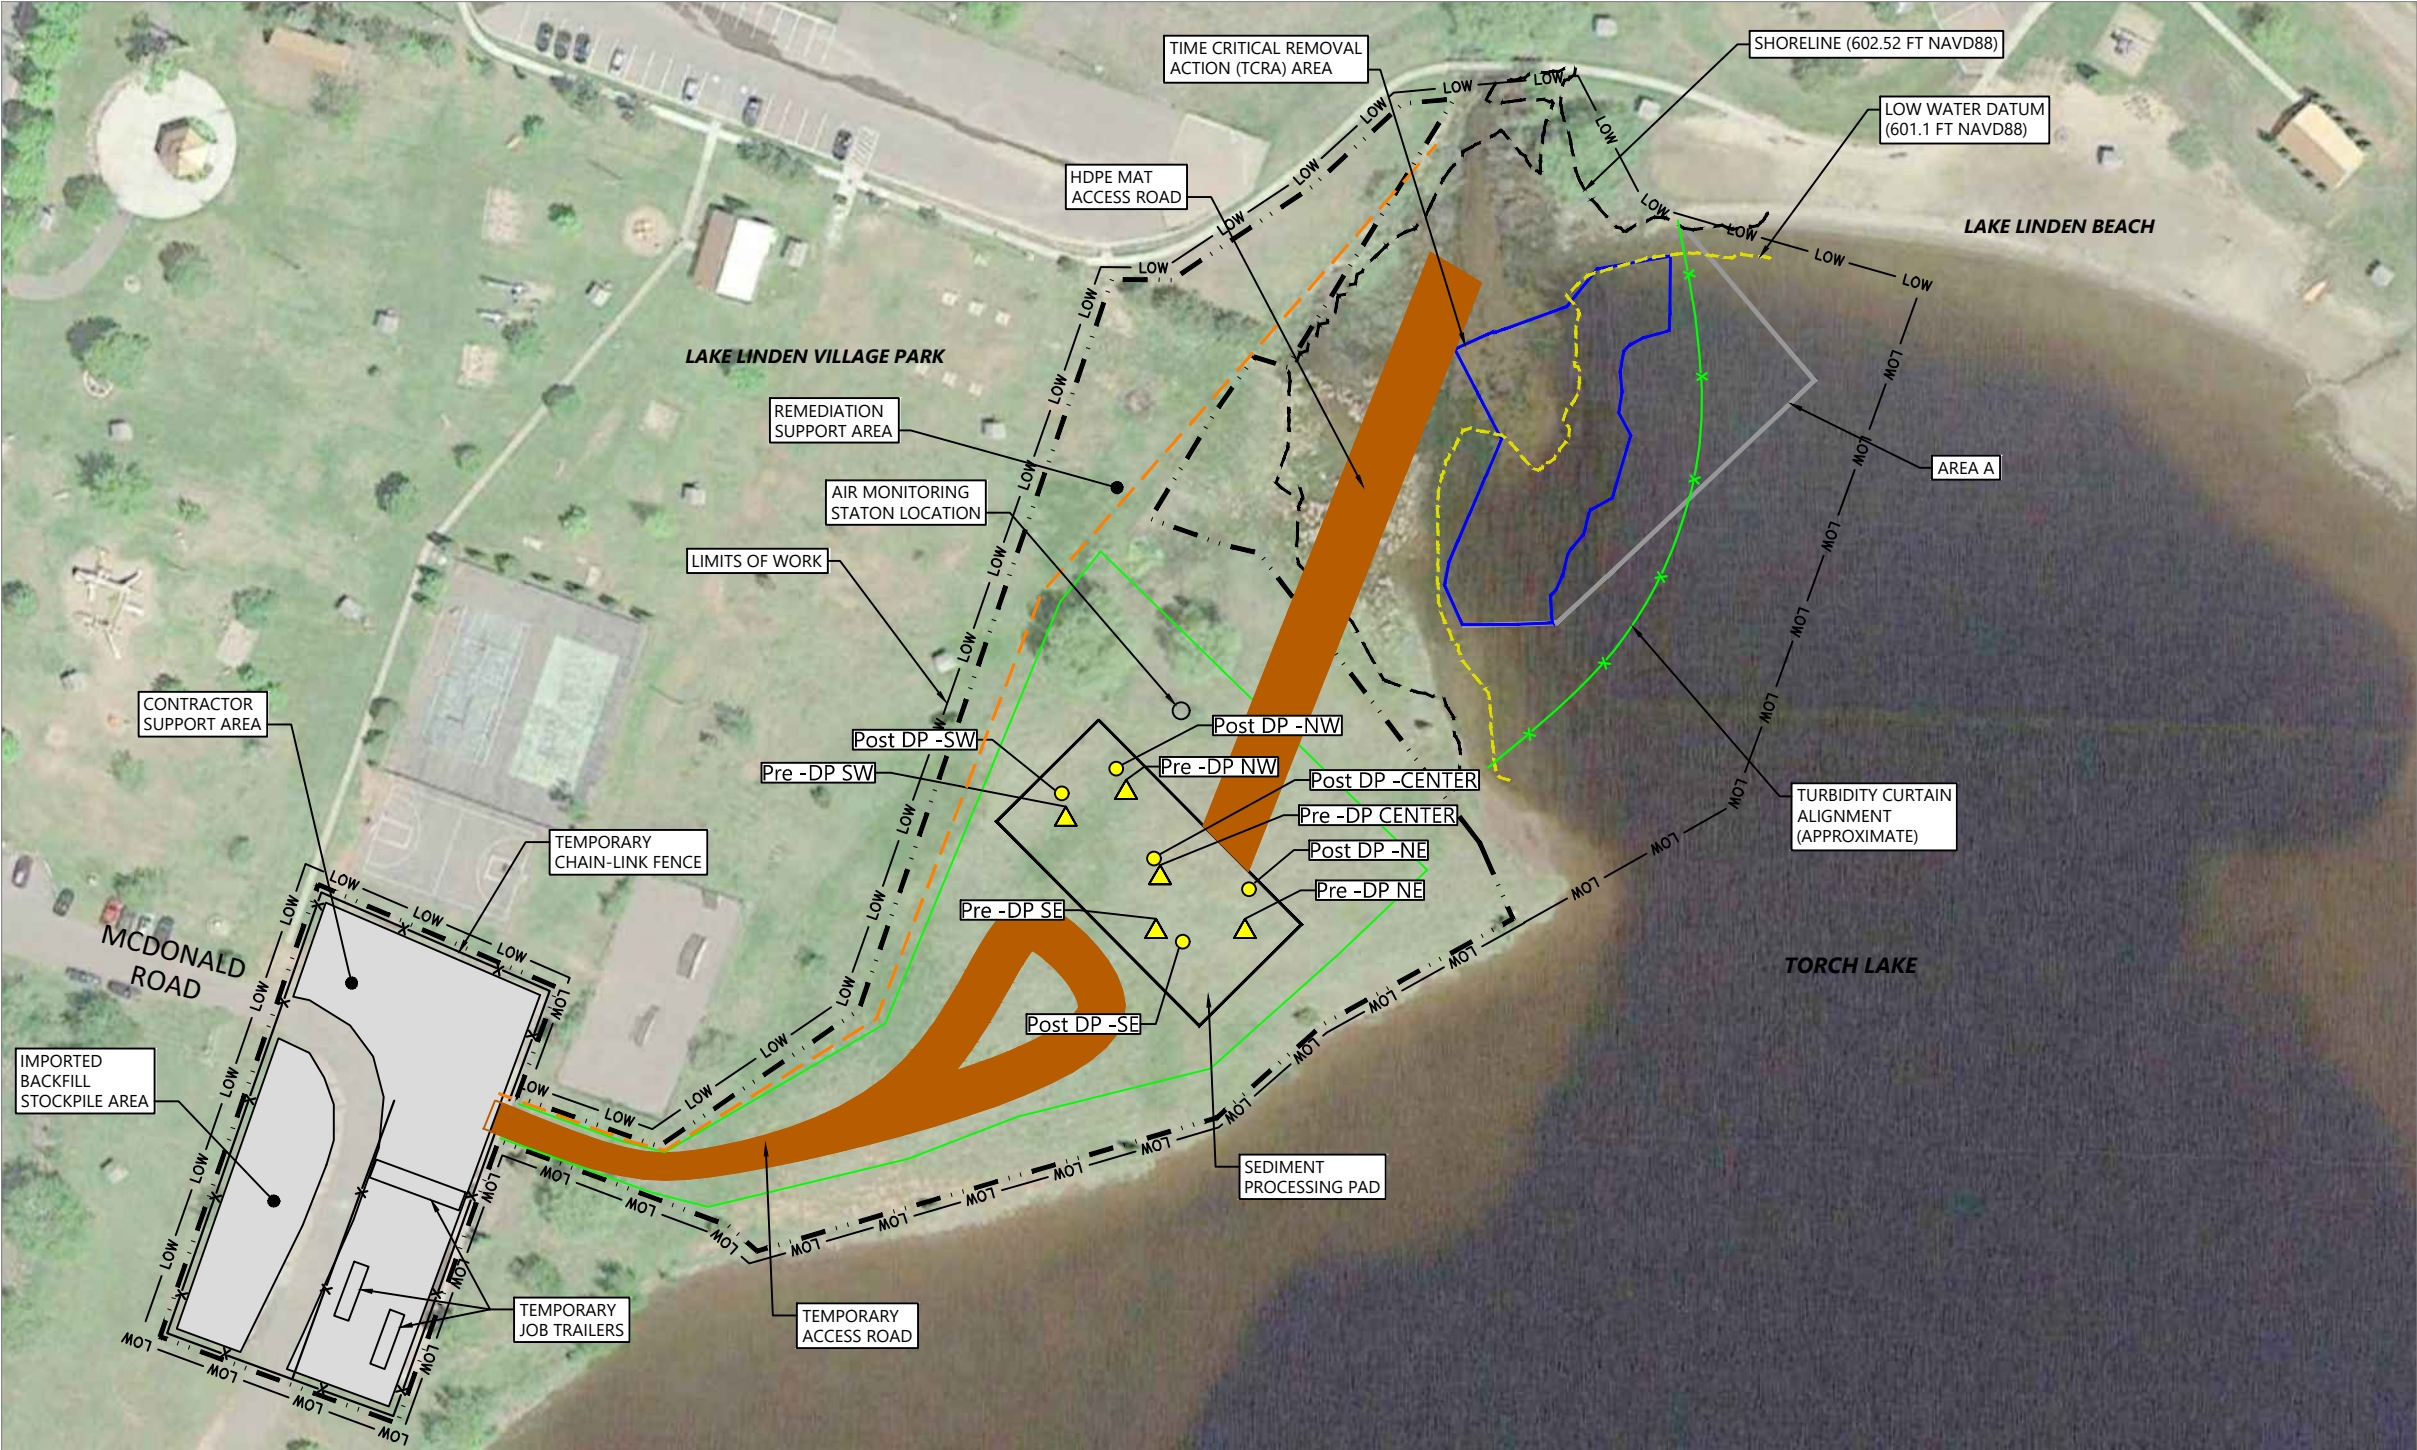
Figure 4.1
Upland Staging Area Site Plan
Lake Linden Recreation Area (LLRA)
Lake Linden, MI

1. THE SHORELINE (I.E. ZERO WATER DEPTH LINE) WAS DEFINED AND SURVEYED AT 602.52 FT NAVD88 BY AFFILIATED RESEARCHERS LLC, ON JULY 10, 2018.
2. APPROXIMATE LOCATIONS OF TEMPORARY FACILITIES, SEDIMENT PROCESSING AND DEWATERING AREA, AND ACCESS ROADS DIGITIZED FROM SEVENSON ENVIRONMENTAL SERVICES, INC. SITE LAYOUT PLAN DATED 9/7/18.

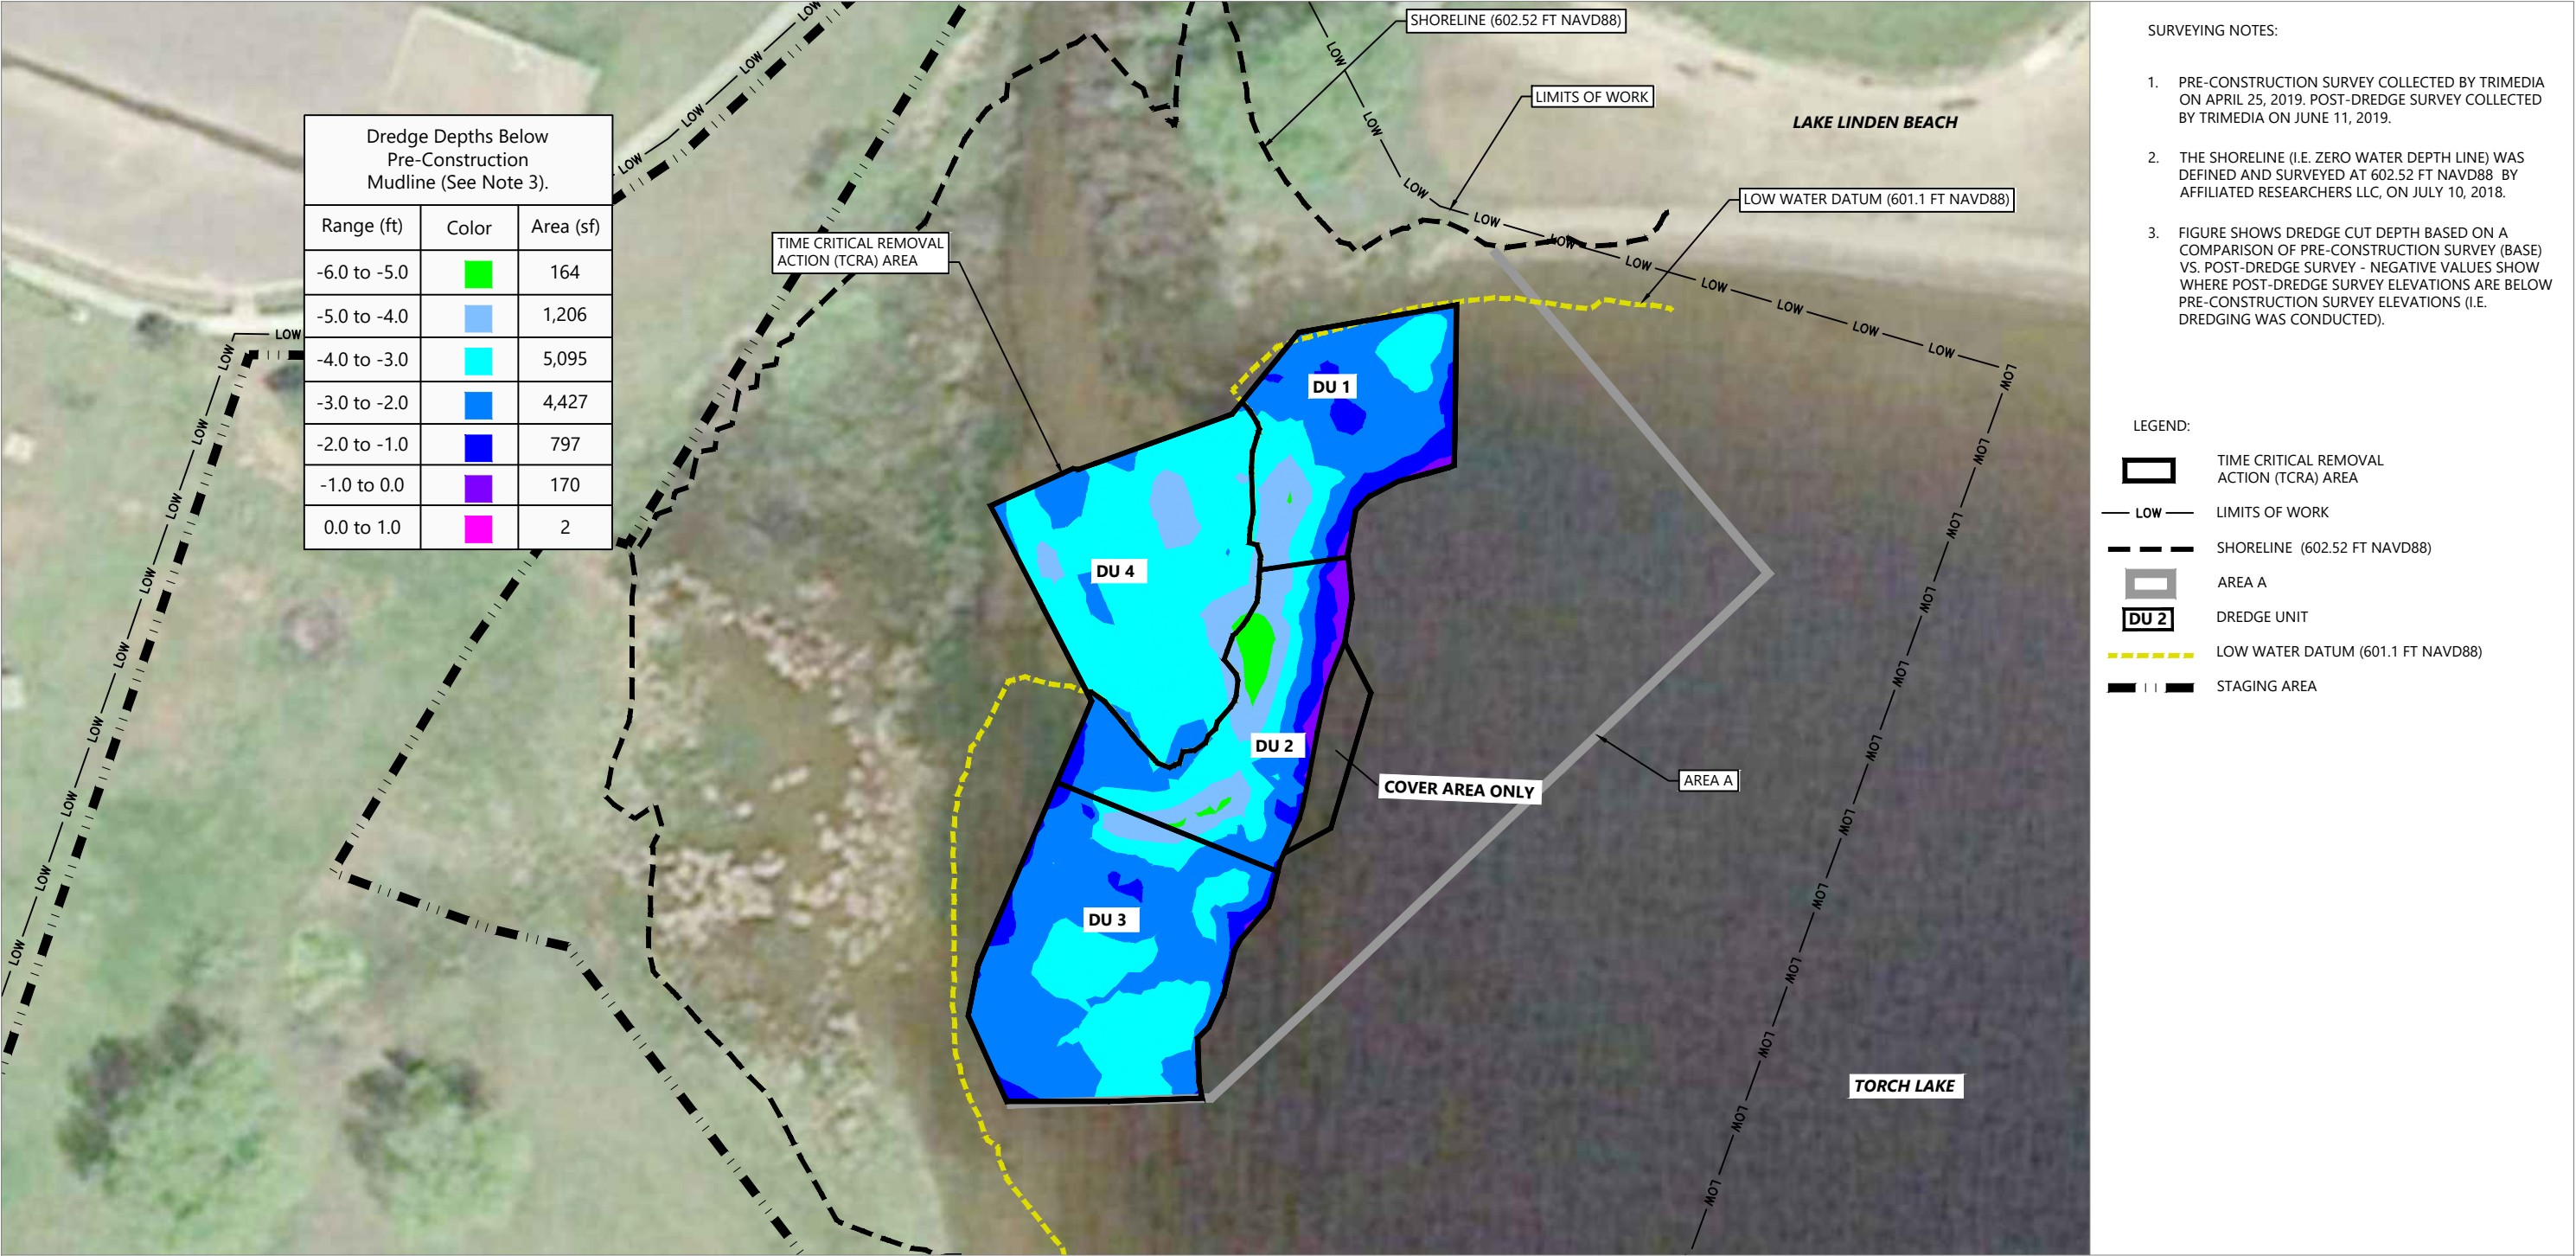
Figure 4.2
As-Built Dredge Depths Below Pre-Construction Mudline

Base Survey - From Trimedia on April 25, 2019 (0287 Lake Linden PRE CONSTRUCTION 20190605)
Comparison Survey - From Trimedia on June 11, 2019 (0287 Lake Linden POST CONSTRUCTION 20190611)

During dredging operations, surveys indicated that the design dredge elevations were not met at the offshore (east) edge of the TCRA area after multiple dredge passes, as discussed in Section 4.2. However, dredging was conducted in the area as observed by Honeywell's on-site representative, and the removed material was accounted for in processing and disposal. The cause was determined to be steep slopes in this area that resulted in minor sloughing of sediment toward toe of the slope in the dredged area. Water depths in this area were about 7 to 8 feet. On June 10, 2019, a request was made to USEPA to discontinue dredging along the east

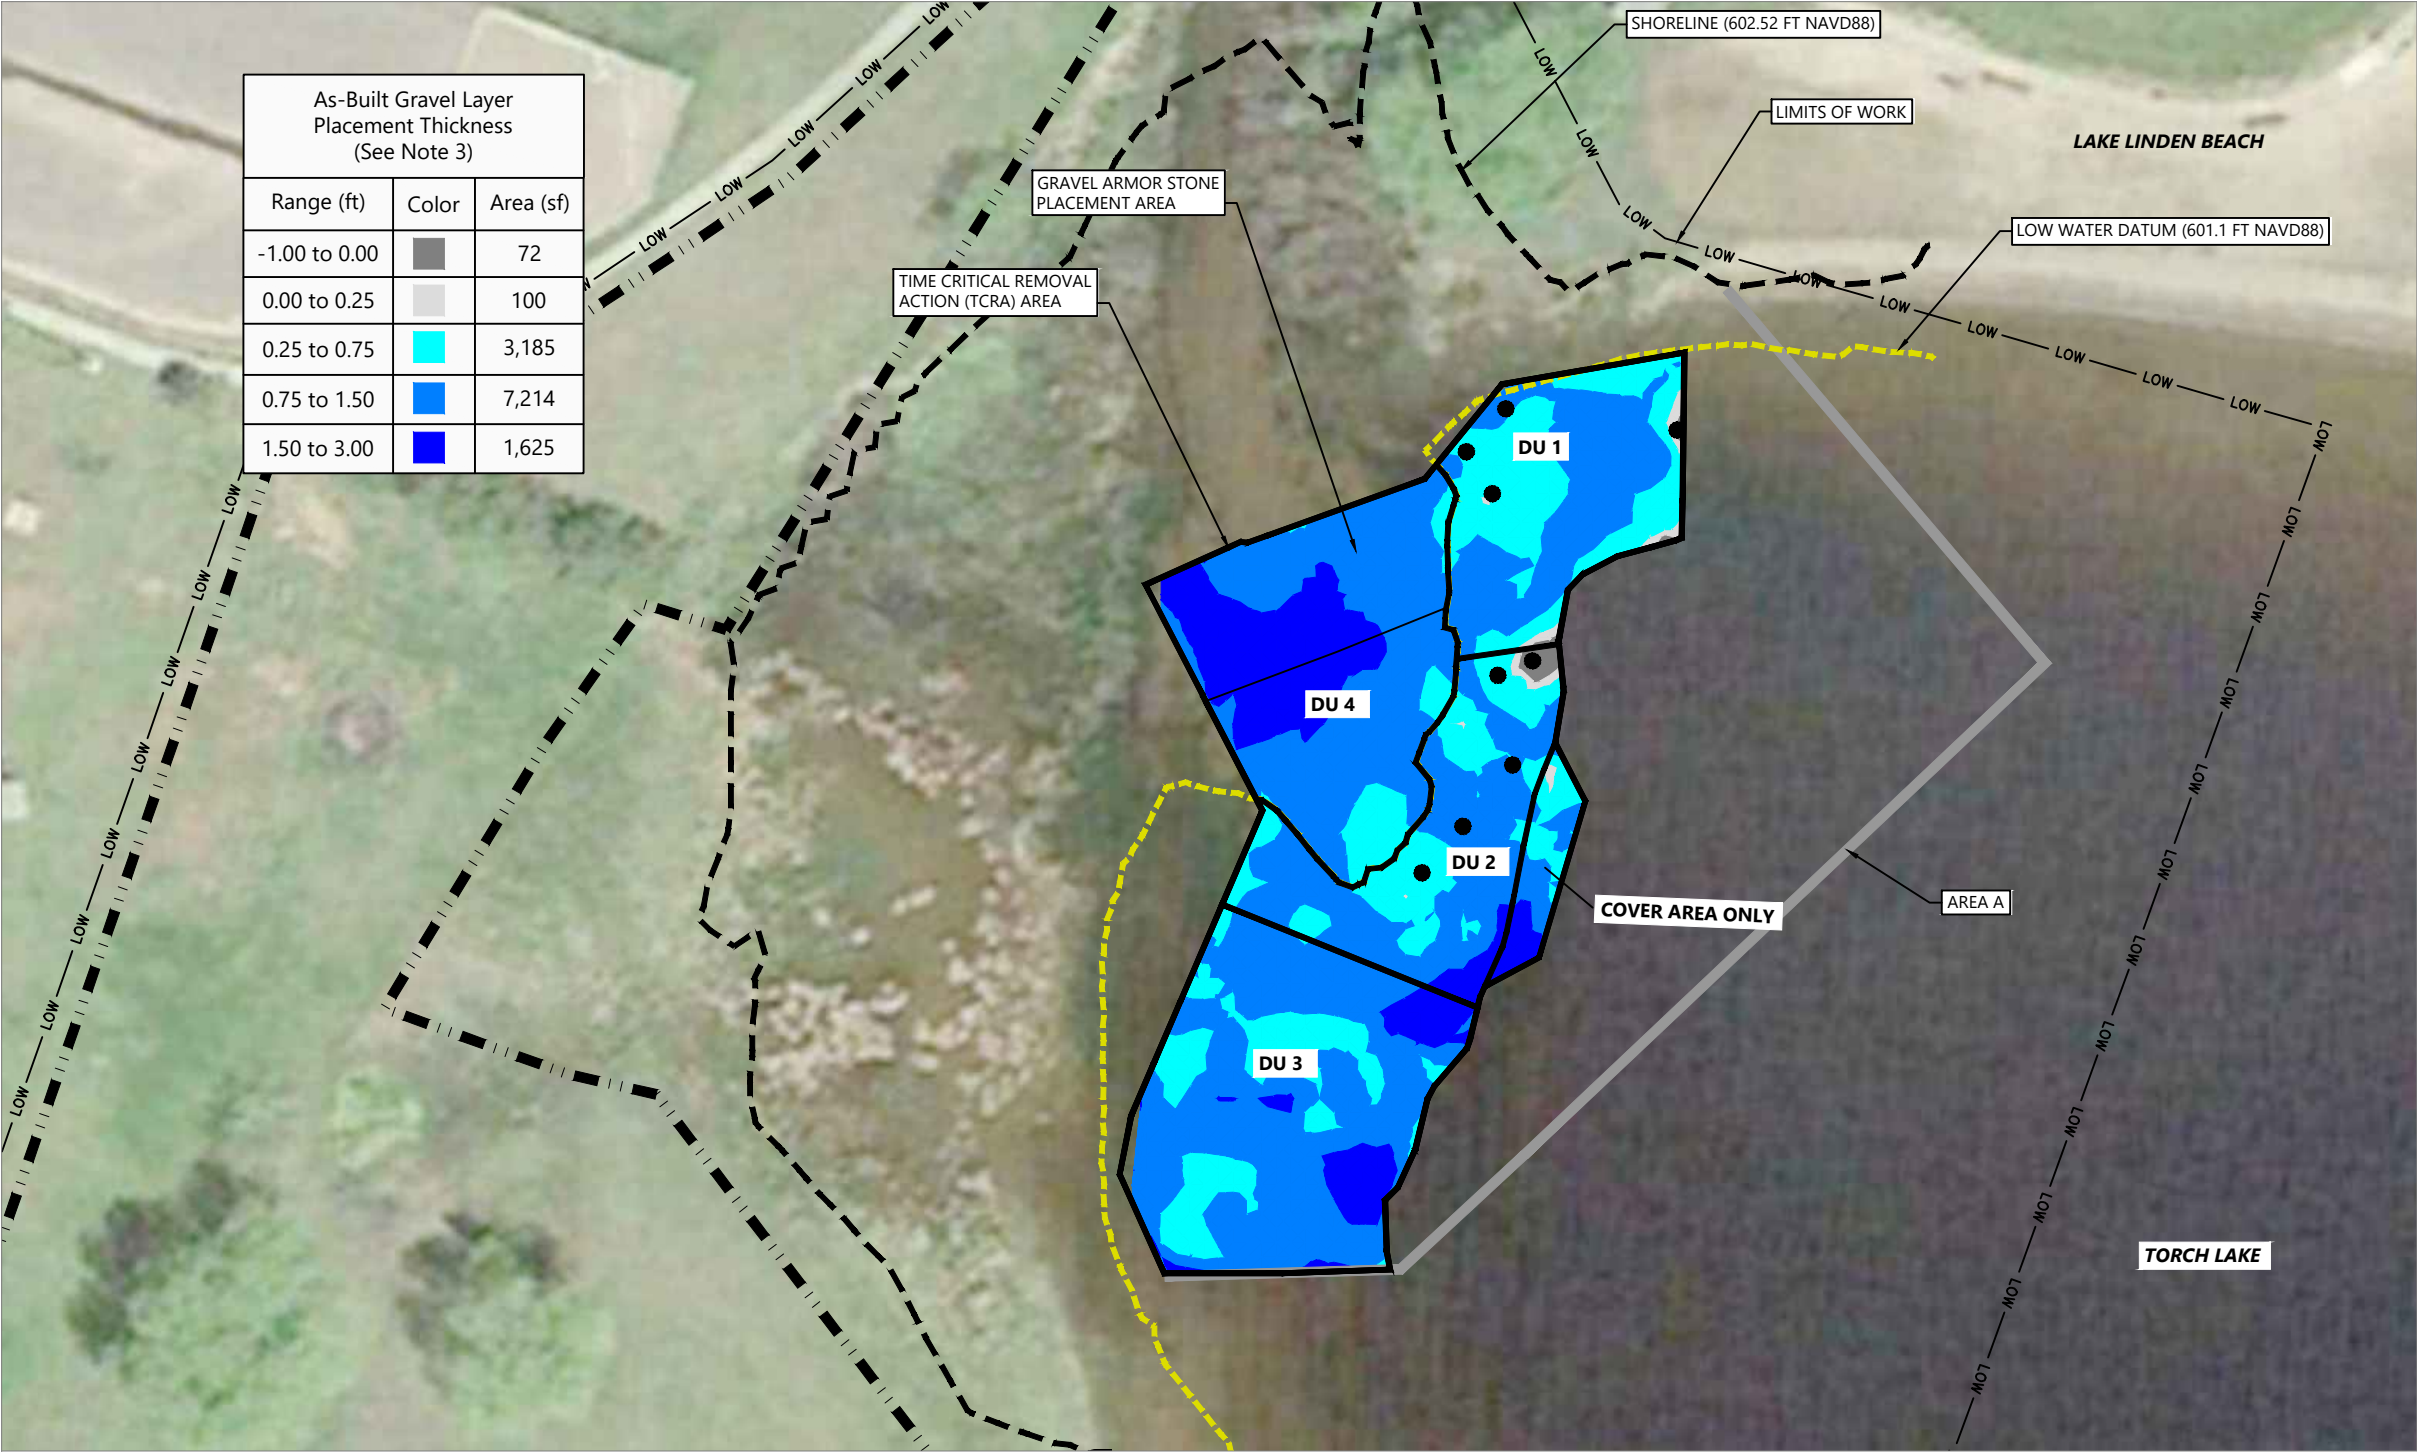
Figure 4.3
As-Built Gravel Layer Placement Thickness
Lake Linden Recreation Area (LLRA)
Lake Linden, MI

- SURVEYING NOTES:
1. POST-DREDGE SURVEY COLLECTED BY TRIMEDIA ON JUNE 11, 2019. POST-GRAVEL SURVEY COLLECTED BY TRIMEDIA ON JUNE 20, 2019.
 2. THE SHORELINE (I.E. ZERO WATER DEPTH LINE) WAS DEFINED AND SURVEYED AT 602.52 FT NAVD88 BY AFFILIATED RESEARCHERS LLC, ON JULY 10, 2018.
 3. FIGURE SHOWS GRAVEL BACKFILL PLACEMENT THICKNESS BASED ON A COMPARISON OF POST-DREDGE SURVEY (6/11/19; BASE) VS. POST-GRAVEL SURVEY (6/20/19) - POSITIVE VALUES SHOW WHERE POST-GRAVEL SURVEY IS ABOVE POST-DREDGE SURVEY (I.E. GRAVEL PLACED).

During placement of the gravel demarcation layer, post-backfill surveys for this layer indicated that the material was not holding on the dredged slopes along the east edge of the TCRA area, and in some areas material mounded at the toe of the slope in thicknesses greater than the specified 6 inches (up to 2 feet in isolated areas; see Section 4.5 for additional details). Rather than remove the additional gravel that accumulated at the toe of slope, the design and construction team recommended that the gravel remain in place and sand be placed using a thickness approach, with the additional requirement of placement of a minimum of 6 inches of sand, as a practical means to meet the intent of the TCRA. This minimum-thickness approach to backfill placement was consistent with Detail 2 in Drawing C-007 of the Backfill Plan design drawing and maintained the requirement for a 2 foot-minimum backfill thickness in all areas (except for the gravel-only area in the northwest portion of the TCRA area). USEPA approved this revised approach in an email dated June 18, 2019. For most of the TCRA area, the construction contractor placed 18 inches of sand backfill over the gravel backfill as originally required in the design, and in most areas, this approach essentially returned the area to pre-construction grade as planned in the design.

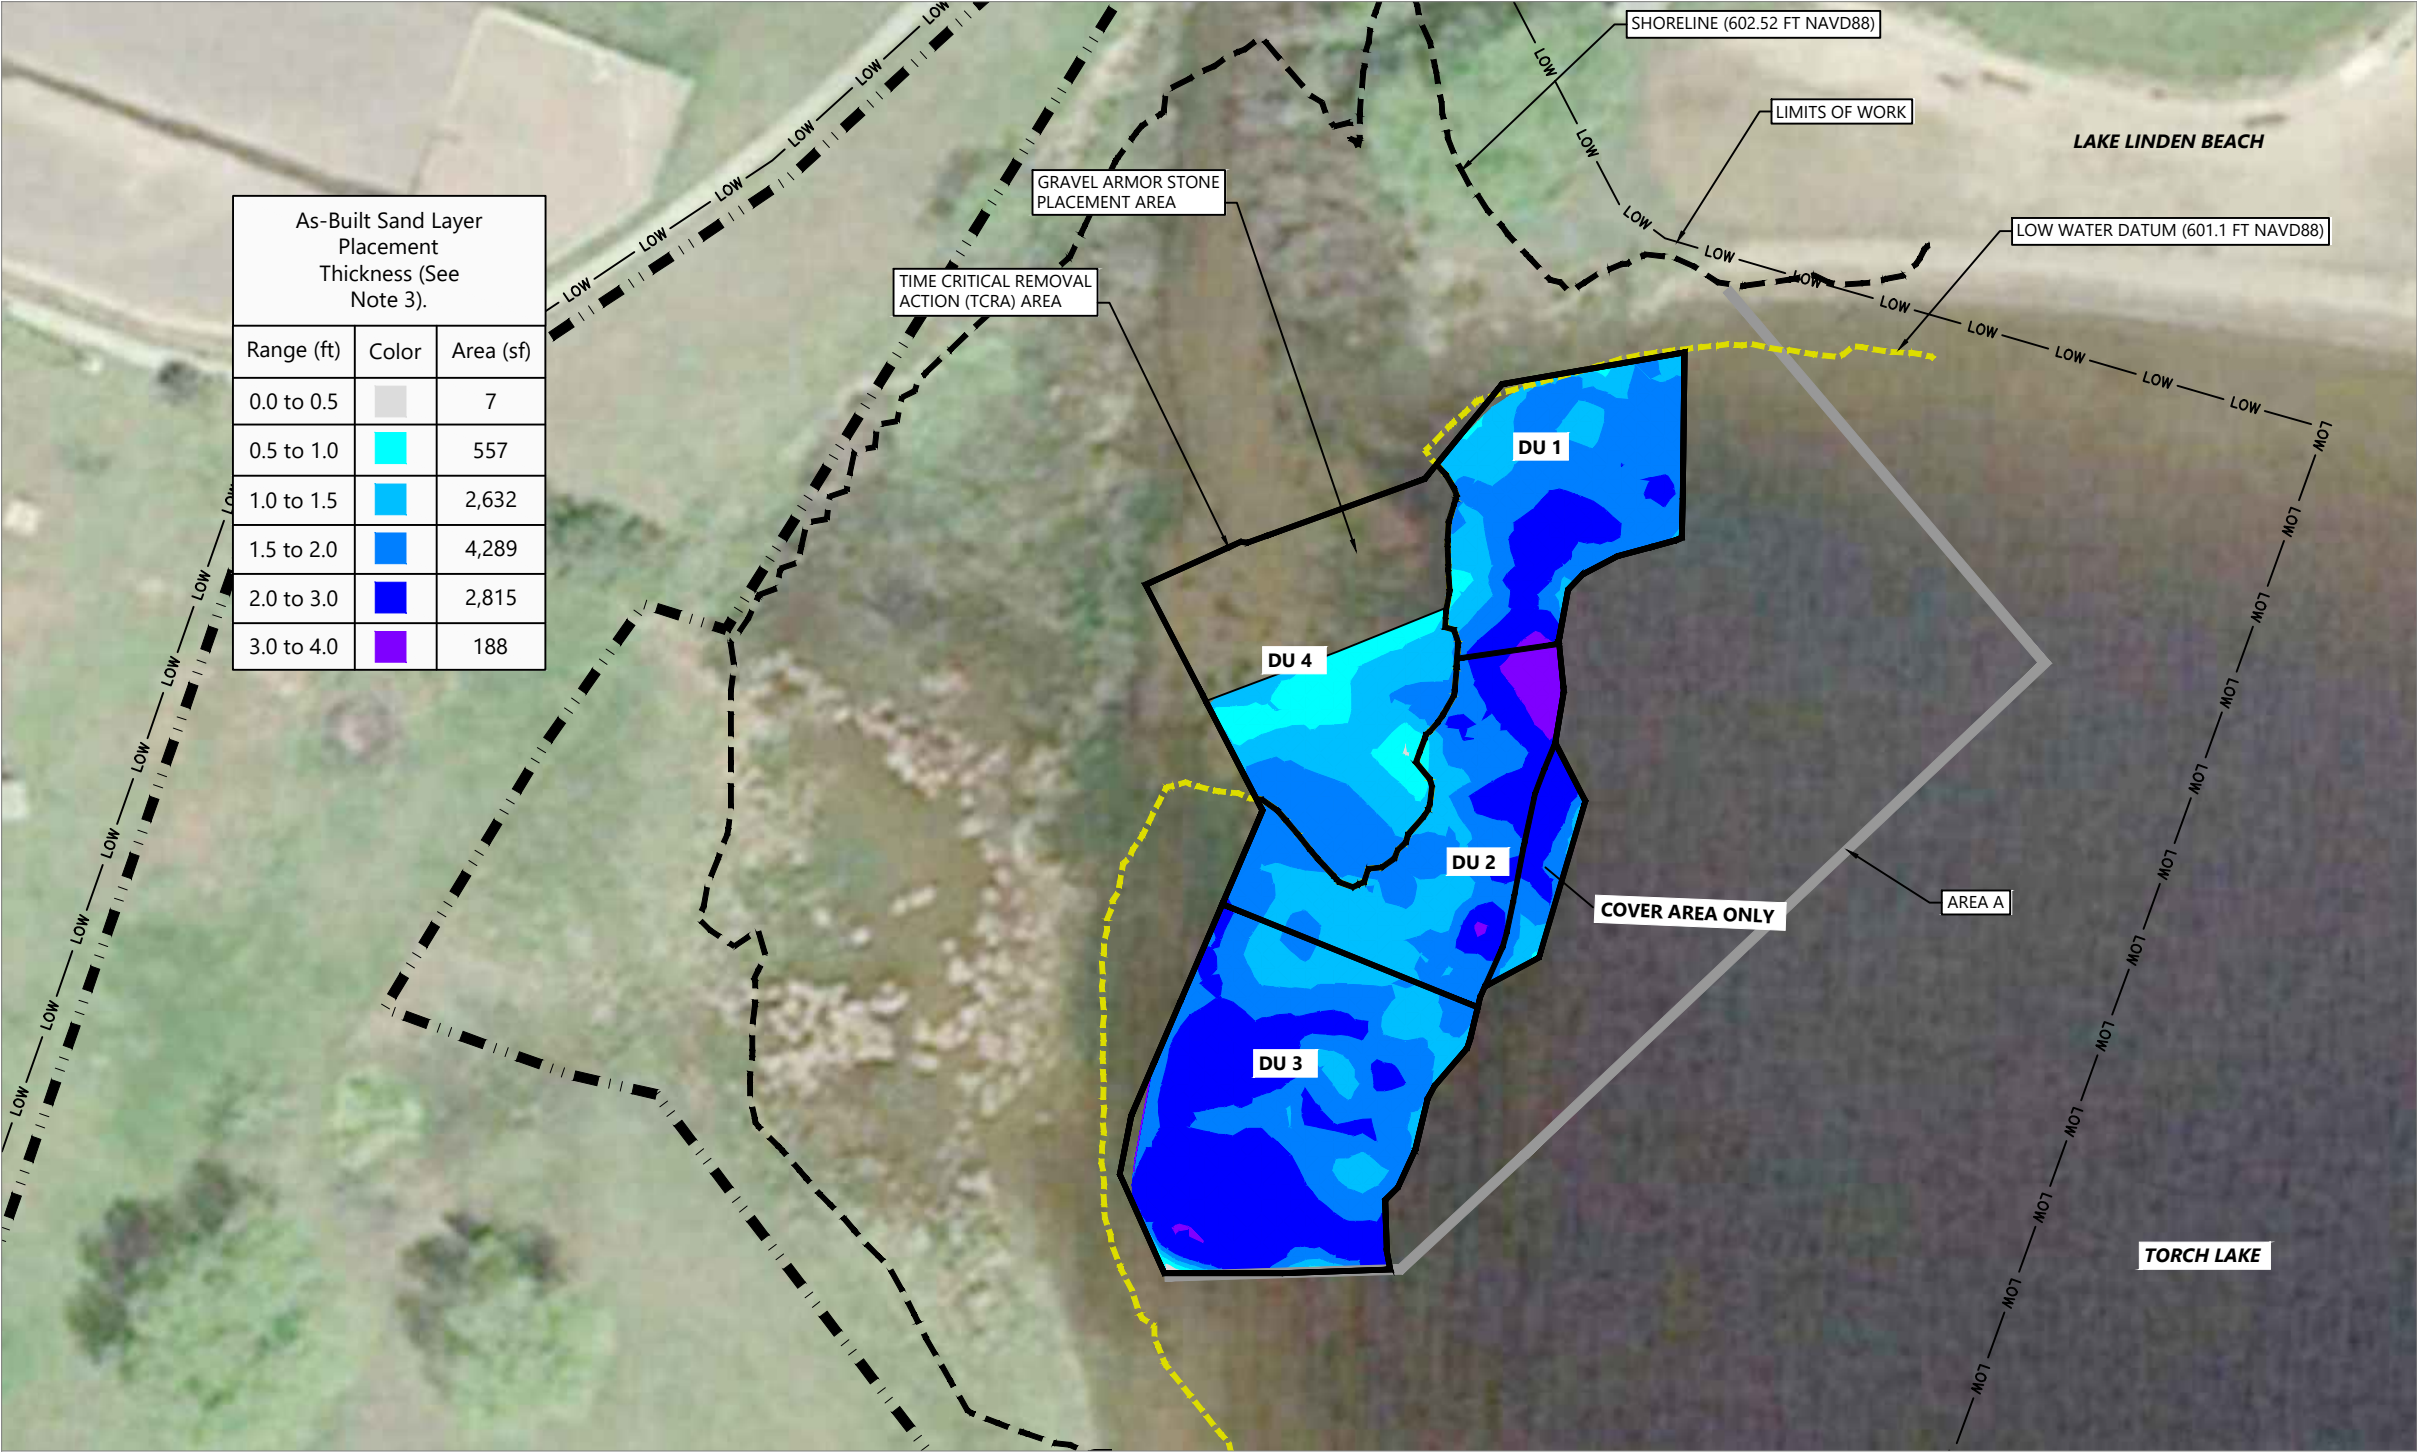
Figure 4.4
As-Built Sand Placement Thickness
Lake Linden Recreation Area (LLRA)
Lake Linden, MI

- SURVEYING NOTES:
1. POST-GRAVEL SURVEY COLLECTED BY TRIMEDIA ON JUNE 20, 2019. POST-SAND SURVEY COLLECTED BY TRIMEDIA ON JUNE 22, 2019.
 2. THE SHORELINE (I.E. ZERO WATER DEPTH LINE) WAS DEFINED AND SURVEYED AT 602.52 FT NAVD88 BY AFFILIATED RESEARCHERS LLC, ON JULY 10, 2018.
 3. FIGURE SHOWS SAND BACKFILL PLACEMENT THICKNESS BASED ON A COMPARISON OF POST-GRAVEL SURVEY (6/20/19; BASE) VS. POST-SAND SURVEY (6/22) - POSITIVE VALUES SHOW WHERE POST-SAND SURVEY ELEVATIONS ARE ABOVE POST-GRAVEL SURVEY ELEVATIONS (I.E. SAND WAS PLACED)
