FINAL REPORT

TIME CRITICAL REMOVAL ACTION

LAKE LINDEN RECREATION AREA –
AREA A

October 2019

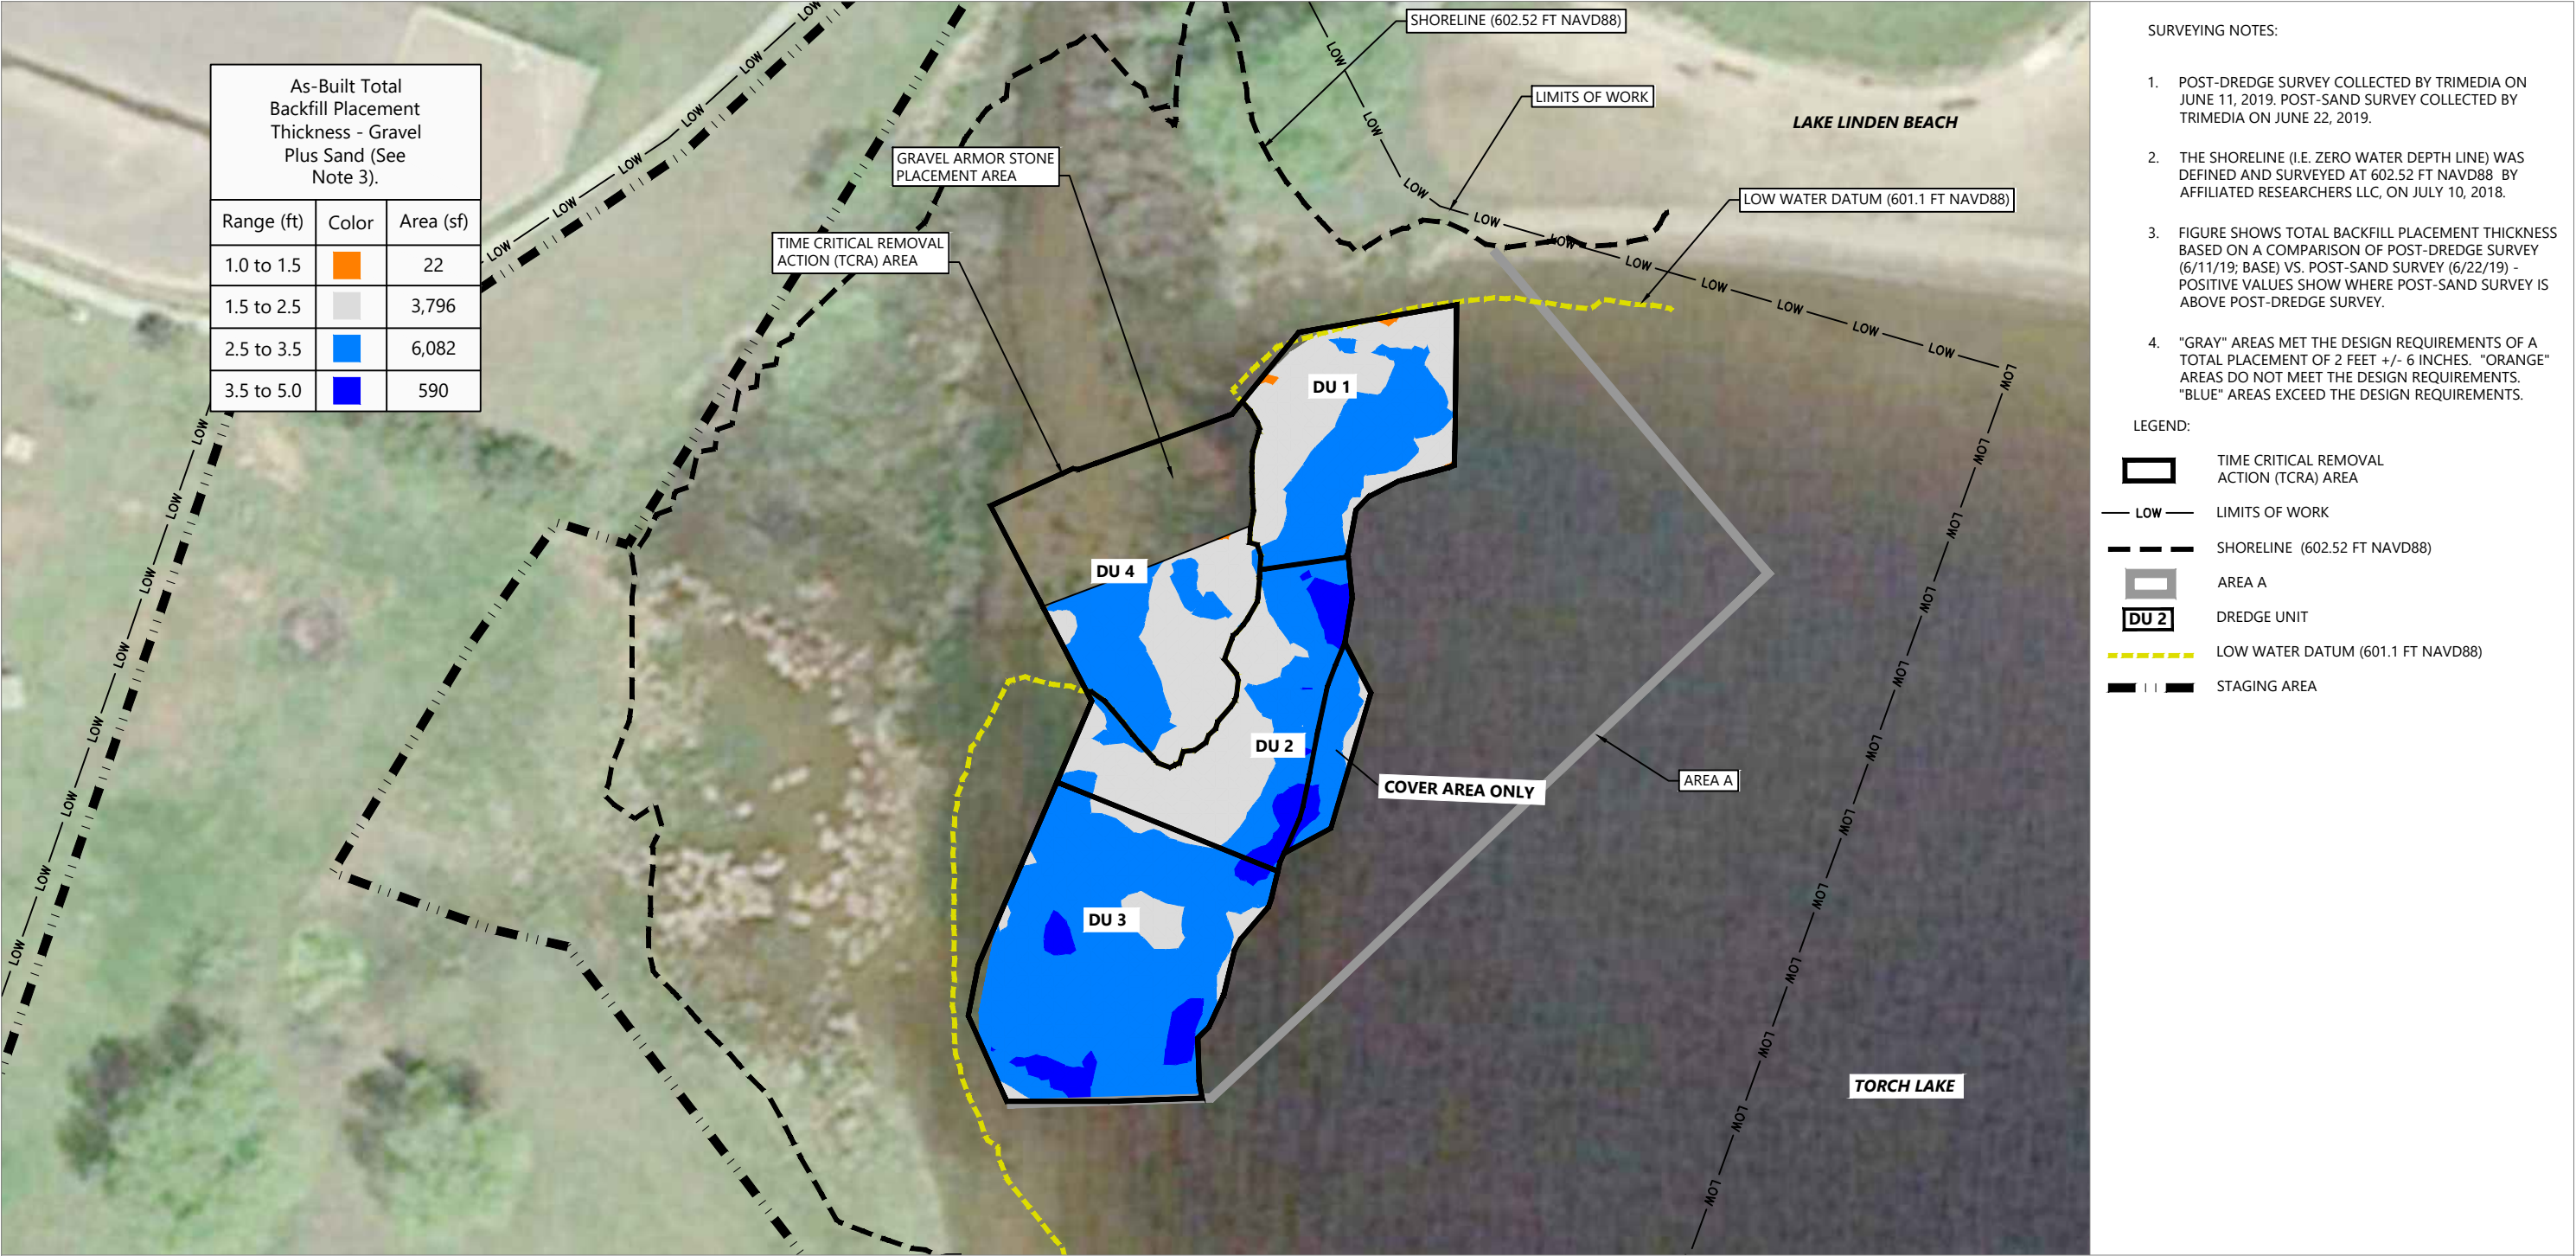
Figure 4.5
Total As-Built Clean Material Placement (Gravel Plus Sand)

Base Survey - From Trimedia on June 11, 2019 (0287 Lake Linden POST CONSTRUCTION 20190611)
Comparison Survey - From Trimedia on June 22, 2019 (0287 Lake Linden PRE CONSTRUCTION 20190622 SAN)
