SITE INVESTIGATION REPORT

ABANDONED MINING WASTES – TORCH LAKE NON-SUPERFUND SITE
QUINCY MINING COMPANY MASON OPERATIONS AREA
HOUGHTON COUNTY, MICHIGAN
SITE ID# 31000098

JANUARY 2019

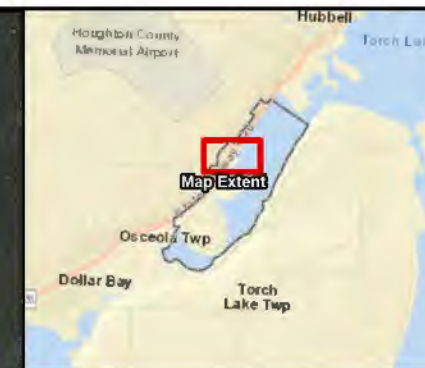
Figure 2-1
Location and Features Map
(Quincy Stamp Mills)
Quincy Mining Company Mason Operations Area
Mason, Houghton County, Michigan

- MTU Identified Mining Era Buildings and Structures
1. Quincy Stamp Mill No. 1
 2. Quincy Stamp Mill No. 1 - Washing/Classifying Floor
 3. Quincy Stamp Mill No. 1 - Rock Bin

4. Quincy Stamp Mill No. 1 - Mineral House
 5. Quincy Stamp Mill No. 2
 6. Quincy Stamp Mill No. 2 - Washing/Classifying Floor
 7. Quincy Stamp Mill No. 2 - Rock Bin

The general locations of these former structures are depicted on **Figure 2-1, Location and Features Map (Quincy Stamp Mills)**.

The Quincy Stamp Mills is generally characterized as being a former industrial area. The industrial footprint of the stamp mill complex, including the locations of former buildings is depicted on **Figure 2-1, Location and Features Map (Quincy Stamp Mills)**. Refer to **Appendix A, MTU Historical Summary**, for the summarized historical account prepared by MTU, pertaining to the Quincy Stamp Mills Area, and specifically Stamp Mill No 1 and No. 2 and associated buildings.

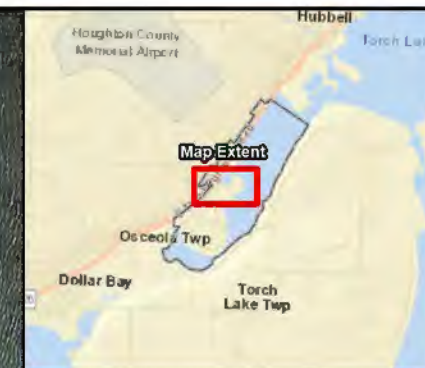
Figure 2-2
Location and Features Map
(Quincy Reclamation Plant)
Quincy Mining Company Mason Operations Area
Mason, Houghton County, Michigan

- MTU Identified Mining Era Buildings and Structures
- 29. Quincy Dredge No. 2
- 30. Quincy Reclaiming Plant
- 31. Substation
- 32. Transport
- 33. Quincy Shore Plant
- △ Site Features from MDEQ 2015 Site Inspection Report
- H. Former Water Intake
- I. Old Transformer Pad
- J. Hydrant

The locations of these former structures are depicted on **Figure 2-2, Location and Features Map (Quincy Reclamation Plant)**.

The Quincy Reclamation Plant is generally characterized as being a former industrial area. The industrial footprint of the reclamation complex, including the locations of former buildings, is depicted on **Figure 2-2, Location and Features Map (Quincy Reclamation Plant)**. Refer to **Appendix A, MTU Historical Summary**, for MTU's historical account of the Quincy Reclamation Plant.

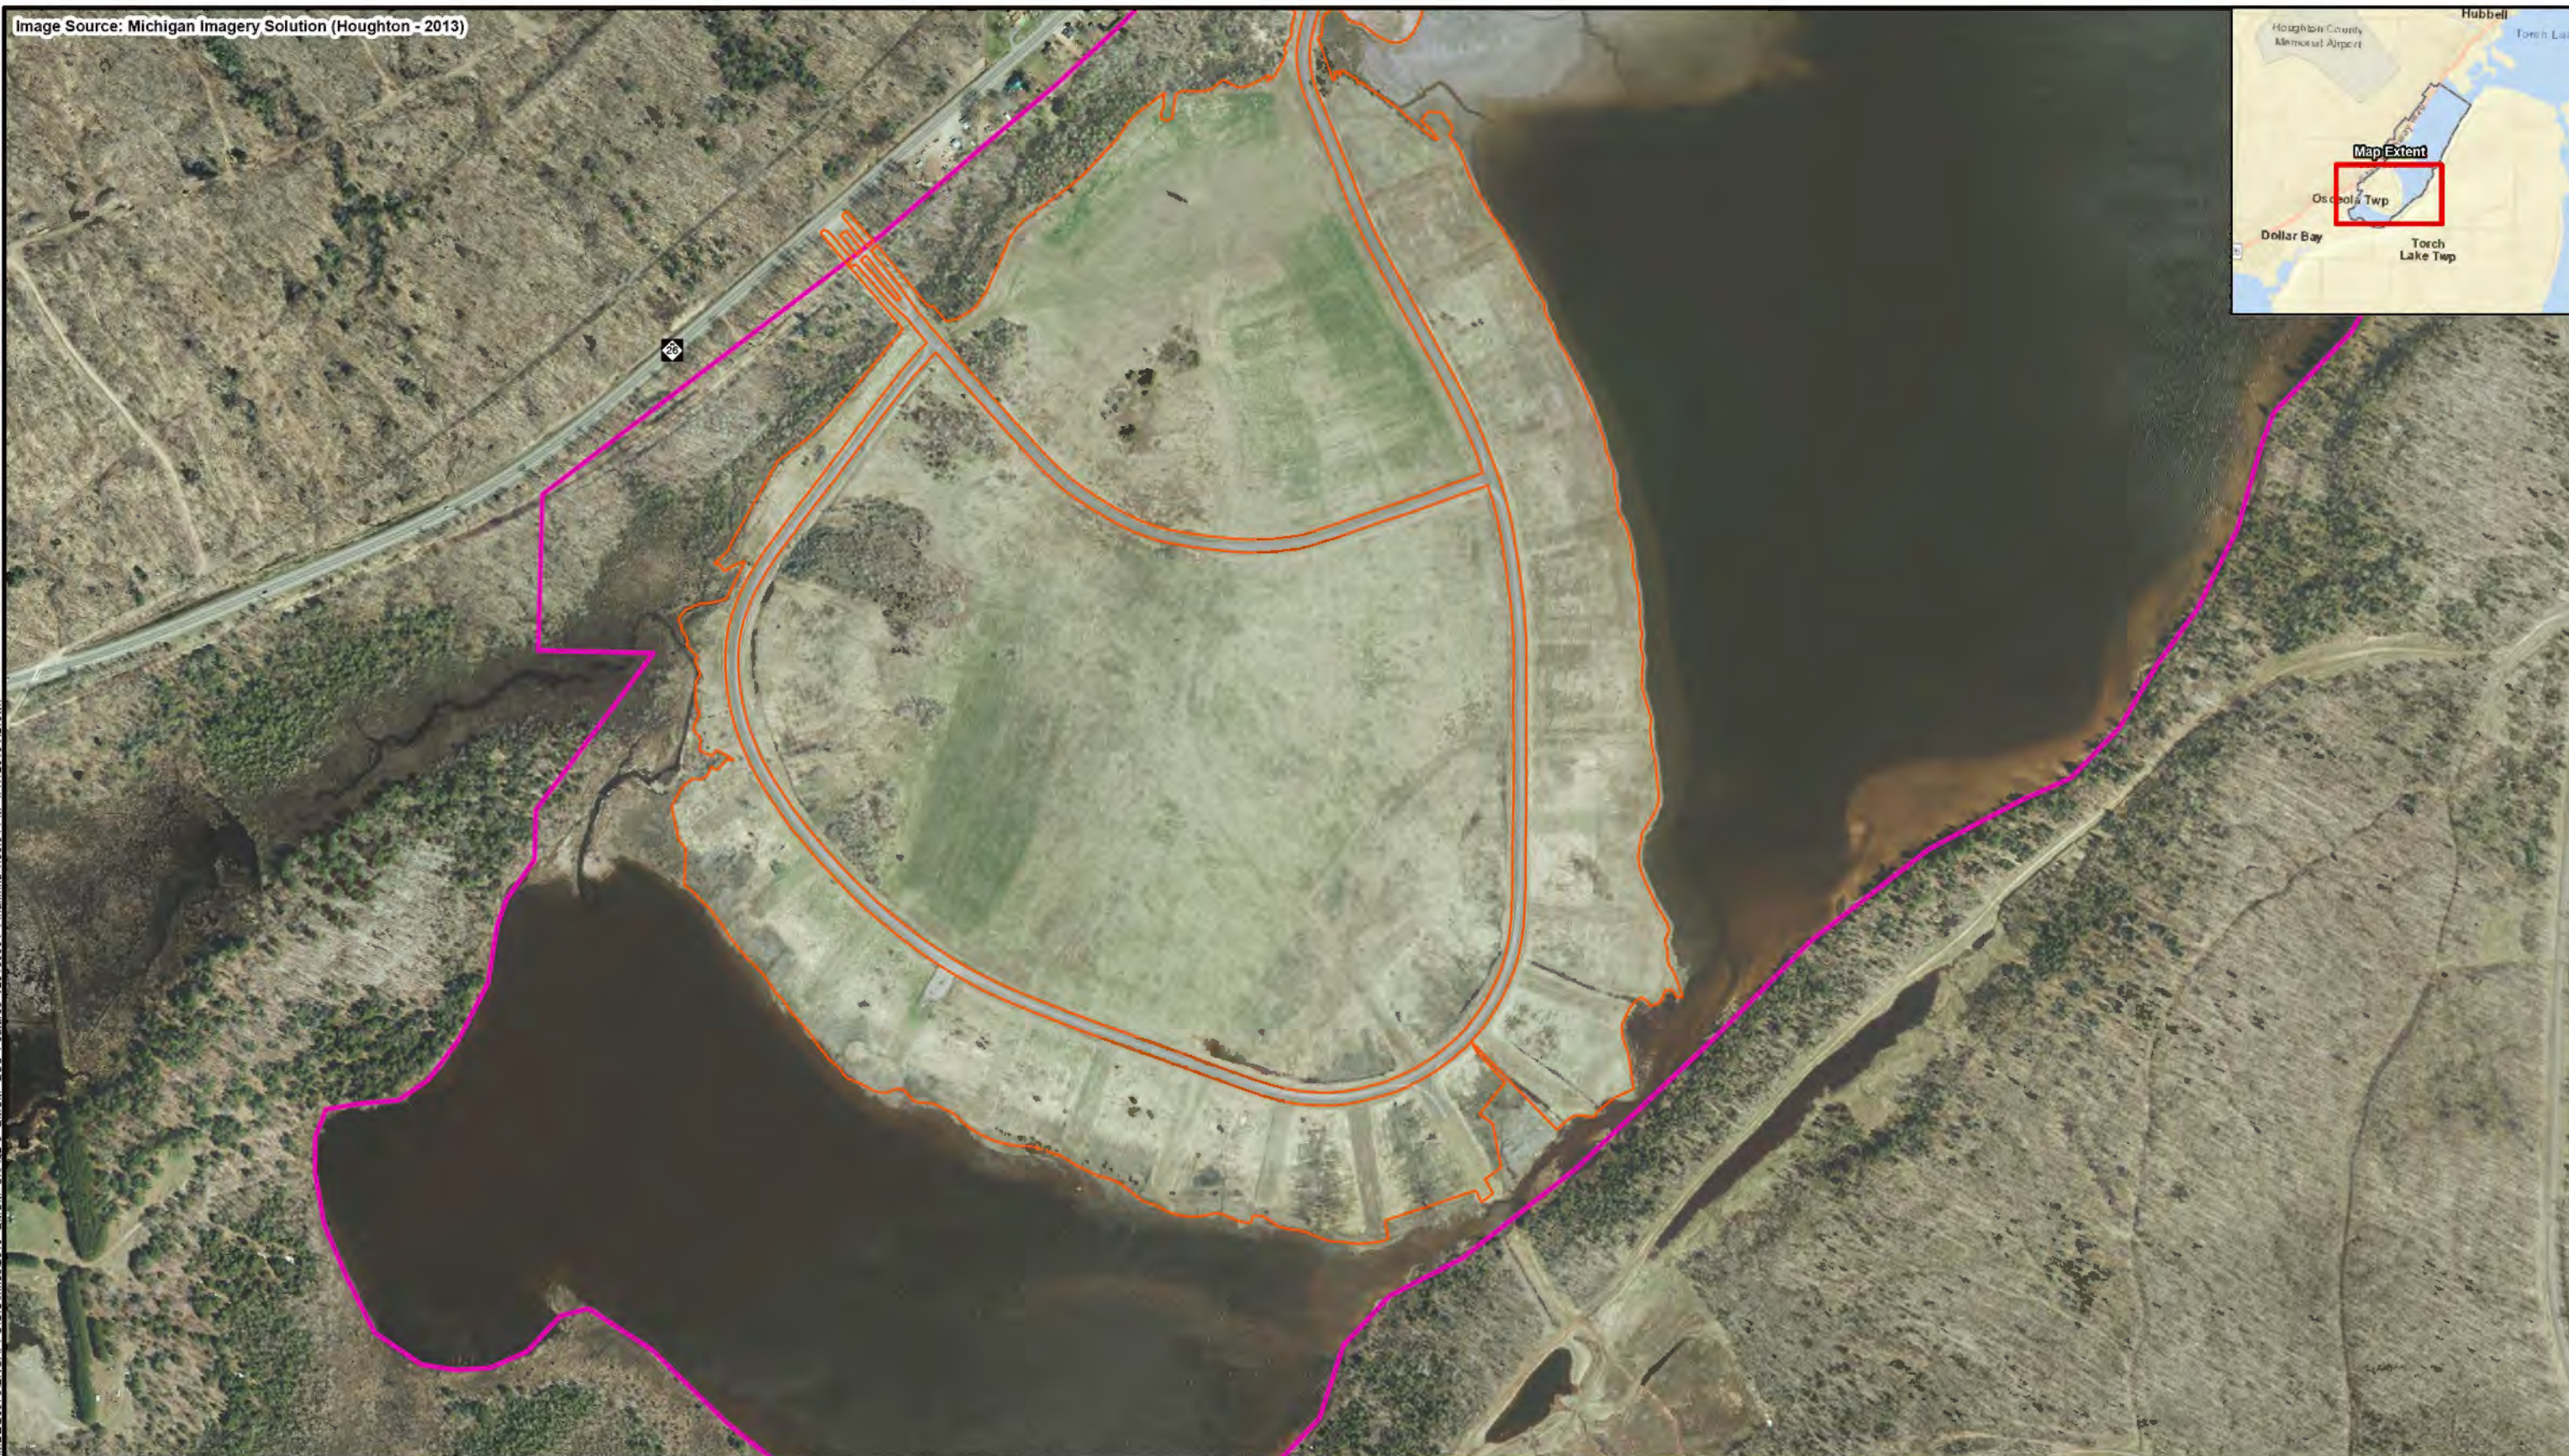
Figure 2-3
Location and Features Map
(Quincy Stamp Sands)
Quincy Mining Company Mason Operations Area
Mason, Houghton County, Michigan

- Cap Boundary (2005 NRCS)
- Mining Era Buildings and Structures
- QMCM Study Area Boundary

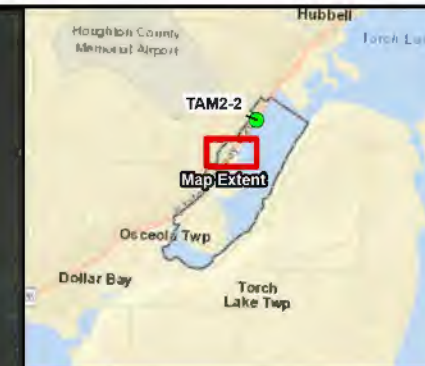
Figure 5-3a
Soil Screening Results Map - Soil
(Quincy Stamp Mills)
Quincy Mining Company Mason Operations Area
Mason, Houghton County, Michigan

**Locations Screened for Metals -
At least one exceedance of:**

- Residential Direct Contact Criteria
- Residential Particulate Soil Inhalation Criteria
- Non Residential Direct Contact Criteria
- Non Residential Particulate Soil Inhalation Criteria

A detailed summary of soil analytical results collected from the QMCM are provided in **Table 5-4, Sample Analytical Summary - Soil**. Previous XRF soil screening results are depicted on **Figure 5-3a** through **Figure 5-3c**. Soil analytical results from QMCM are depicted on **Figure 5-4a** through **Figure 5-4e**. Soil boring logs are included in **Appendix H, Boring Logs** of this SI Report.

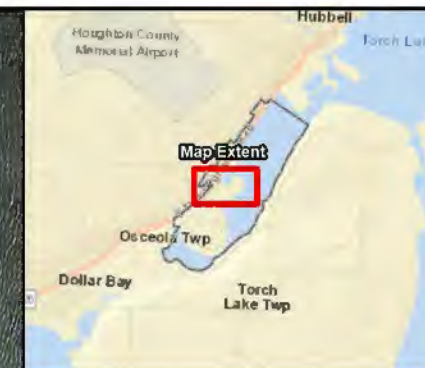
Figure 5-3b
Soil Screening Results Map - Soil
(Quincy Reclamation Plant)
Quincy Mining Company Mason Operations Area
Mason, Houghton County, Michigan

**Locations Screened for Metals -
At least one exceedance of:**

- Residential Direct Contact Criteria
- Residential Particulate Soil Inhalation Criteria
- Non Residential Direct Contact Criteria
- Non Residential Particulate Soil Inhalation Criteria

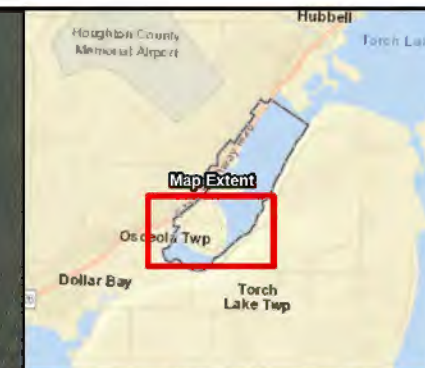
Figure 5-3c
Soil Screening Results Map - Soil
(Quincy Stamp Sands)
Quincy Mining Company Mason Operations Area
Mason, Houghton County, Michigan

**Locations Screened for Metals -
At least one exceedance of:**

- Residential Direct Contact Criteria
- Residential Particulate Soil Inhalation Criteria
- Non Residential Direct Contact Criteria
- Non Residential Particulate Soil Inhalation Criteria

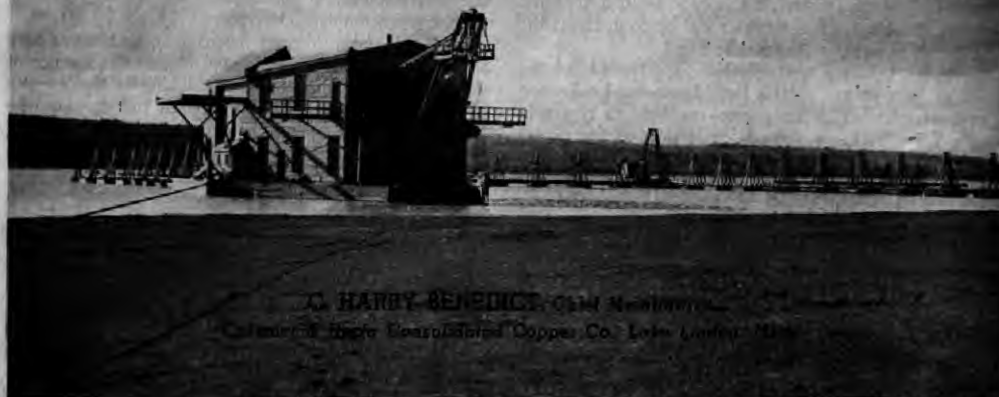
- Present potential exposure risk to human and ecological receptors;
- Limit the recovery of the Torch Lake ecosystem;
- Create uncertainty over safe and beneficial reuse of the land; and,
- Prevent delisting of Torch Lake as an AOC under the Great Lakes Water Quality Agreement due to BUIs related to restrictions on fish and wildlife consumption because of the on-going presence of PCBs in fish and degradation of benthos because of metals contaminated sediments.

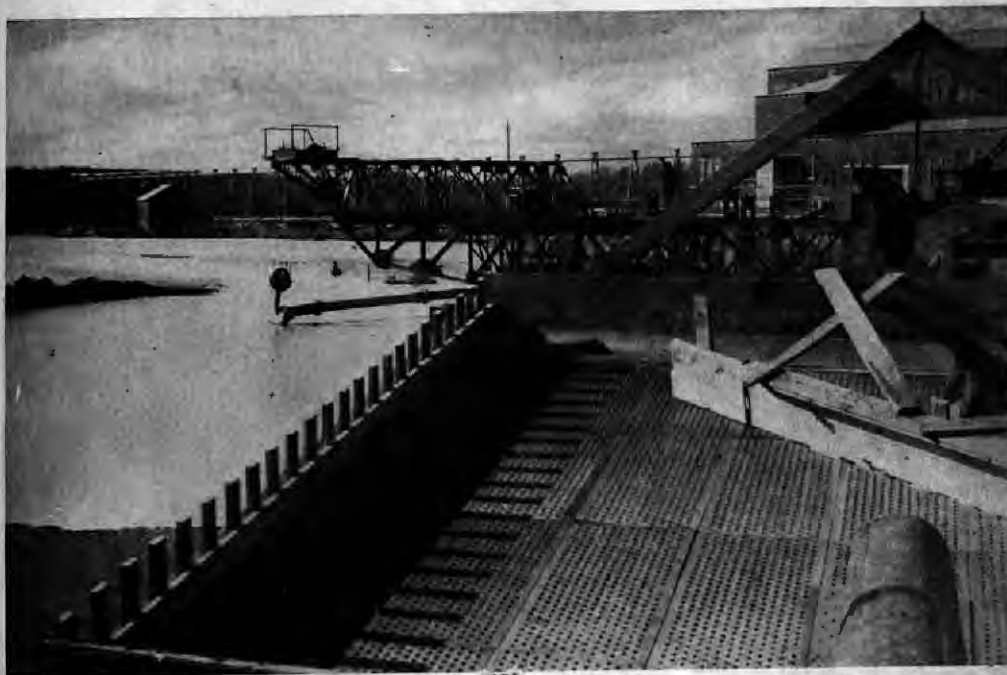
- Inorganic COCs (Metals) by methods 6010/200.7, 6020/200.8, and 7471/245.5;
- VOCs by 8260;
- PCBs by 8081/8082; and
- PNAs by 8270

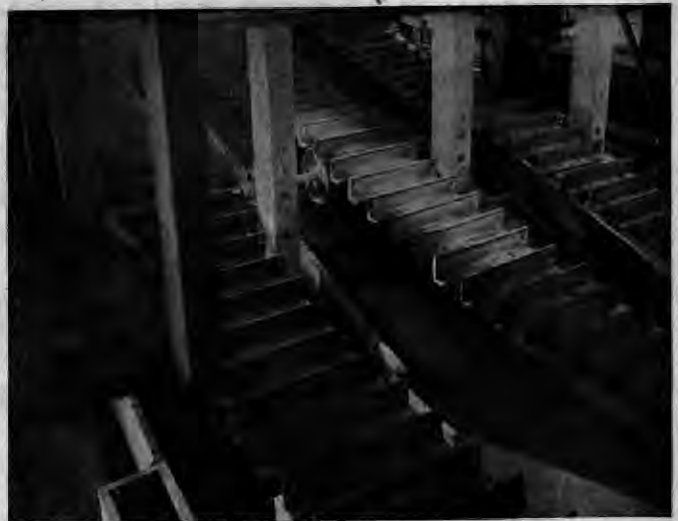
- Rocks and organic matter (including grasses, shallow vegetation roots, and leaves) were removed from the surface of each location before a sample was collected.
- Hand tools and direct-push boring techniques were used to collect samples from each sampling location.
- Soil samples were transferred directly into laboratory-provided sample jars. Sample jars were then labeled and placed in a cooler on ice for transportation to the analytical laboratory under chain of custody.
- SACM, waste material, and residual process material sampling utilized the following nomenclature:
 - ASBBLK – Generally described as a SACM sample;
 - DM – Described as a hand-tool collected waste material or soil sample collected in proximity to an abandoned container; and,
 - RPM – Described as a hand-tool collected residual process material sample.

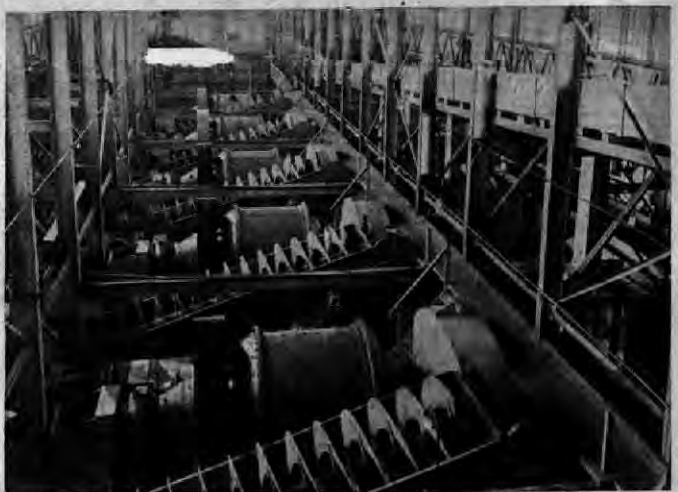
Findings are provided in **Section 5**.

- The lithology for each boring was classified by the field geologist in accordance with the Unified Soil Classification System (USCS) and recorded on the field log.
