PFAS Treatment and Investigation at a Former Chromium Plating Facility – A Case Study

Brad Hoare
AECOM Project Manager

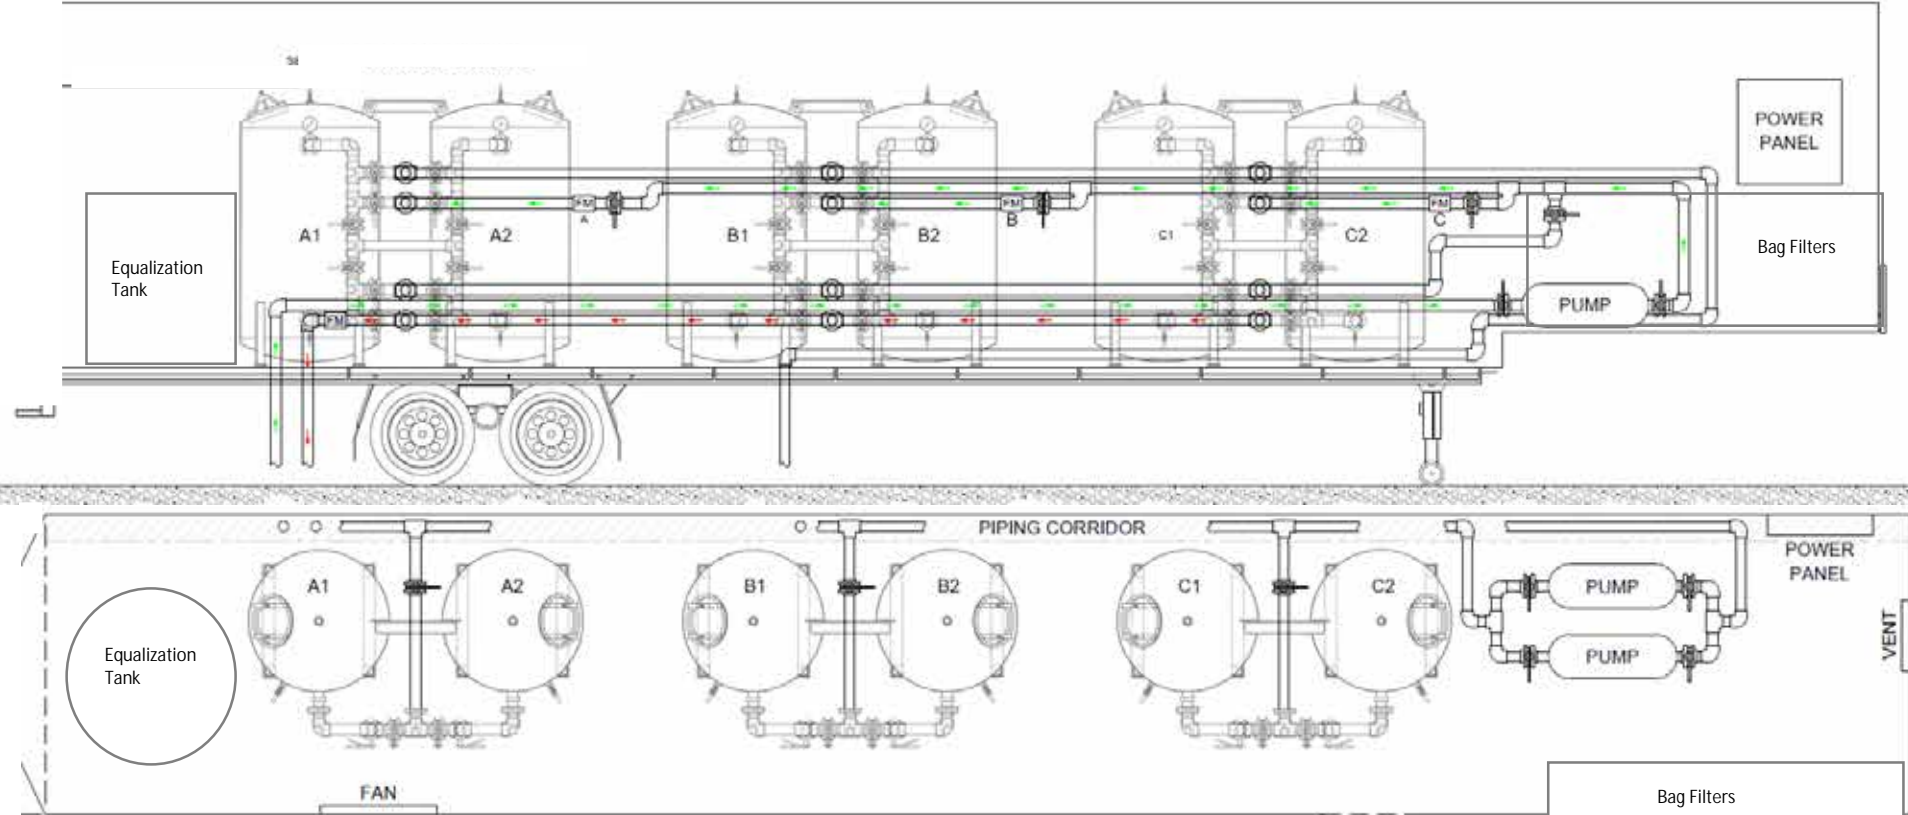
Pre-Treatment System

- \ Equalization Tank (500 gal.)
- \ Bag filters
- \ (6) 2,000 lbs. vessels - (1) Reactivated Carbon, (1) Resin, (4) Virgin Carbon
- \ Flow: 60 GPM; Adjust up to 75 GPM
- \ Telemetry for remote operation and alarms

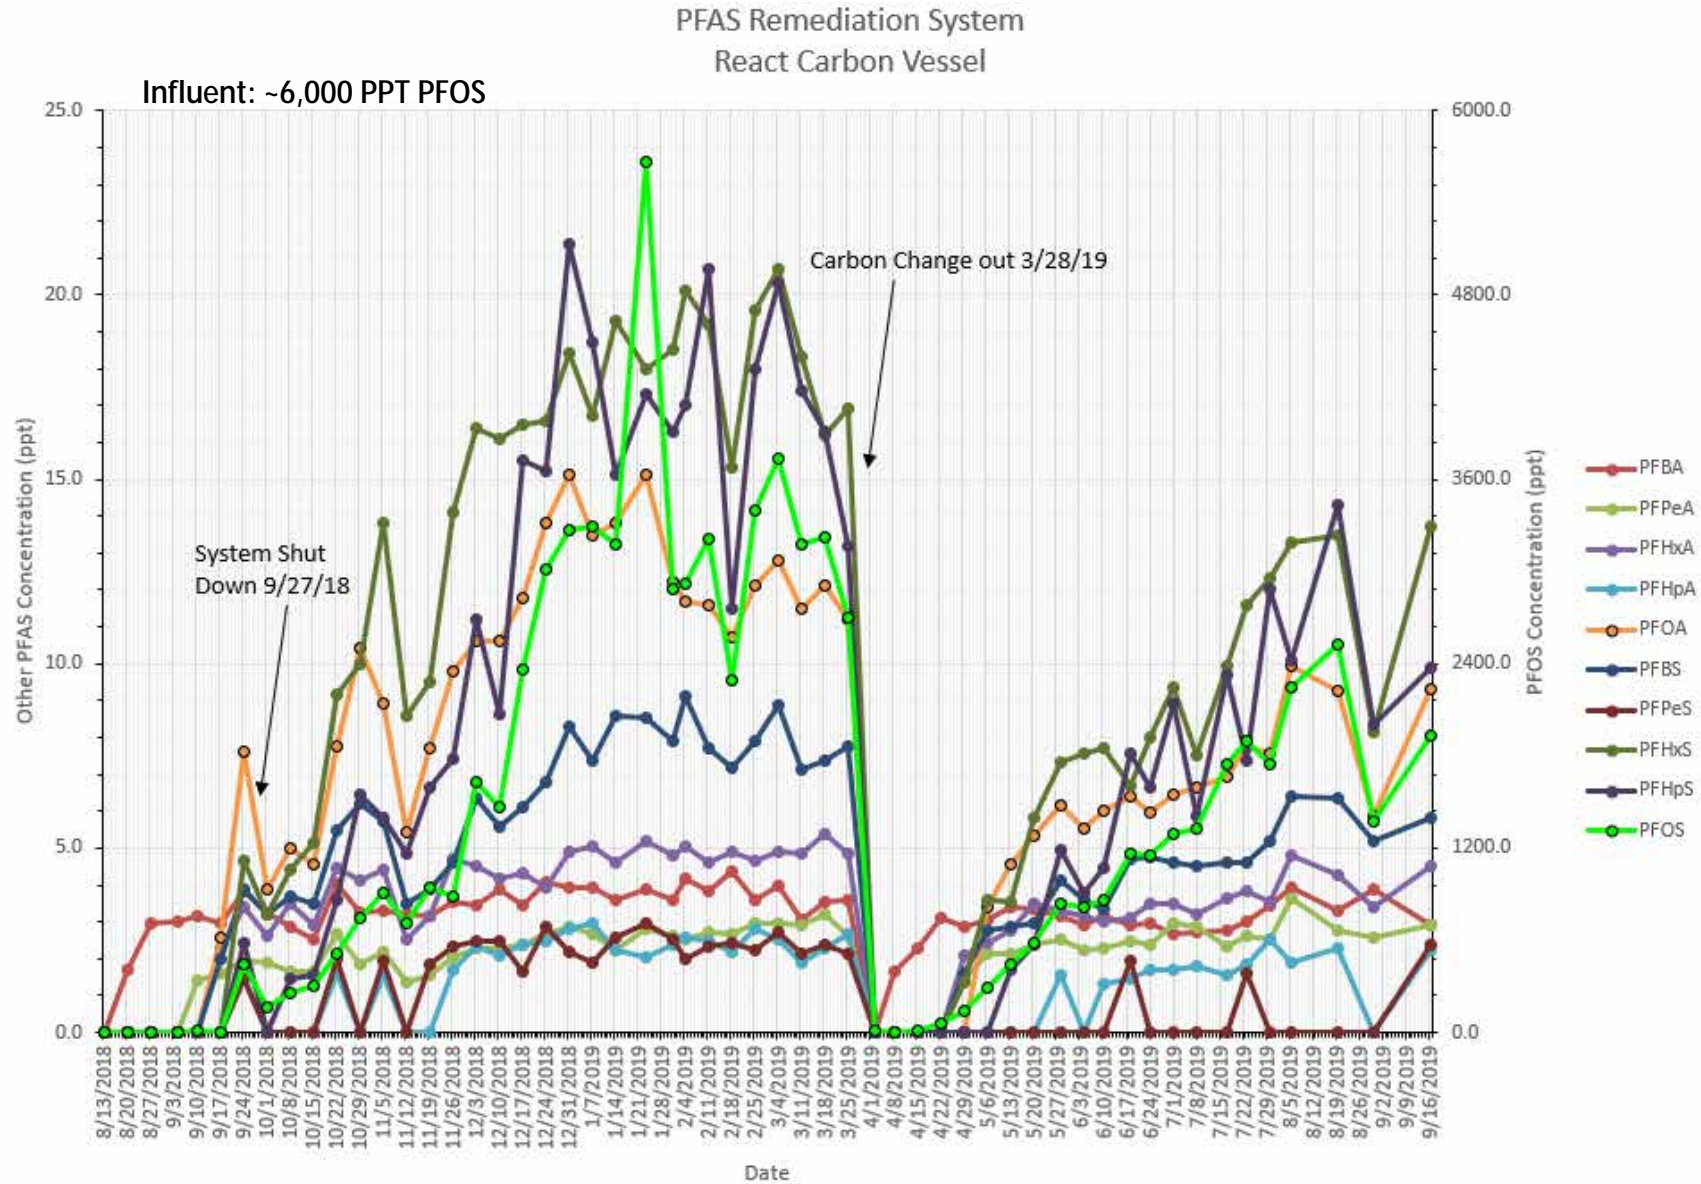
Pre-Treatment System – Reactivated Carbon

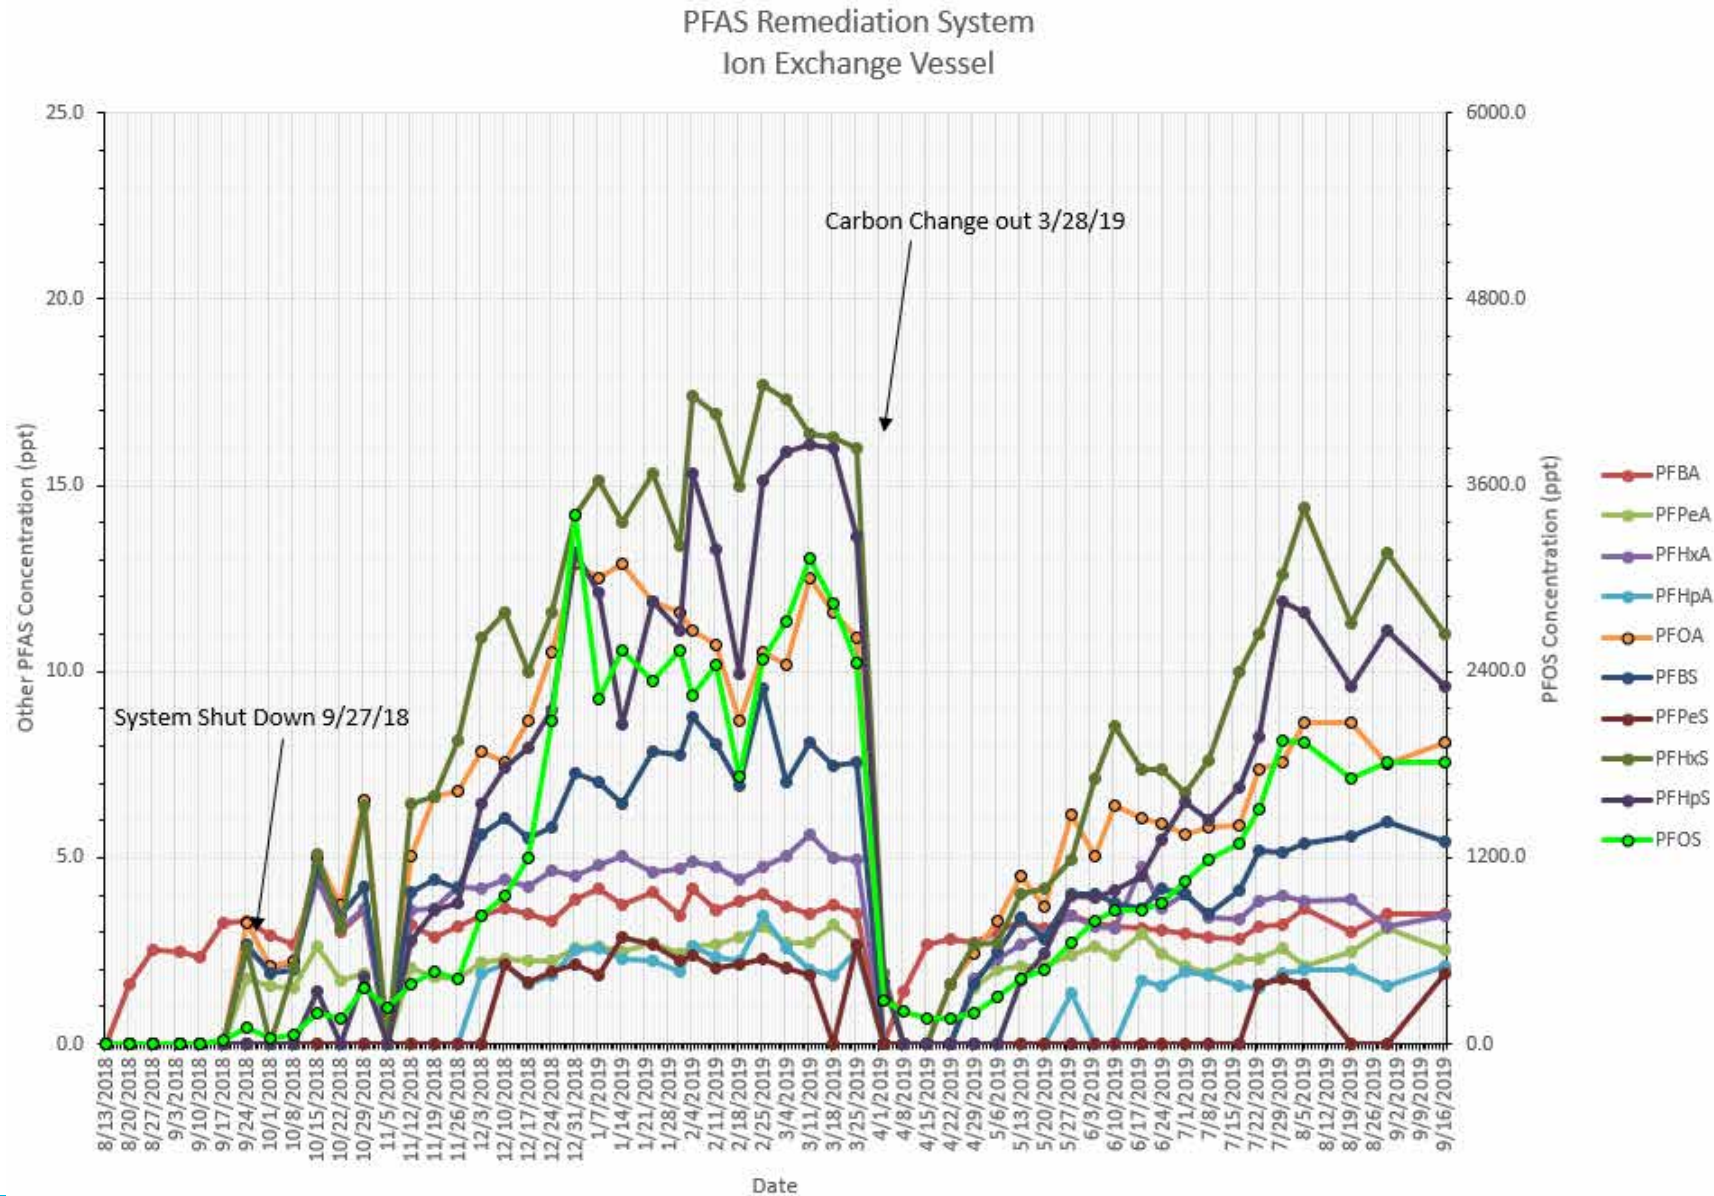
Pre-Treatment System – Ion Exchange

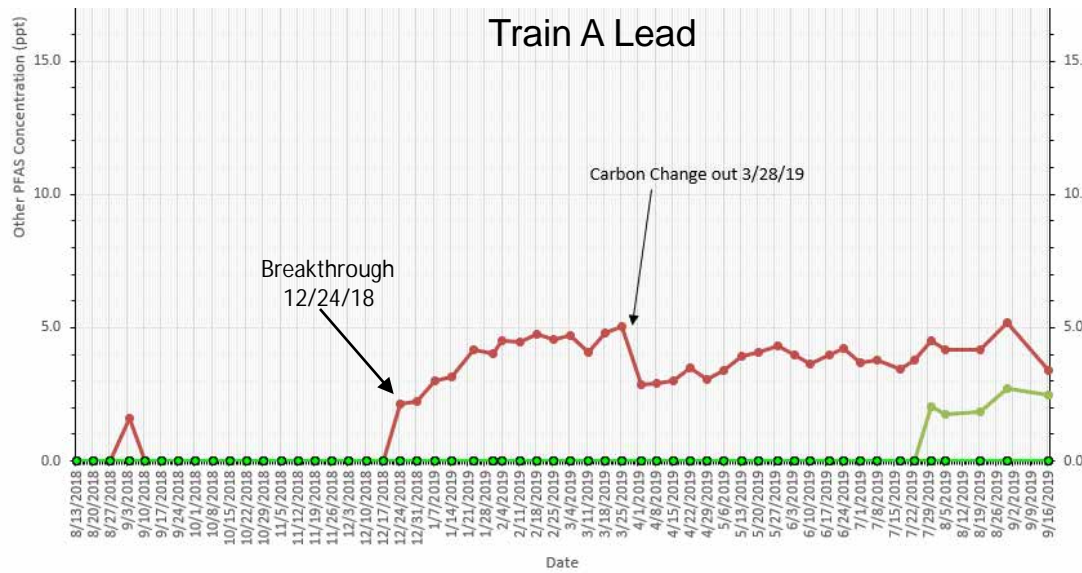
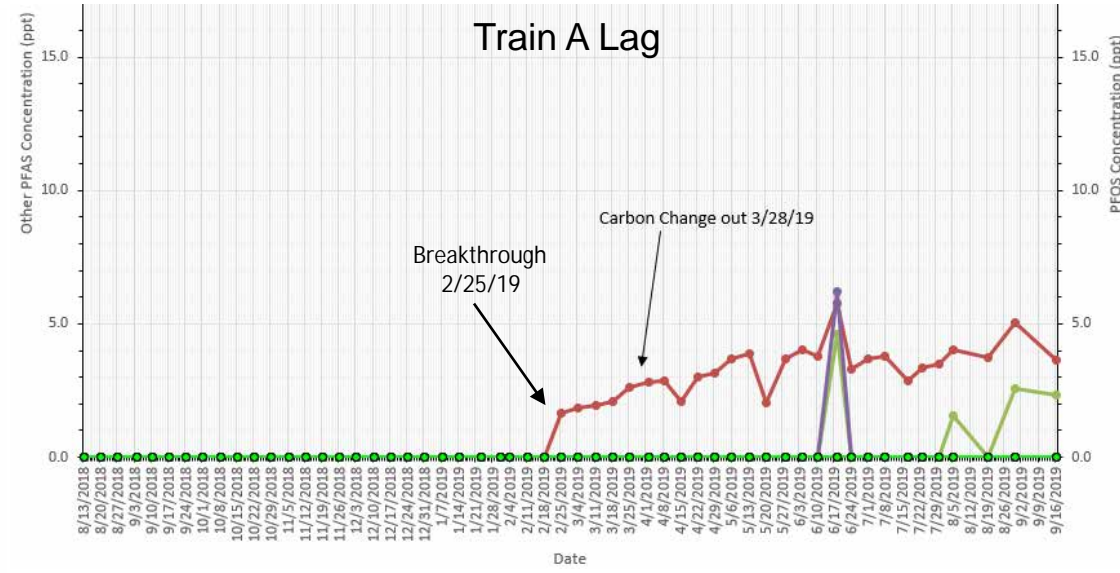
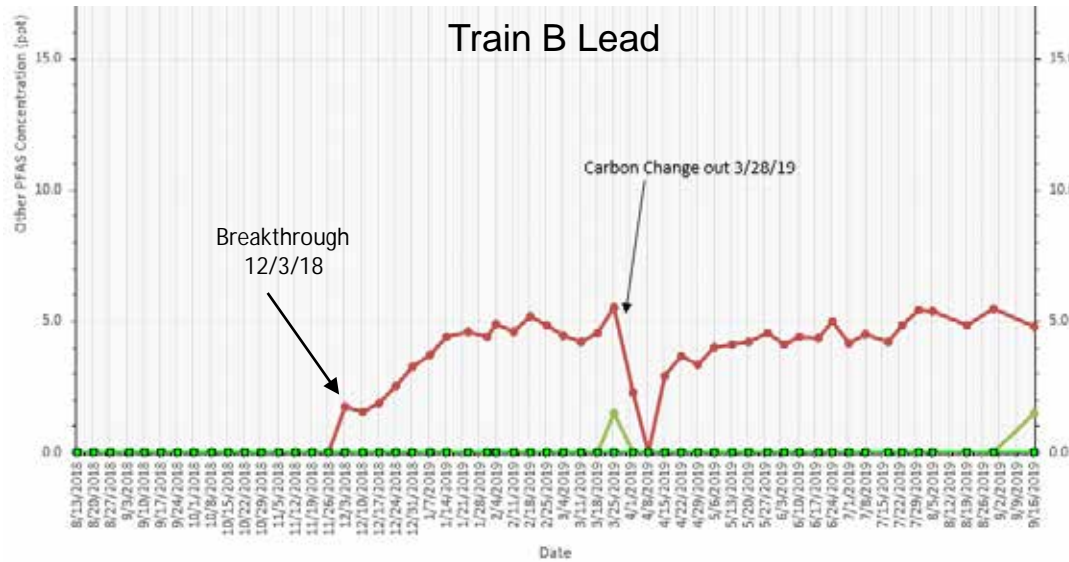
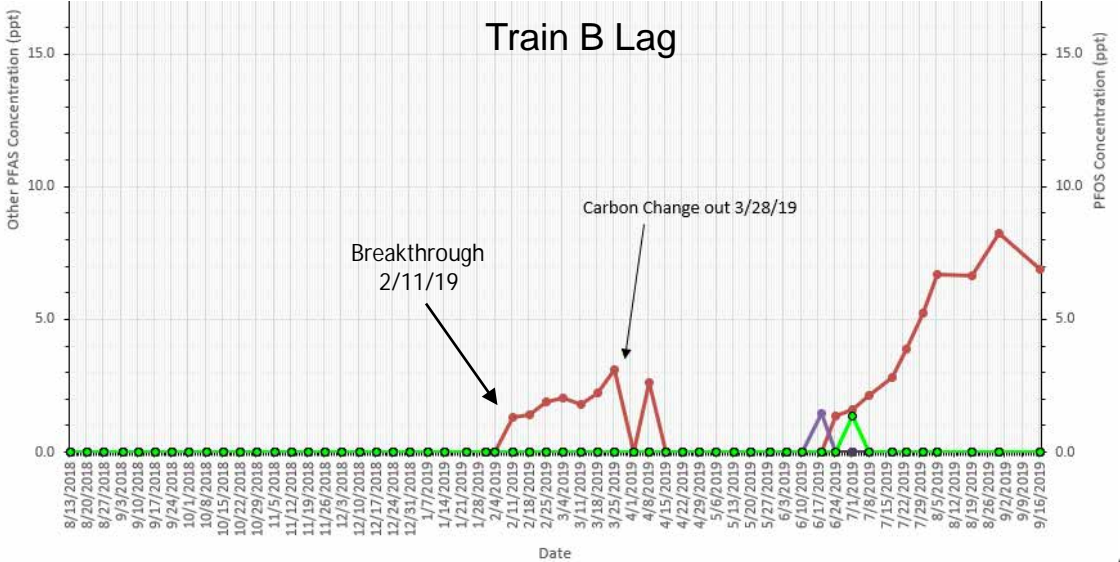
Pre-Treatment System – Lead/Lag

- PFBA
- PFPeA
- PFHxA
- PFHpA
- PFOA
- PFBS
- PFPeS
- PFHxS
- PFHpS
- PFOS
