## **Mackinac County Recession Rate Study 2018 Predesignation Report**

Prepared by Kate Lederle, Environmental Quality Specialist, High Risk Erosion Area Program,  
Field Operations Support Section, Water Resources Division,  
Michigan Department of Environment, Great Lakes, and Energy  
Lansing, Michigan

May 21, 2019

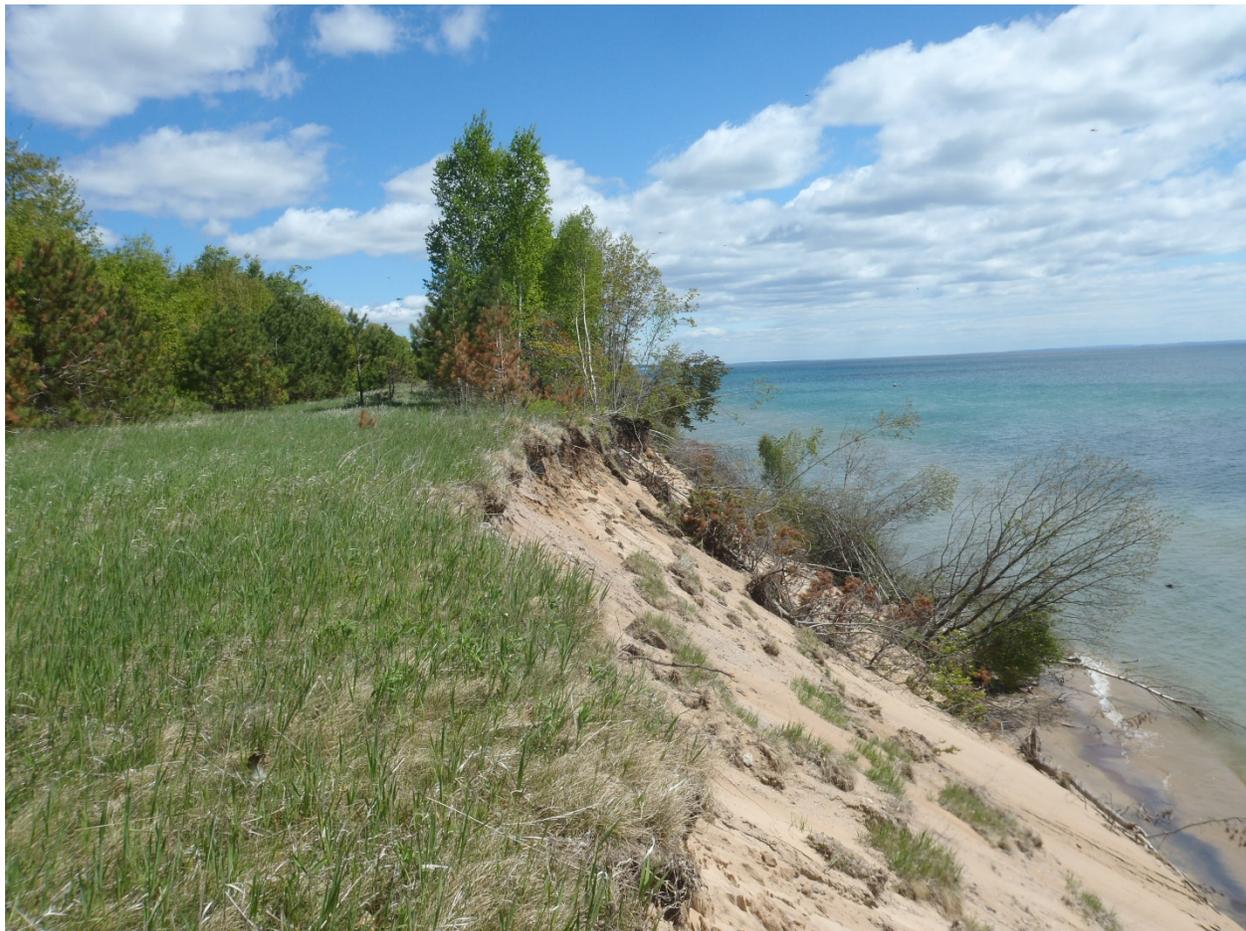
Photo 1. Old MDOT Brevort Scenic Turnout, Moran Township in Mackinac County, Lake Michigan, looking south. Note slumping, clumps of vegetation sliding down slope, trees falling into the lake.

The existing HREA at the site of the previous MDOT, Brevort Scenic turnout was receding at a rate of 1.3 feet per year in 1984. A permit for this site, US-2-Escanaba: 15-49-0041-P, was written in 2015 to remove failing guard rails and asphalt due to erosion. The site is a high sand bluff. In 2018, the site was found to have considerable slumping and evidence of piping. Large trees had fallen down the slope and into the lake, see Photo 1. The slope measured approximately 70 percent. The EHL location data collected in 2018 and compared to historic photos noted increased average recession rates of 1.7 and 3.0 feet per year at this site. The erosion hazard line is the top of the bluff for this site. The new setback for a readily moveable structure is 65 feet and for a permanent structure such as a septic system is 115 feet for the shoreline located 900 feet east of the west quarter section line. The new setback for a readily moveable structure is 105 feet and 195 feet respectively on the MDOT, US 2 Right-of-Way C21S.
