**MICHIGAN DEPARTMENT OF ENVIRONMENTAL QUALITY
WATER RESOURCES DIVISION
OCTOBER 2018
STAFF REPORT**

Biological and water chemistry surveys of selected stations in the Looking Glass River watershed in Shiawassee and Clinton Counties, Michigan, June-September 2017

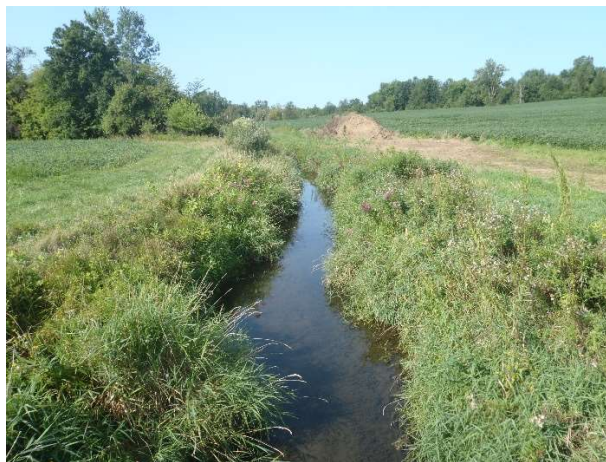
Figure 2. Perry Drain #2 upstream of Reuss Road, Shiawassee County, Michigan, September 2017.

Habitat and fish community surveys were not conducted at Station 1. At Reuss Road (Station 2), the glide/pool habitat was rated marginal (82, moderately impaired; Table 4). Overhanging grass provided the only cover for fish. Pools were rare, and silt was the dominant substrate type (Figure 2). The macroinvertebrate community scored acceptable at this station in 2012 and at other stations in the Perry Drain #2/Kellogg Drain watershed. Macroinvertebrate community conditions were expected to be similar in 2017 and were not resampled.

The fish community at Reuss Road scored poor (-8; Tables 5 and 6), despite it being a cold system (53 degrees Fahrenheit). Only four species of fish were collected, all of which are considered more tolerant. Continuous pH, DO, and temperature measurements were taken in Perry Drain #2 at several locations in late summer 2017 including at Stations 1 and 2. A separate report will be written to document these measurements. Overall, the results indicate that the DO WQS is being met, yet the warmwater fish community designated use is not being met. This is most likely due to a lack of habitat that is the result of it being a maintained drain. Therefore, Perry Drain #2 will be designated as Category 4c for the warmwater fish designated use in the 2020 Sections 303(d) and 305(b) Integrated Report.

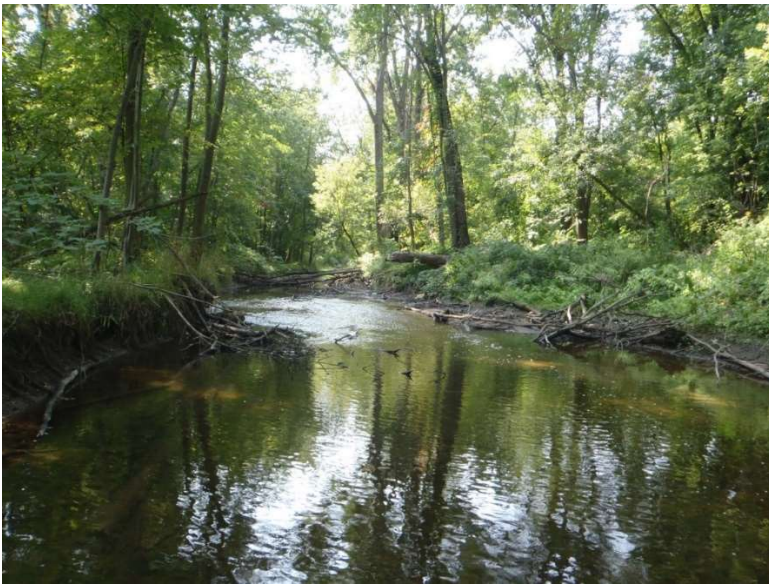
Figure 11. Remy-Chandler Drain upstream of Looking Glass River confluence, looking upstream.

Upon arrival, the Remy-Chandler drain was observed to be at low flow and 6-10 inches deep. It is a riffle run type stream in this reach (Figure 11).

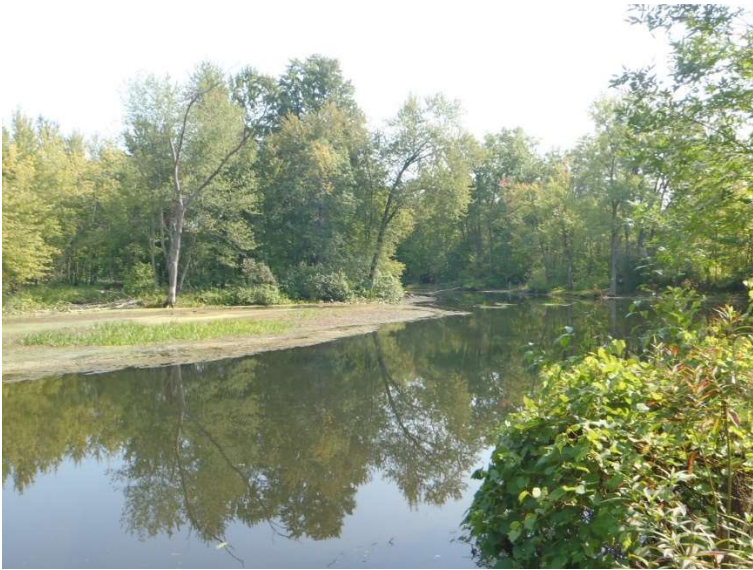
Figure 12. Looking Glass River upstream of Remy-Chandler drain confluence, facing upstream.

The Looking Glass River just upstream of the confluence of Remy-Chandler Drain is quite deep (more than 4 feet) and slow moving. There is a large amount of floating vegetation and sediment deposits with vegetation growing on them (Figures 12 and 13). Sedimentation was also observed at the mouth of Remy-Chandler Drain (Figures 14-16).

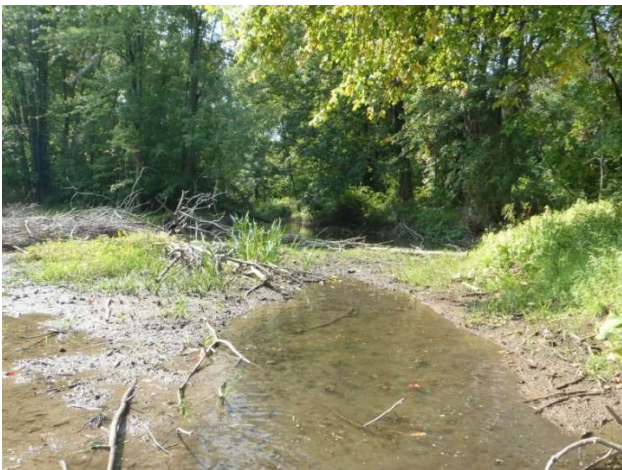
Figure 14. Remy-Chandler Drain confluence with the Looking Glass River, photo taken while standing on sediment deposition and facing the mouth of Remy-Chandler Drain.

Although it was obvious that the Remy-Chandler Drain transports and deposits a large amount of sediment at the confluence of the drain with the Looking Glass River, it is not apparent that a change in sedimentation could be measured downstream of the confluence when compared to upstream. In addition, due to the wetland nature of the Looking Glass River and the siltation and sedimentation that happens in the agriculturally dominated watershed upstream of the confluence, it would be difficult to quantify the amount of sedimentation caused by the drain without continuous water quality monitoring or much more in-depth and expansive pattern, profile, and dimension measurements. Regardless of these measurements, best management practices (BMP) that would address sedimentation load in the Remy-Chandler Drain watershed would be beneficial.

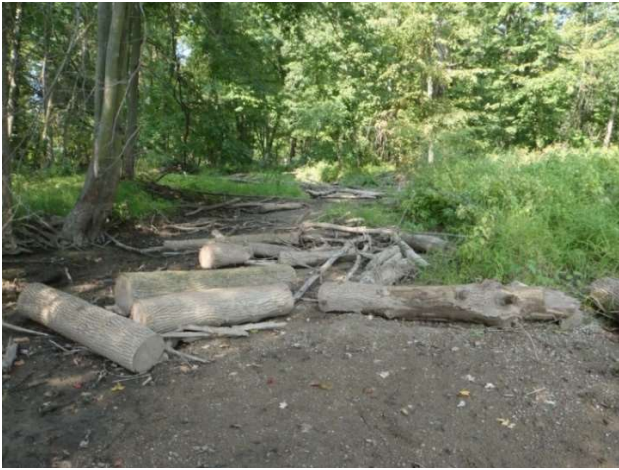
Figure 15. Sediment deposition in a dry backwater area at mouth of Remy-Chandler Drain. Photo was taken facing the east while standing and the confluence of the drain and Looking Glass River.

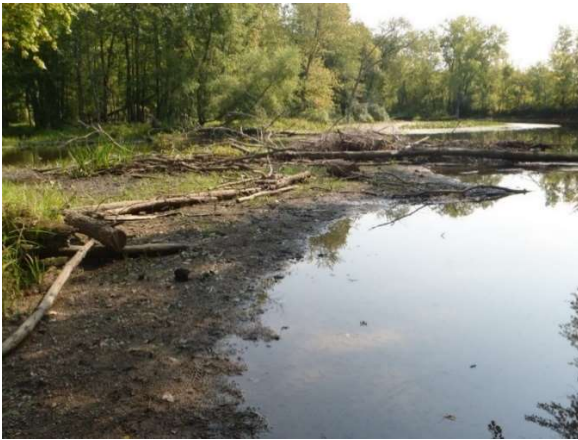
Figure 16. Sedimentation at the mouth of the Remy-Chandler Drain. Photo taken at the mouth of the drain, facing upstream in the Looking Glass River.

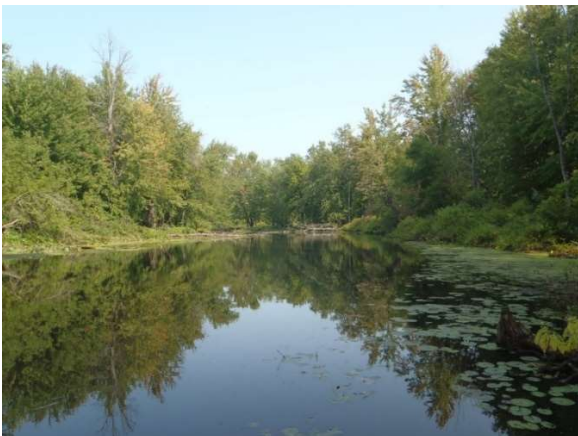
Figure 17. Looking Glass River upstream of Remy-Chandler confluence, looking upstream.

Upstream of the deep and slow-moving portion, the Looking Glass River looks very similar to upstream road crossings (Figure 17). It is an average of 2 feet deep with deeper pools. There are many floating macrophytes (lilies and duckweed) present along the edges. The river bottom is dominated by firm sand covered with 4-6 inches of fine silt.

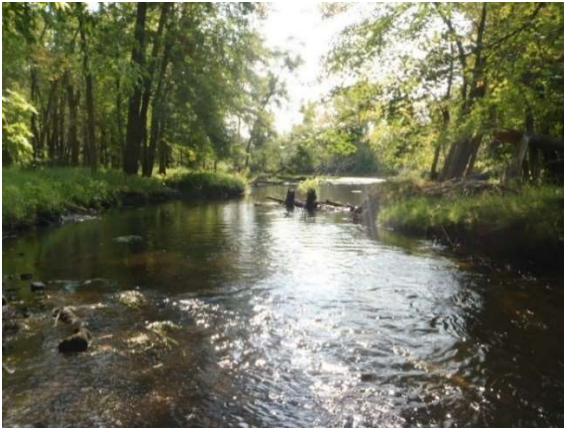
Figure 18. Looking Glass River downstream of Remy-Chandler Drain confluence, looking upstream.

Downstream of the confluence the Looking Glass River is much shallower (6 inches) and gravel and sand substrate are present (Figure 18). The substrate looks more similar to what is found downstream in the city of Dewitt, indicating that flow and possibly slope increases at this confluence allowing sediment to be transported downstream.

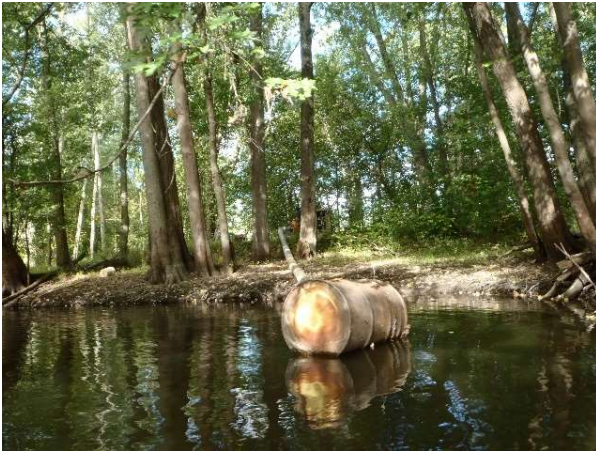
A monitoring request was received from the Clinton County Conservation District regarding complaints they received in 2016 of a sewage smell approximately one mile upstream of Lowell Road. In 2017, MDEQ staff kayaked from Airport Road downstream approximately 2 miles to Lowell Road to determine if a smell was noticeable and observe if there was an indication of an illicit connection. No unusual smells were noted. A large water pump used for water withdrawal was documented at 42.81852, -84.62866 (Figure 19) and reported to the appropriate MDEQ staff to determine if appropriate permits were in place.

Figure 19. Water withdrawal pump on the Looking Glass River, Clinton County, Michigan, September 2017.
