**MICHIGAN DEPARTMENT OF ENVIRONMENT, GREAT LAKES, AND ENERGY  
WATER RESOURCES DIVISION  
MARCH 2020  
STAFF REPORT**

**Biological and water chemistry surveys of selected stations in the Betsie, Platte, and Crystal Rivers, and Herring and Bowens Creeks watersheds; Benzie, Leelanau, Grand Traverse, and Manistee Counties, Michigan; June-September 2018**

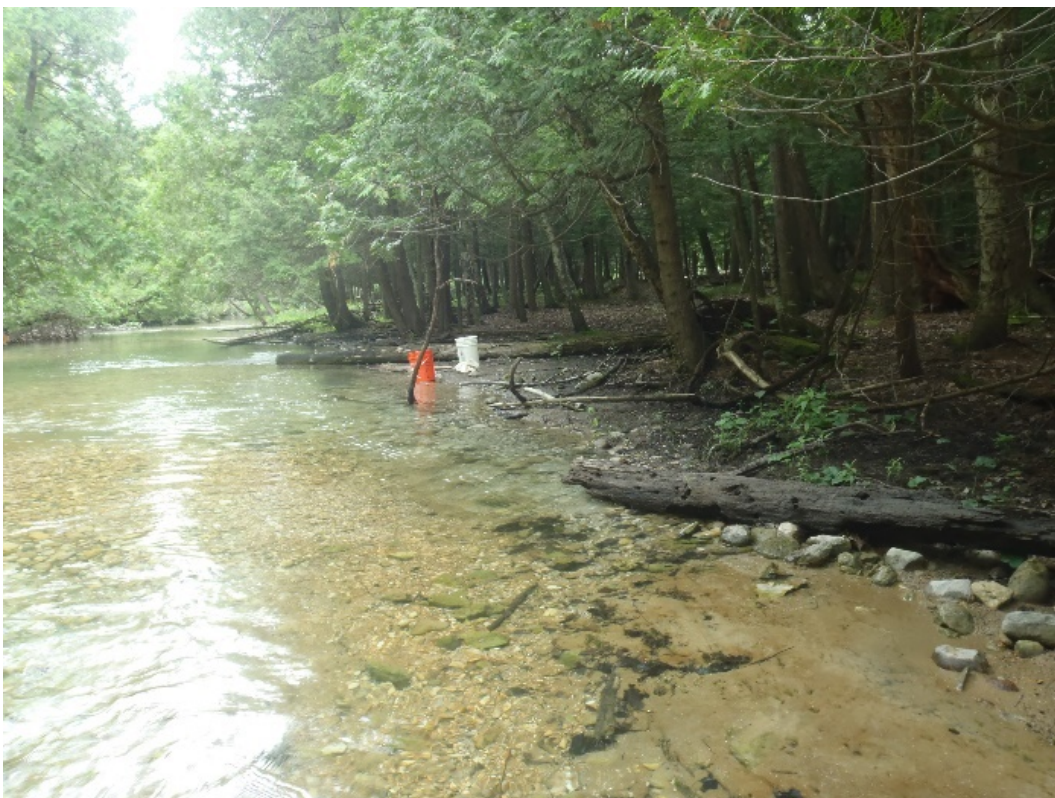
Figure 3. Crystal River downstream of water control structure at Fisher Road, Leelanau County, Michigan.

The riffle/run habitat was rated excellent (177; Table 7). The riparian area consisted of a mature cedar forest with little understory due to shading. There were extensive riffle areas with clean substrate and large woody debris (LWD) available as epifaunal substrate (Figure 3). The macroinvertebrate community scored acceptable (-2; Table 8 and Table 9). Of the EPT families that are more sensitive to pollution and other environmental stressors, two mayfly, one stonefly, and five caddisfly families were found. The two mayfly families that were found were low in numbers. The dominant taxa found (52%) was black flies (*Simuliidae*).

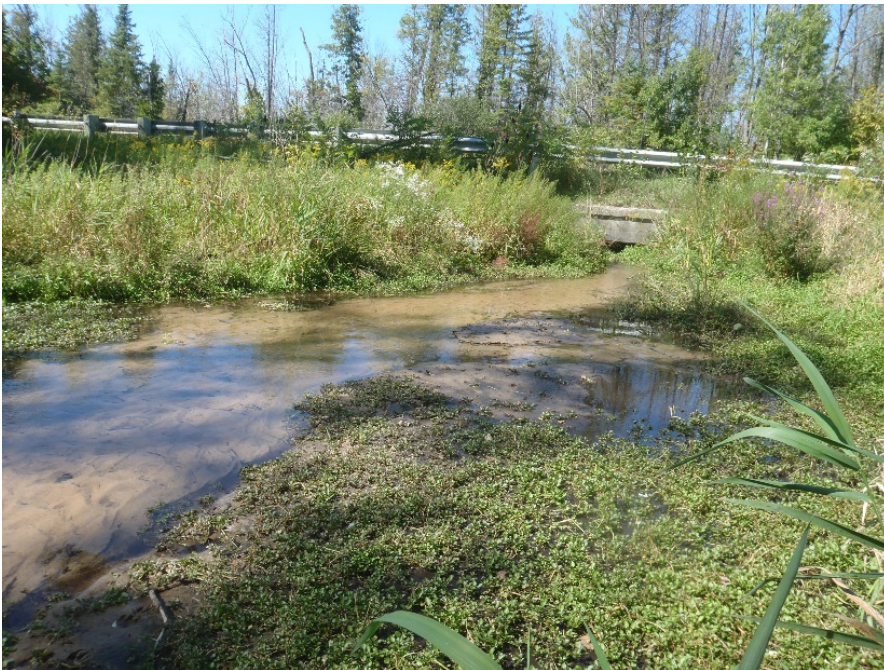
In 2018, the east branch of the unnamed tributary was sampled upstream of US-31 (Station 2). The riffle/run habitat was rated as excellent (170; Table 7). The east branch is a small (mean width, 3 feet) coldwater, high gradient stream with substantial flow for the small size. Epifaunal substrate consisted of mostly gravel and sand. There were some undercut banks, aquatic macrophytes, and overhanging grass, woody debris, and cobble. The riffle substrate was clean except for a large amount of sand deposition evident just upstream of US-31 (Figure 4) and at the few bends found in the stream. The stream has few bends, most likely due to historic (>50 years) drain maintenance. The east branch had an impacted riparian area due to agriculture land use. There were few large trees and a large amount of herbaceous vegetation and grasses. The macroinvertebrate community scored acceptable (-1; Table 8 and Table 9).

**Figure 4. East branch unnamed tributary to Platte Lake Upstream of US-31. Note the large amount of sedimentation.**

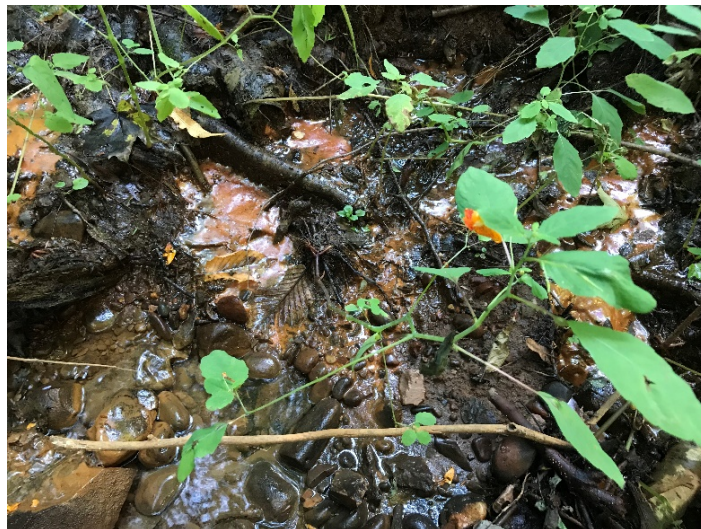
Although the macroinvertebrate community in the west branch meets the OIALW designated use, it is not attaining WQS based on the narrative standard, Rule 50 (R 323.1050) of the Part 4 Rules. This narrative addresses the following physical characteristics of a water body: turbidity, color, oil films, floating solids, foams, settleable solids, suspended solids, and deposits. Michigan does not have specific assessment methods or numeric standards for these physical characteristics; therefore, best professional judgement (including visual observation) in conjunction with other assessment types (e.g., biological) is used to determine the OIALW designated use support based on this narrative standard (Goodwin, 2016).

**Figure 5. Close-up of groundwater seepage and orange bacterial slimes in the west branch of the unnamed tributary to Platte Lake, Benzie County, Michigan.**

Although the macroinvertebrate community scored acceptable in the west branch of the unnamed tributary in 2018 and the amount of bacterial slimes has decreased since 2003 and even since 2013, the orange biofilm is still apparent, is not typical of small streams in the Platte River watershed, and is not found in the control reach that has been chosen as a comparison to background conditions. This combined with the exceedance of the arsenic WQS (Table 6) indicates the west branch of the unnamed tributary to Platte Lake is still not meeting Michigan WQS and has not returned to background conditions.

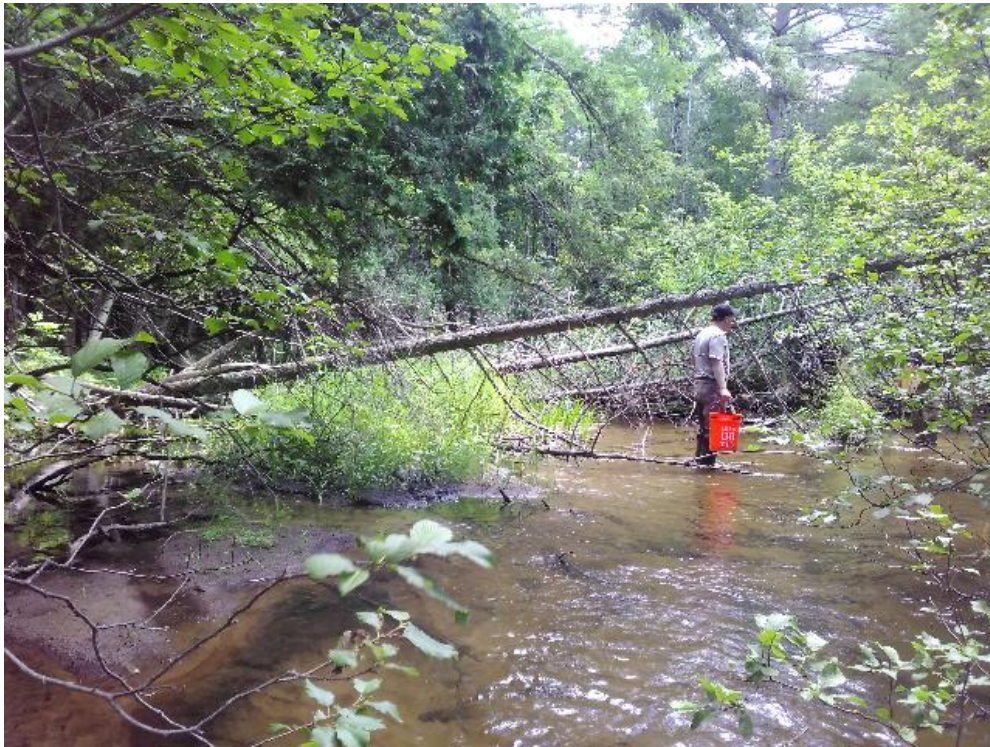
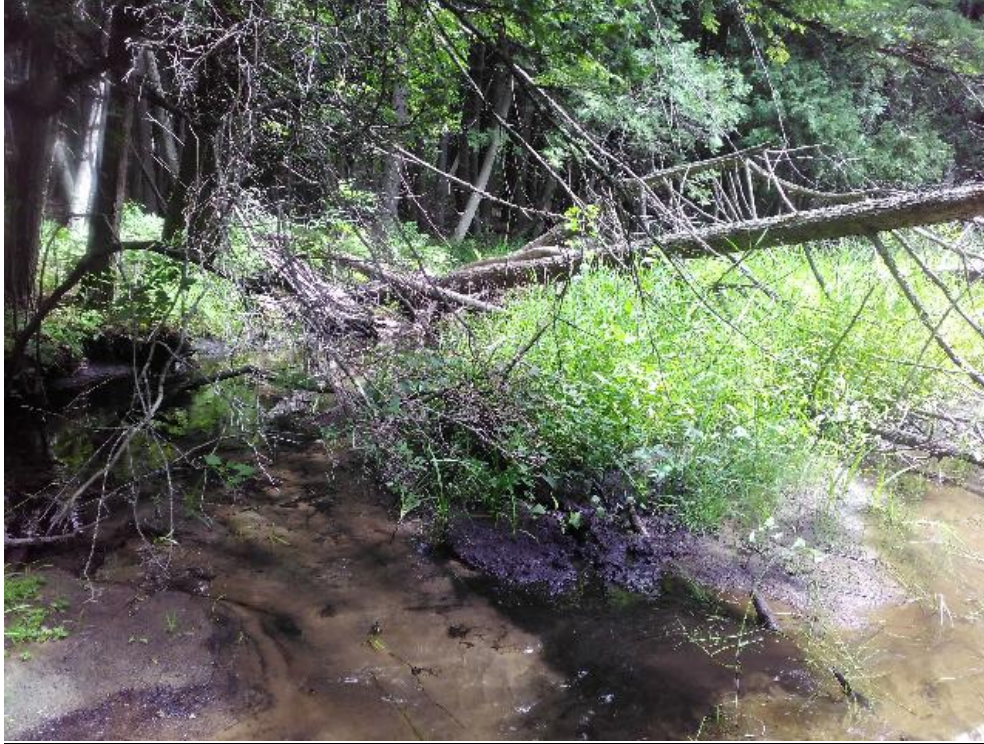
Platte Lake Road. A lot of sediment deposition was observed at the site (Figure 6 and Figure 7). The glide/pool habitat was rated as good (150; Table 7).

The macroinvertebrate community scored poor (-7; Table 8 and Table 9). No stonefly taxa, a low density of caddisfly taxa, a high density of *Amphipoda*, and a large percentage of air surface breathers, all contributed to the poor score. The sediment and wetland-like nature of the stream is most likely impacting the Procedure 51 score. More information and a comparison to the 2013 data can be found under Objective 4 and 5 below.

**Figure 6. Unnamed tributary to Platte Lake upstream of Platte Road. Note the large amount of silt and sediment deposits.**

**Figure 7. Unnamed tributary to Platte Lake upstream of Platte Road looking downstream. Note the large amount of silt and sediment deposits.**

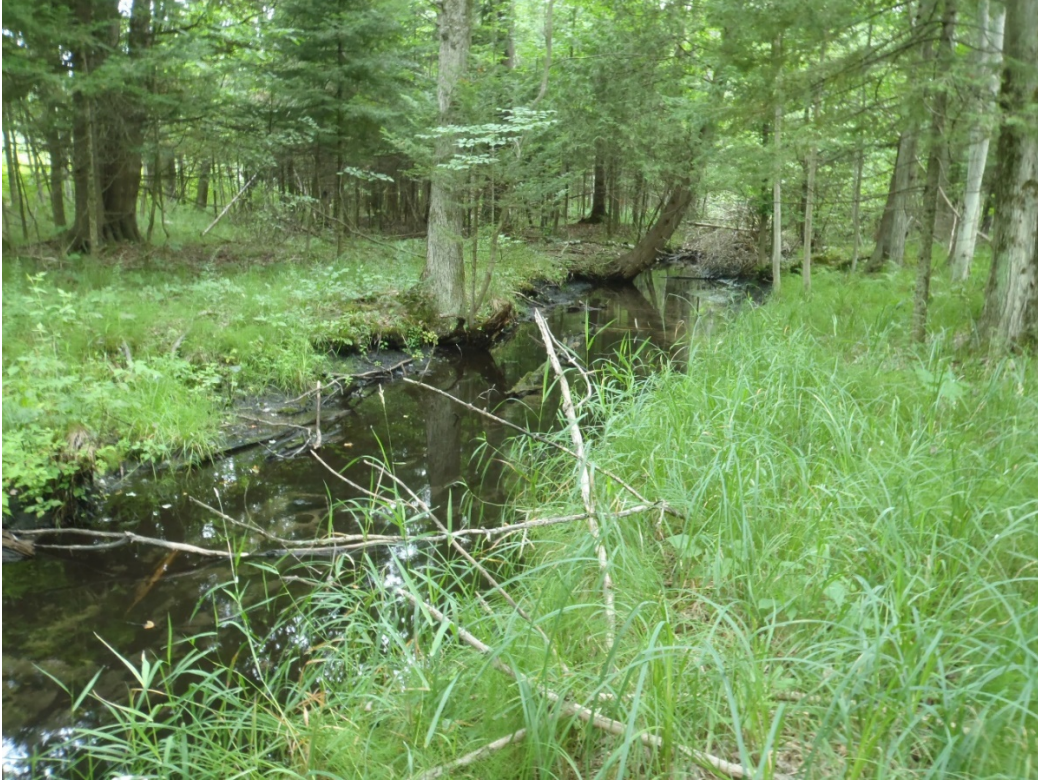
**Figure 8. Unnamed tributary to Little Platte Lake upstream of Saffron Road, Benzie County, Michigan.**

The unnamed tributary to Little Platte Lake was sampled both upstream and downstream of Saffron Road, in anticipation of a planned road crossing replacement. The stream is a very small headwater stream draining wetland areas. At the upstream station (Station 5a), the glide/pool habitat was rated good (122; Table 10). The riparian area consisted of a mature floodplain (Figure 8). Some trees may have been cleared in the past by adjacent landowners. There was no aquatic vegetation, cobble, or gravel available for epifaunal substrate. There were several LWD jams present, but they were covered with silt. The silt was deep along the edges of the stream and where it had piled up behind LWD (Figure 9). The culvert was placed at an odd angle and seemed to be preventing adequate flow and transport of sediment downstream (Figure 10). The macroinvertebrate community scored poor (-5; Table 11 and Table 12). No stonefly taxa were found, and only two mayfly taxa (three individuals) and two caddisfly families (3 individuals) were found. Amphipods made up over 92 percent of the total individuals found.

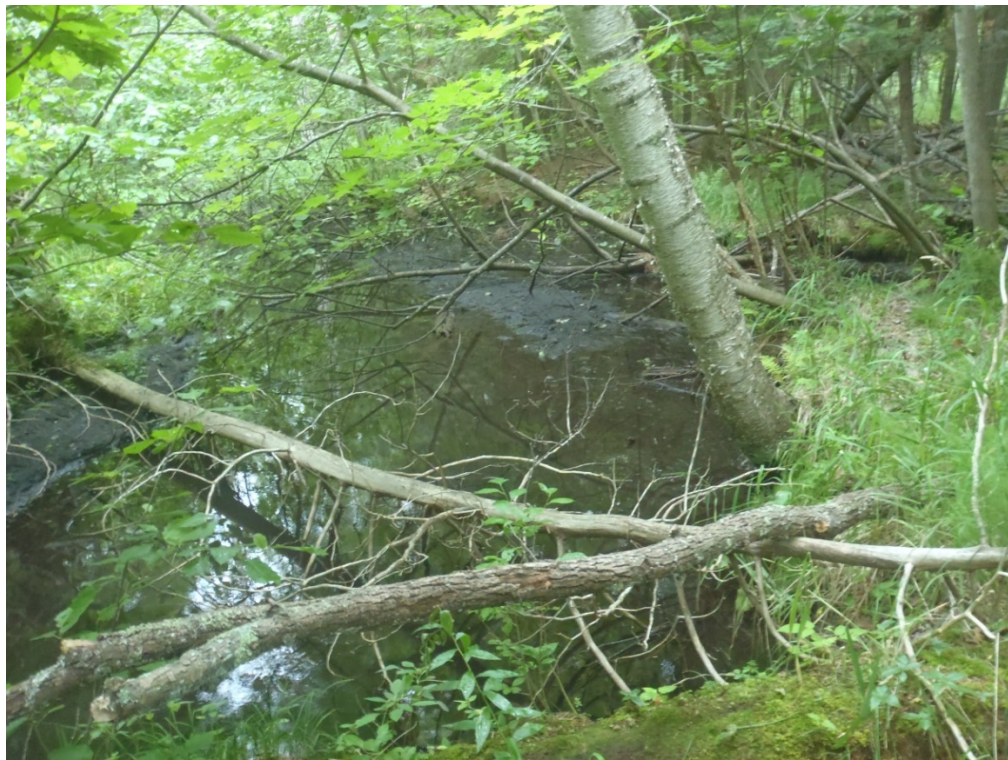
**Figure 9. Sedimentation in unnamed tributary to Little Platte Lake upstream of Saffron Road, Benzie County, Michigan.**

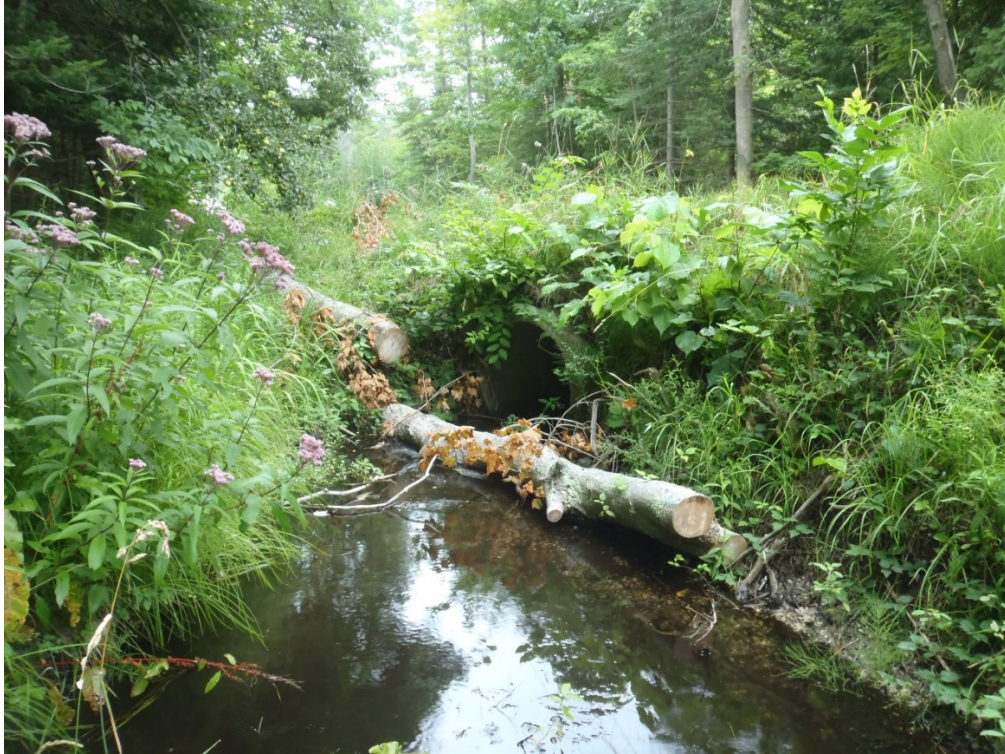
**Figure 10. Unnamed tributary to Little Platte Lake. View of misaligned culvert upstream of Saffron Road, Benzie County, Michigan.**

The Conservation Resource Alliance is seeking funds to replace the undersized culvert at Saffron Road (Conservation Resource Alliance, personal communication). The road fill embankments are vertical, and the left approach is steep, causing runoff to enter directly into the stream. This is the only crossing on this stream since it flows through undeveloped land and the Medenbrook Nature Preserve before entering Little Platte Lake. A larger bottomless arch culvert and road approach work are tentatively planned for this site. Monitoring information may help justify funding of the replacement of this structure or provide information necessary for future grant projects or to measure success of those projects. In addition to macroinvertebrate community and habitat surveys, NPS unit staff may also be conducting channel dimension, pattern, and profile information. DO measurements were planned if the stream looked impounded. There was a pool upstream of the culvert; however, the stream was very small and shallow overall so DO readings were deemed not necessary or useful.

The Conservation Resource Alliance and partners were scheduled to replace the undersized culvert at this crossing in 2019. Fish data are available for this stream from the MDNR (Conservation Resource Alliance, personal communication), but EGLE did not have any macroinvertebrate data to share and assist with pre-construction data collection. The habitat was rated good at both stations, and individual scores did not vary much with the exception of riparian zone width, sedimentation, and embeddedness being slightly worse upstream (Table 13). The macroinvertebrate community scores were the same (-1) upstream and downstream.

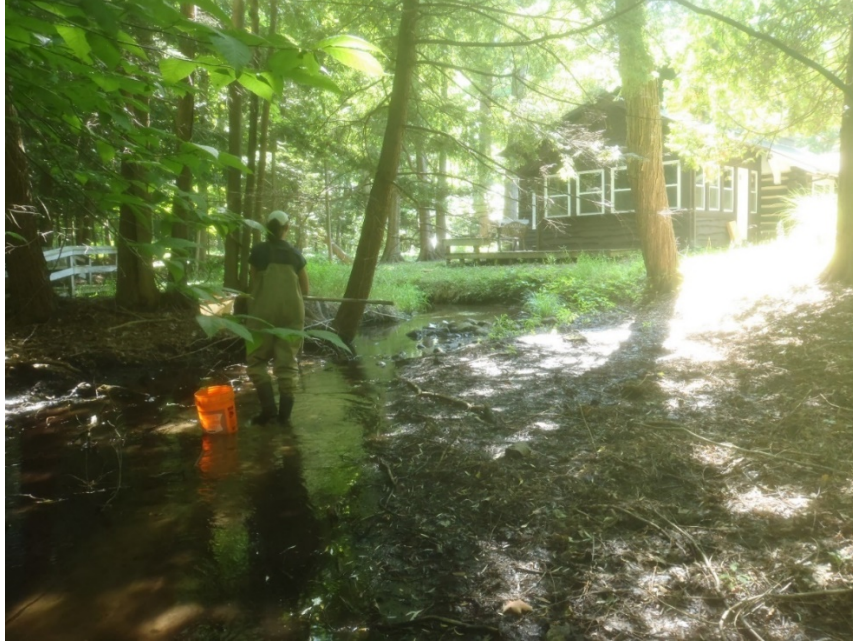
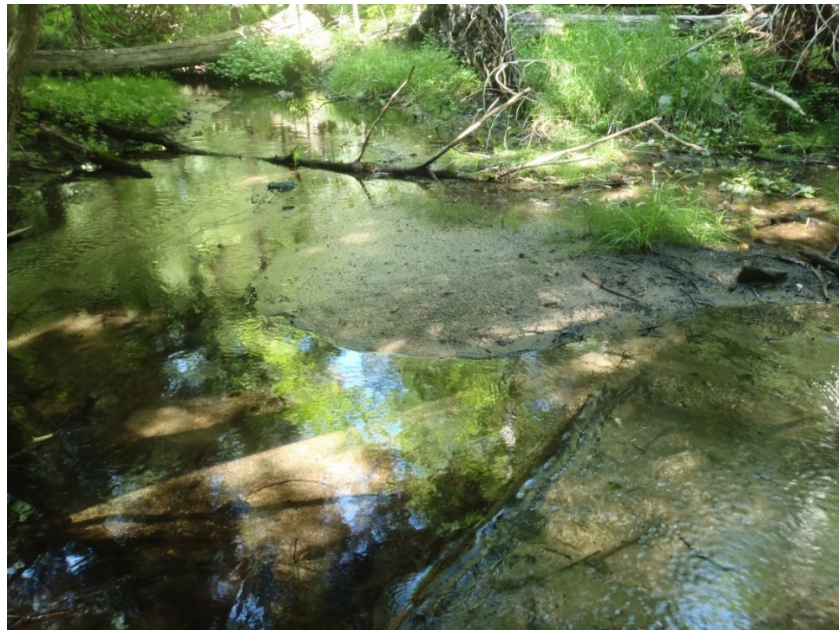
At the downstream station (Station 5b), the stream continued to be very shallow with substrate consisting mostly of sand and silt (Figure 11 and Figure 12). The stream appeared a bit flashy (Figure 13). Sandbags were holding the road near the undersized culvert. The habitat at the glide pool station was rated good (117; Table 10). The macroinvertebrate community scored better than the upstream station at the low end of acceptable (-1; Table 11 and Table 12). Once again only two mayfly taxa were found with three individuals, but one stonefly and three caddisfly taxa were also found.

**Figure 11. Unnamed tributary to Little Platte Lake downstream of Saffron Road, Benzie County, Michigan.**

**Figure 12. Sedimentation in Unnamed tributary to Little Platte Lake downstream of Saffron Road, Benzie County, Michigan.**

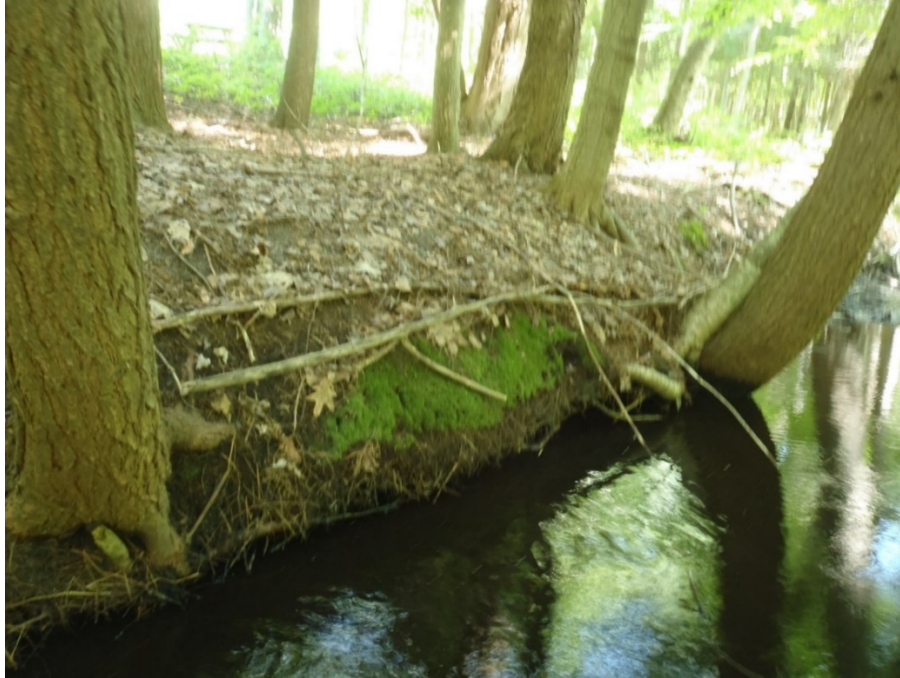
**Figure 13. Eroded banks in the unnamed tributary to Little Platte Lake downstream of Saffron Road, Benzie County, Michigan.**

As noted in Objective 1, the macroinvertebrate community in the unnamed tributary to Little Platte Lake scored poor (-5; Table 11 and Table 12) upstream of Saffron Road and acceptable (-1; Table 11 and Table 12) downstream of the road. At both the upstream and downstream station the habitat scored good. However, upstream of the road, the culvert was observed at an odd angle and seemed to be preventing adequate flow and transport of sediment downstream (Figure 10). The stream continued to be very shallow downstream of the station with substrate consisting mostly of sand and silt (Figure 11 and Figure 12). The stream downstream of the station appeared a bit flashy (Figure 13). Sandbags were holding the road near the undersized culvert.

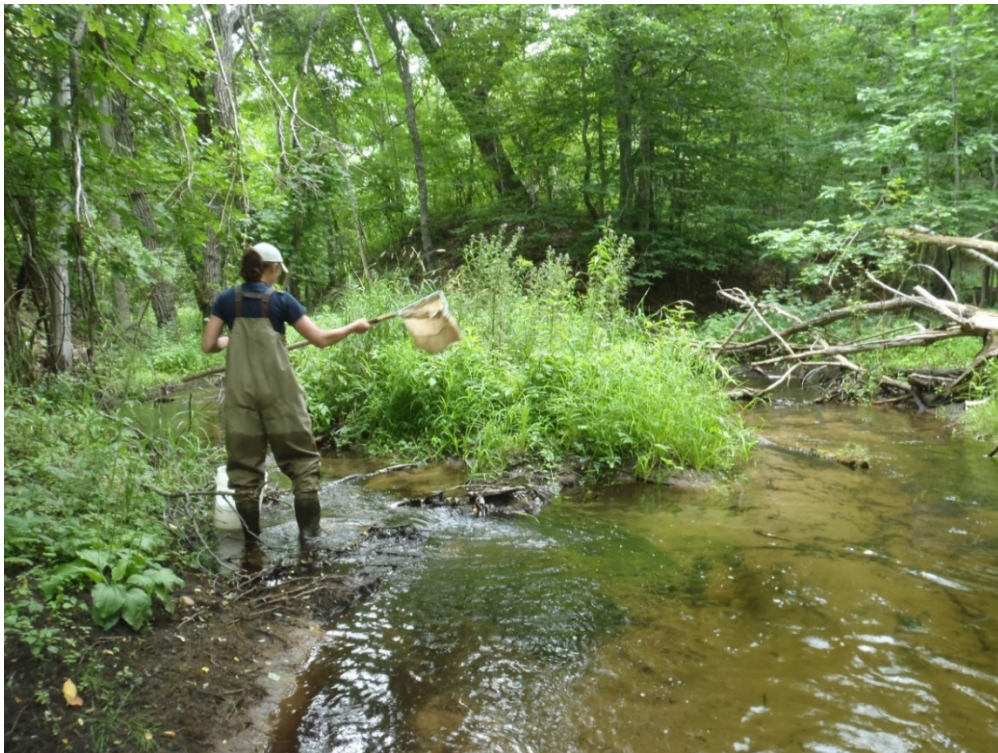
Mason Creek was sampled upstream (Station 8a) and downstream (Station 8b) of Duck Lake Road in anticipation of a planned road crossing replacement. The riffle/run habitat at Station 8a was rated good (138; Table 13). The riparian habitat upstream of the road was a forested wetland floodplain (Figure 14 and Figure 15). There was a lot of shifting sand with one deposit forming an island, but pool diversity was good and there was a lot of LWD for macroinvertebrates to colonize. Small amounts of aquatic macrophytes and gravel were also present, but the gravel was partially embedded and not readily available for colonization. The road crossing consisted of two small culverts, which were greatly undersized for the size of the stream. Upstream the culverts appeared to act as a dam, backing up water during high flow events. Even under the low flow conditions we observed, the culverts were half underwater. The banks were bare in spots as much as three feet above the surface of the water, and sediment deposits were evident. Downstream of the road crossing, the riffle/run habitat was rated as good (143; Table 13). The culverts were perched and a plunge pool that was much wider than the average width of the stream had formed (Figure 16). Further downstream remnants of an old dam were present (Figure 17). Upstream of the dam, gravel and riffle areas were abundant, but downstream of the dam was a deeper pool with a silt bottom (Figure 18). The riparian area has been greatly impacted by landowners and is often mowed to the edge. Duck Lake was visible from this site. The macroinvertebrate community was rated as acceptable both upstream and downstream of the road crossing (-1; Table 14 and Table 15). One additional mayfly family was found upstream, while two additional caddisfly were found downstream. A few more snails and surface air breathers were found downstream, but the numbers of EPT individuals increased downstream. Overall, a large difference in macroinvertebrate communities was not observed. It is anticipated that a lot of sediment will be moving through the system when the road crossing is replaced.

Figure 14. Sediment deposit in Mason Creek upstream of Duck Lake Road, Grand Traverse County, Michigan.

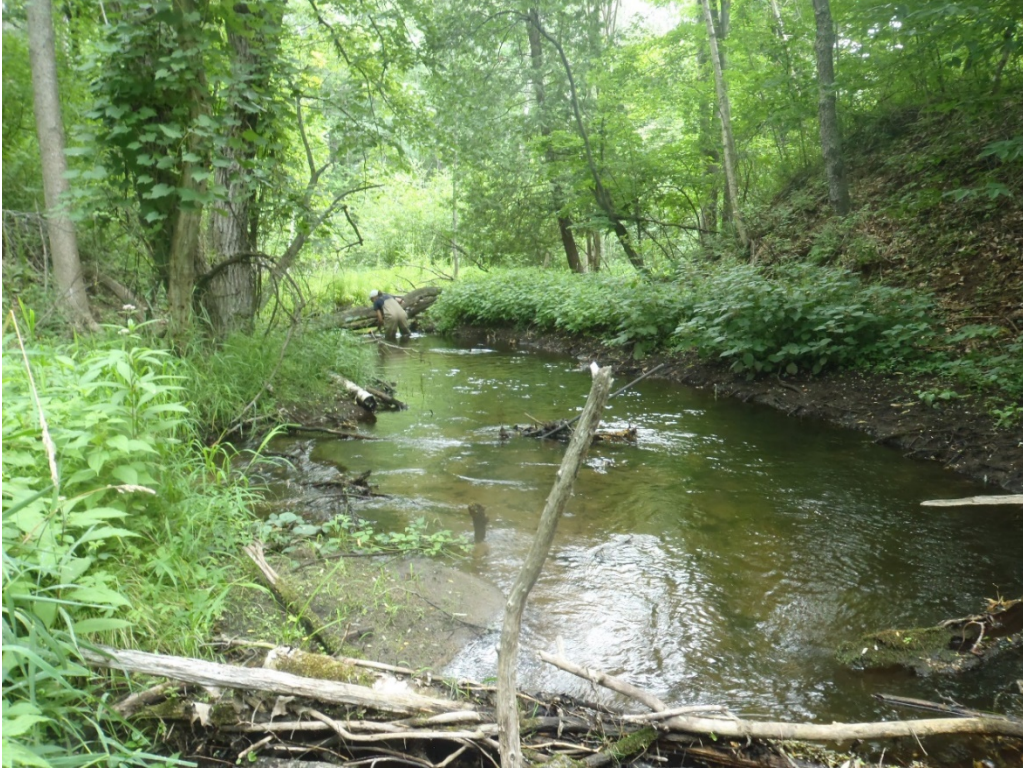
**Figure 15. Mason Creek upstream of Duck Lake Road, Grand Traverse County, Michigan.**

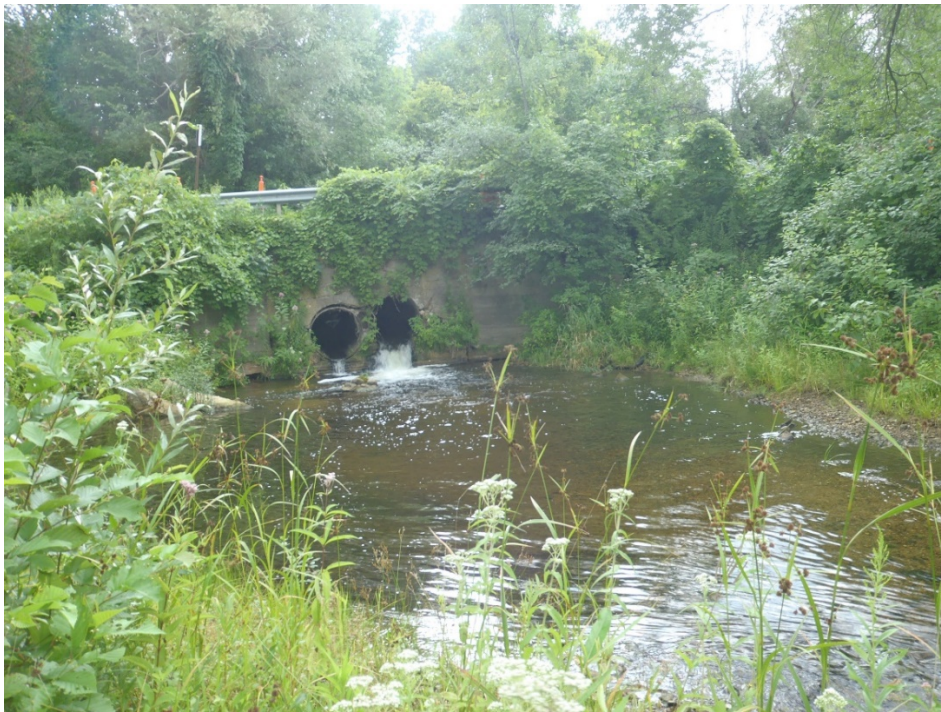
**Figure 16. Mason Creek downstream of Duck Lake Road. Grand Traverse County, Michigan.**

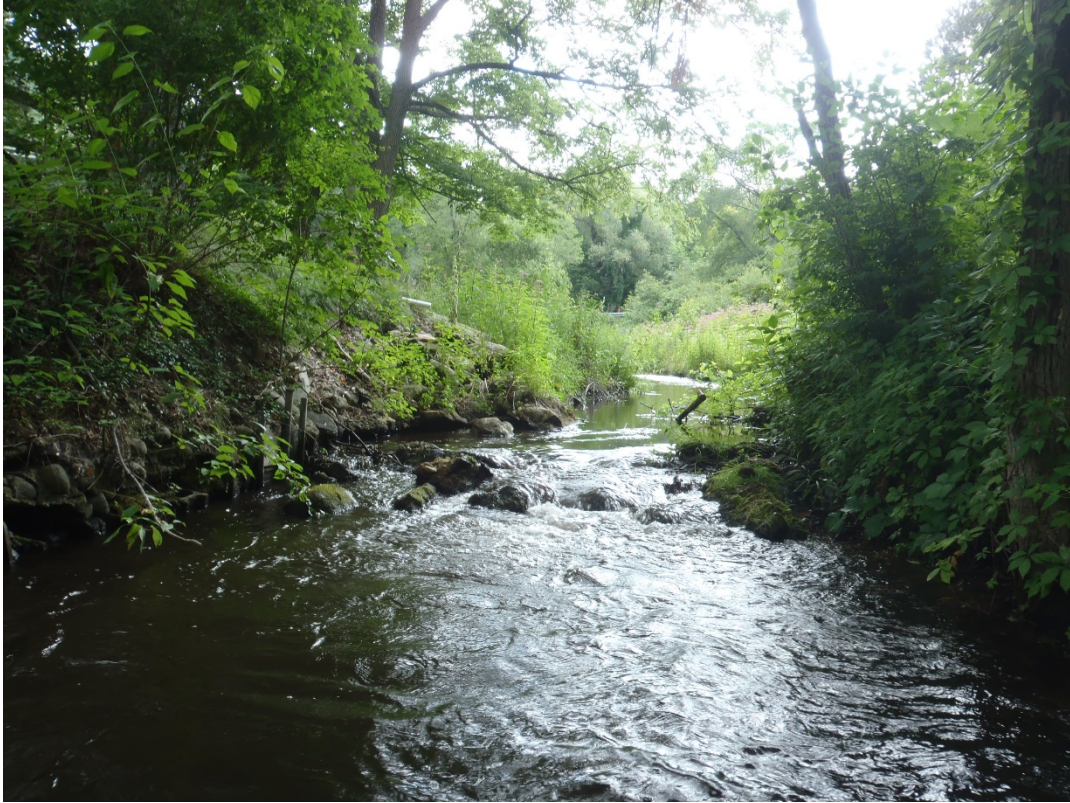
**Figure 17. Dam remnants in Mason Creek downstream of Duck Lake Road, Grand Traverse County, Michigan.**

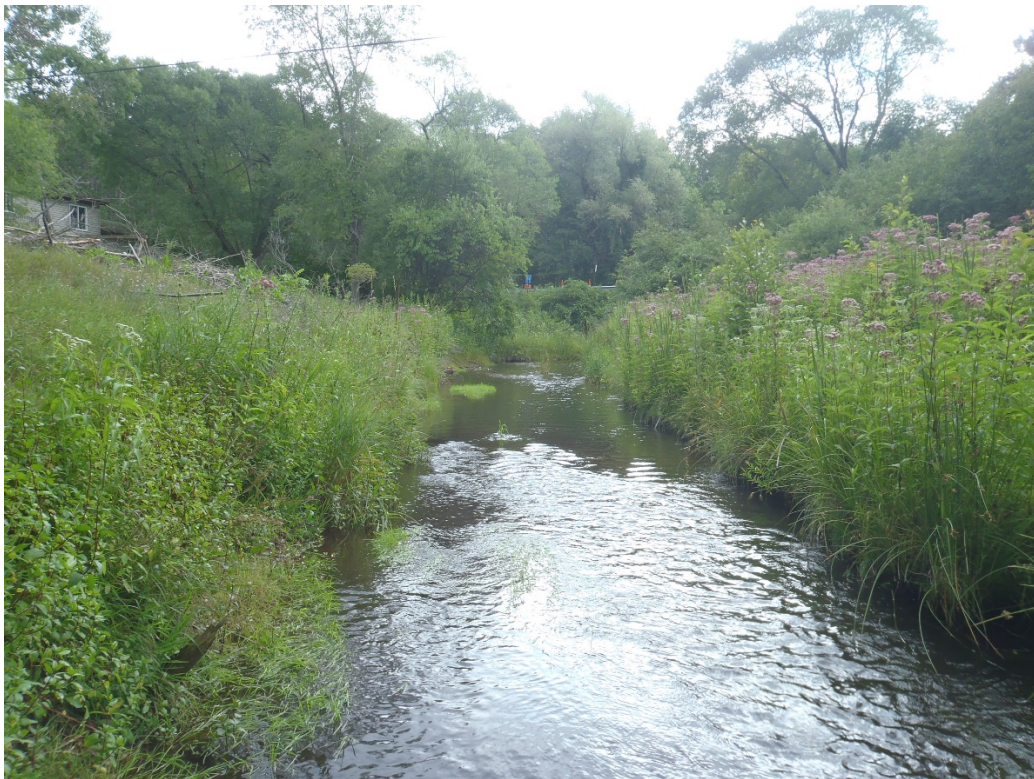
**Figure 18. Mason Creek downstream of Duck Lake Road, looking upstream, Grand Traverse County, Michigan.**

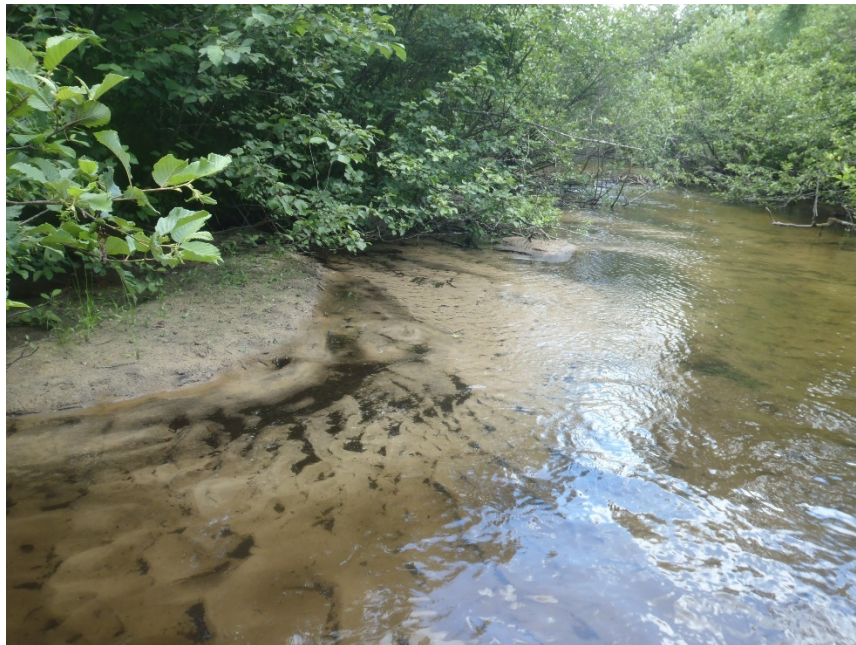
Station 10 was sampled 1.3 miles downstream in the Little Betsie River at Bentley Road. The riffle/run habitat was rated good (141; Table 13). This station is approximately 1.7 miles downstream of Nessen Road. The right side of the stream has a riparian area that is constrained to 10-20 feet in width due to Bentley Road running almost parallel to the stream. Large trees were not abundant. The substrate was primarily sand with some sparse gravel. A large sand deposit was noted at the upstream end of the sampling reach (Figure 19). Some LWD was available for colonization. The water temperature was 5 degrees Fahrenheit (F) warmer than the Nessen Road site. Reasons are not clear, but it is noted here for future reference. The macroinvertebrate community was rated as acceptable (-1; Table 14 and Table 15). No stoneflies were found and only 13 *Baetidae* made up the mayfly community. *Baetidae* can be tolerant of more conditions than many mayfly families. Six *Trichoptera* families were present. *Amphipoda* were dominant at 62 percent.

Figure 19. Little Betsie River upstream of Bentley Road, July 2018, Manistee County, Michigan. Note the shifting sand deposits.

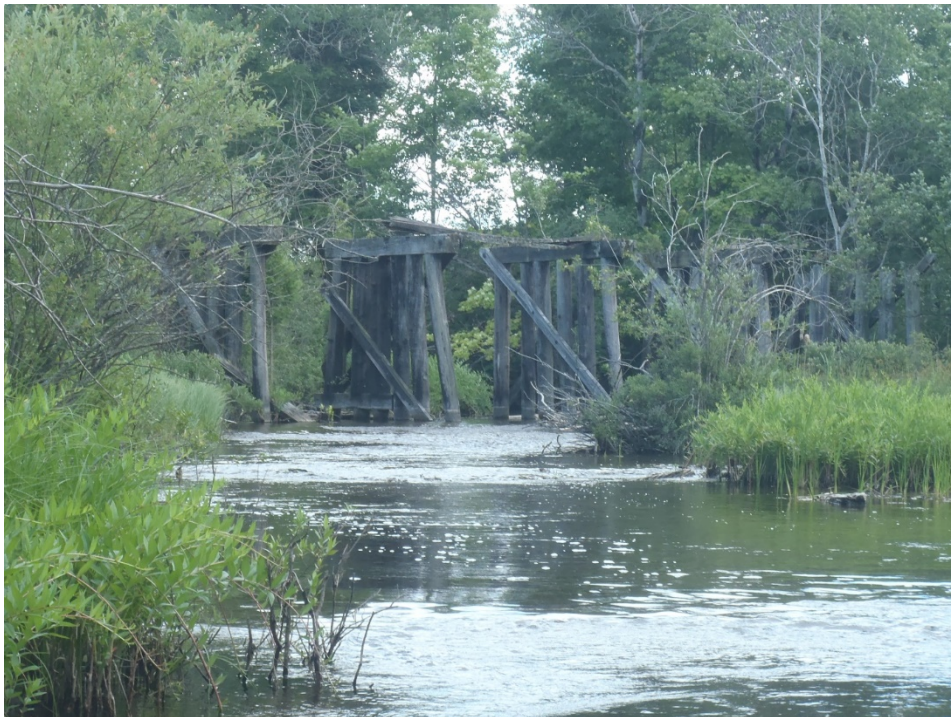
**Figure 20. Betsie River upstream of Nostwick Road. July 2018, Manistee County, Michigan.**

Stations 11, 12, and 13 were sampled in the Betsie River at Nostwick, Reynolds, and off Old Grade Road, respectively. Both Stations 11 and 12 are in the upper portions of the watershed while Station 13 is in the mid portion of the watershed. The riffle/run habitat at Nostwick Road Station 11 was rated excellent (183; Table 16). The transect was started upstream of an old bridge (Figure 20). The riparian area was natural on the right and was a field and yard on the left. There was a lot of gravel and cobble, and a fair amount of LWD and in-stream vegetation. The water temperature was very warm at 79 degrees F. The Betsie River is impounded approximately two miles upstream of this station and likely impacts the river temperature. The macroinvertebrate community also was rated excellent (5; Table 17 and Table 18) with a large number of mayfly and caddisfly taxa but no stonefly. Overall diversity was very high as well at 32 taxa.

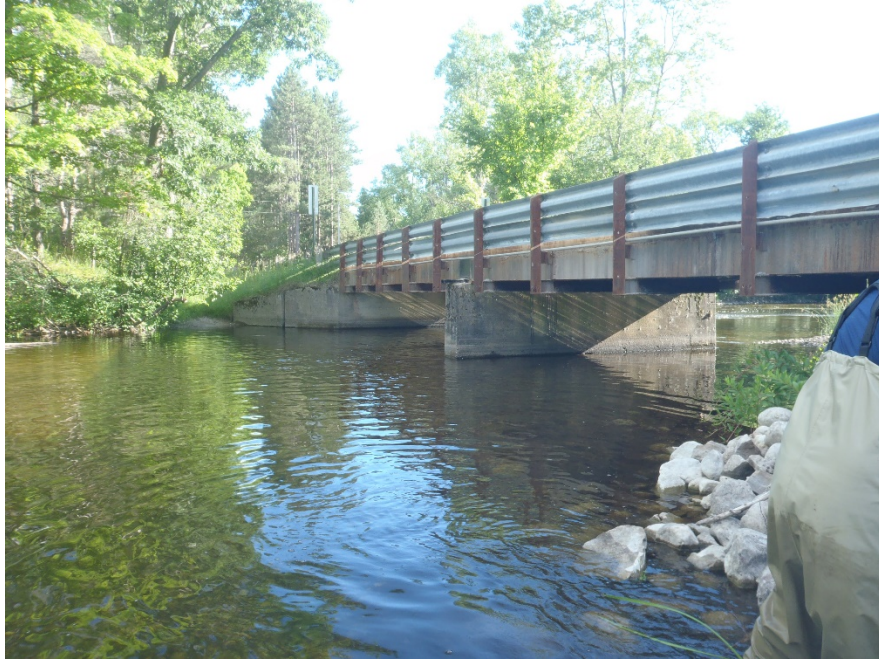
**Figure 21. Betsie River upstream of Reynolds Road, Benzie County, Michigan, July 2018.**

The glide/pool habitat 0.7 miles upstream at Reynolds Road (Station 12) was also rated excellent (156; Table 16). The river was wider and shallower at this station with less LWD and habitat diversity (Figure 21). There was a large amount of algae and more silt and the water temperature continued to be warm (80 degrees F). The macroinvertebrate community was rated acceptable (-1; Table 17 and Table 18). Fewer EPT taxa and less caddisfly density were found than when compared with the downstream Nostwick Road station.

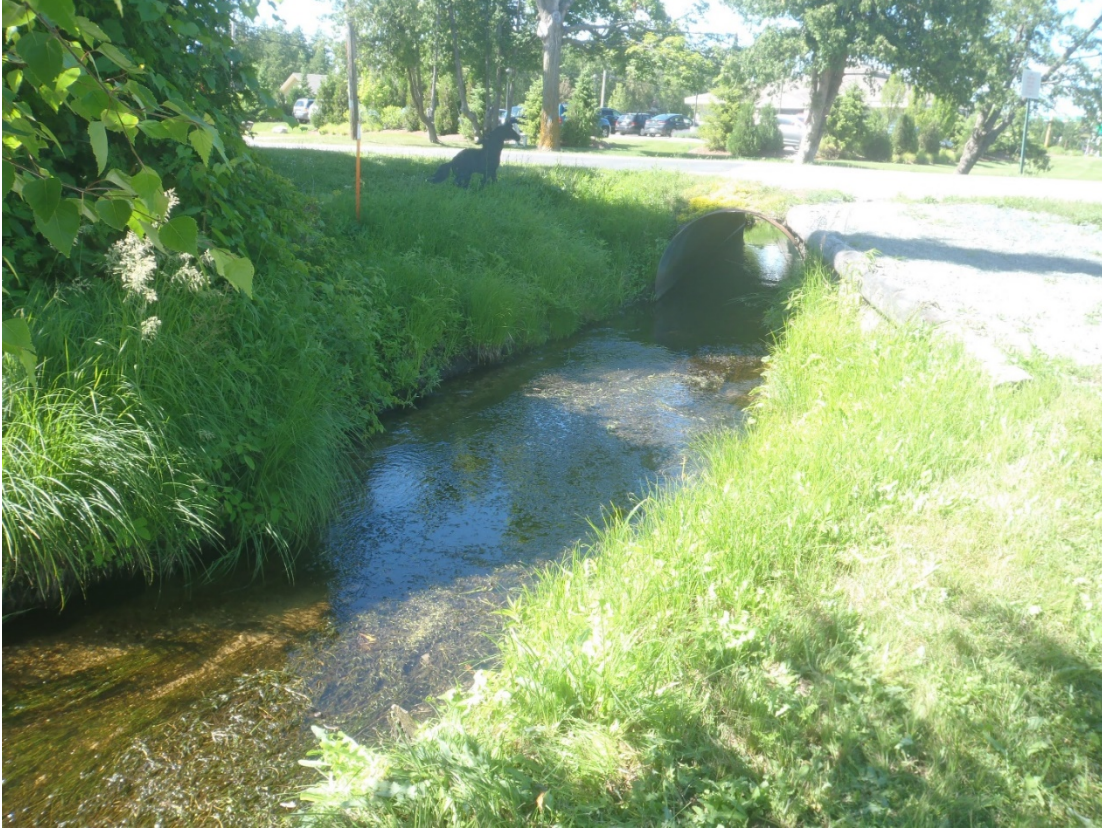
The north and south branches of Cold Creek were sampled at Stations 14 and 15. The north branch was sampled downstream of East Street (Figure 22). The glide/pool habitat scored marginal (86; Table 19). The water temperature was measured at 70 degrees F. The macroinvertebrate community was rated as poor (-6; Table 20 and Table 21). The coldwater fish community was meeting the coldwater fish designated use with 4% of salmonids being present (Table 22). However, the Central Mudminnow, a very tolerant species, made up almost half of all the individuals found. Additional details can be found in the Objectives 3 and 4 section below.

**Figure 22. Cold Creek downstream of East Street. Note the lack of overhanging vegetation and lack of riparian cover to shade stream. Beulah, Michigan, July 2018.**

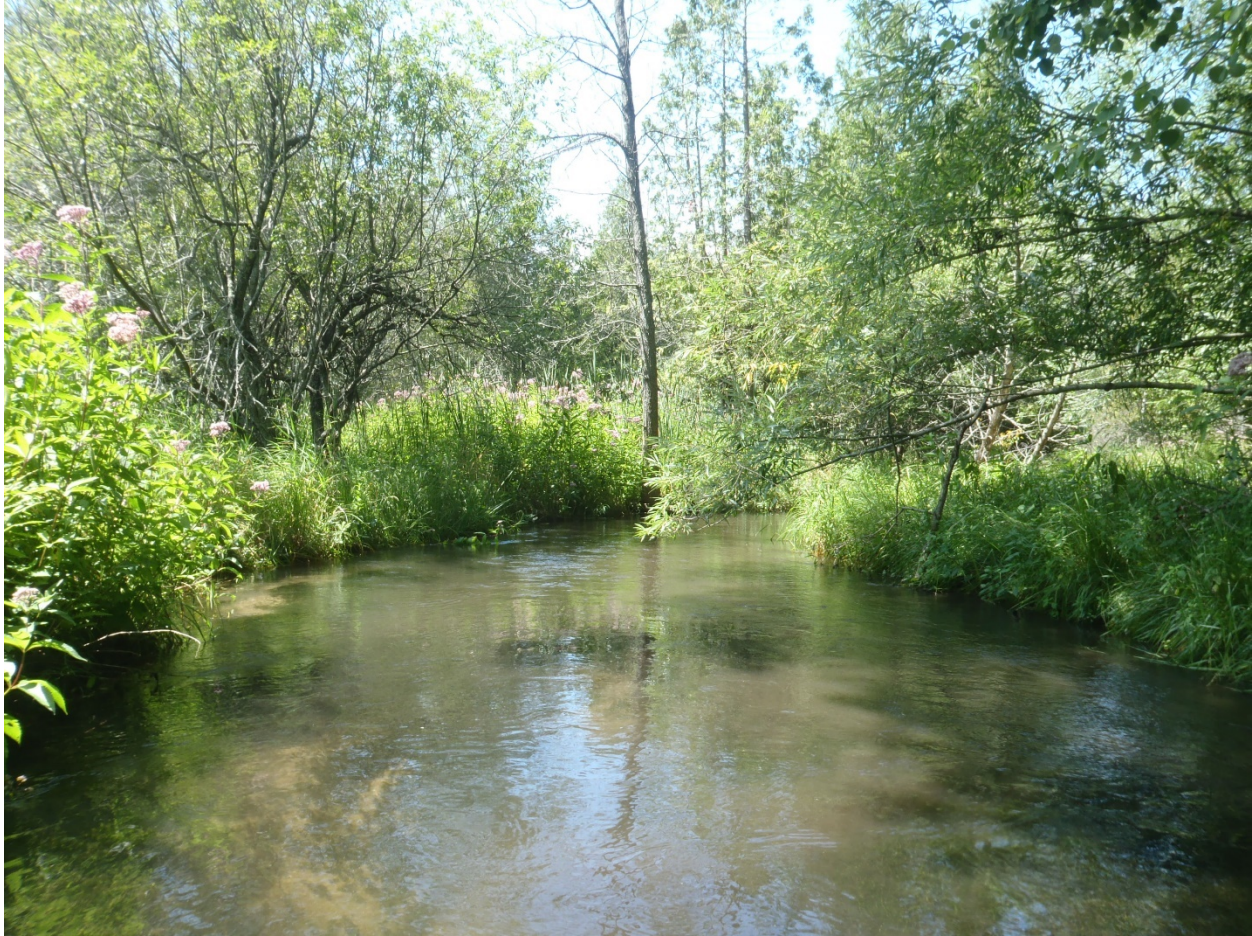
Figure 24. Bowens Creek downstream of Gilbert Road, Manistee County, Michigan, August 2018.

Bowens Creek was sampled downstream of Gilbert Road at Station 16. The glide/pool habitat scored good (146; Table 19). The riparian area was primarily wetland vegetation, with swamp milkweed, cedars, cattails, and willows (Figure 24). The temperature was very cold at 59 degrees F. The substrate was primarily shifting sand and silt, sinking up to two feet in places. There was no gravel or cobble, but some LWD was present and there were deep pools with lots of aquatic vegetation (*Elodea*) for substrate and cover. The macroinvertebrate community was rated at the low end of acceptable (-4; Table 20 and Table 21). There was only one mayfly taxa and the number of individuals was very low. There was one stonefly and four caddisfly taxa but again the numbers were low. The dominant taxa were midges at almost 60%. More discussion can be found in the Objectives 3 and 4 section below.

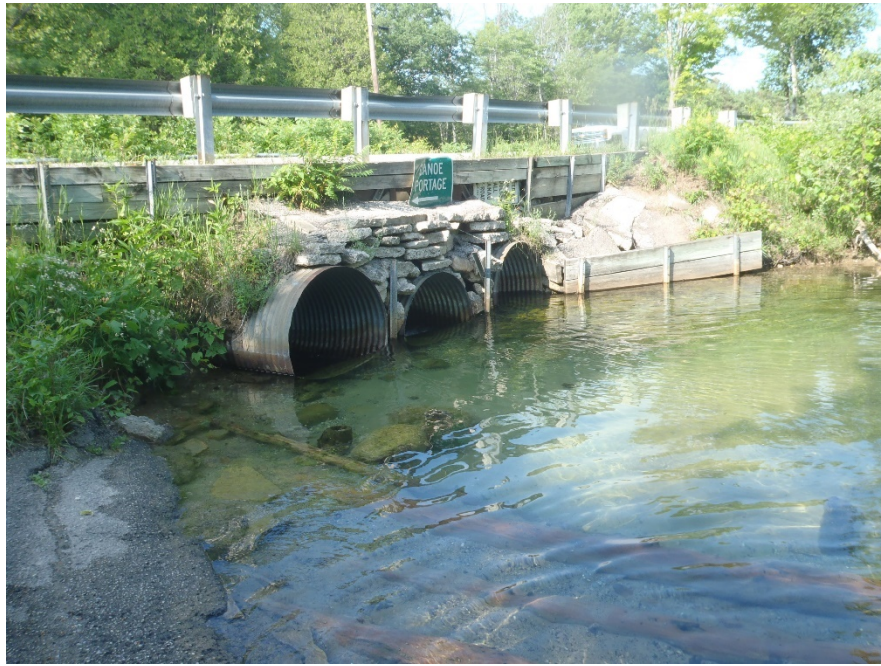
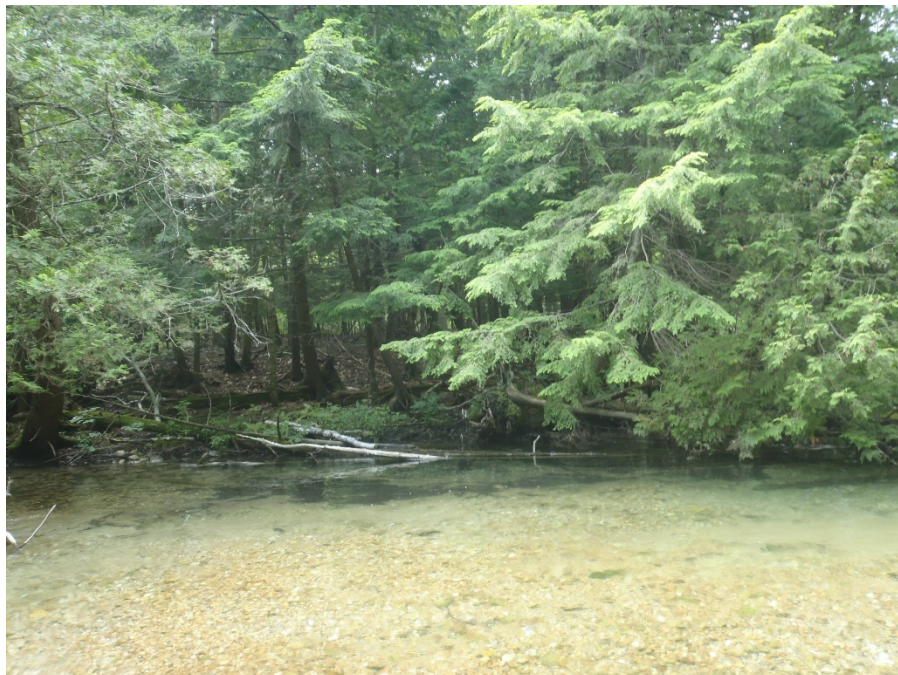
In 2013 the Crystal River was sampled downstream of Crystal View/County Road 675, which is in critical need of replacement. Currently, the three culverts do not allow sufficient flow resulting in sediment deposition and a very wide channel with a uniform stream bottom lacking pool habitat diversity upstream of the culverts (Figure 25 and Figure 26). This road crossing would be a great candidate for a road crossing replacement project.

**Figure 25. Road Crossing at County Road 675, Crystal River, Leelanau County, Michigan, July 2018.**

**Figure 26. Sand deposition and widening pool upstream of County Road 675, caused by water not flowing properly through the culvert. Crystal River, Leelanau County, Michigan, July 2018.**

- 1) The culverts at the Crystal River at the Crystal View Road/County Road 675 road crossing are in critical need of replacement. Currently, the three culverts do not allow enough flow resulting in sediment deposition and a very wide channel with a uniform stream bottom that lacks the pool habitat diversity found upstream near Fisher Road.

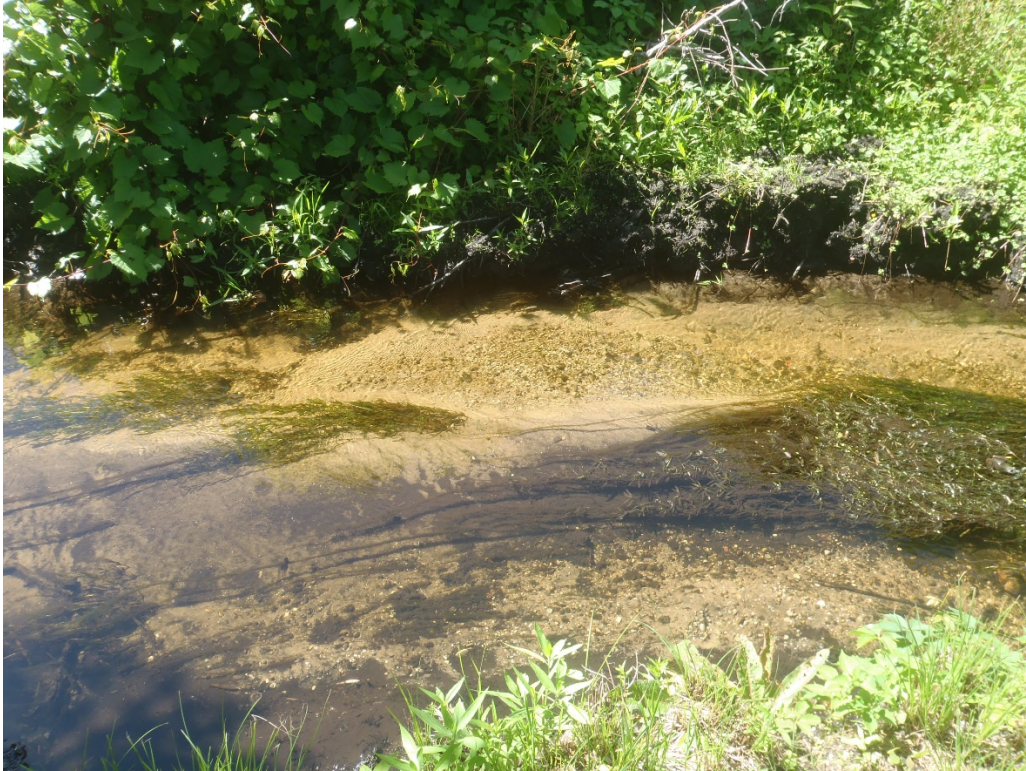
The first station sampled was the north branch of Cold Creek downstream of East Street. Monitoring could not be conducted upstream because there was not much distance available for sampling prior to the US-31 road crossing. The glide/pool habitat scored marginal (86; Table 19). The creek is a straight channel that runs along a mowed field that is adjacent to US-31. The substrate was a silt and sand mix (Figure 27). The muck was at least 2 feet deep in areas. Aquatic vegetation, sparse rootwads, and undercut banks was the only colonizable substrate available. The water temperature was very warm for a coldwater stream at 70 degrees F. The macroinvertebrate community was rated as poor (-6; Table 20 and Table 21). A low diversity of taxa, a lack of EPT taxa, and the dominance of isopods are all indicators of poor habitat and/or water quality conditions. Sedimentation likely contributes as a cause of nonattainment of the OIALW designated use. It was not clear if the channel is maintained as a county drain. The coldwater fish community was meeting the coldwater fish designated use with four percent of salmonids being present (Table 22). However, the Central Mudminnow, a very tolerant species, made up almost half of all the individuals found.

**Figure 27. Silt covering vegetation in Cold Creek downstream of East Street, Benzie County, Michigan, July 2018.**
