**MICHIGAN DEPARTMENT OF ENVIRONMENT, GREAT LAKES, AND ENERGY  
WATER RESOURCES DIVISION  
MARCH 2020  
STAFF REPORT**

**Biological and water chemistry surveys of selected stations in the Betsie, Platte, and Crystal Rivers, and Herring and Bowens Creeks watersheds; Benzie, Leelanau, Grand Traverse, and Manistee Counties, Michigan; June-September 2018**

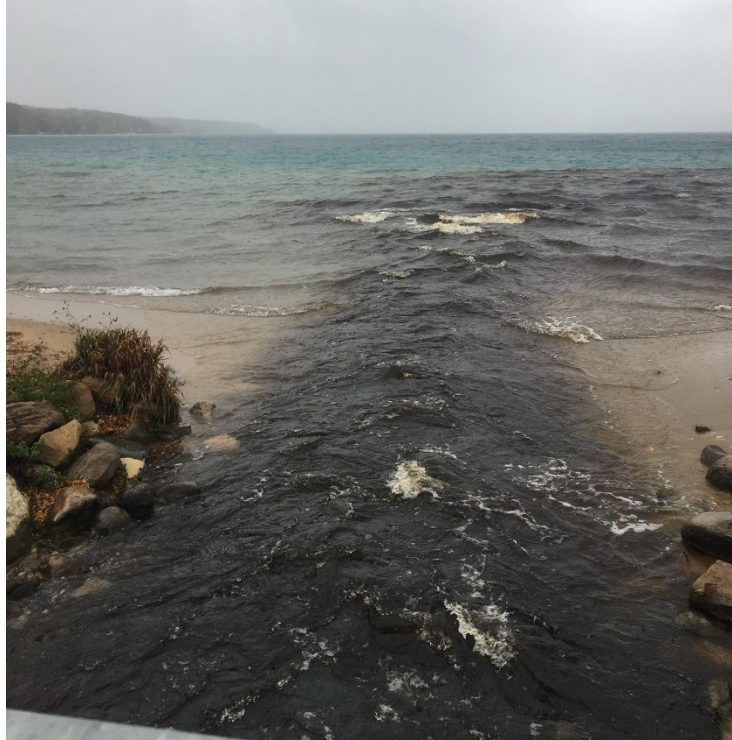
Figure 28. Cold Creek confluence with Crystal Lake during a rain event, October 2018, Beulah, Michigan.

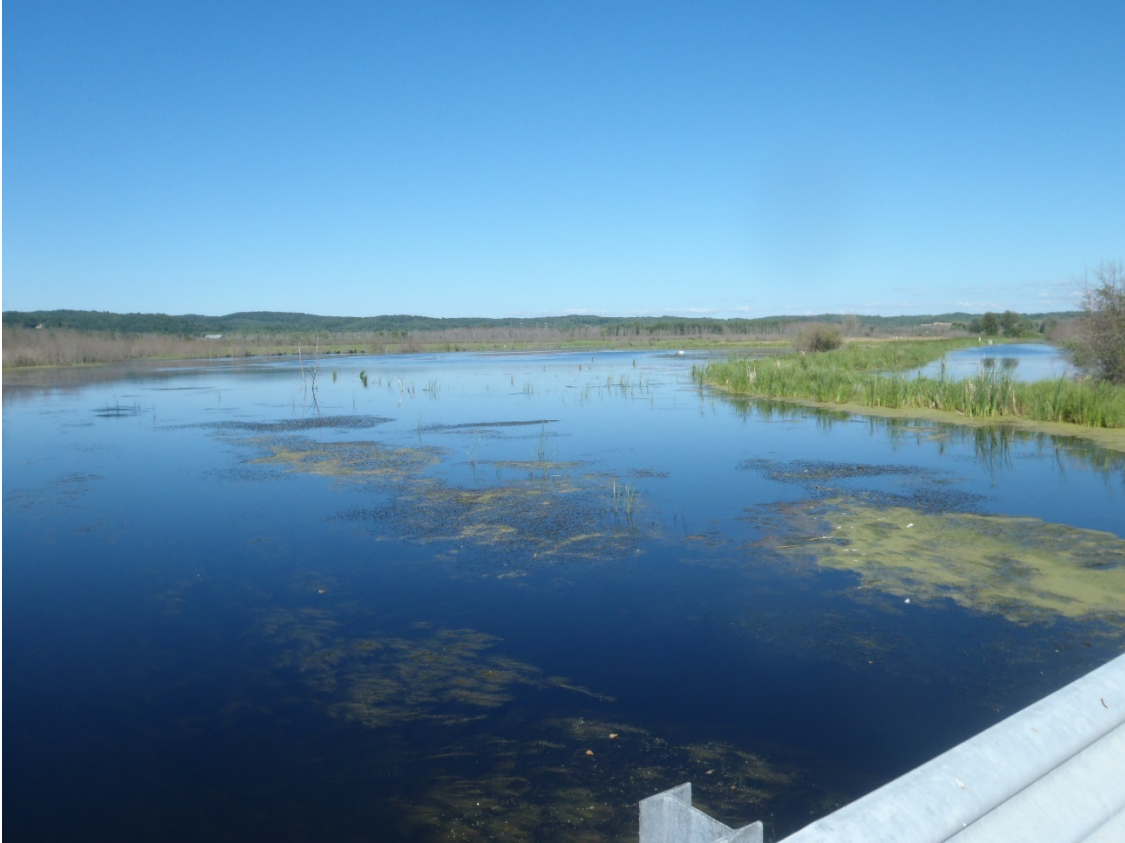
**Figure 29. Arcadia Marsh upstream of Northwood Highway, downstream of restored area. Arcadia, Michigan, July 2018.**

The 2018 sampling plan included determining the OIALW designated use support in the lower reaches of Bowens Creek. One survey was conducted downstream of the restored section and one at St. Pierre Road upstream of the restored section. However, it was not possible to sample downstream of the restored section using Procedure 51 because it is a wetland/lake area and not a wadable stream (Figure 29). At St. Pierre Road, the stream was also too deep for Procedure 51 sampling. Therefore, we sampled Bowens Creek downstream of Gilbert Road (Station 16), which is about .7 miles upstream of St. Pierre Road.

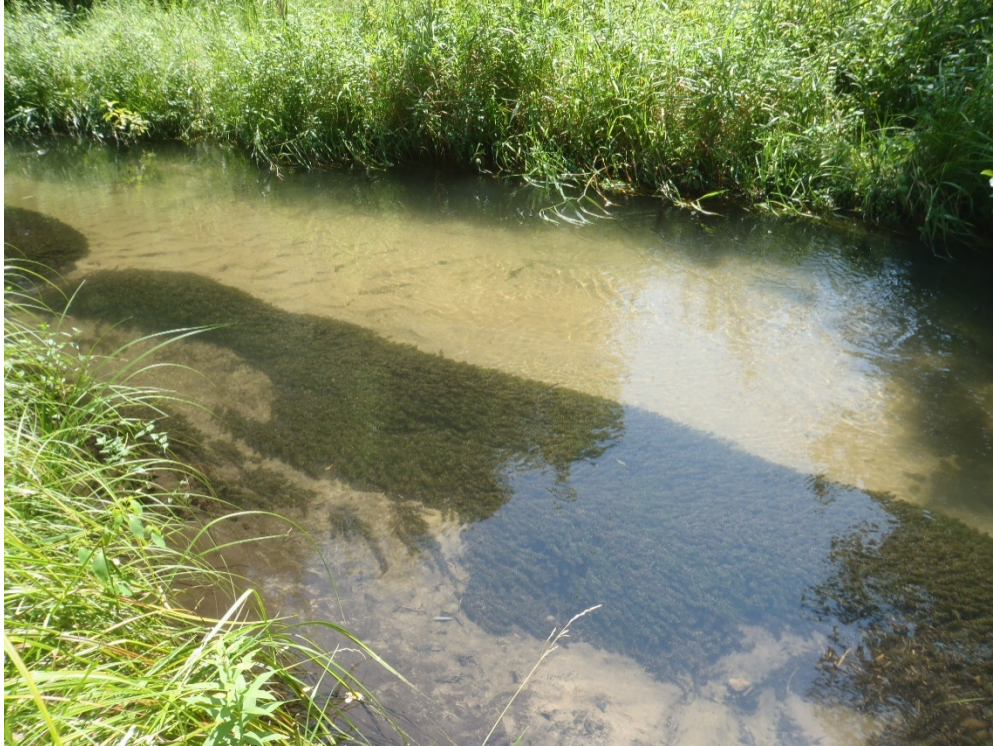
**Figure 30. Sediment in Bowens Creek downstream of Gilbert Road, Manistee County, Michigan, July 2018.**

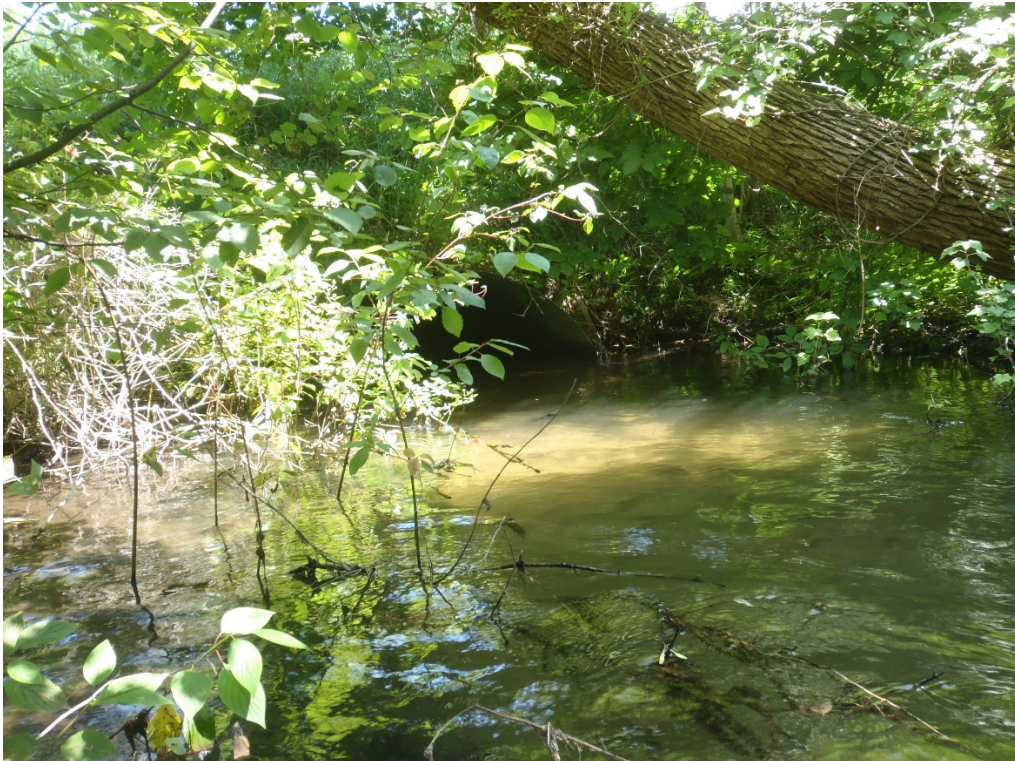
**Figure 31. Undersized Culvert and widening of stream channel downstream of Gilbert Road, Bowens Creek, Manistee County, Michigan, August 2018.**

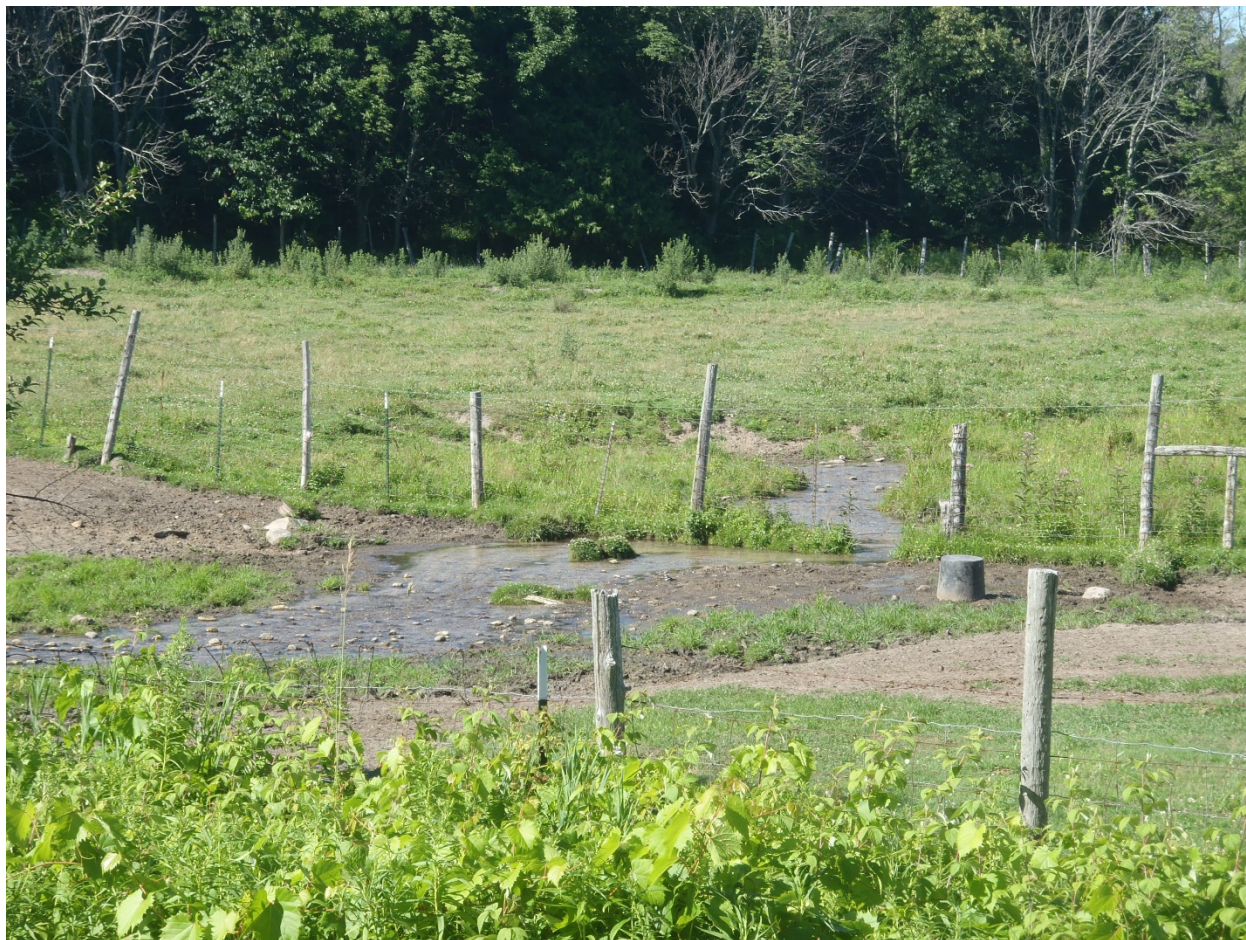
Overall the stream and riparian habitat conditions along Putney and Gorivan Roads seemed slightly improved since last observed in 2013. Although the vegetation is still actively grazed (Figure 32), the ground was not bare dirt in as many places as was observed in 2013. However, an alternate water source and exclusion of livestock should be considered to remove the potential pathogens and increased sediment entering the stream and downstream water bodies.

**Figure 32. Herring Creek upstream of Putney Road. Image shows the livestock water access area.**
