Title: Livestock exclusion fencing improves Cedar Creek habitat and macroinvertebrates

Water body improved: Cedar Creek (AUID number 040500060406-02) is in the Cedar Creek sub-watershed within the Rogue River watershed located in Kent County, Michigan. Cedar Creek is listed on the Clean Water Act Section 303(d) list of impaired waters for a Fish Consumption Designated Use impairment due to polychlorinated biphenyls. While Cedar Creek is listed as fully supporting the Other Indigenous Aquatic Life and Wildlife Designated Use, there are areas where macroinvertebrate scores are acceptable, but trending toward poor.

Project highlights: Best management practices (BMPs) installed in 2015 were 1,300 feet of livestock exclusion fencing, restricted cattle crossing, and trees along with native vegetation planted on stream banks.

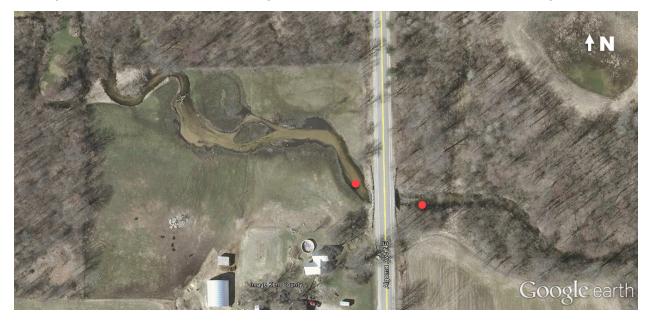
Figure 1. Aerial of Cedar Creek in April 2009 with extensive livestock access, before exclusion fencing was installed. Stream is flowing west to east. Red dots represent sampling locations.

Problem: Unlimited cattle and horse access created a wide muddy stream channel with trampled banks. Instream habitat and macroinvertebrate populations were degraded (Figure 1).

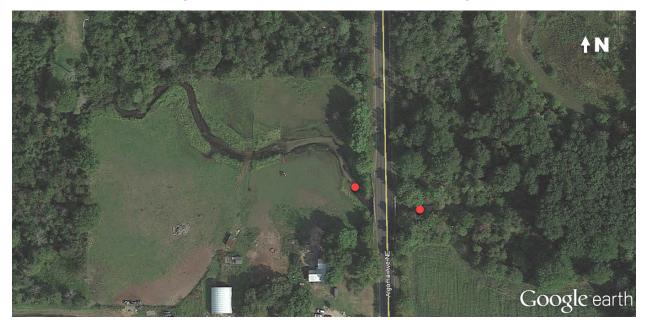
Figure 2. Post BMP aerial of Cedar Creek in September 2017 after exclusion fencing was installed. Stream is flowing west to east. Red dots represent sampling locations.

Results: BMP installation narrowed the stream channel and stabilized the banks where fencing was installed and vegetation planted (Figure 2). Based on the Michigan Department of Environmental Quality's (MDEQ's) biological and habitat monitoring protocol, livestock exclusion had beneficial impacts on instream habitat (Table 1) and the macroinvertebrate community (Table 2). Specifically, improvements were mostly measured on the upstream side of Algoma Avenue, directly adjacent to the livestock access site.
