Michigan's
Nonpoint Source
Program

Elk River Watershed Protection

October 2015-July2019

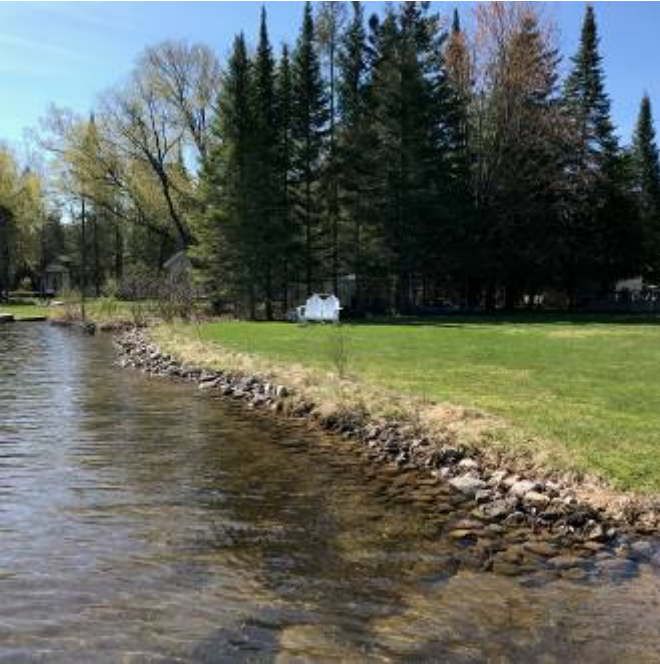
Spalding on Clam Lake Before: Maintaining turf to the water's edge. Minor erosion due to high waves overtopping existing rock revetment.

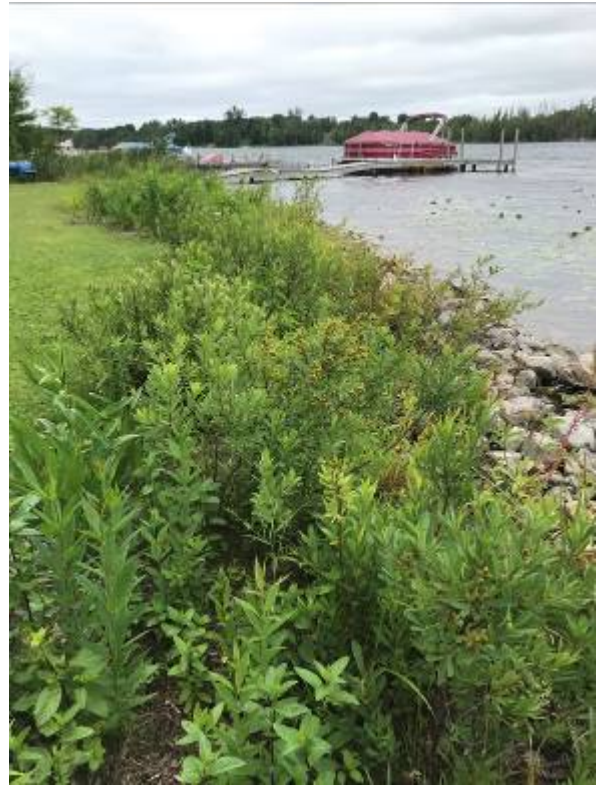
Spalding on Clam Lake After: Native plant buffer installed entire length of shoreline.

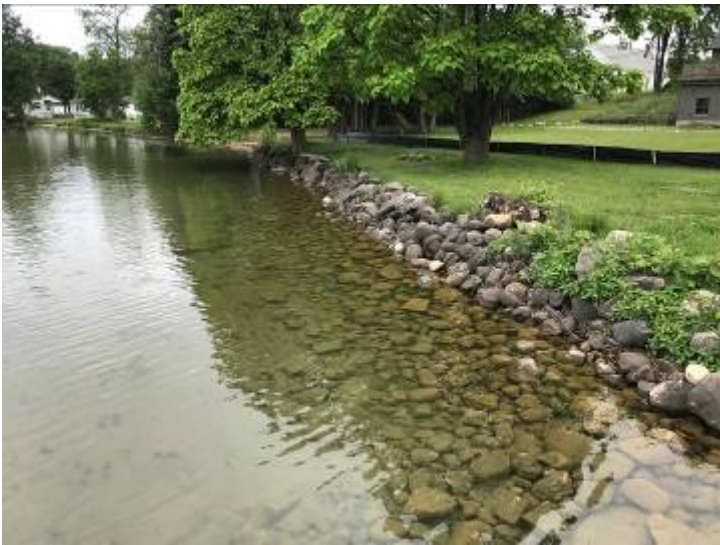
**Milton Township Park on Elk Lake After:
/ Native plant buffer installed entire length of
/ shoreline. Width varies.**
