REQUEST FOR PROPOSAL

MICHIGAN LAND BANK FAST TRACK AUTHORITY

**DEMOLITION AND ABATEMENT CONTRACTOR AT
53, 77 AND 95 WEST WOOD STREET, NEWAYGO, MICHIGAN**

Pre-Demolition and Hazardous Materials Survey

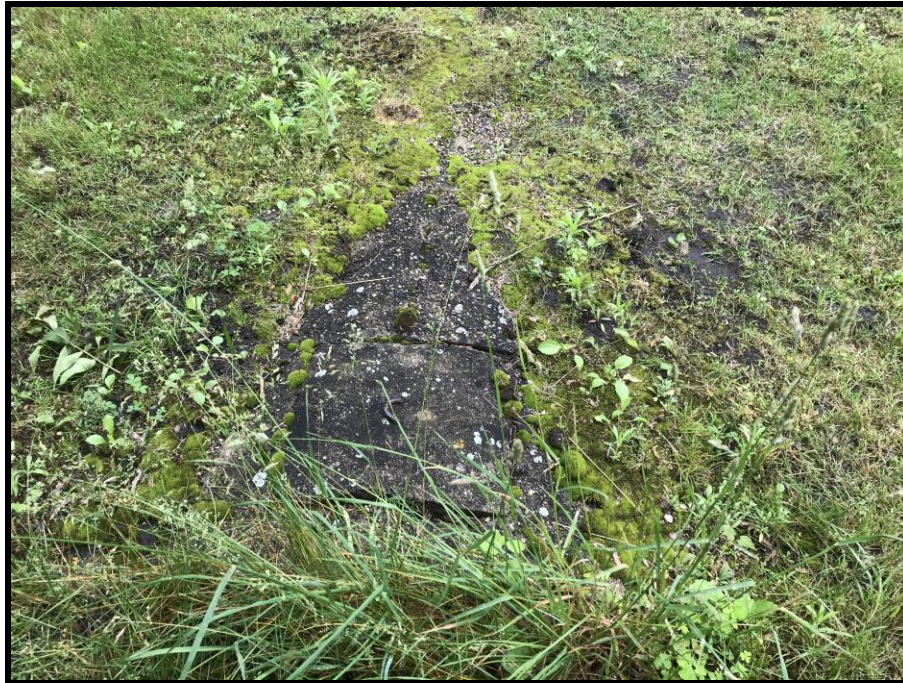
**REPRESENTATIVE VIEW OF SUSPECT SEPTIC TANK OR CISTERN
53 WEST WOOD**

- i. Contractor is responsible to cut and cap utilities other than gas and electric and pay all associated fees. This may include well capping and proper closure of any on-site sewer systems or drainage systems as detailed in Phase I/II reports, or as found by successful Respondent.
