Phase I Environmental Site Assessment

404 W. Houghton Avenue, West Branch, Michigan 48661

May 3, 2019

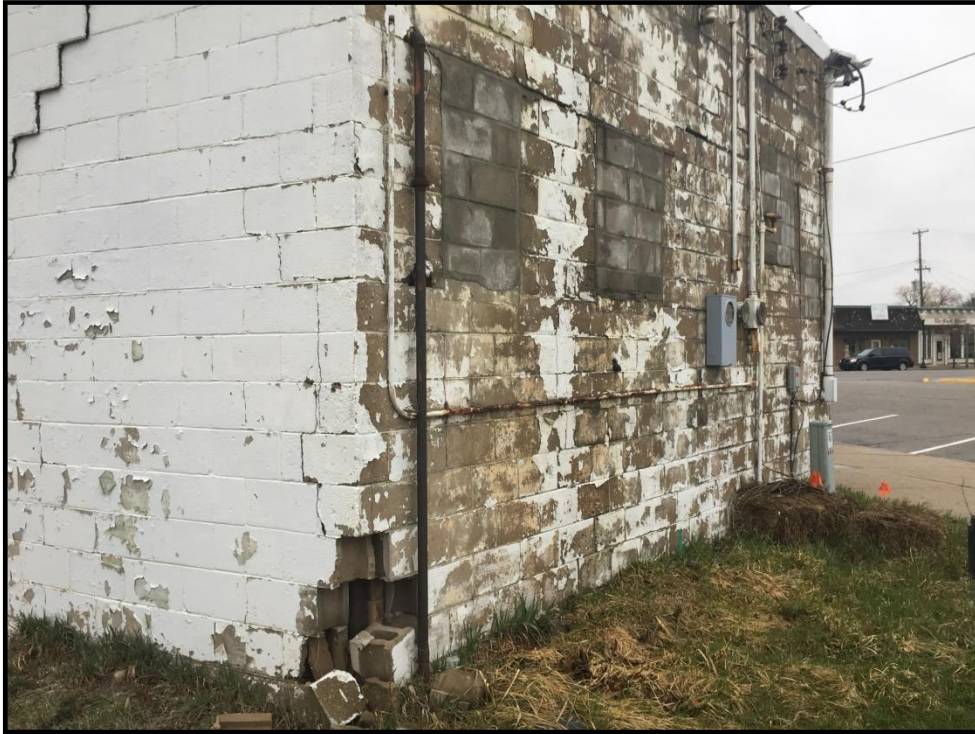
Photo 5: View of the visible exterior utilities located on the southeast corner of the Property building.

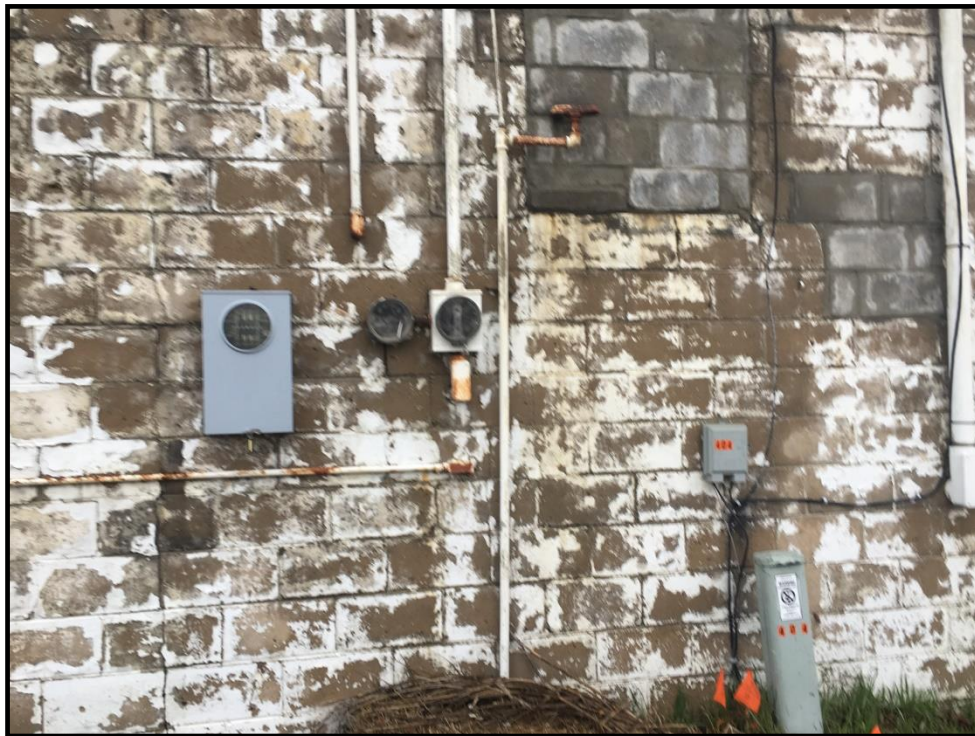
Triterra observed a potential UST vent pipe on the southeast exterior wall of the Property building. Refer to Section 4.3.4 and 5.1 for more information.

Photo 6: View of a vent pipe on the southeast side of the Property building.

During the subsurface investigation and walkover, Triterra observed a vent pipe located on the south side of the building. On April 29, 2019, Triterra returned to the Property for underground storage tank (UST) removal activities. The tank was located on the south end of the Property, about 1.5-feet from the Property building. Upon removal, the previously unidentified tank was found to be a 550-gallon heating oil tank. The tank was found empty, with a large hole on the bottom side. There were no visible signs of a release. A verification soil sample was collected from the tank basin for analysis. Concentrations of tetrachloroethene and phenanthrene in soil were reported above the MDEQ Part 201 GRCC.

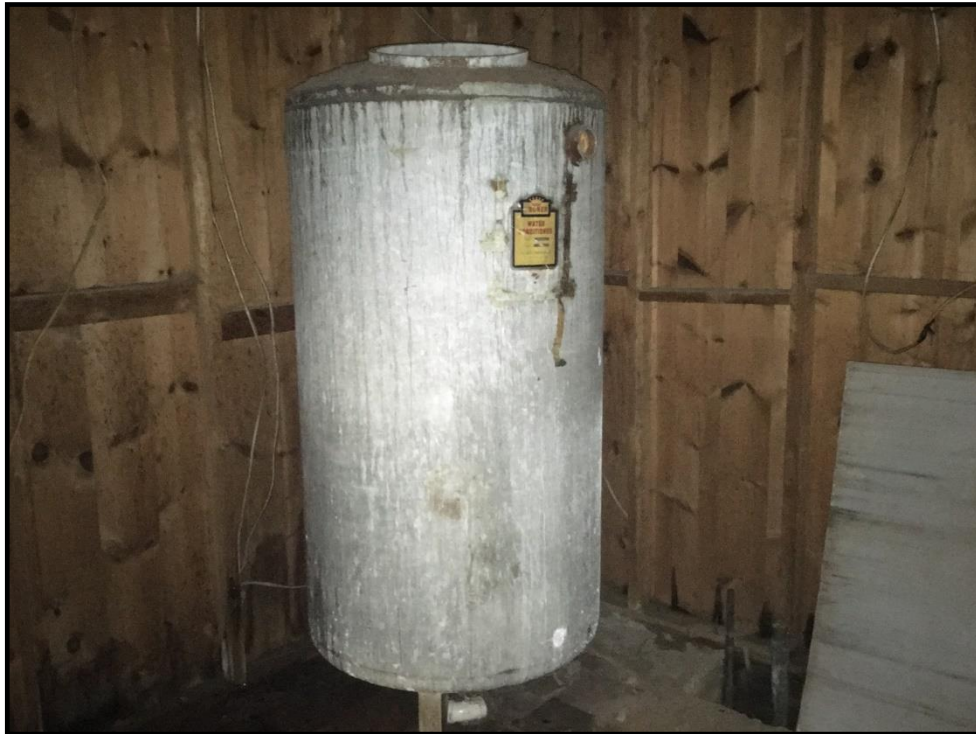
Photo 15: View of a tank labeled Water Conditioner.

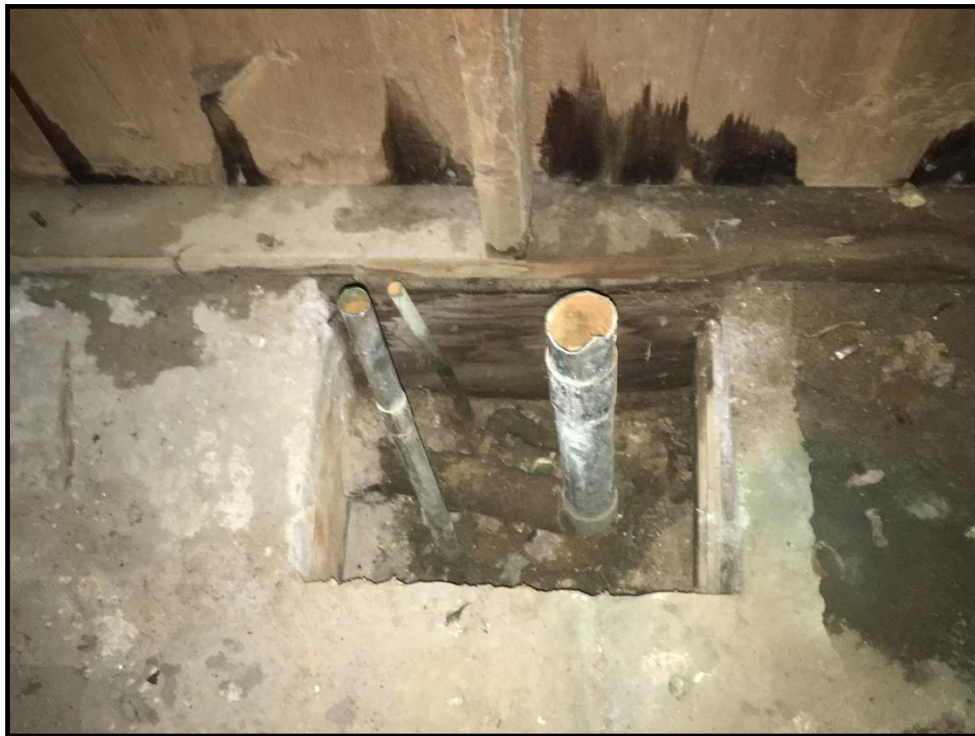
Photo 16: View of pipes that appear to have been connected to the water conditioner.

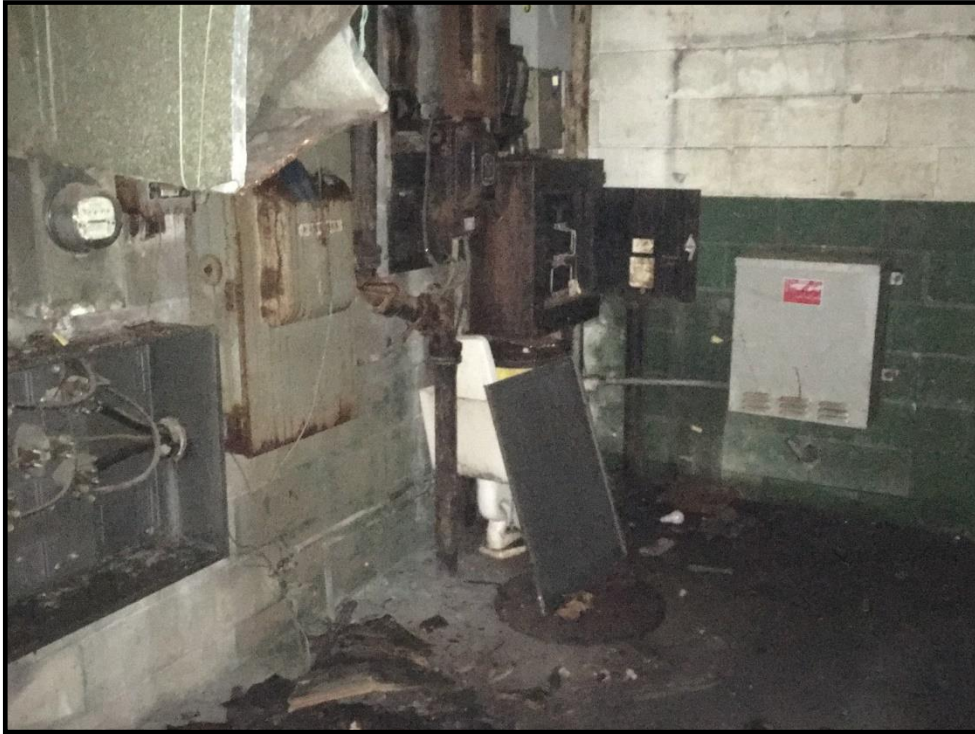
Photo 17: View of utilities inside the Property building.

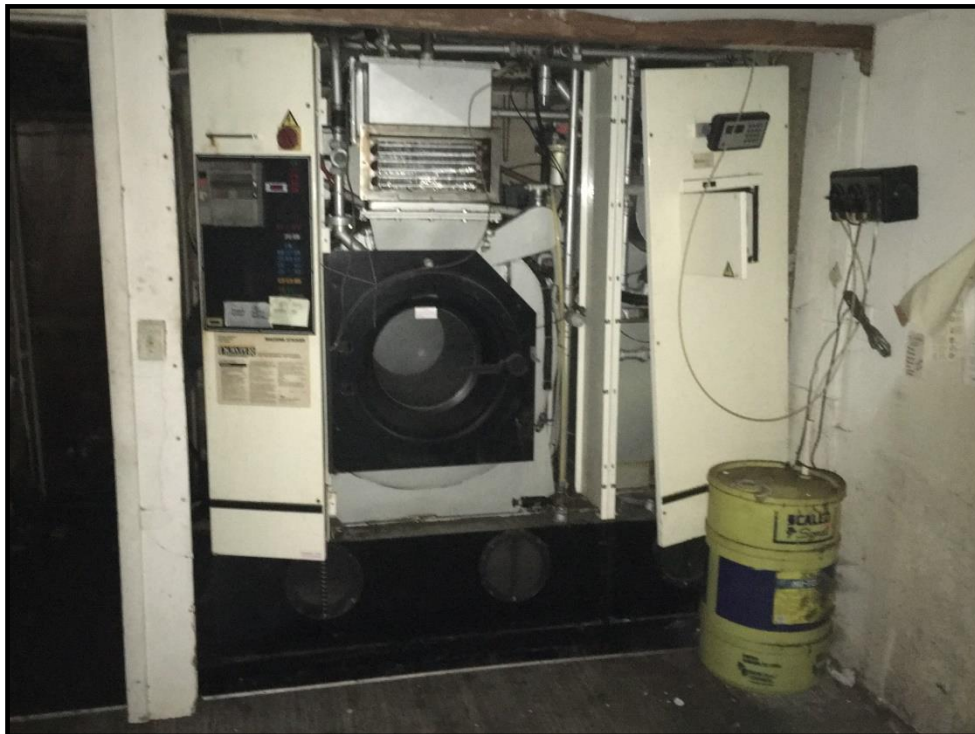
Photo 18: View of the dry cleaning machine located in the southern portion of the Property building.

A sump/catch basin was located in the south portion of the building. Floor drains were observed near the sump, beneath the dry-cleaning machine, and in the boiler room. It is Triterra's opinion that these do not represent a REC in connection with the Property.

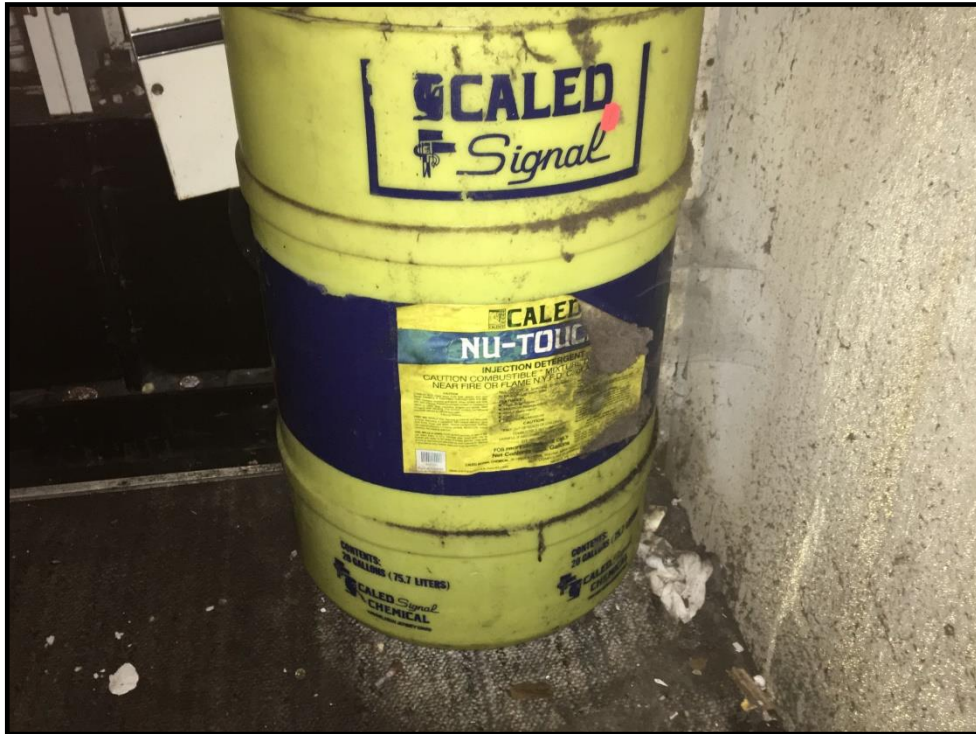
Triterra observed hazardous substances ranging in size from a 20-gallon drum to 1-gallon containers of dry-cleaning or laundromat related chemicals. Refer to Section 4.3.4 for more information.

Photo 19: View of an approximately 20-gallon drum located next to the dry cleaning machine in the southern portion of the building.

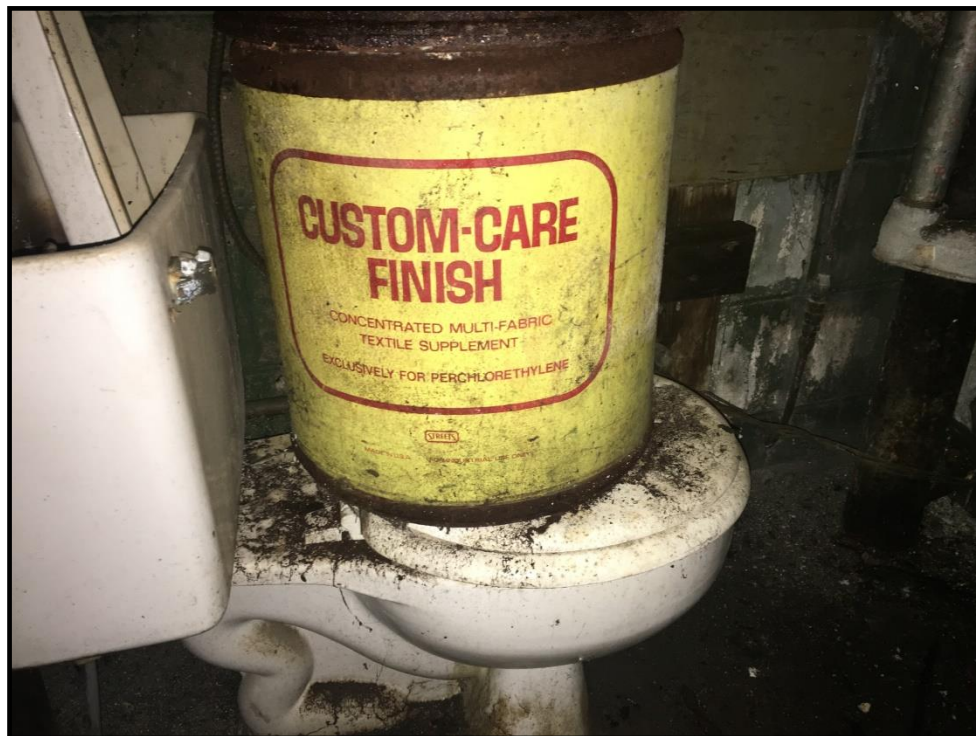
Photo 20: View of an approximately 10-gallon container located near the dry cleaning machine in the southern portion of the building.

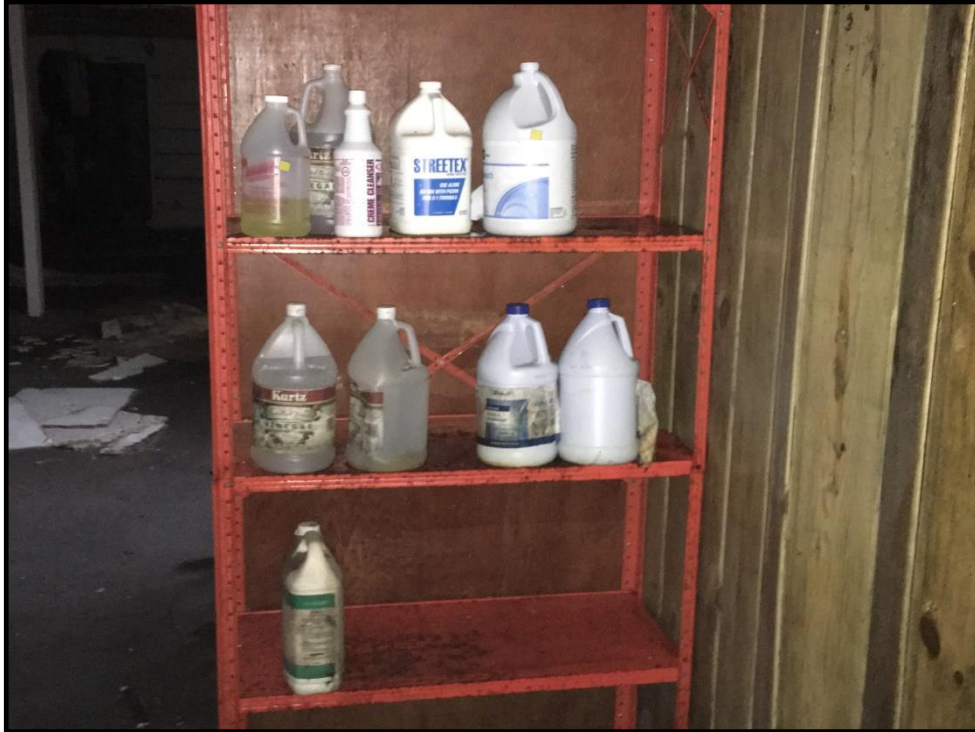
Photo 21: View of one-gallon containers of various cleaners on a steel shelf located in the southern portion of the building.

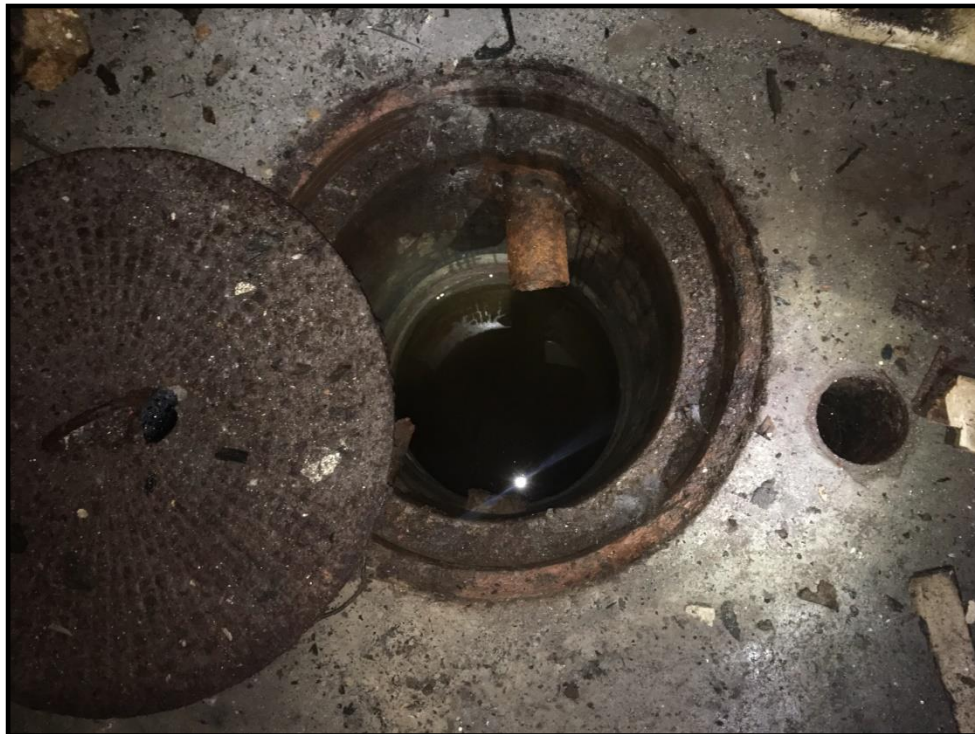
Photo 22: View of a sump and cleanout located along the southern wall inside the Property building.
