**REQUEST FOR PROPOSAL**

**MICHIGAN LAND BANK FAST TRACK AUTHORITY**

**DEMOLITION AND ABATEMENT CONTRACTOR AT**  
**404 W HOUGHTON AVENUE, WEST BRANCH, MICHIGAN**

**RFP-CASE-19-0020**

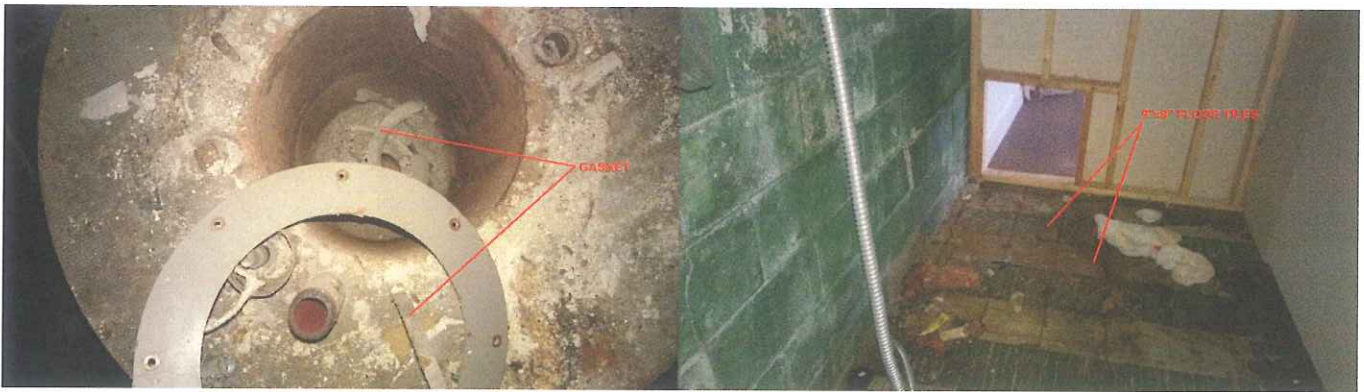
*View of fibrous gasket material and two colors of 9"x9" floor tiles.*

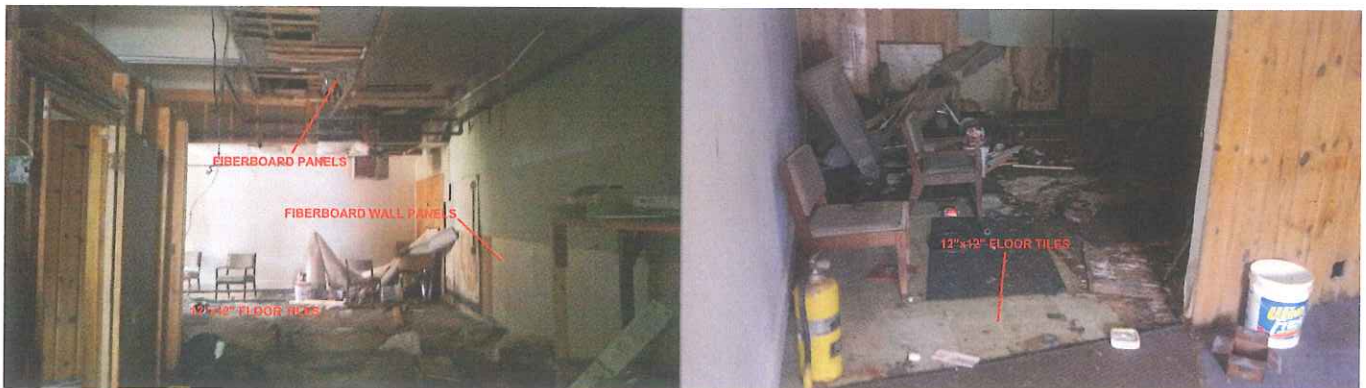
*Views of fiberboard panels, fiberboard wall panels, and 12"x12" floor tile sample locations.*
